# **Gerroa Sand Resource Annual Environmental Management Report**

**Period 01 July 2020 – 30 June 2021**

**Cleary Bros (Bombo) Pty Ltd**

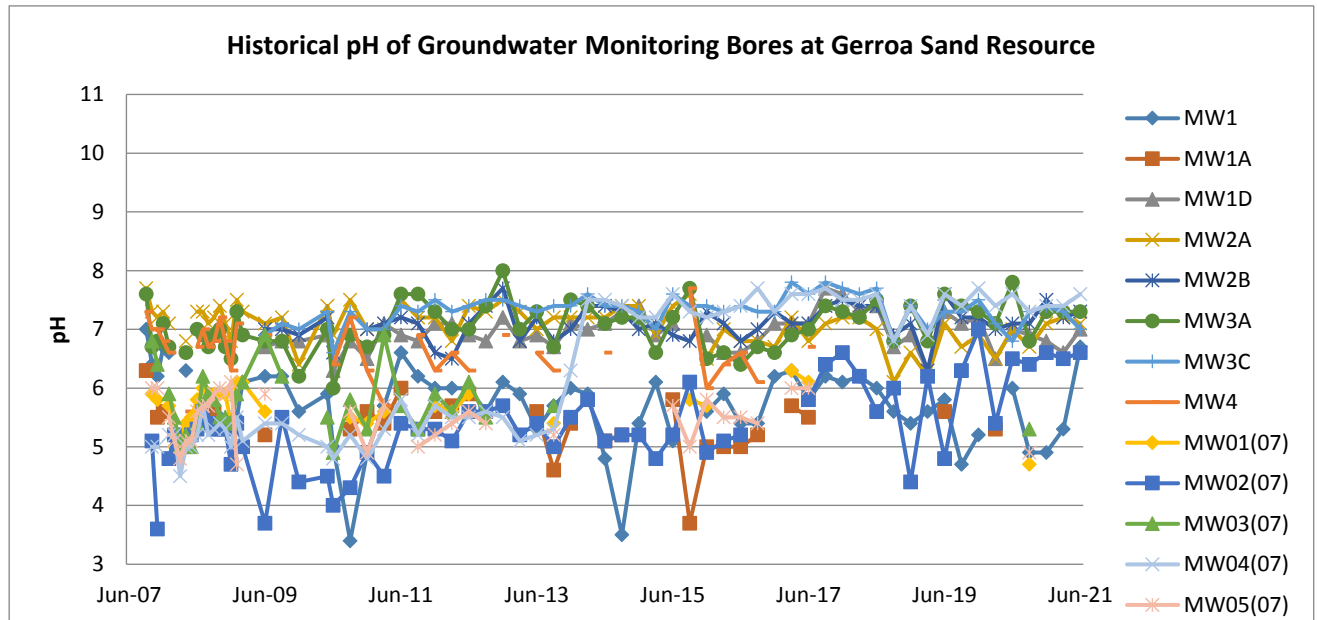
The pH values over the past 12 months have exhibited variability similar to that observed across the historical record. Most groundwater bores recorded pH levels in line with historical averages, with only the single result for MW01(07) recording a value slightly below the historical range for this bore, which is likely to reflect the natural liberation of acids in the vicinity of this bore as a result of the significant winter 2020 rainfall. The extended rainfall deficit leading into the reporting period has meant some bores were unable to be sampled during the reporting period.

Bores MW1, MW01(07), MW03(07), and MW02(07) have continued to exhibit mildly acidic groundwater in line with historical results. Dredging has now progressed through the area of the new (2007) monitoring bores, with pH relatively unchanged as a consequence of dredging. The mildly acidic groundwater in certain bores appears to be a result of natural conditions, rather than as a result of dredging operations.

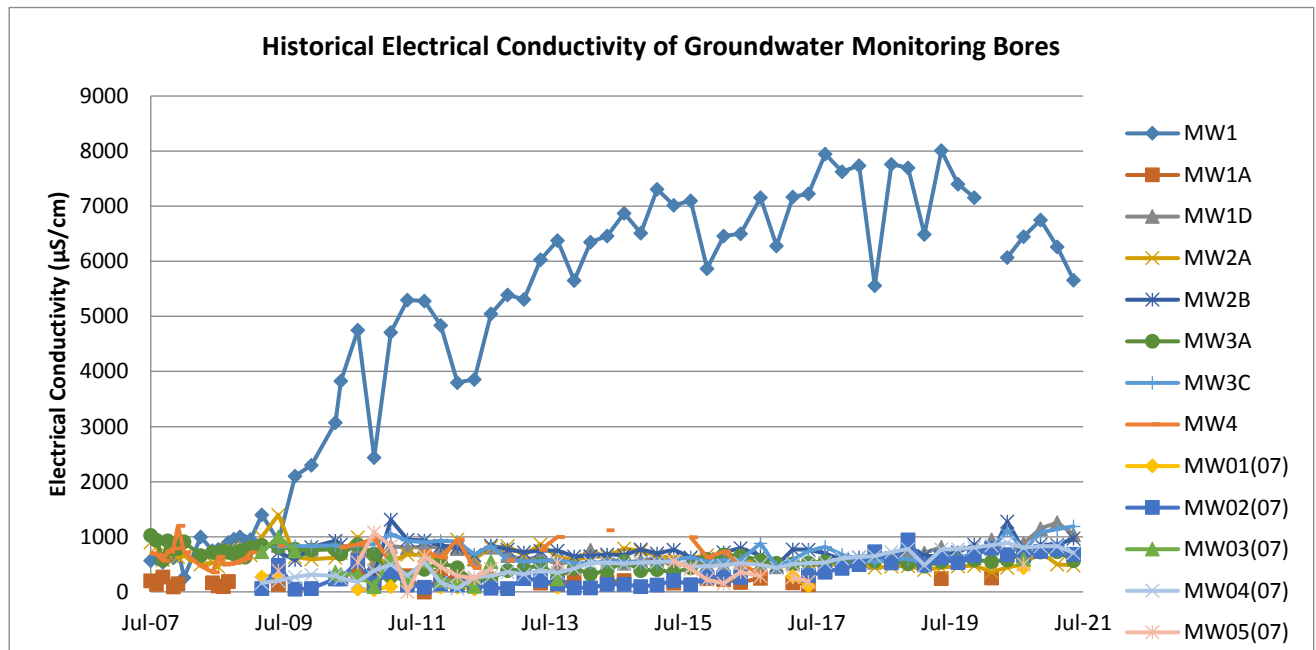
The results over the 12 month period show that the Electrical Conductivity (EC) of the groundwater in the boreholes is within the objective levels for all bores with the exception of MW1. The brackish groundwater in MW1 has not been observed at any other bore or within the dredge pond, and is consistent with other recorded groundwater records for bores screened within the Berry Siltstone unit to the southwest. The EC of this bore has reduced slightly in the current reporting period.

The monitoring bores have continued to show significant variability in EC concentrations across the monitoring network, and with the exception of MW1, the southernmost and eastern bores generally showing slightly lower EC than those bores to the northwest, albeit amongst a pattern of ongoing variability. This variability has likely been enhanced at various times throughout the current reporting period with the replenishment of rainfall infiltration to the aquifer.

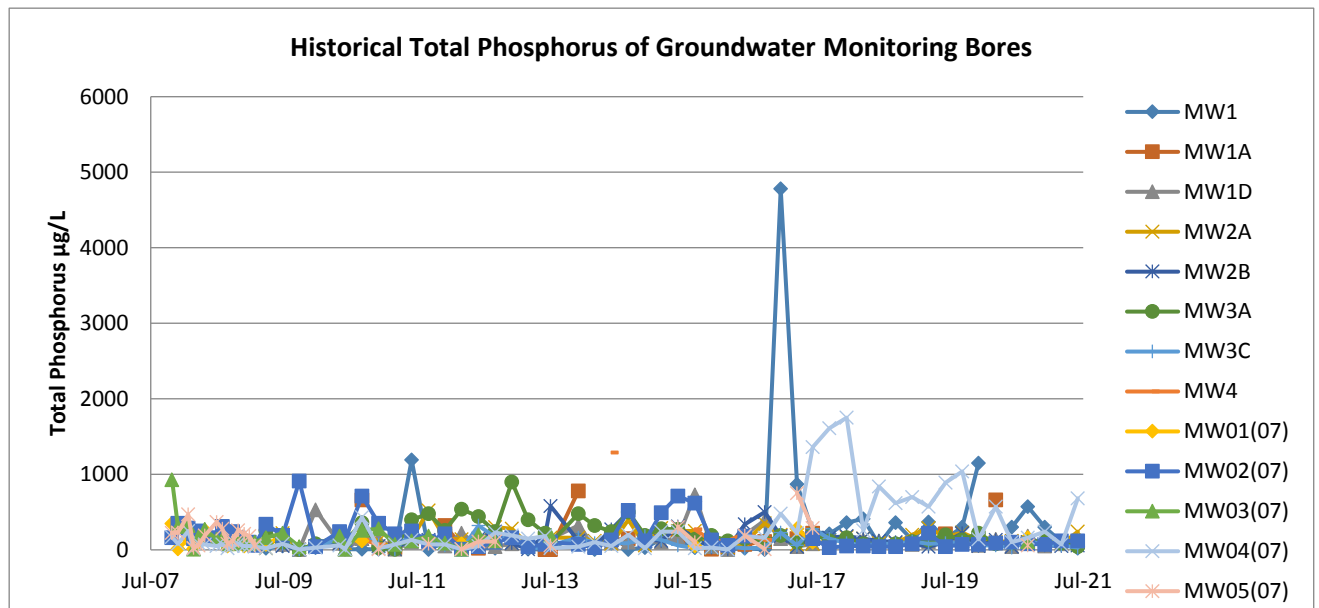
Concentrations of total phosphorus in the boreholes were generally above the groundwater quality objective, however they were all within the historical range for their respective bores. During the reporting period, the concentration of total phosphorus in the dredge pond was generally less than that measured in all bores, suggesting the agricultural land uses surrounding the Gerroa Sand Resource may have contributed to the measurements of total phosphorus in all bores.

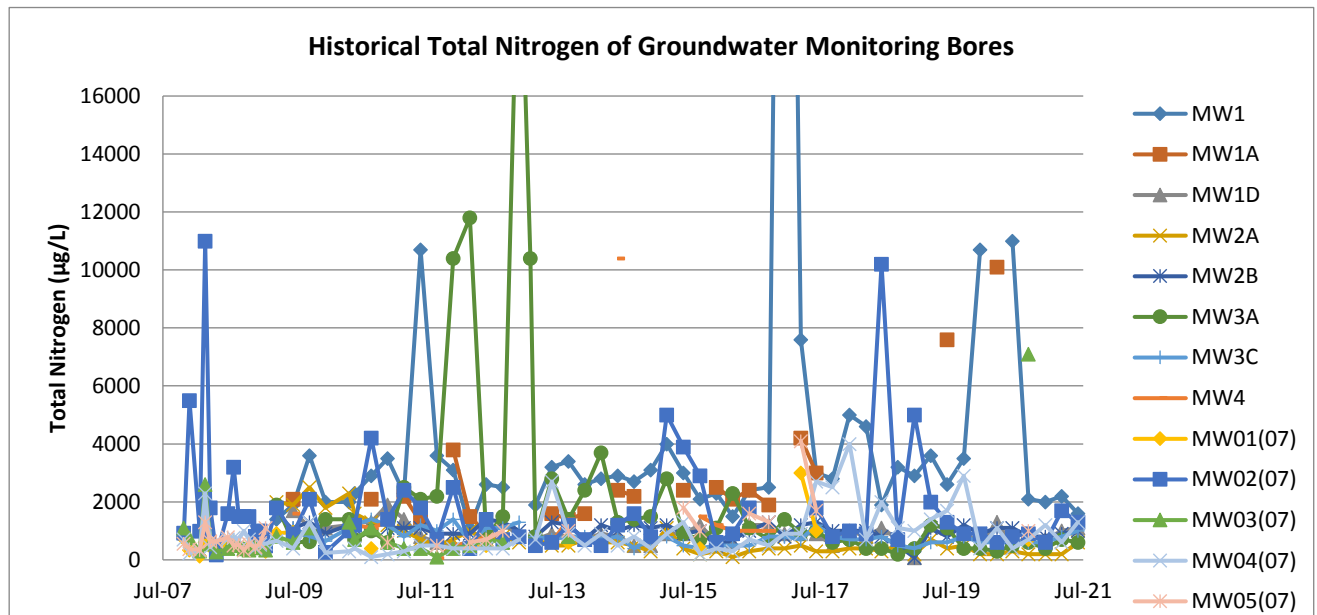
The concentrations of Total Nitrogen in all groundwater monitoring bores have consistently exceeded the objective levels since monitoring of groundwater quality began. In the current reporting period, nitrogen concentrations were recorded within the historical range in all bores with the exception of the single result for bore MW03(07), which was above the previous historical range. The presence of Total Nitrogen at those concentrations recorded in the bores are likely to be related to the presence of agricultural activities in the area surrounding the Gerroa Sand Resource. This is supported by an analysis of water quality within the dredge pond, which shows that nitrogen concentrations in the pond are consistently lower than that recorded across the broader groundwater monitoring network.

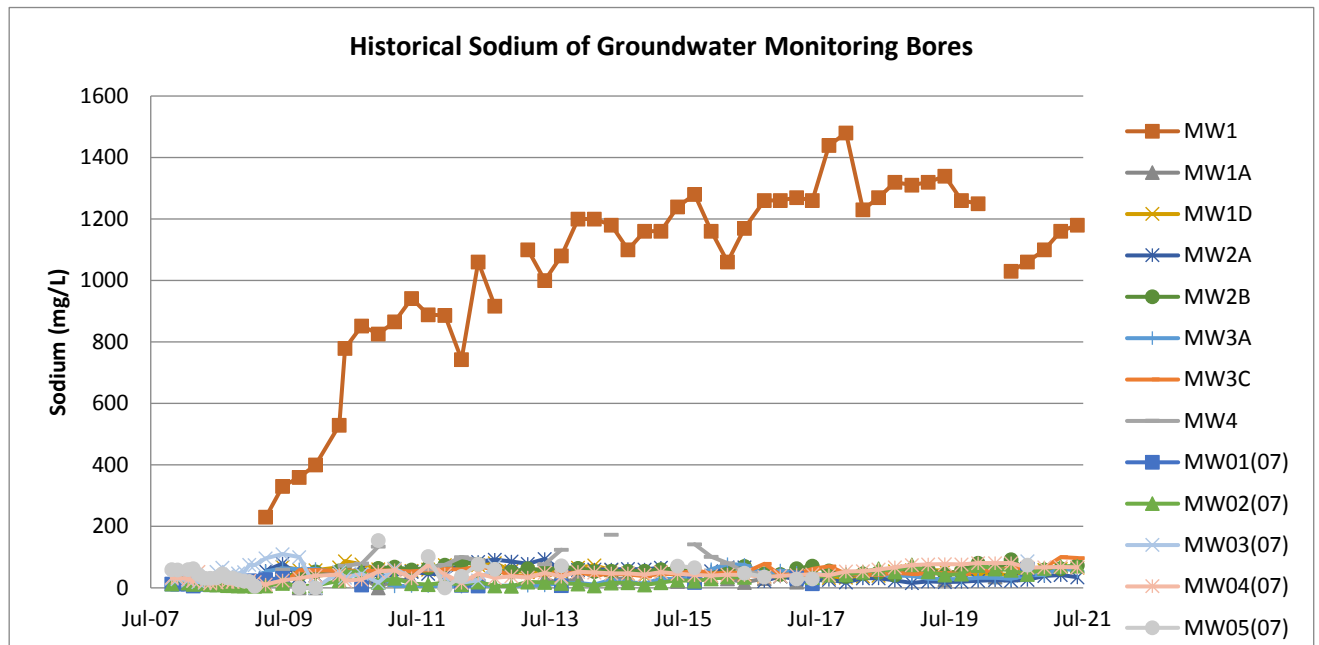
With the exception of borehole MW1, all sodium concentrations recorded in the boreholes are within the DC objectives, and consistently at a low level. Two bores (MW3C and MW01(07)) recorded sodium concentrations above the historical ranges for the respective bores. These are mirrored the EC recorded in the bores, and are likely reflective of greater tidal ingress into the bores closer to Blue Angle Creek in these drier periods of recent years, notwithstanding the improved rainfall recorded in the current reporting period.

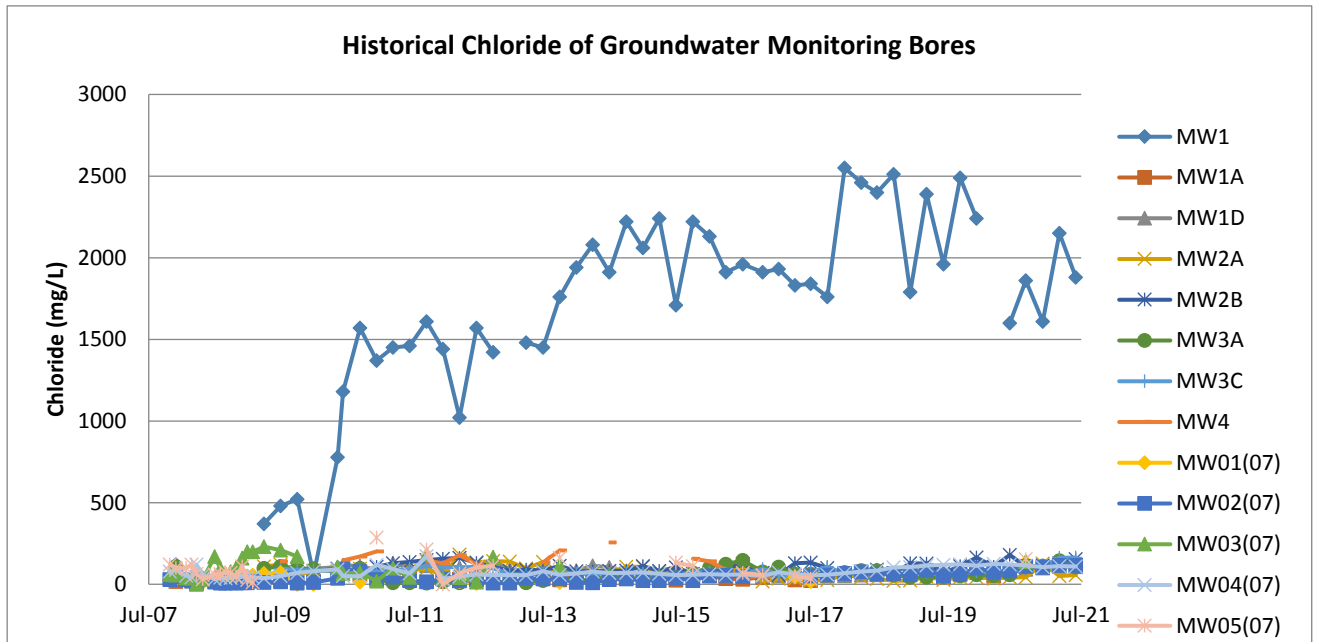
As for sodium, the concentration of chloride in all groundwater bores were within DC objectives with the exception of MW1. Chloride concentrations in MW1 have been variable within the reporting period, consistent with results from recent years. All samples from other bores were measured within the respective historical ranges during the current reporting period, with the exception of samples in bores MW3C, MW01(07) and MW02(07). These variations are in line with observations relating to electrical conductivity.

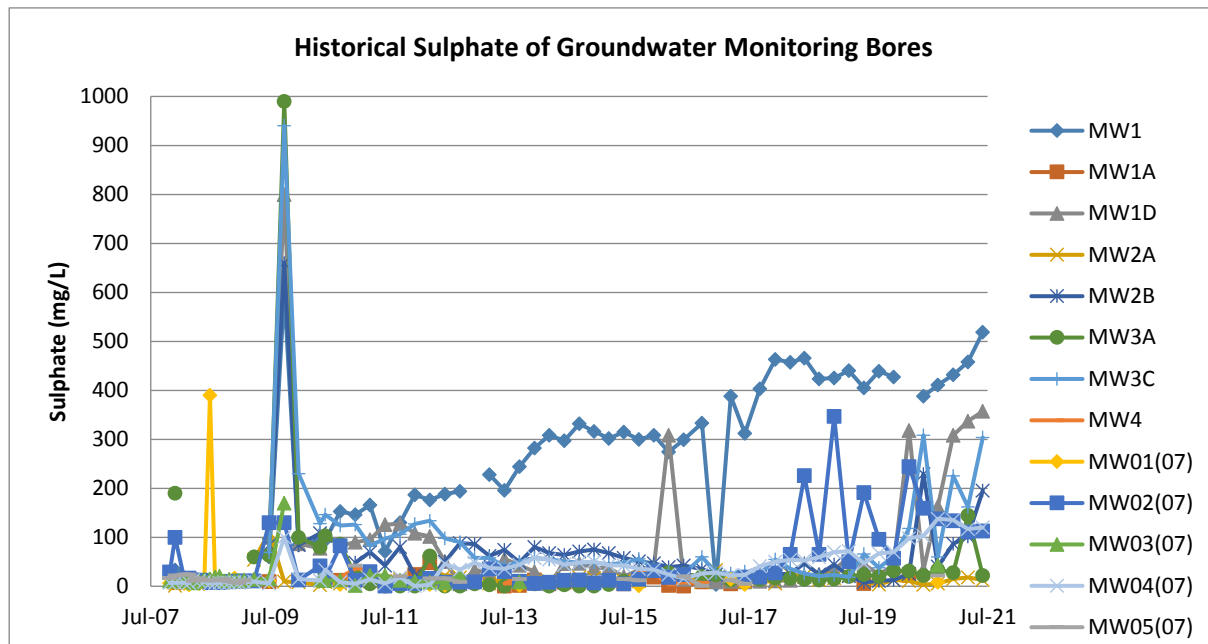
The concentration of sulphate in all groundwater bores were within DC objectives with the exception of MW1, MW1D and MW3C. Sulphate concentrations in MW1 appear to have followed the trend of other major ions, with all samples within the historical range of measurements. Other bores have continued to show considerable variability in the current reporting period, which is likely related to rainfall infiltration to the groundwater table that has seen lower levels in recent years. All samples were within the historical ranges for the respective bores with the exception of MW04(07) which was above the historical range for this bore.

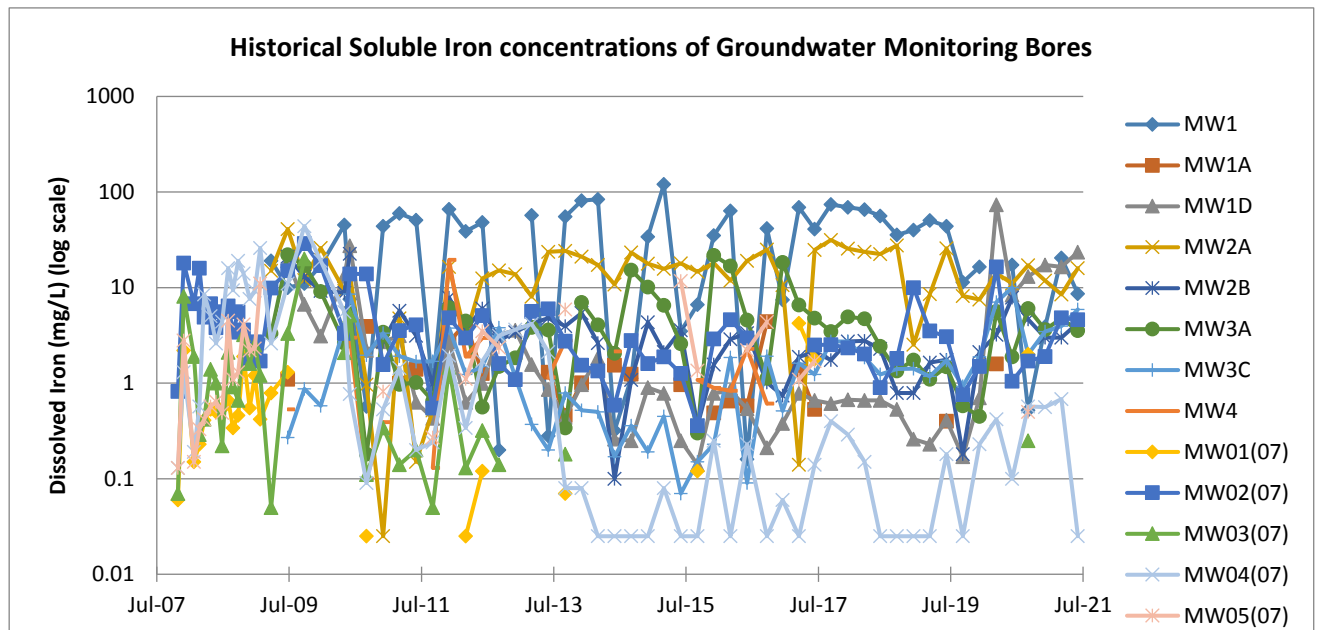
The dissolved iron concentrations were above the objective levels for several bores at times during this reporting period. This is a common phenomenon, with the graph above showing significant fluctuations throughout the historical period of monitoring for all bores. This historical trend has continued in the current reporting period. The concentrations of dissolved iron in all bores for the reporting period are within the historical range for the respective bores, which indicates no deterioration in groundwater quality as evident by soluble iron concentration across the monitoring network.

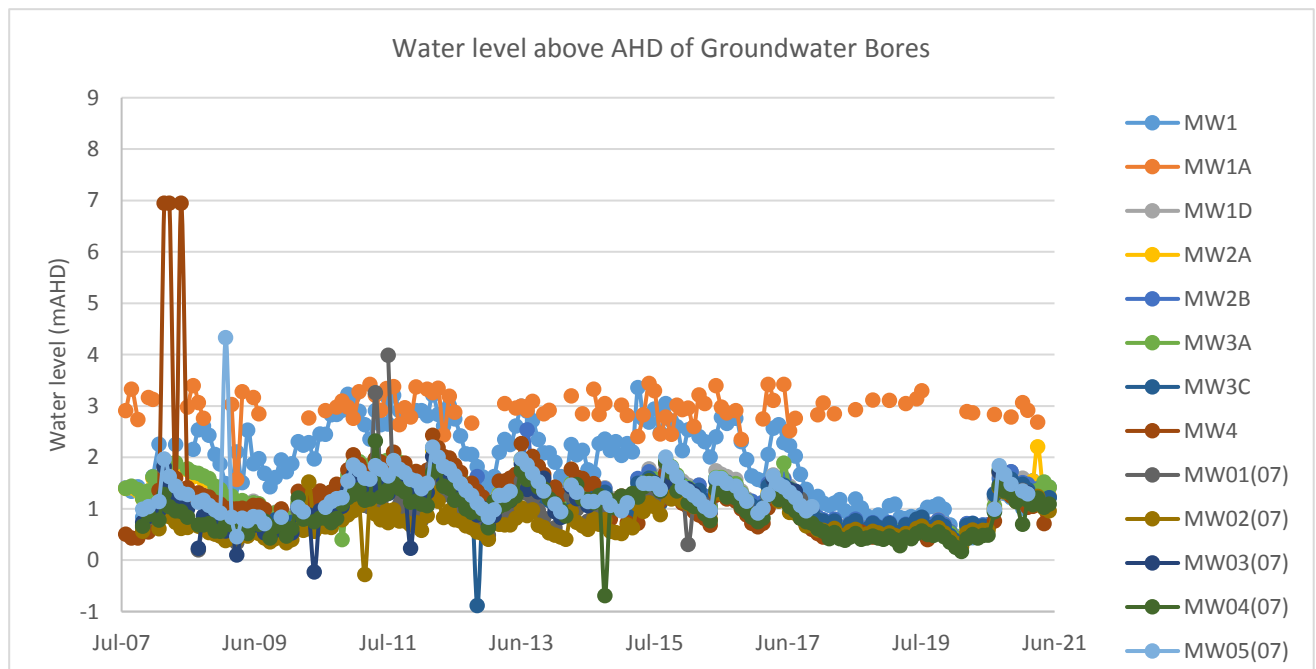
Groundwater levels have varied consistent with significant rainfall events during the current reporting period, increasing from low base levels observed as a result of 3 years of significantly below average rainfall. A small rise was observed in March 2020, which coincided with the only month of above average rainfall (February) during the reporting period. All measurements were within the historical ranges for the respective bores. All bores are following a similar pattern, which is closely aligned to rainfall patterns, suggesting climate is the predominant driver of groundwater levels within each bore across the monitoring network.

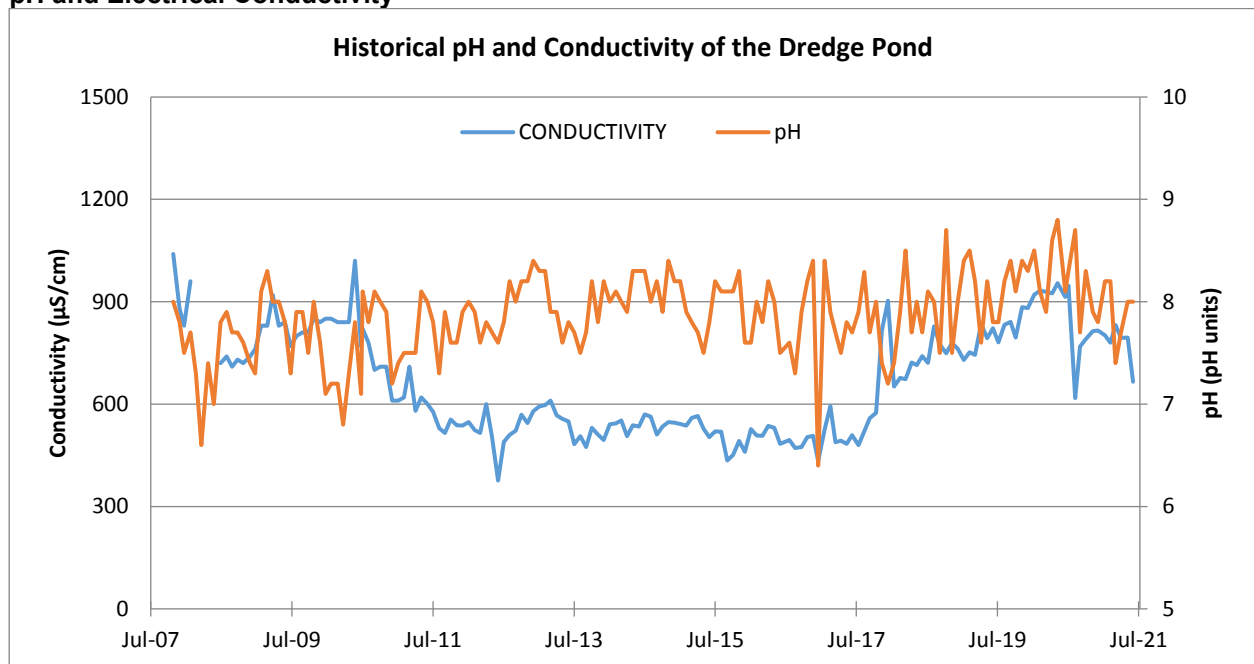
In the current reporting period, the dredge pond pH has reduced slightly as the water level has increased, to return to levels approximating the long term average pH of the dredge pond. All measurements were within the surface water quality objectives with the exception of a single measurement (8.7) in August 2020, which is likely related to the significant rainfall recorded in July 2020. Electrical Conductivity has reduced during the reporting period, consistent with rainfall patterns associated with the replenishment of the dredge pond with rainwater. The EC has remained within both the historical range and water quality objectives throughout the reporting period.

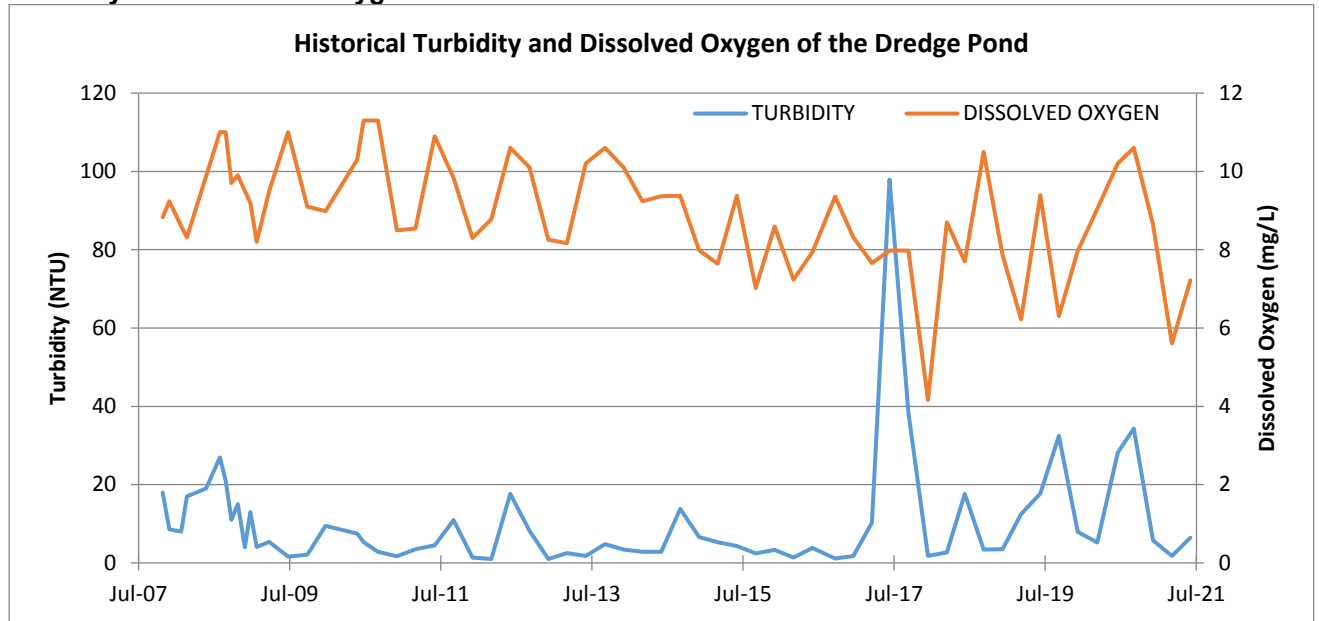
Turbidity and dissolved oxygen have remained within their historical ranges in the current reporting period. Two samples recorded slightly below the percent saturation objective level for DO, with one of these samples also slightly below the mg/L objective level. One sample was above the upper limit of the turbidity objectives at the start of the reporting period, however recent turbidity results have been low.

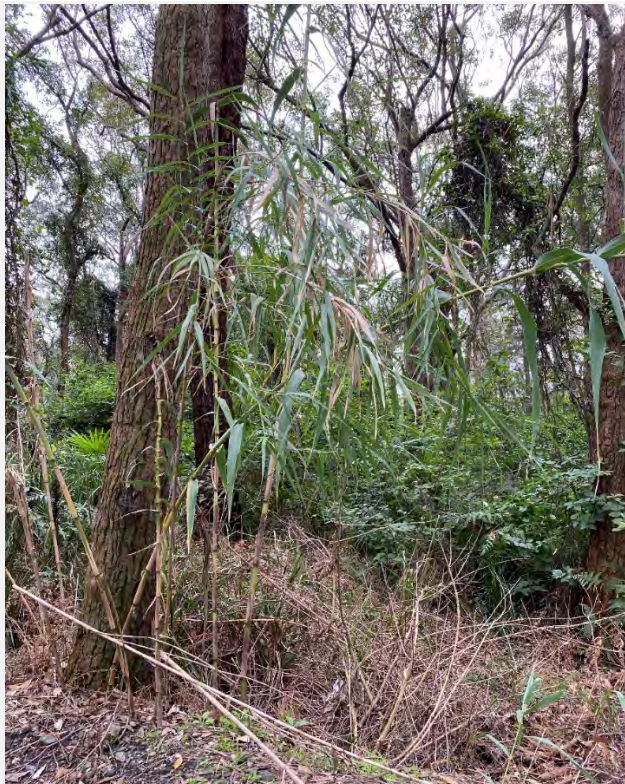
Zone	Location/description	Recommendations for ongoing works 2021/22	Reference Images
<b>Zone 1: Forest Enhancement Zone Objectives (41.95 ha)</b> <ul style="list-style-type: none"> <li>• Improve the quality of the forest by removal of weeds</li> <li>• Restrict access to grazing stock</li> <li>• Monitor the health of the forest</li> <li>• Strengthen tree cover south of previous dredge pond</li> </ul> <p>Work in the past has included Lantana control and removal of some selected weeds such as Bitou Bush. Weed management is ongoing and is guided by the Weed Management Plan for the Site (KMA 2008)</p>			
<b>Subzone 1.1</b>	Main area of existing forest, extending from the northern to near the southern extremities of the Site	<p>Removal of Giant Arundo Grass (<i>Arundo donax</i>) from the roadside and lower lying areas via cut and paint method.</p> <p>Ongoing Lantana (<i>Lantana camara</i>) treatment to reduce extent throughout the area using cut and paint method.</p> <p>Spraying for African Love Grass (<i>Eragrostis curvula</i>) along roadside.</p>

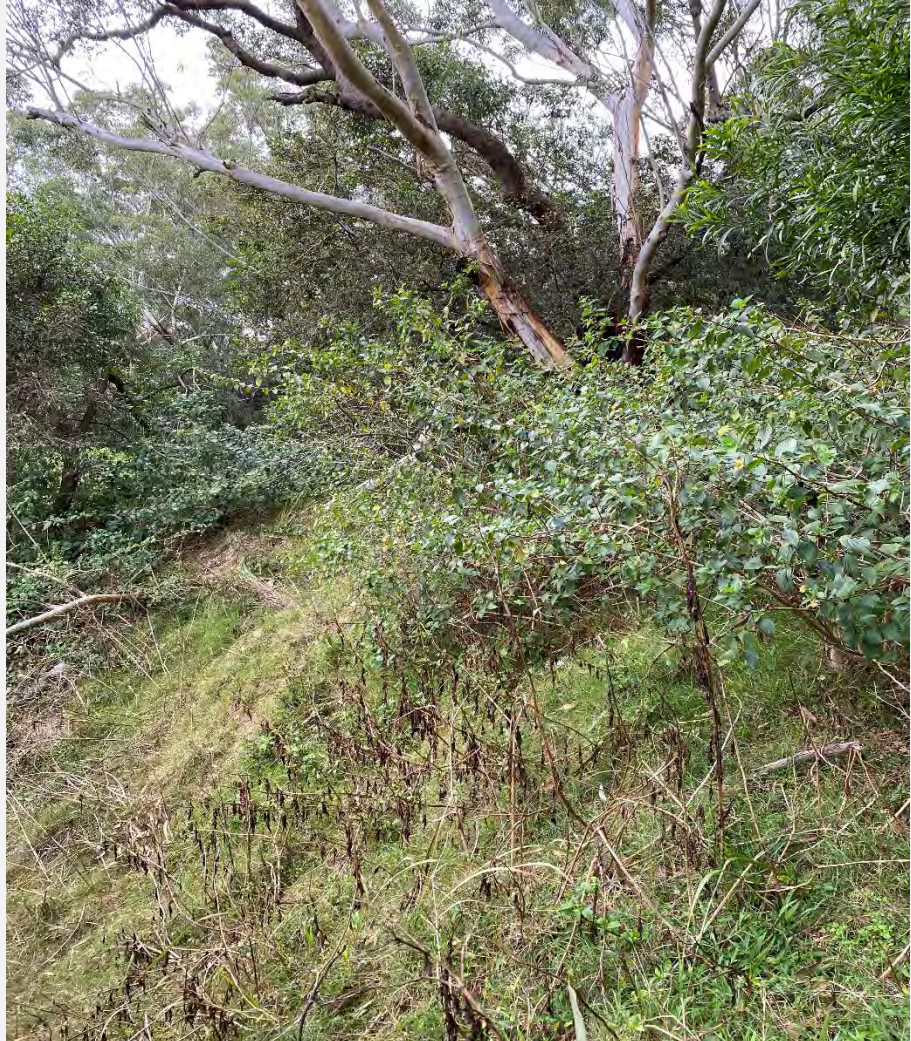
Zone	Location/description	Recommendations for ongoing works 2021/22	Reference Images
Subzone 1.2	Covers the forest around the eastern and southern sides of the old dredge pond, which was planted many years ago. Lantana control is an ongoing management requirement.	Increase cut and paint control of Lantana to control spread. Small patch of Giant Arundo Grass, which requires cut and paint method. Moth Vine ( <i>Araujia sericifera</i> ) also requires maintenance particularly in eastern portions of the subzone.

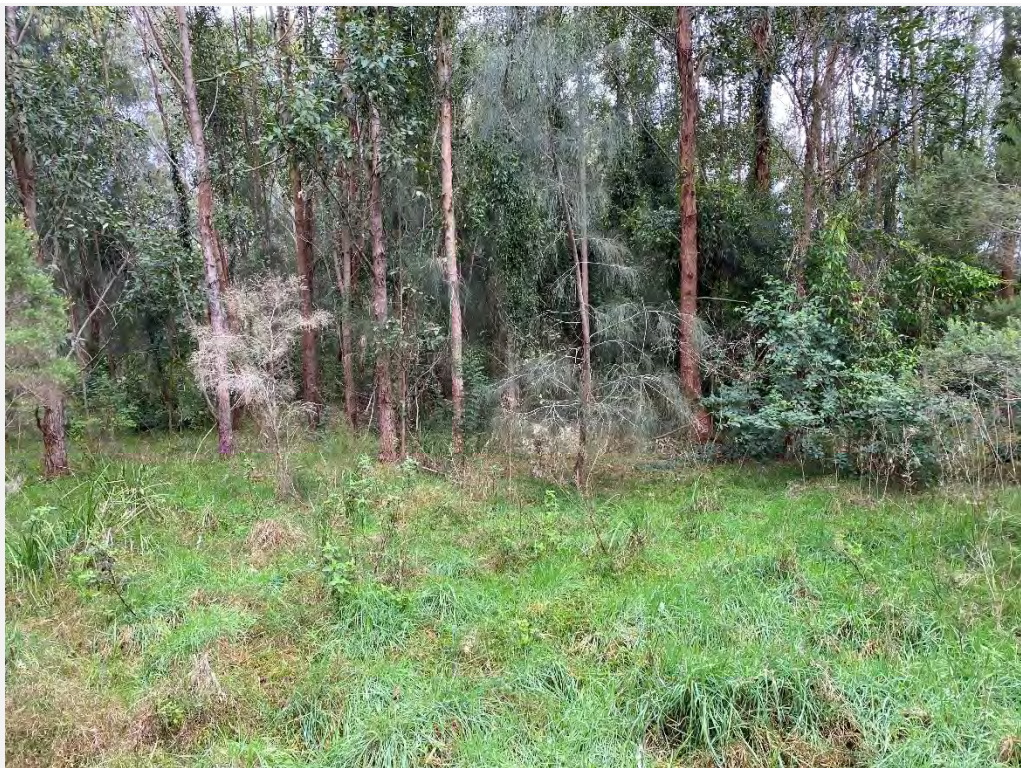
Zone	Location/description	Recommendations for ongoing works 2021/22	Reference Images
Subzone 1.3	Covers the old bund wall that was planted with trees long ago, behind the site office and towards the front gate.	Morning Glory ( <i>Ipomoea indica</i> ) weed extent seemingly reduced. Lantana thickets should be the priority weed in this area using cut and paint methods, however, Senna ( <i>Senna pendula</i> var. <i>glabrata</i> ) and Crofton ( <i>Ageratina adenophora</i> ) weeds also require attention starting from roadside to reduce extent.

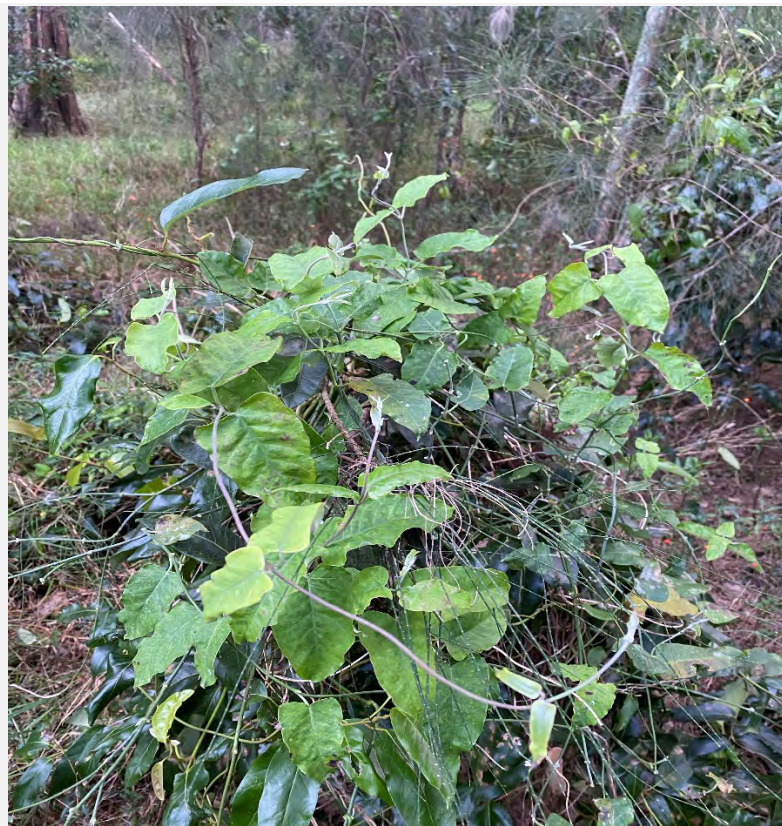
Zone	Location/description	Recommendations for ongoing works 2021/22	Reference Images
Subzone 1.4	A fenced patch of Swamp Oak within grazing land, which now has a planted link to the east (planting zone 2E). Vegetation is well established and requires very little ongoing work	Good condition <i>Allocasuarina</i> stand, some Moth Vine starting to creep into swamp extent. Remove Moth Vine via cut and paint, be sure not to confuse with nearby native Common Silkpod ( <i>Parsonisa straminea</i> ) – see Plate 4.

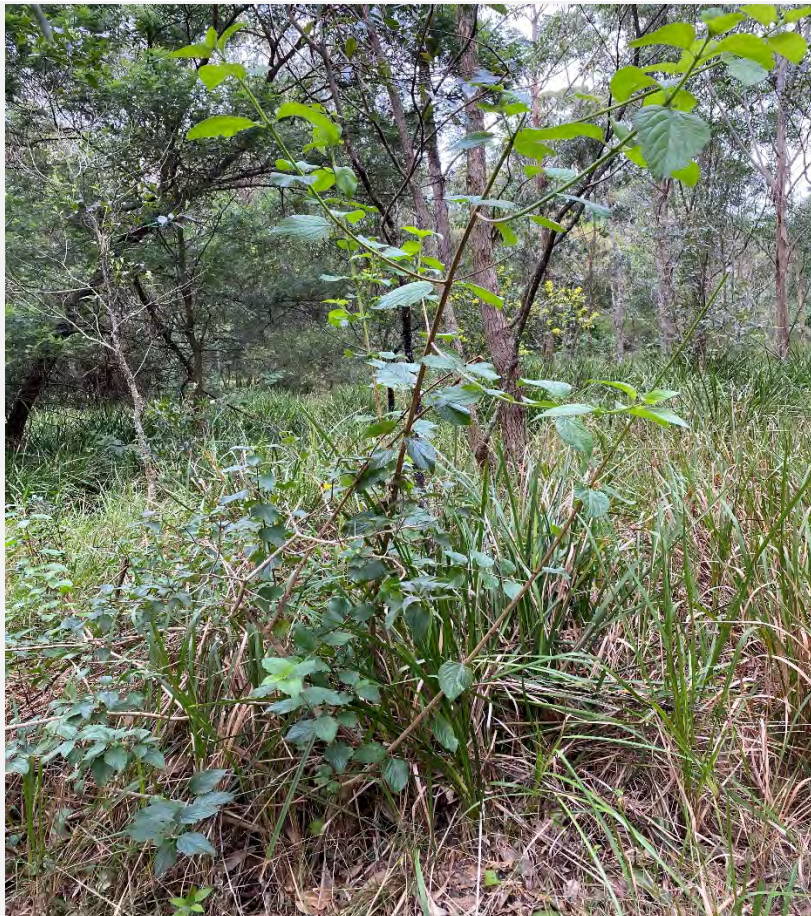
Zone	Location/description	Recommendations for ongoing works 2021/22	Reference Images
Subzone 2A.1	The prime area for developing the forested link in the northeast of the Site; i.e. establishing the northern corridor including Zone 2A.1, 1.1 and 2C.1. Extensive work has been carried out over the past eleven years to develop this area as habitat for native fauna.	Efforts of creek weed management evident, ongoing maintenance to roadside still required – tend to Crofton and Tobacco Bush ( <i>Solanum mauritianum</i> ) along road extent via spray and cut and paint methods. Multiple, small stands of Lantana popping up on eastern sides of the road in the oldest revegetation site. These small Lantana stands should be high priority given the current good condition of the area.

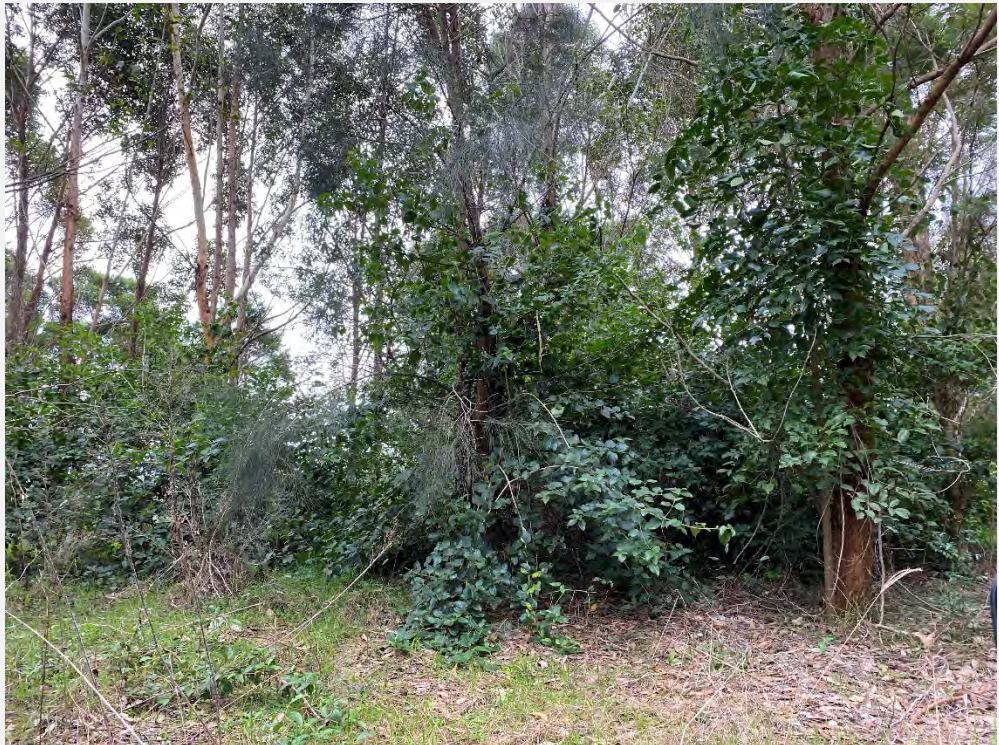
Zone	Location/description	Recommendations for ongoing works 2021/22	Reference Images
Subzone 2A.2	Is important for the forest link to the south and into Seven Mile Beach National Park on the southern side of Beach Road. Good tree growth continues in most places.	Ongoing Lantana management required via cut and paint method. Moreover, stands of Senna, Moth Vine and Wild Tobacco require ongoing management.

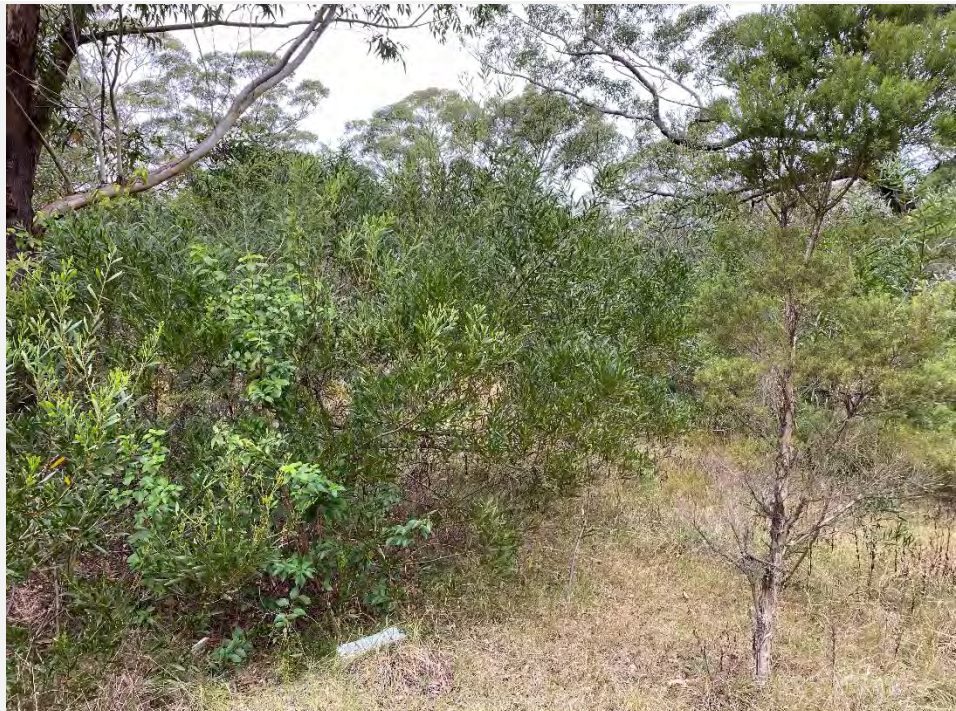
Zone	Location/description	Recommendations for ongoing works 2021/22	Reference Images
Subzone 2A.3	Planted early in the re-planting program but experienced considerable obstacles with tree survival and growth. One obstacle has been Swamp Wallaby browsing on the new growth. However, there was obvious growth on trees during inspections in the previous 12 months.	Tree survival still an obstacle, however, those which did survive are standing strong. Lantana creeping into the subzone and should be removed. There is also a small Senna stand which should be removed simultaneous to the Lantana management.

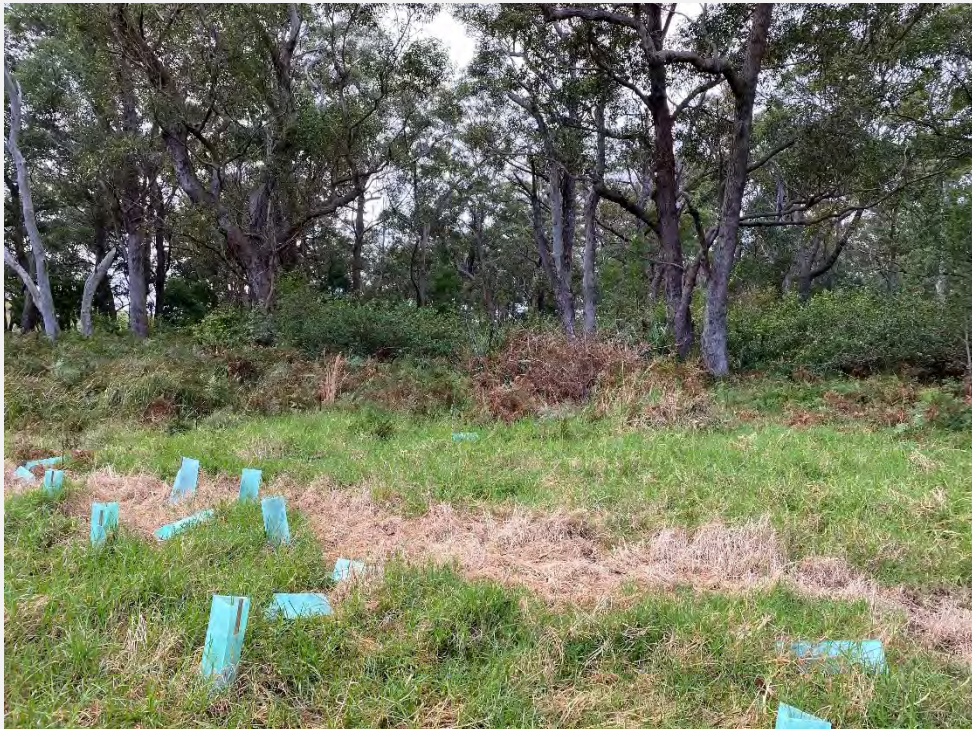
Zone	Location/description	Recommendations for ongoing works 2021/22	Reference Images
Subzone 2B.1	Small revegetation patch roadside adjacent to subzone 1.1. Plantings undertaken recently and generally in good condition	Continue to monitor noxious woody weed growth and take action when required. Continue to mow around tree guards and remove Kikuyu grass from within the guards when required.

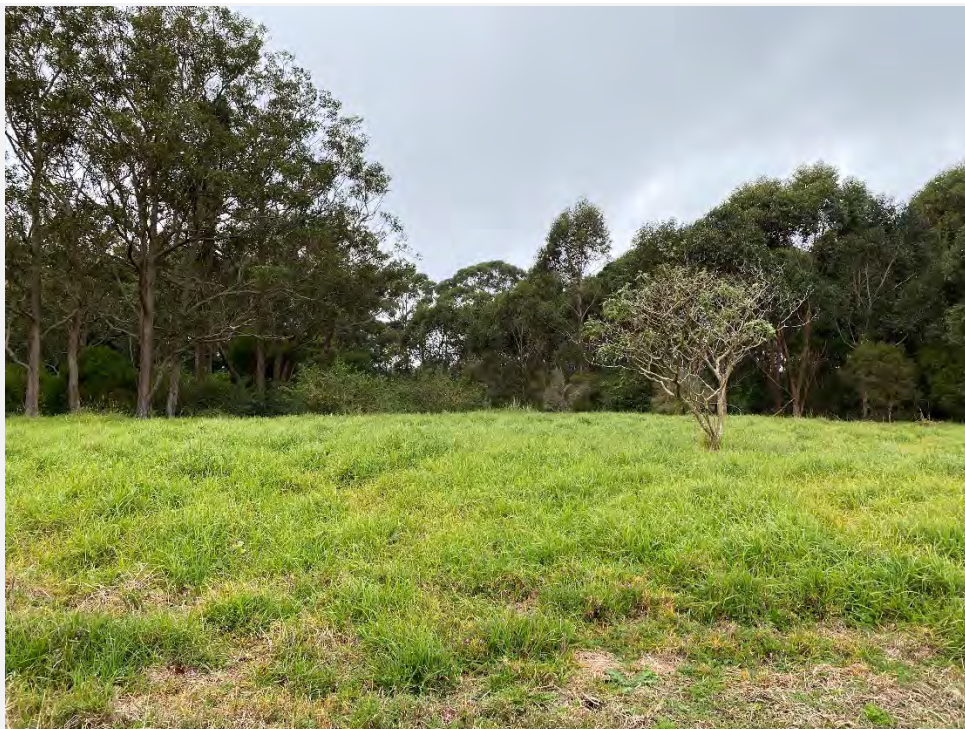
Zone	Location/description	Recommendations for ongoing works 2021/22	Reference Images
Subzone 2B.2	<p>Very low lying and is being colonised by Swamp Oak and a few other native trees without the need for further planting. Some planting was carried out on a higher part of the subzone in the south and west in previous years (KMA 2018).</p>	<p>Small stands of Tobacco Bush, Lantana and Thistle among grasses nearer the roadside that could be managed via cut and paint.</p>

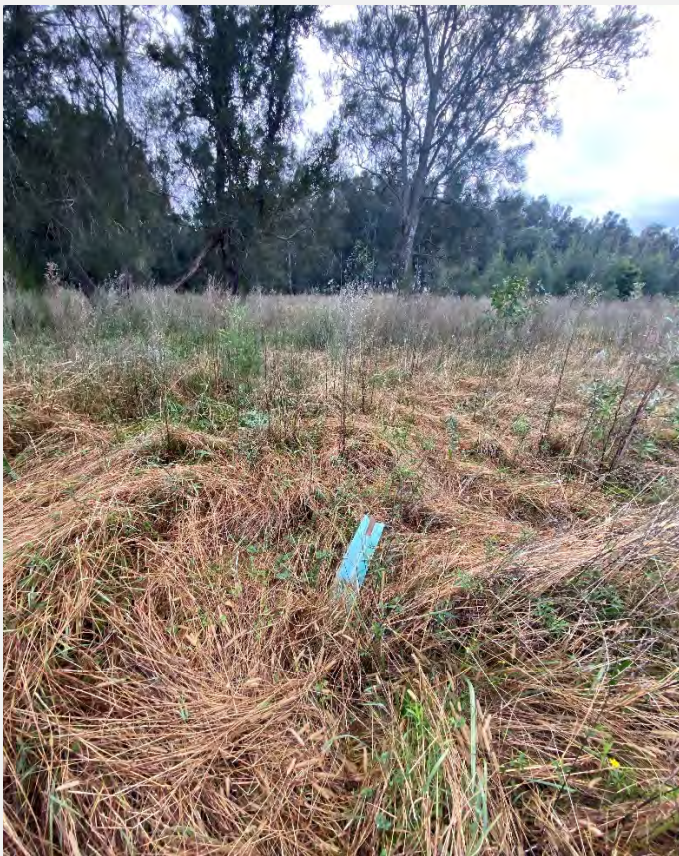
Zone	Location/description	Recommendations for ongoing works 2021/22	Reference Images
Subzone 2D	Modified some time ago to a triangular area between subzones 2E and 2D. This area was originally sprayed and partly spread with timber mulch prior to plantings. Growth since last year has been good. This area is prone to water inundation during wetter months, limiting some access to areas.	Zone in good condition, however, recent plantings have become overrun with low threat weeds resultant from limited access. Mowing the area should be a priority to keep competition with plantings to a minimum. Deer grazing and antler rubbing evident (Plate 1) – Deer control may be necessary if plantings fail to take despite increased weed control.

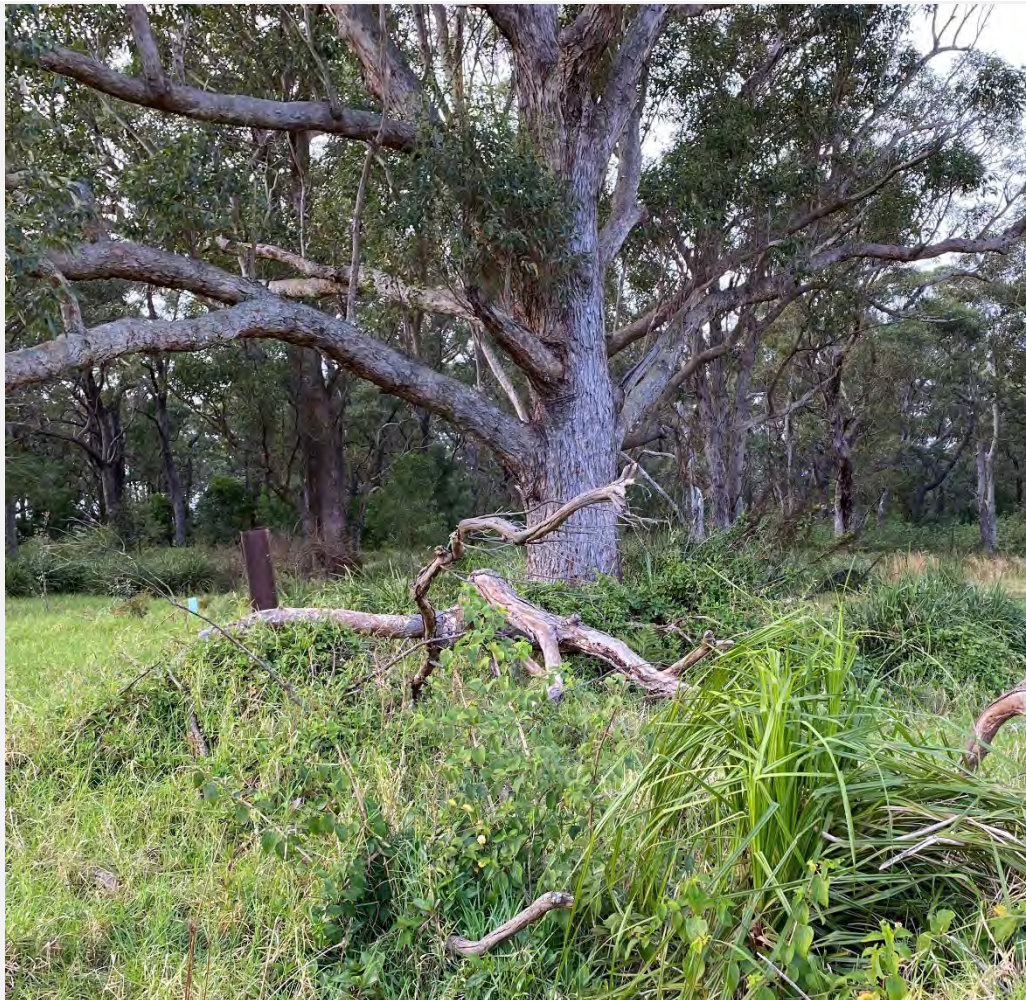
Zone	Location/description	Recommendations for ongoing works 2021/22	Reference Images
Zone 4	A natural stand of Bangalay trees with a native understorey. Lantana has been removed from this zone in the past and is targeted during maintenance.	Some Lantana stands that still require attention (pictured), Single Coral Tree ( <i>Erythrina crista-galli</i> ) in distance that requires cut and paint method.

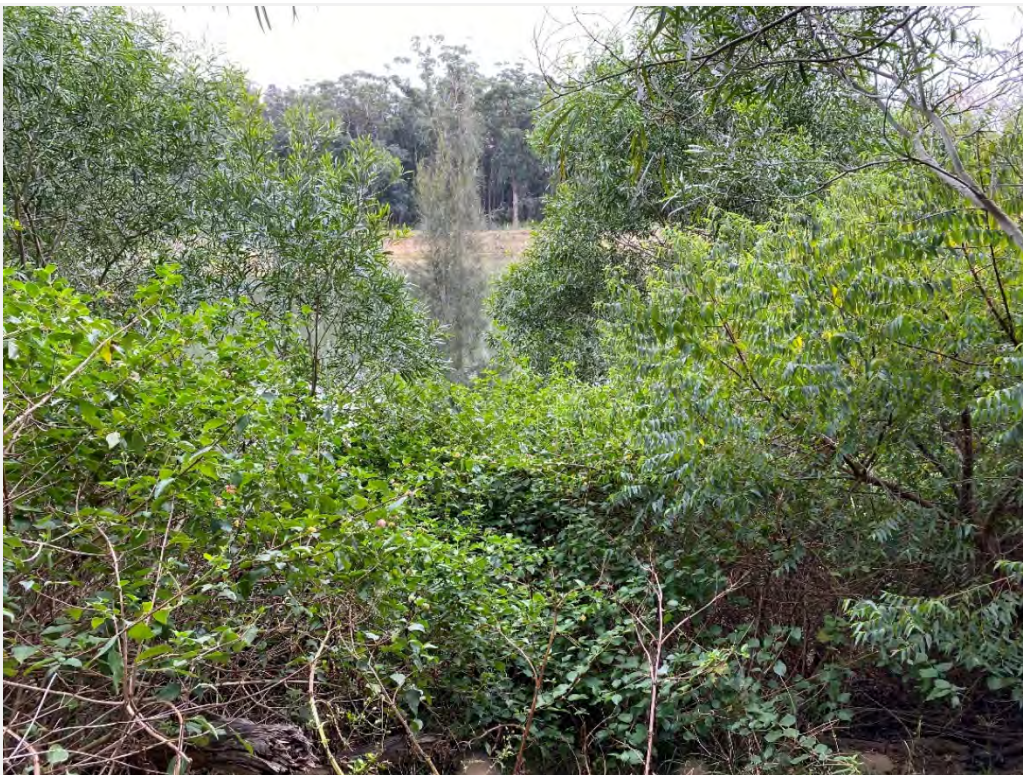
Zone	Location/description	Recommendations for ongoing works 2021/22	Reference Images
<b>Zone 6</b>	Occurs within the foreshore areas of the Dredge Pond, being shaped, topsoil spread and planted as the dredge pond has progressed northwards. The pond banks are stable and erosion is not obvious. Considerable growth of colonising plants, mainly grasses, is occurring on the newest batter slopes. Trees are appearing on the older batter slopes.	Monitor and control of priority weeds such as Lantana and Tobacco Bush using cut and paint method as necessary. Avoid spraying in this area to ensure native species retain dredge pond bank stability.

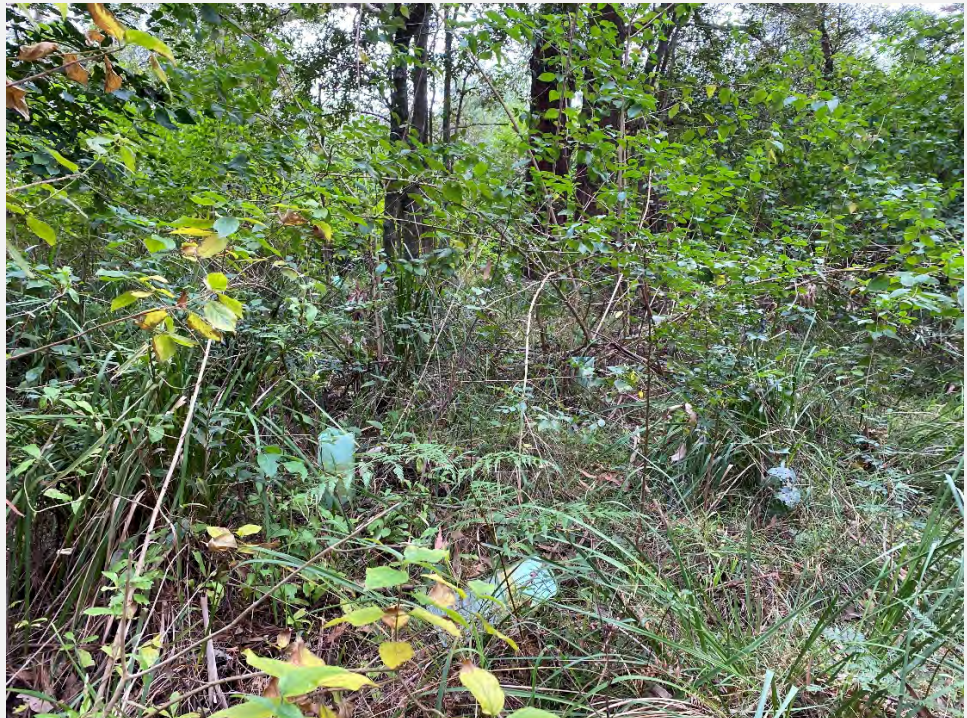
Zone	Location/description	Recommendations for ongoing works 2021/22	Reference Images
Zone 7	Occurs along the eastern edge of the Site and has cultural significance, therefore minor works on Lantana have been conducted over time as necessary, between Zone 1.2 and Zone 3.	Monitor and control Lantana as necessary. Continue with mosaic methods of weed removal (i.e. working in patches). Starting office end and working eastwards.
