# **Gerroa Sand Resource Annual Environmental Management Report**

**Period 01 July 2020 – 30 June 2021**

**Cleary Bros (Bombo) Pty Ltd**

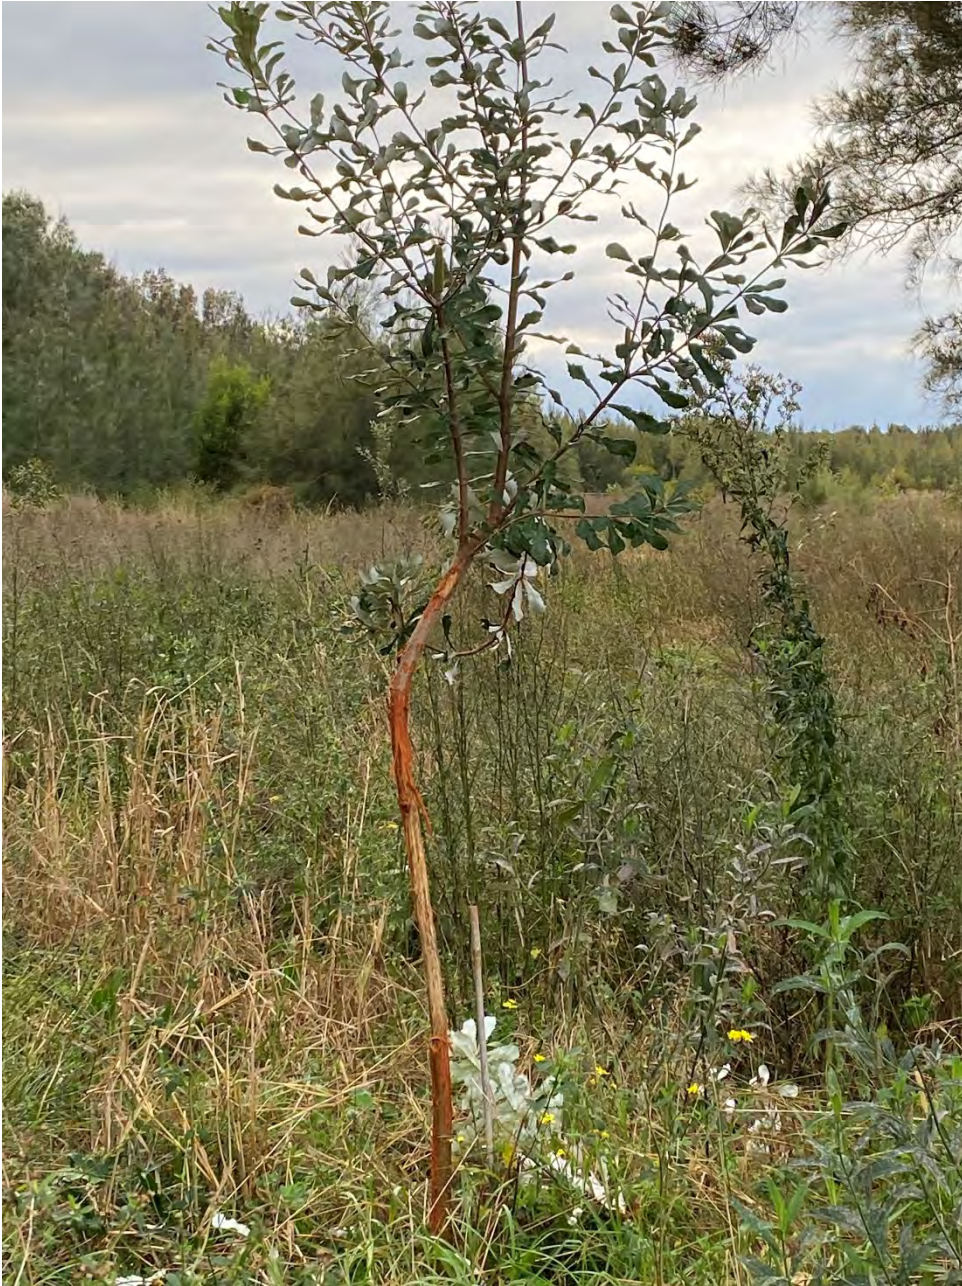
**Plate 1: Deer rubbing on *Banksia integrifolia* within subzone 2D planting areas.**

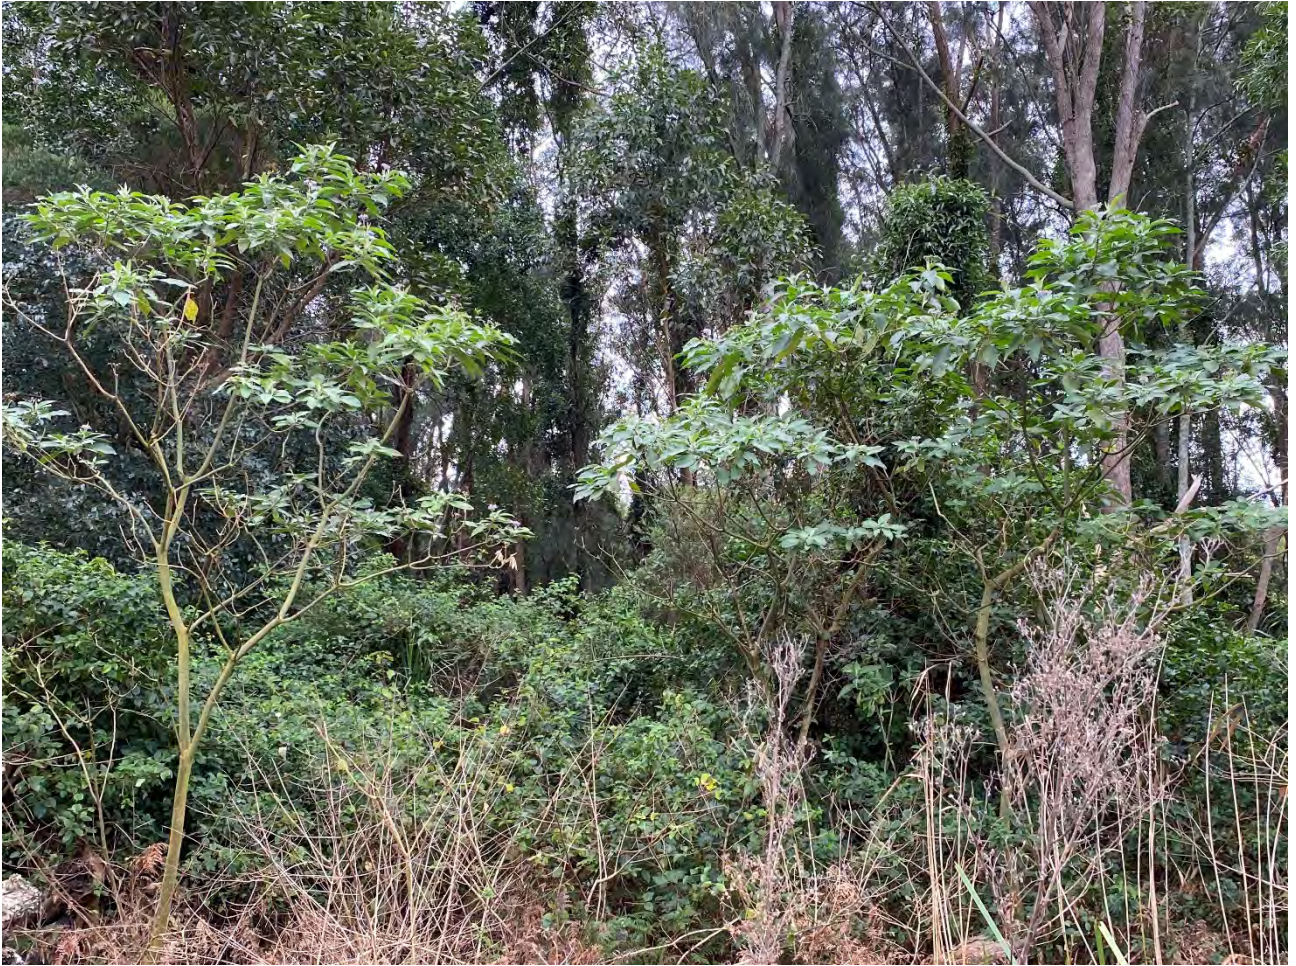
**Plate 2: Mature wild tobacco bush stand in Zone 2A.1.**

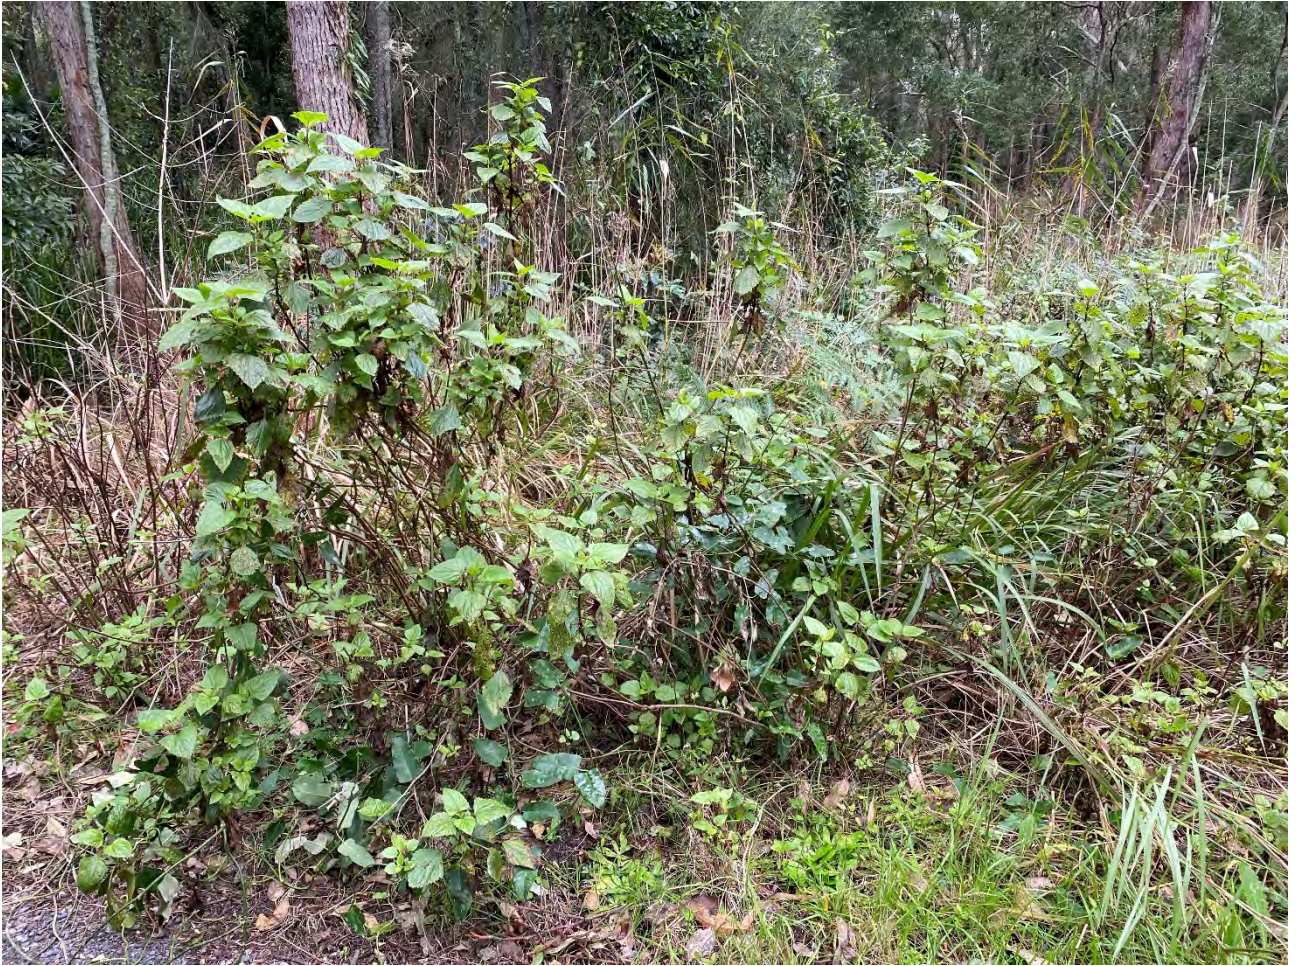
**Plate 3: Crofton weed stands along the roadside in Zone 2A.1.**

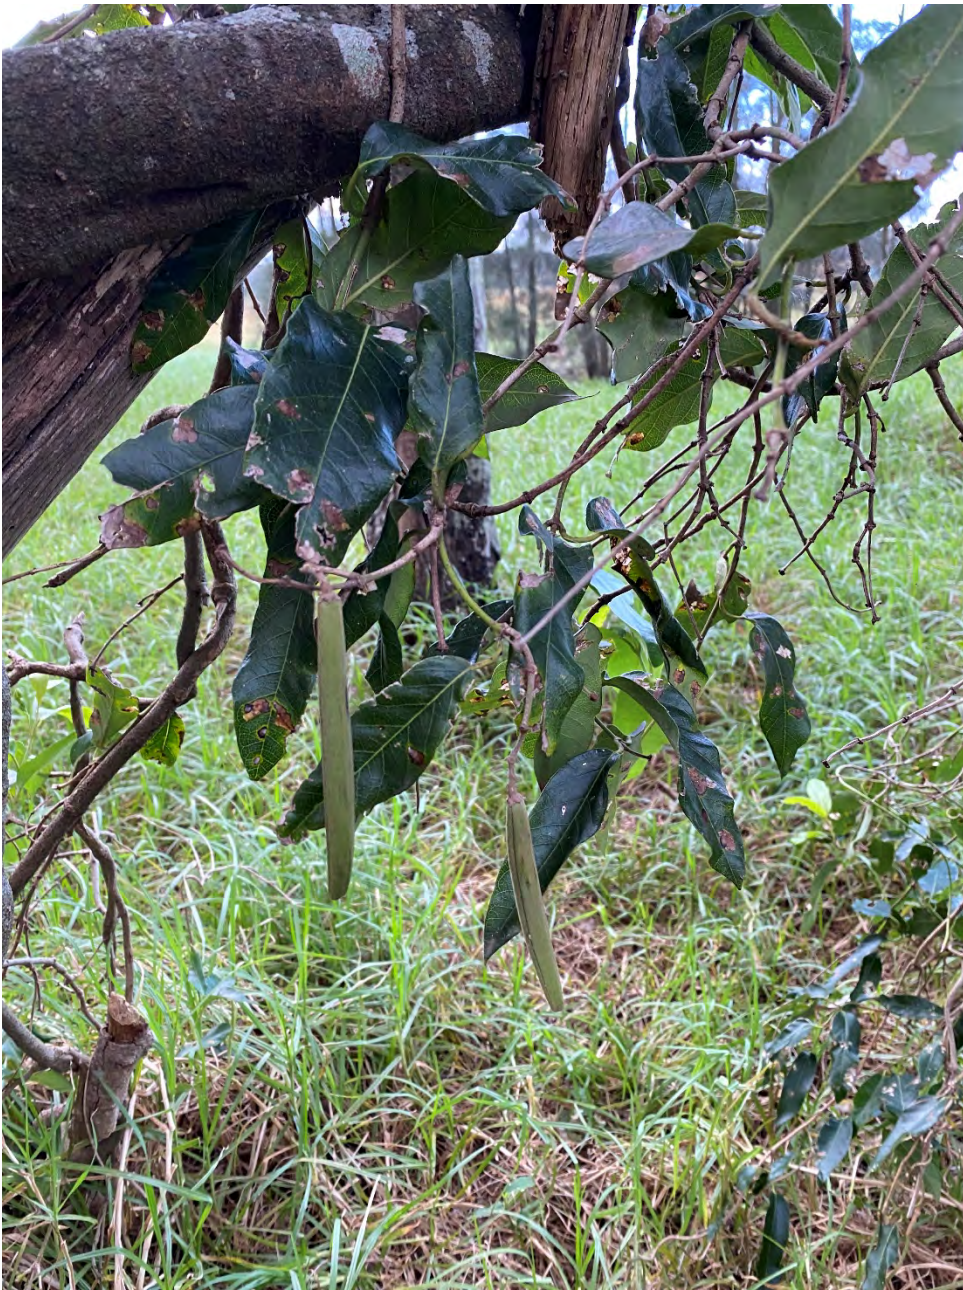
**Plate 4: Native Common Silkpod (*Parsonia straminea*) not to be confused with Moth Vine (*Araujia sericifera*) when targeting Moth Vine in Zone 1.4.**

Zone	Location/description	Recommendations for ongoing works 2021/22	Reference Images
Subzone 1.4	A fenced patch of Swamp Oak within grazing land, which now has a planted link to the east (planting zone 2E). Vegetation is well established and requires very little ongoing work	Good condition <i>Allocasuarina</i> stand, some Moth Vine starting to creep into swamp extent. Remove Moth Vine via cut and paint, be sure not to confuse with nearby native Common Silkpod ( <i>Parsonisa straminea</i> ) – see Plate 4.

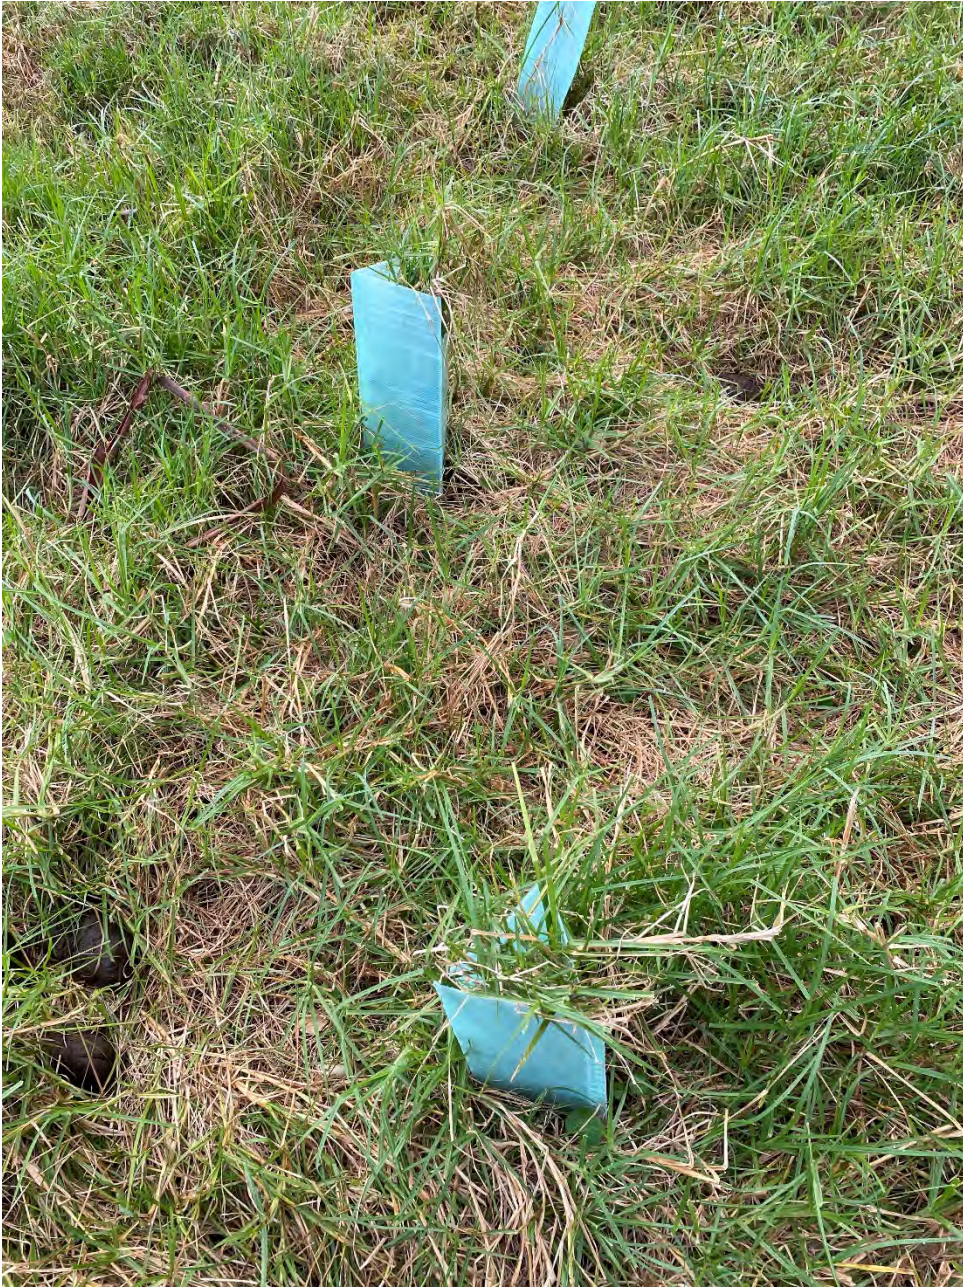
**Plate 5: Example of kikuyu grass growing through tree guard and strangling planting, avoidance via more frequent mowing and hand removal to improve revegetation success in affected areas.**

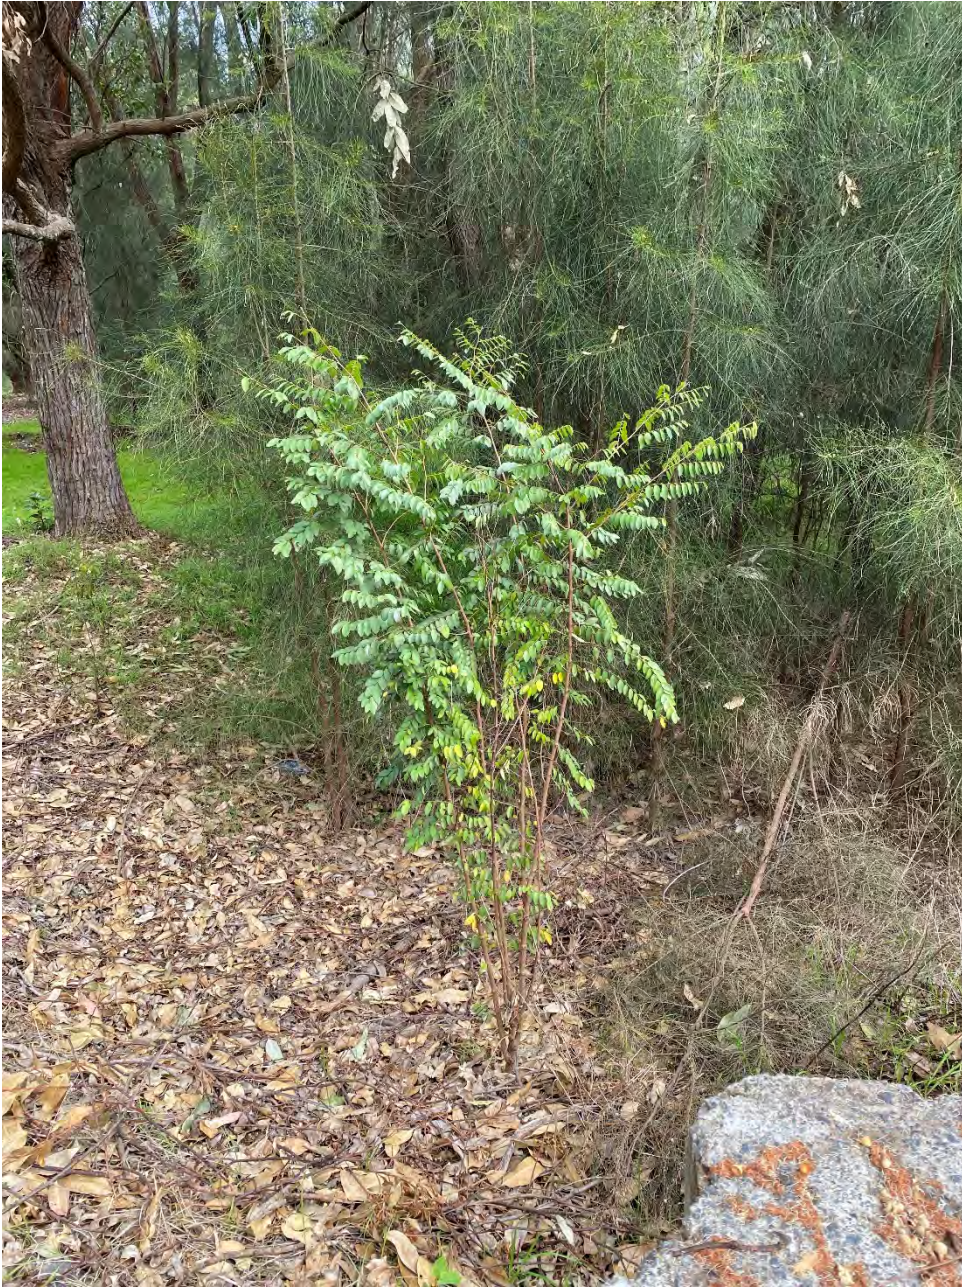
**Plate 6: Small Senna stand near Site entry. Small stands like this should be removed prior to fruiting to avoid further seed dispersal.**
