GERROA SAND RESOURCE

ANNUAL ENVIRONMENTAL MANAGEMENT REPORT

Period 01 July 2021 – 30 June 2022

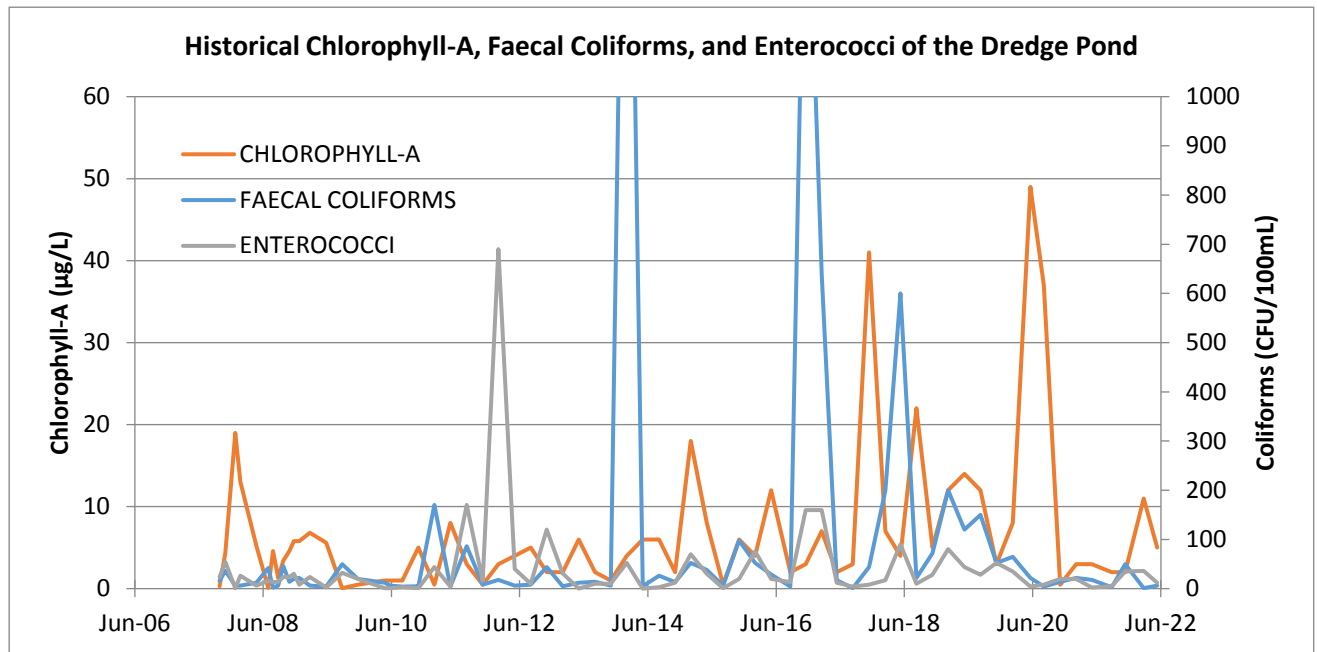
All chlorophyll-A, faecal coliform, and enterococci results were within the historical ranges and the objective levels for the respective analytes during the reporting period, and generally below historical averages.

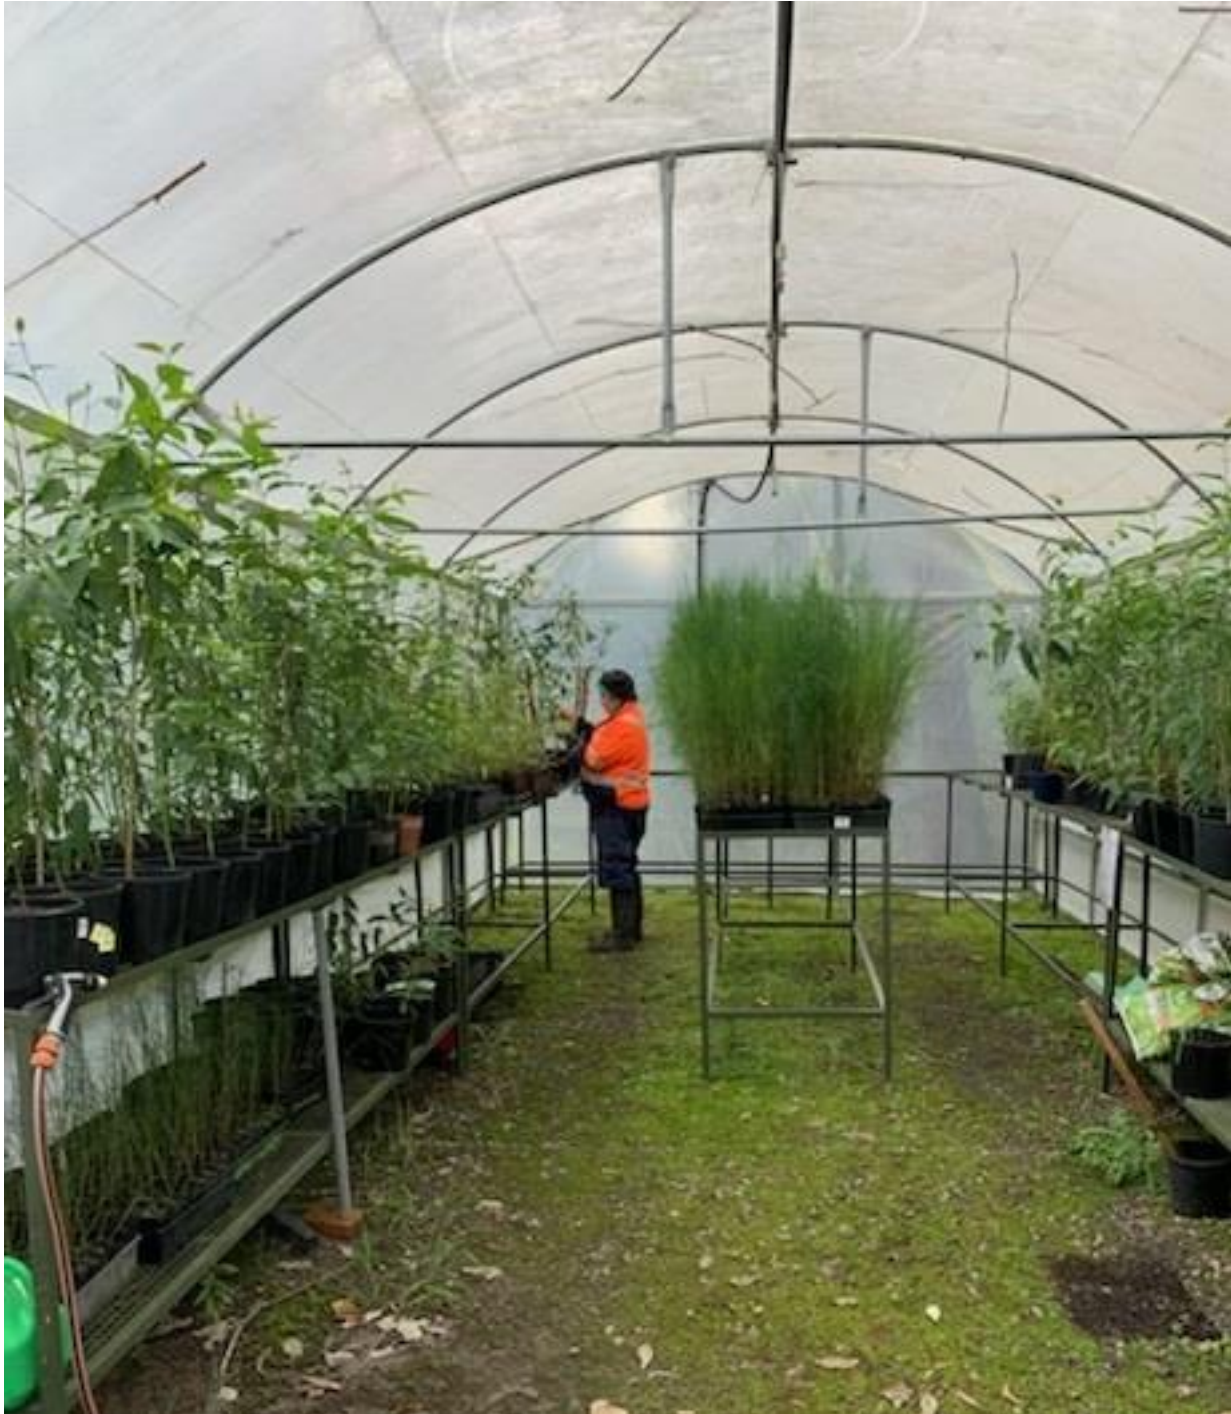
Figure 3 – Greenhouse in early June 2022 with seedlings ready for planting

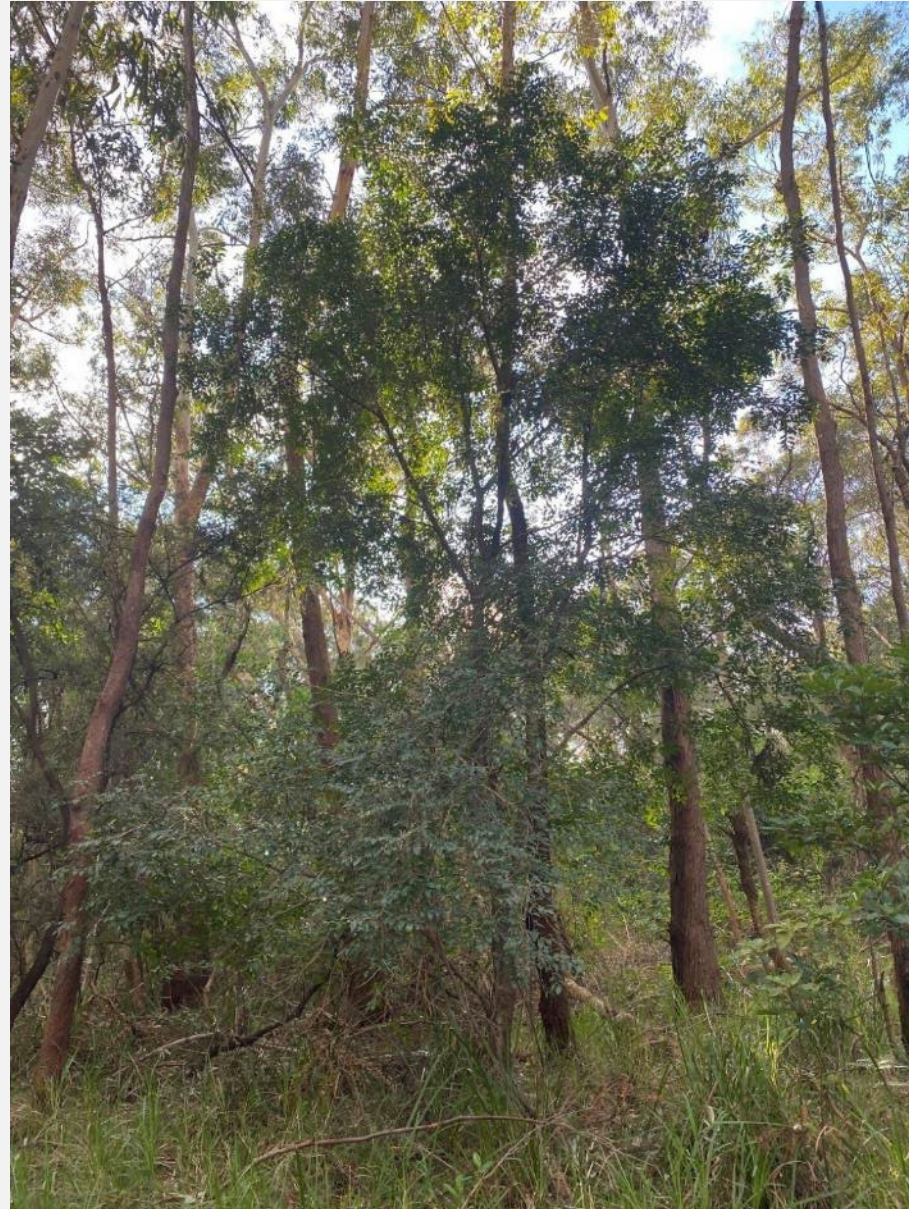
Zone	Location/description	Recommendations for ongoing works 2022/23	Reference Images
Subzone 1.3	Covers the old bund wall that was revegetated earlier in the rehabilitation program. This subzone is located behind the site office and towards the front gate.	Lantana thickets should be the priority weed in this area using cut and paint methods, however, Senna (<i>Senna pendula</i> var. <i>glabrata</i>) (Plate 7) and Crofton weed (<i>Ageratina adenophora</i>) weeds should also be controlled to reduce spreading.

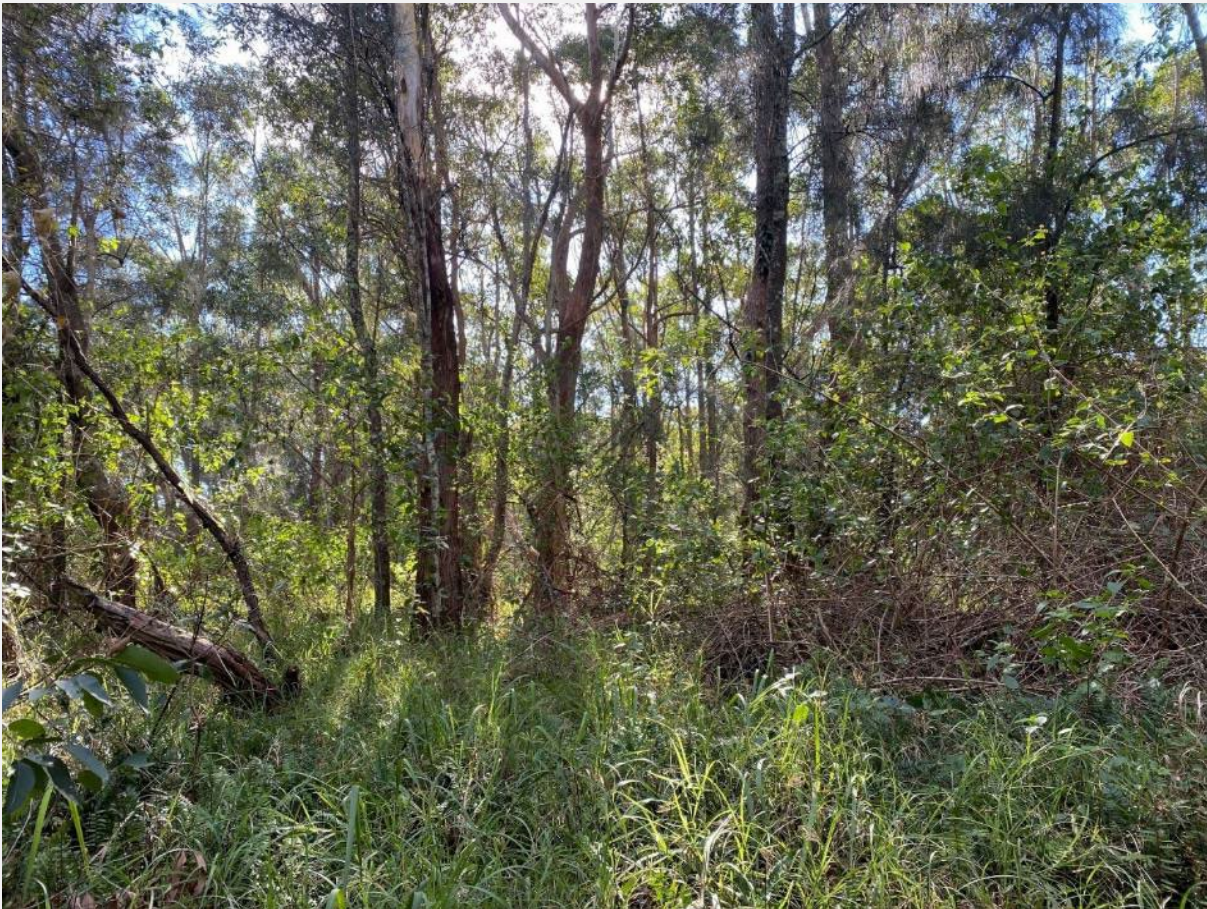
Zone	Location/description	Recommendations for ongoing works 2022/23	Reference Images
Subzone 1.4	A fenced patch of Swamp Oak within grazing land, which now has a planted link to the east (planting zone 2E). Vegetation is well established and requires very little ongoing work.	Unable to inspect subzone due to recent flooding. Previously stated to be a good condition <i>Allocasuarina</i> stand, some Moth Vine starting to creep into swamp extent. If any Moth vine still present continue weed control efforts via cut and paint, be sure not to confuse with nearby native Common Silkpod (<i>Parsonisa straminea</i>) – see Plate 5.	N/A

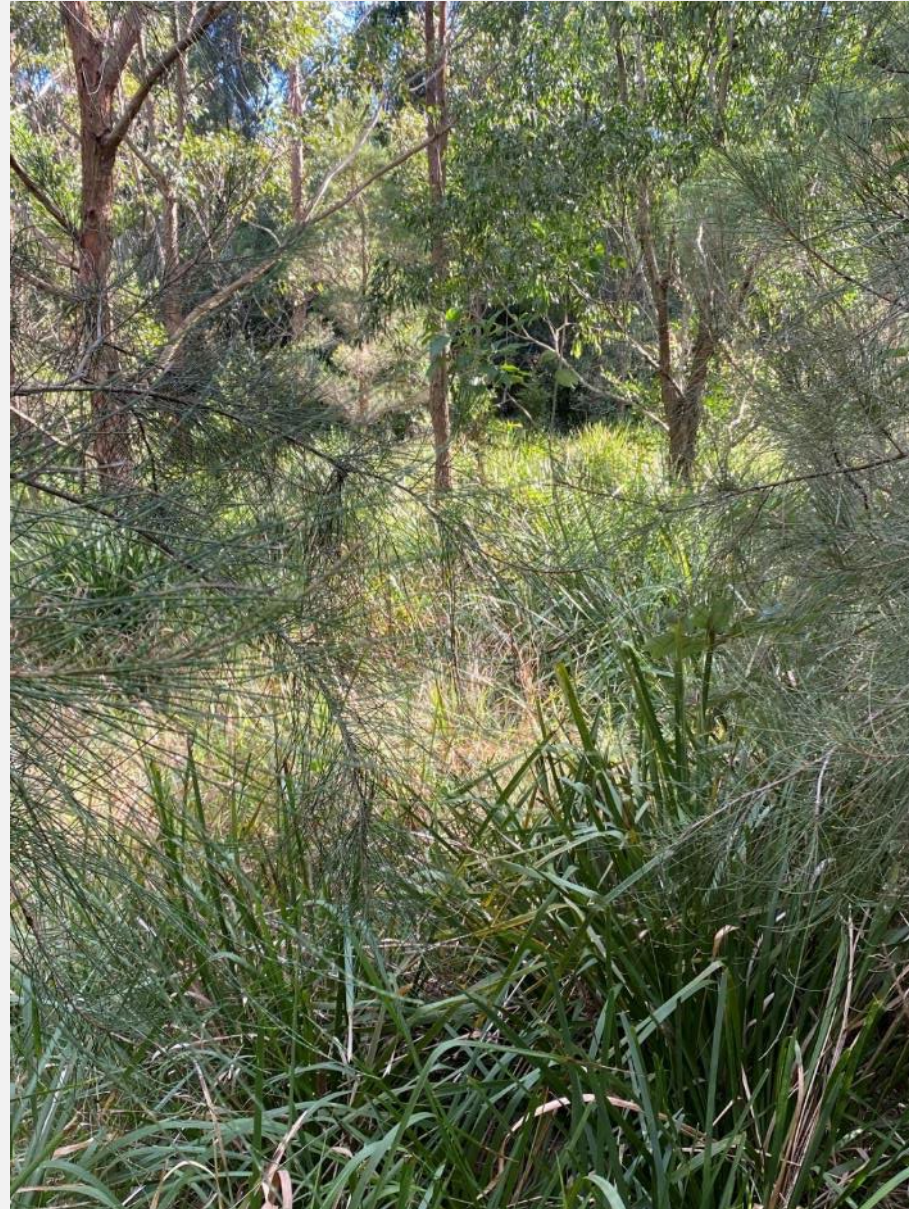
**Subzone
2A.2**

This area is important for the forest link to the south and into Seven Mile Beach National Park on the southern side of Beach Road. Planted trees are becoming well established in most places. Previously most of the planted Swamp Oak (*Casuarina glauca*) in the northern area died. A total of 24 replacement trees were subsequently planted in the following year to replace the trees that died (KMA 2018).

Ongoing Lantana management required via cut and paint method. Stands of Senna, Moth vine (pictured) and Wild Tobacco require continued management.

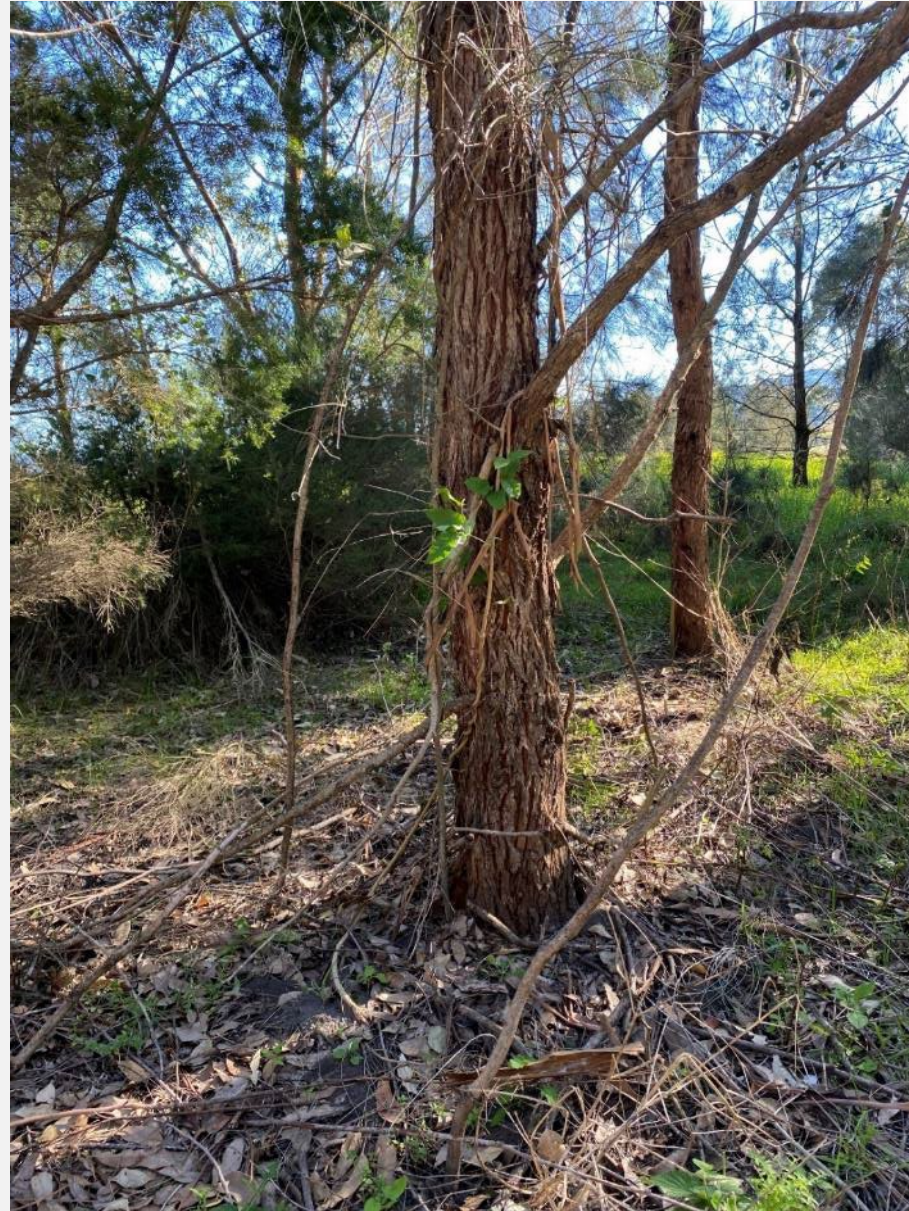
Zone	Location/description	Recommendations for ongoing works 2022/23	Reference Images
Subzone 2A.3	<p>This area was revegetated early in the re-planting program. The plantings that have survived in this area have become well established despite previous impacts from grazing native fauna.</p>	<p>Continued control of Lantana via cut and paint methods should be the main priority in this subzone. Removal of small clustering of Moth vine evident.</p>

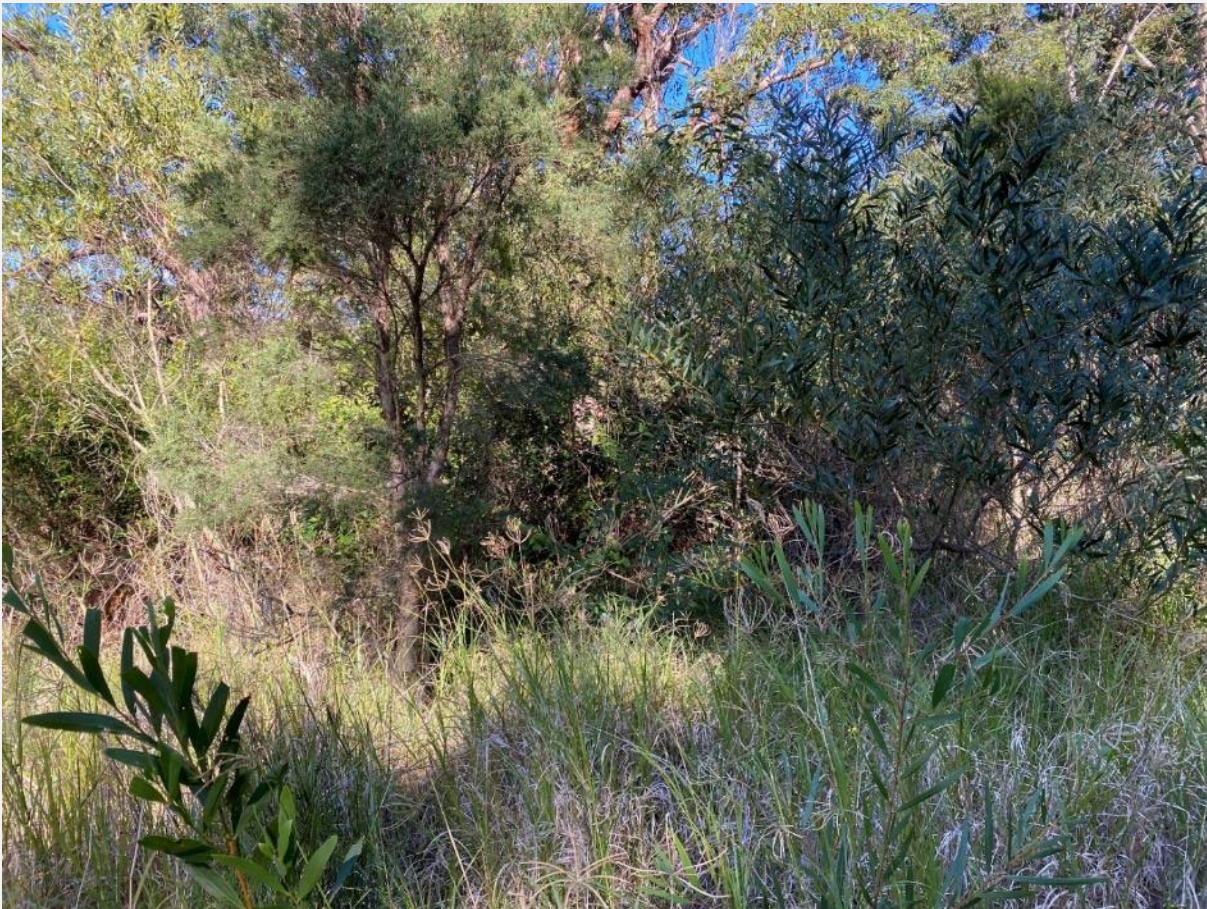
Zone	Location/description	Recommendations for ongoing works 2022/23	Reference Images
Subzone 2C.1 (southern end)	Small revegetation patch that was completed recently to link the forest with Zone 4, located roadside adjacent to subzone 1.1.	This subzone requires continued monitoring and management of noxious woody weed growth. Continue to mow around tree guards and remove Kikuyu grass from within the guards when required (Plate 6). The plantings have been subjected to grazing pressures but overall, the plants are in good condition. If grazing continues to impact the plantings, measures to protect them will need to be put into place i.e. A fence similar to subzone 2C.1. Continue to promote native tree and shrub cover via planting of native species to lessen risk of weed reinvasion.

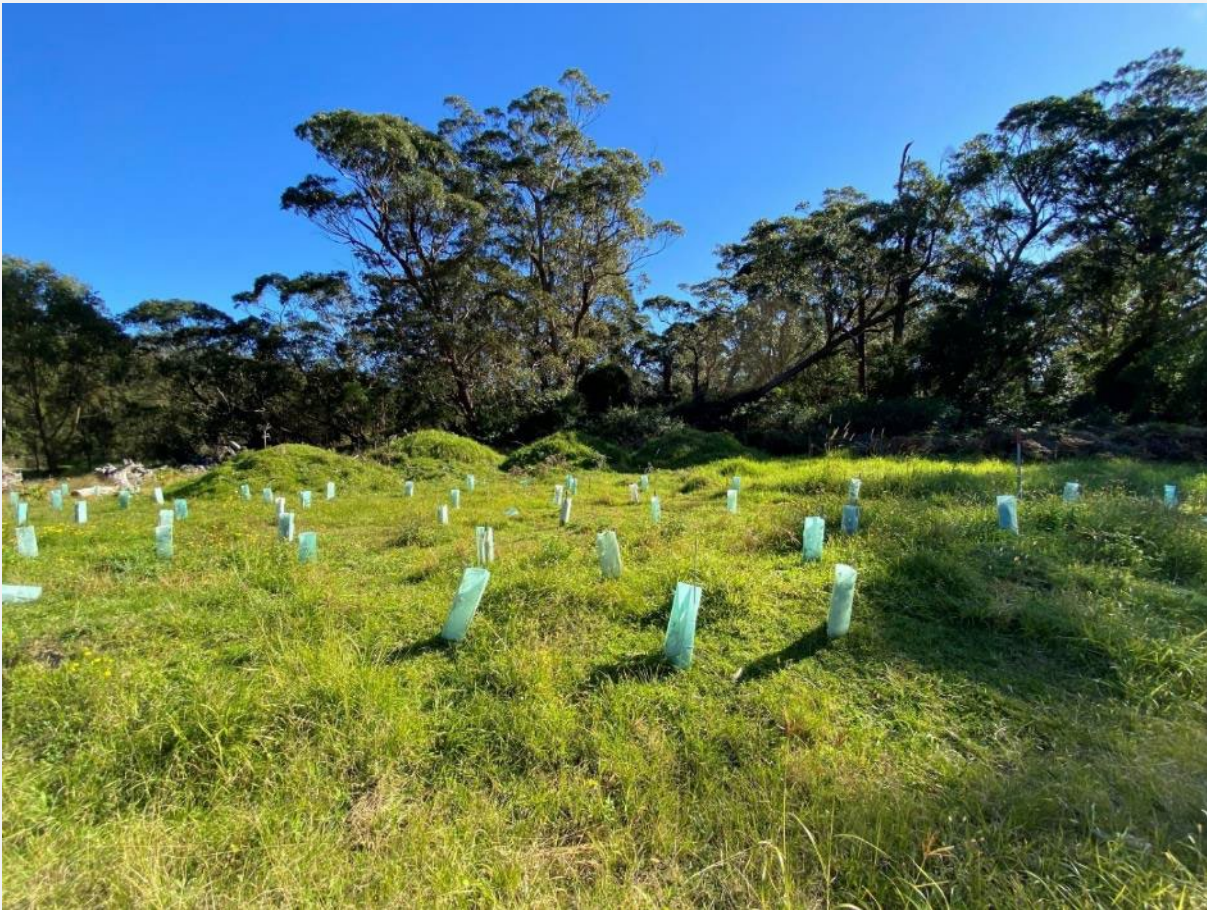
Zone	Location/description	Recommendations for ongoing works 2022/23	Reference Images
Subzone 2B.2	<p>This area is located in a low-lying swamp and is being colonised by Swamp Oak. Some planting was carried out on a higher part of the subzone in the south and west in previous years (KMA 2018). The natural regeneration occurring in this subzone is adequate.</p>	<p>The understorey in this subzone is largely made up of pasture grass. Small stands of Tobacco Bush, Lantana and Thistle are evident near the roadside that should be managed via cut and paint methods.</p>

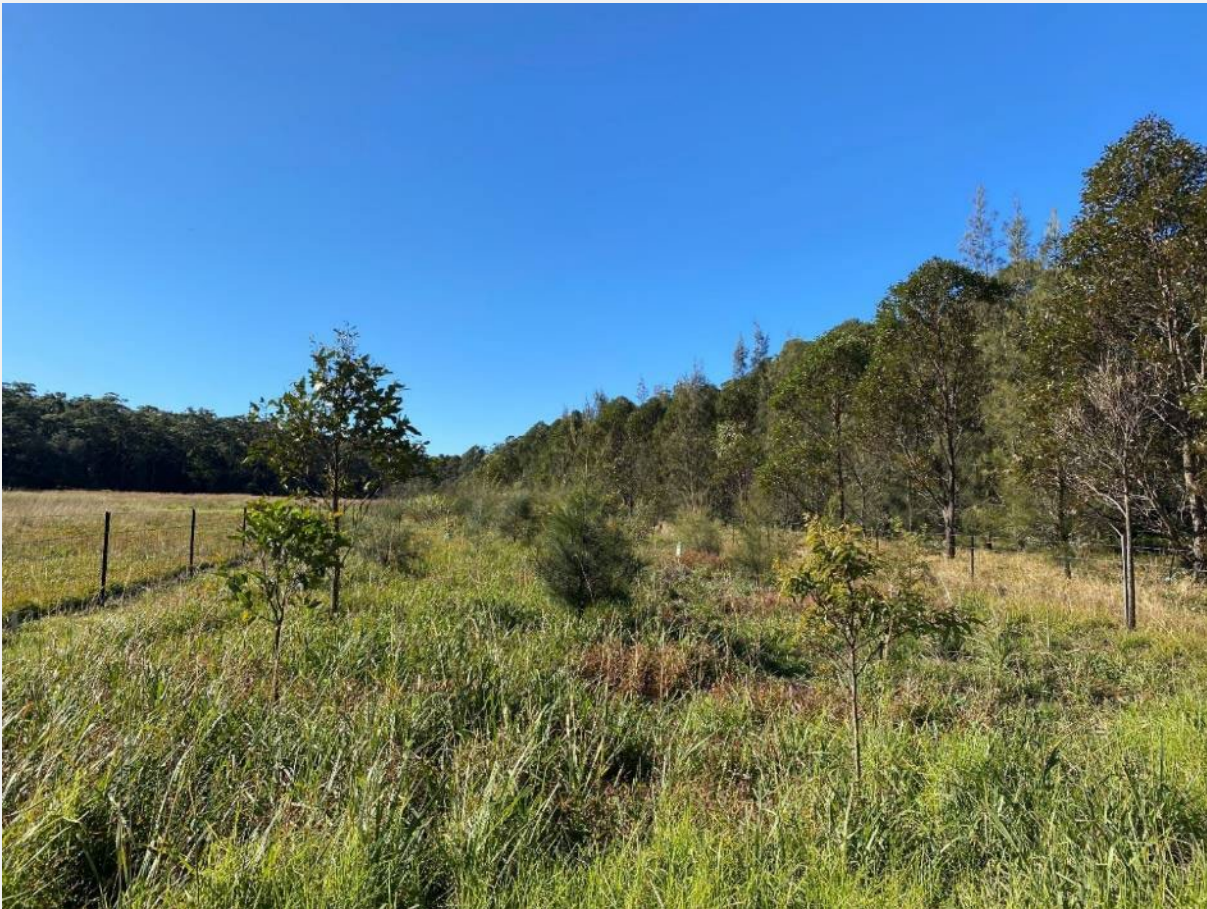
Zone	Location/description	Recommendations for ongoing works 2022/23	Reference Images
Subzone 2C.1	This subzone is known as 'The Garden' and is a planted area adjacent to more established vegetation located in subzone 1.1.	'The Garden' is in good condition, plantings have become well established and the area is generally free from high threat weeds. This subzone is a good example for techniques that should be implemented on newer plantings. Undertake infill plantings as required to promote native tree and shrub growth and to lessen risk of weed reinvasion.

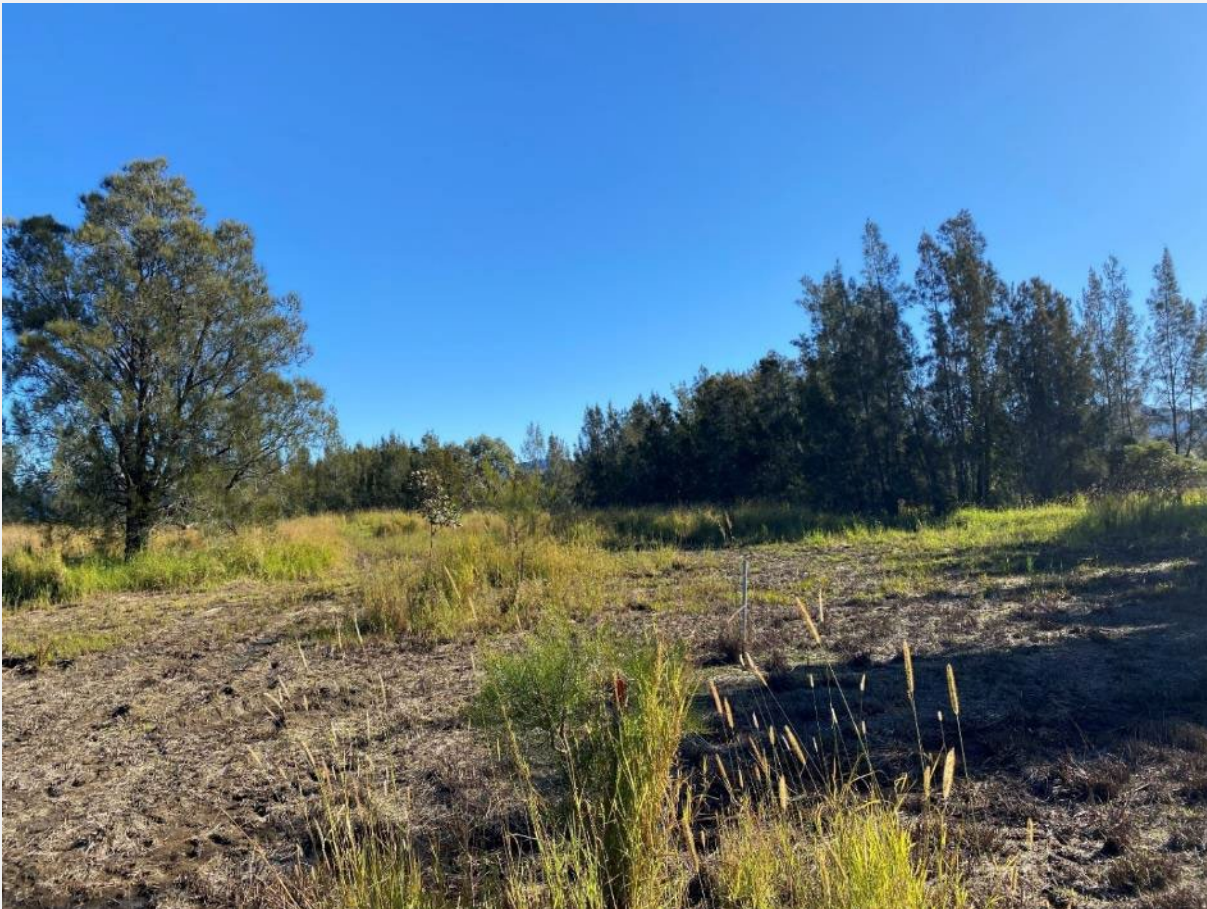
Zone	Location/description	Recommendations for ongoing works 2022/23	Reference Images
Subzone 2C.2	A long narrow area supporting some well-established plantings.	Some plantings have been impacted by recent flooding events. There was also evidence of deer grazing on the plantings (Plate 1), deer control methods may need to be implemented if this continues. Further planting is required to replace plants that were impacted and to promote growth of surrounding native plants. Management of weeds and pasture grasses should be completed once area starts to recover from flood damage.

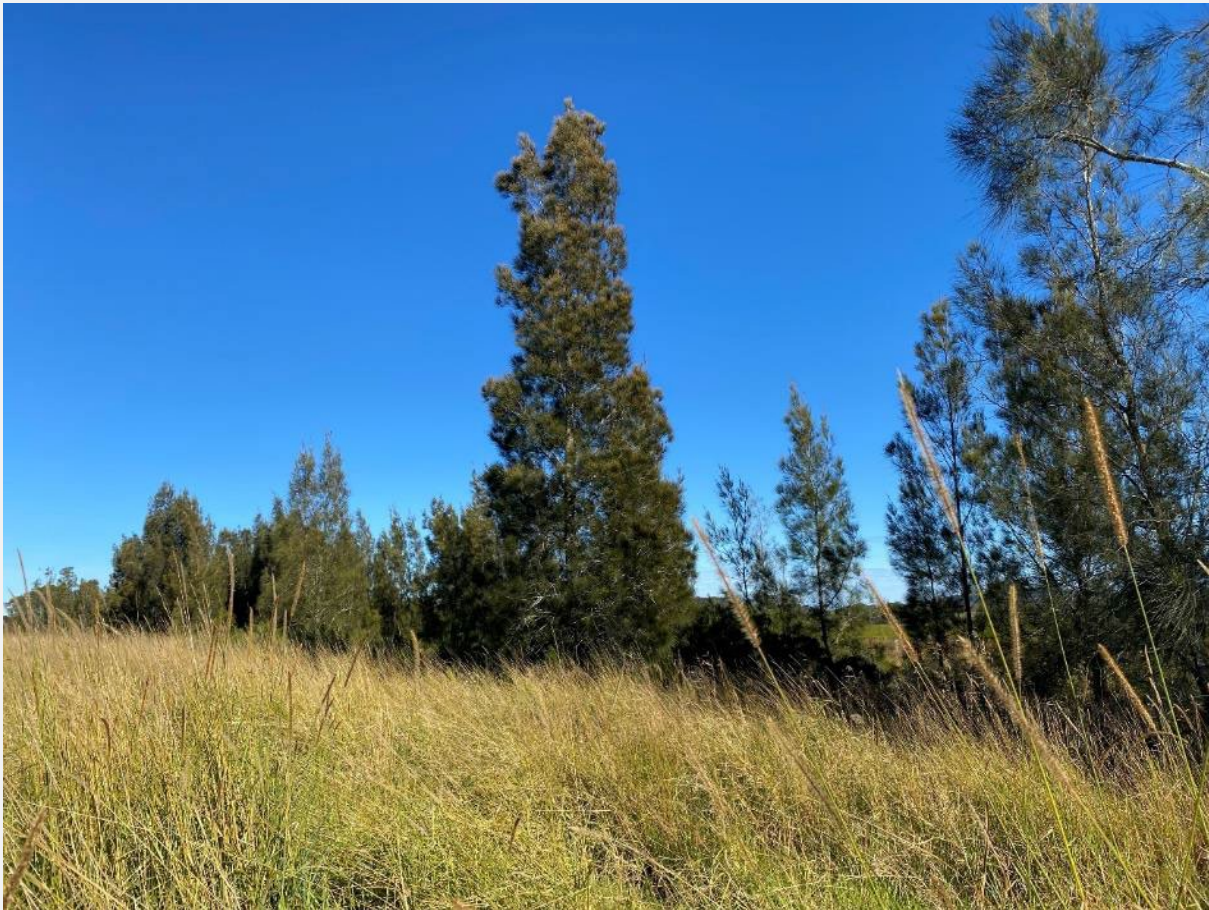
Zone	Location/description	Recommendations for ongoing works 2022/23	Reference Images
Subzone 2E	Plantings in this area have become well established and tree growth continues to be progressing well. This narrow strip of trees extends into subzone 1.4, an established area of trees.	Only able to access northern end of subzone due to recent weather. This area overall is in good condition. Continued treatment of any woody weeds that reappear and monitor for any Moth vine.

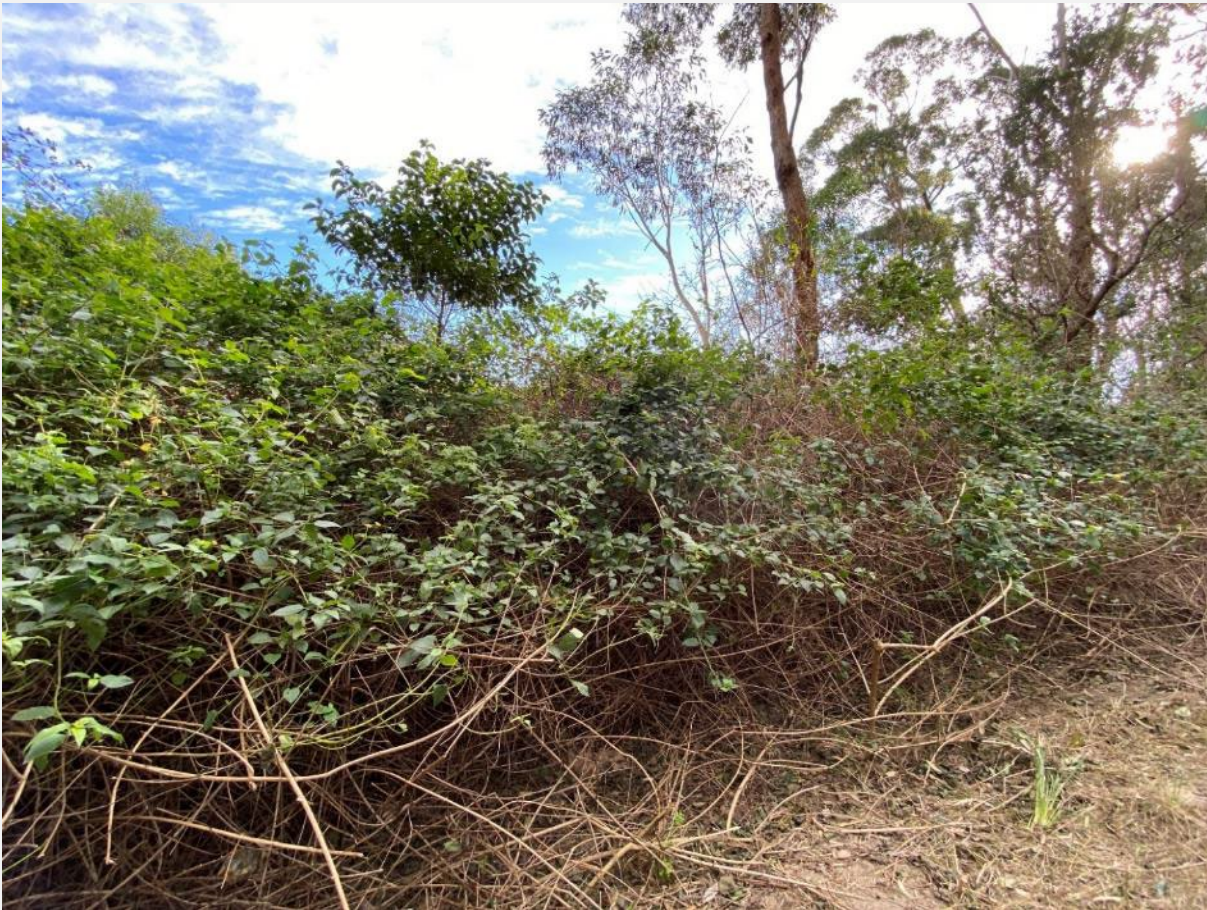
Zone	Location/description	Recommendations for ongoing works 2022/23	Reference Images
Zone 3	This zone includes the bund wall which reached its final height early in 2015. A screen of native vegetation was established along the eastern edge of the pond extension. The sand bund is currently stabilised by growth of plants, the majority of which are weeds.	Evidence of previous spraying of Lantana but the bund wall is still currently overrun with Lantana. Continue removal of Lantana using spraying and cut and paint methods. Planting is required to encourage native growth to stabilise bund wall. Removal of old plant guards on mature plants (Plate 3) to encourage future growth.

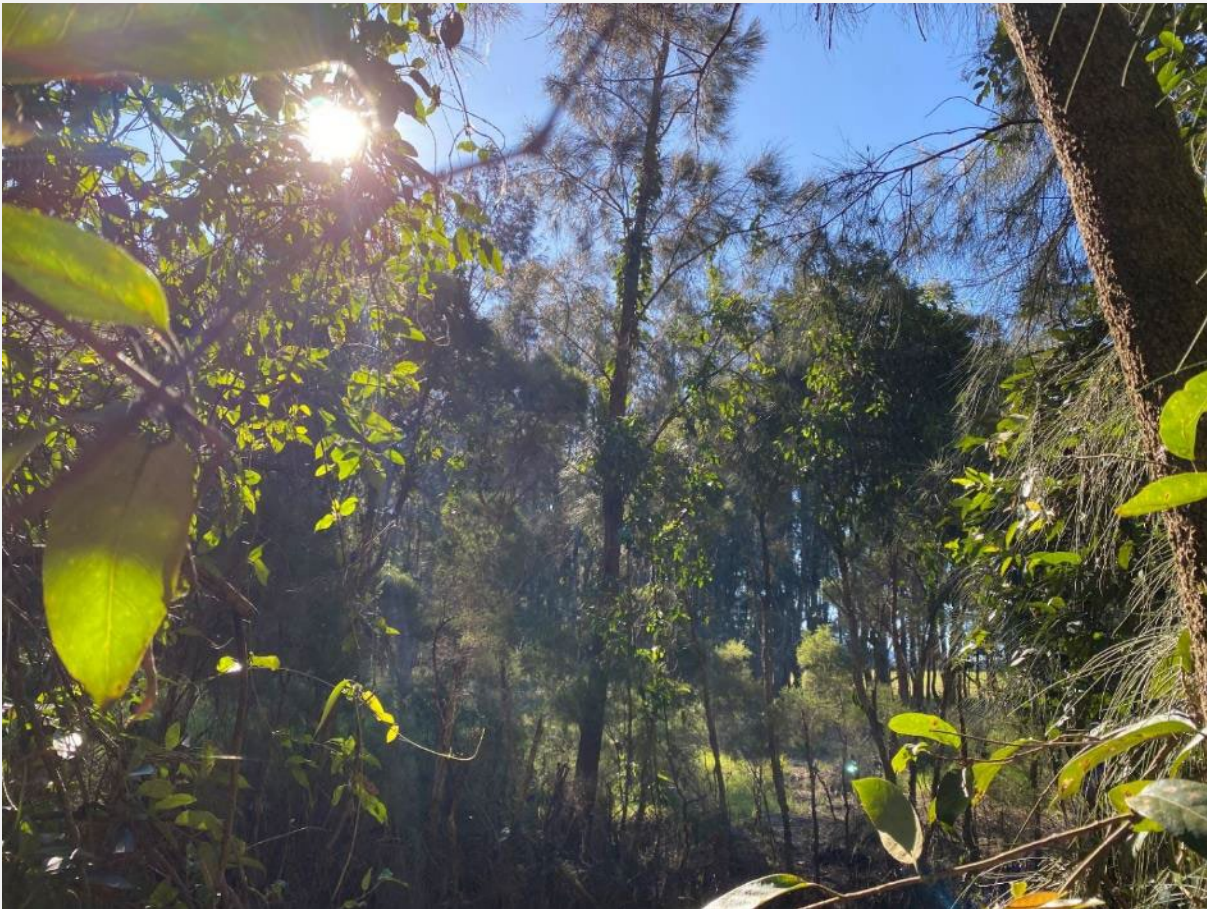
Zone	Location/description	Recommendations for ongoing works 2022/23	Reference Images
Zone 5	This zone includes remnant Swamp Oak Forest. Area is overall in good condition with a relatively open mid/understorey.	Continue to maintain perimeter fencing to stop stock from grazing on plantings. Undertake weed control on any woody weeds present and carry out future plantings to promote native growth and help out compete pasture grasses.

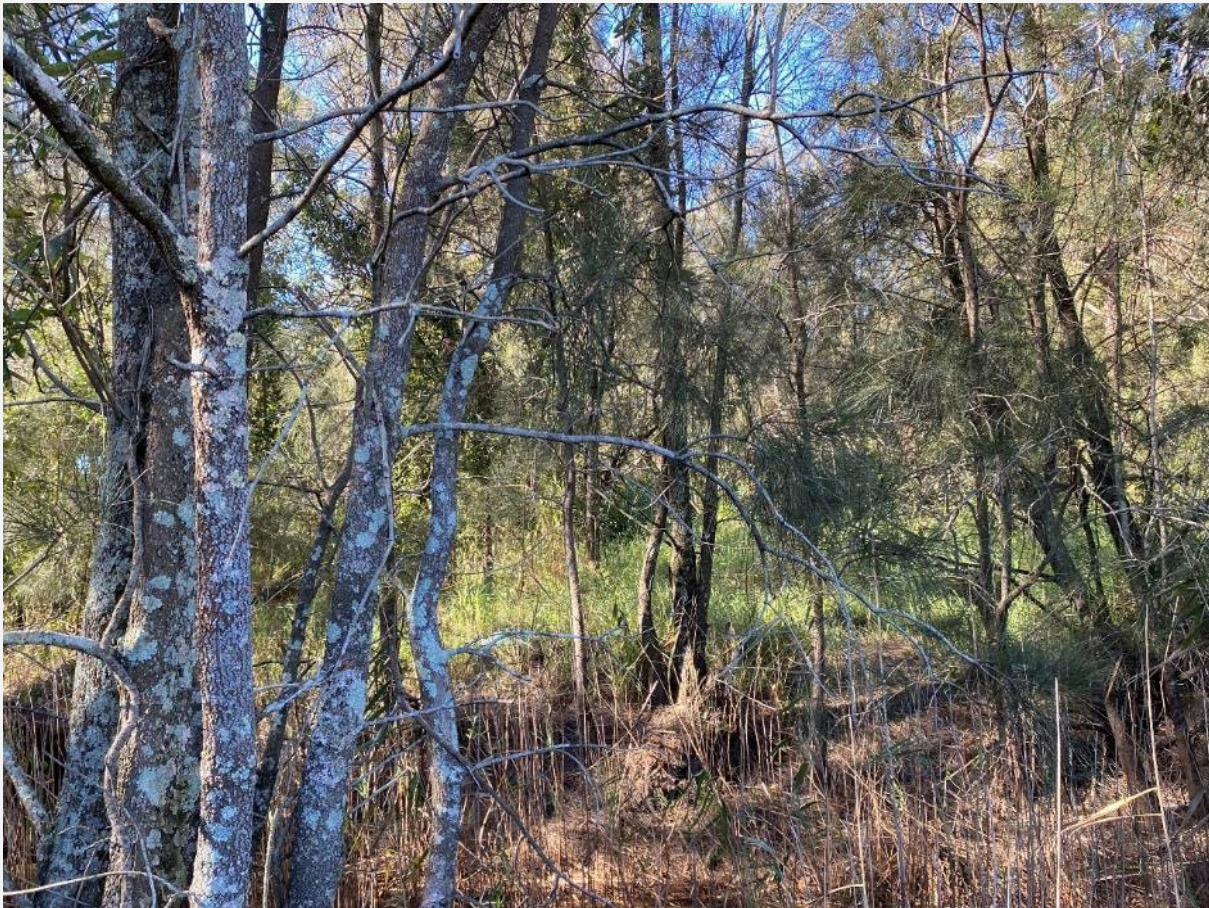
Zone	Location/description	Recommendations for ongoing works 2022/23	Reference Images
Zone 5C.1	Occurs between the Swamp Oak Forest in zone 5 and the creek that has been planted. The area is dominated by Kikuyu Grass. The shrub <i>Melaleuca ericifolia</i> is continuing to expand from the creek-side.	Control of Lantana via cut and paint methods to encourage the growth of native vegetation.

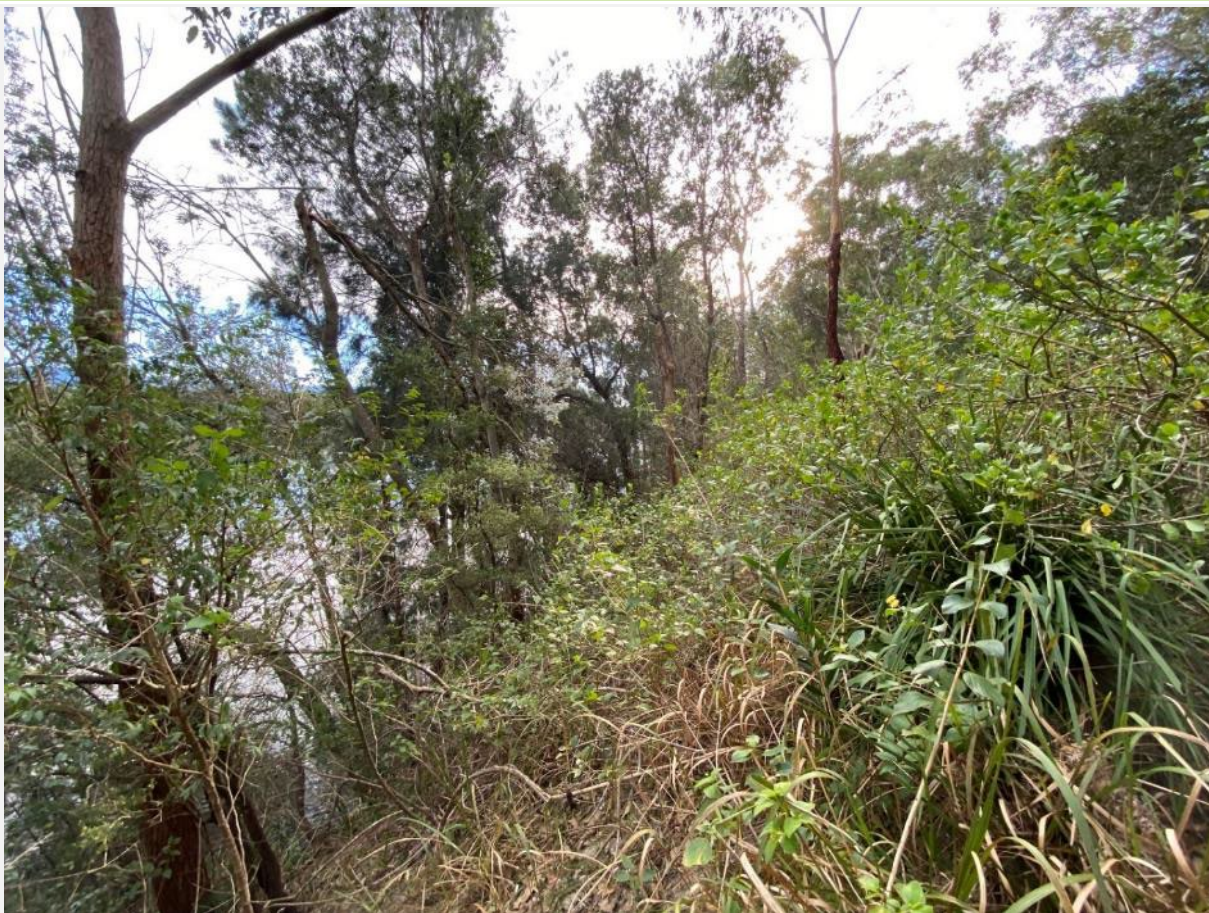
Zone	Location/description	Recommendations for ongoing works 2022/23	Reference Images
Zone 6	<p>This zone occurs within the foreshore areas of the Dredge Pond. The foreshore has been previously shaped, had topsoil spread and planted as the dredge pond has expanded northwards. Overall, the pond bank is stable with little to no erosion evident. Natural regeneration and pre-existing native growth have helped to stabilise area.</p>	<p>Monitor and control of priority weeds such as Lantana, Bitou bush and Tobacco bush using cut and paint method as necessary. Avoid spraying in this area to ensure native species retain dredge pond bank stability. Additional plantings may be beneficial to encourage native growth and to control annual weeds and invasive grasses from dominating.</p>

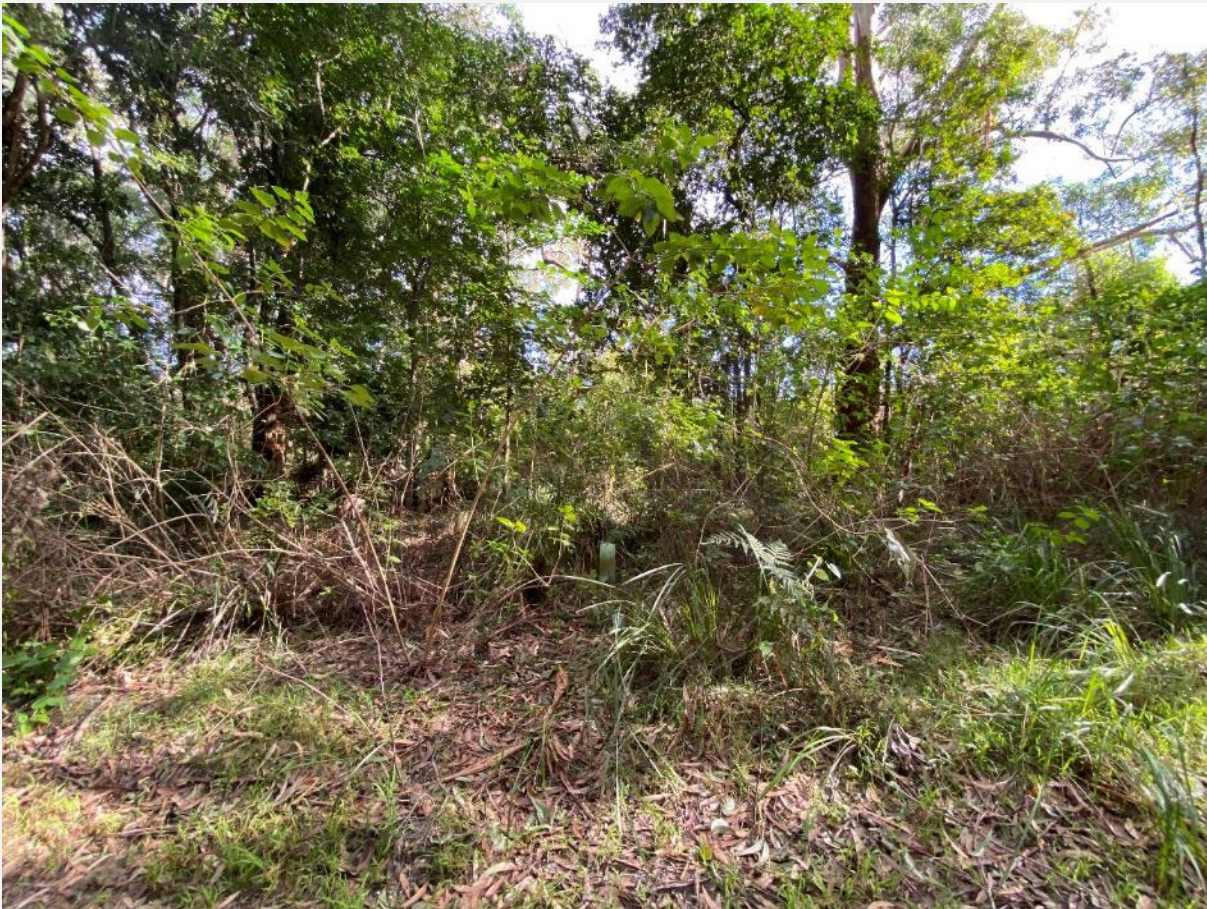
Zone	Location/description	Recommendations for ongoing works 2022/23	Reference Images
Zone 7	This zone occurs along the eastern edge of the Site between zones 3 and 1.2. This zone has cultural significance, therefore only minor control of Lantana has been conducted over time.	Southern end of zone is well maintained with minimal Lantana present. Presence of Lantana increases in the Northern section of the zone. Monitor and control Lantana and Tobacco bush as necessary using the mosaic methods of weed removal (i.e. working in patches). Remove any plant guards that are no longer being used.

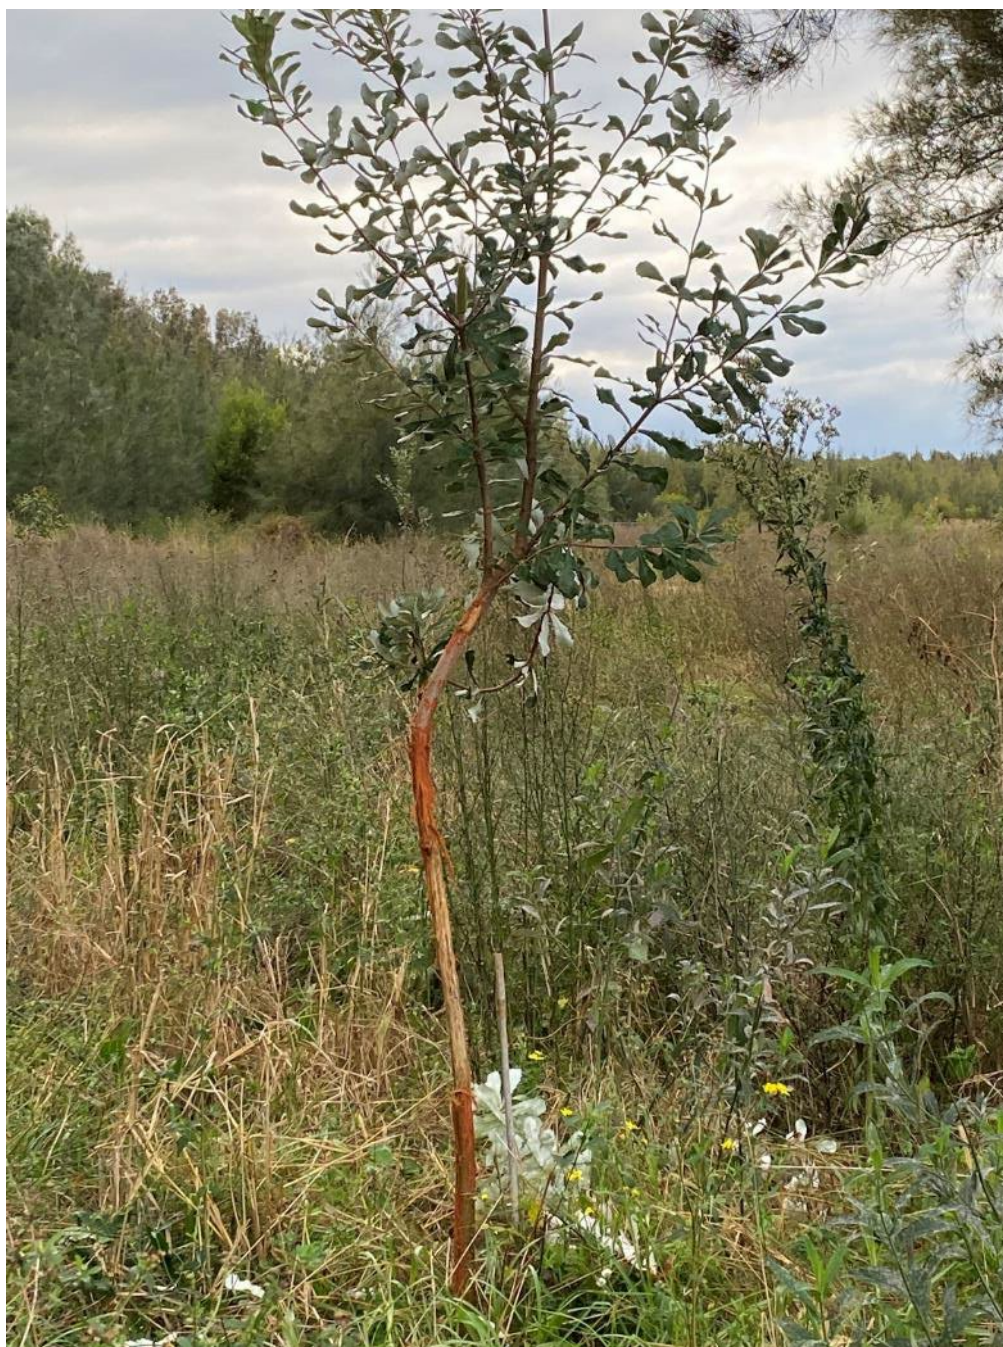
Plate 1: Deer rubbing on *Banksia integrifolia* within subzone 2C.2 planting area. Note: the length of weedy grass species.

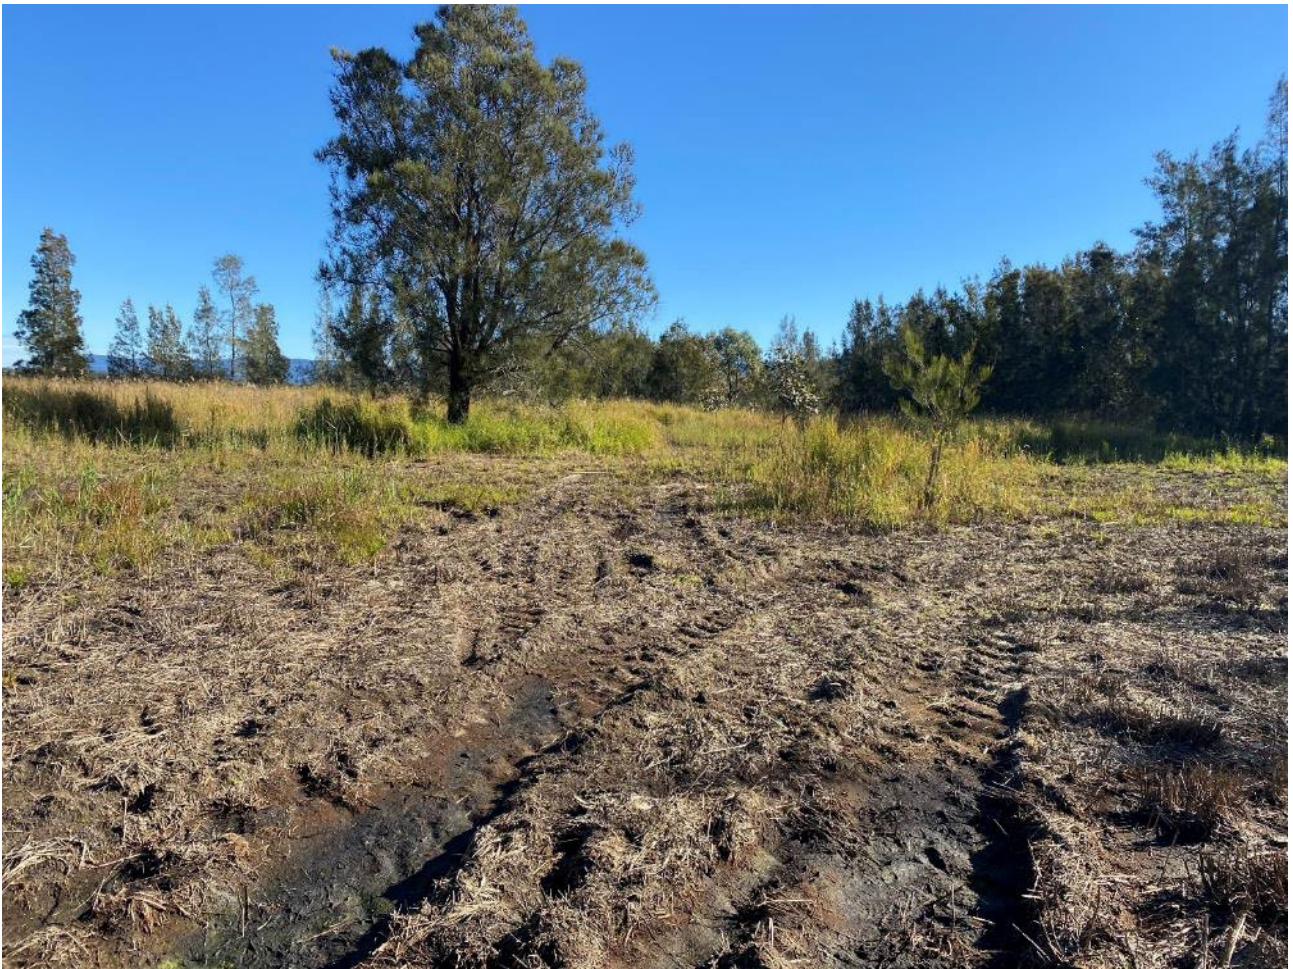
Plate 2: Damage to planting site from recent flooding at subzone 2C.2.
