GERROA SAND RESOURCE

ANNUAL ENVIRONMENTAL MANAGEMENT REPORT

Period 01 July 2021 – 30 June 2022

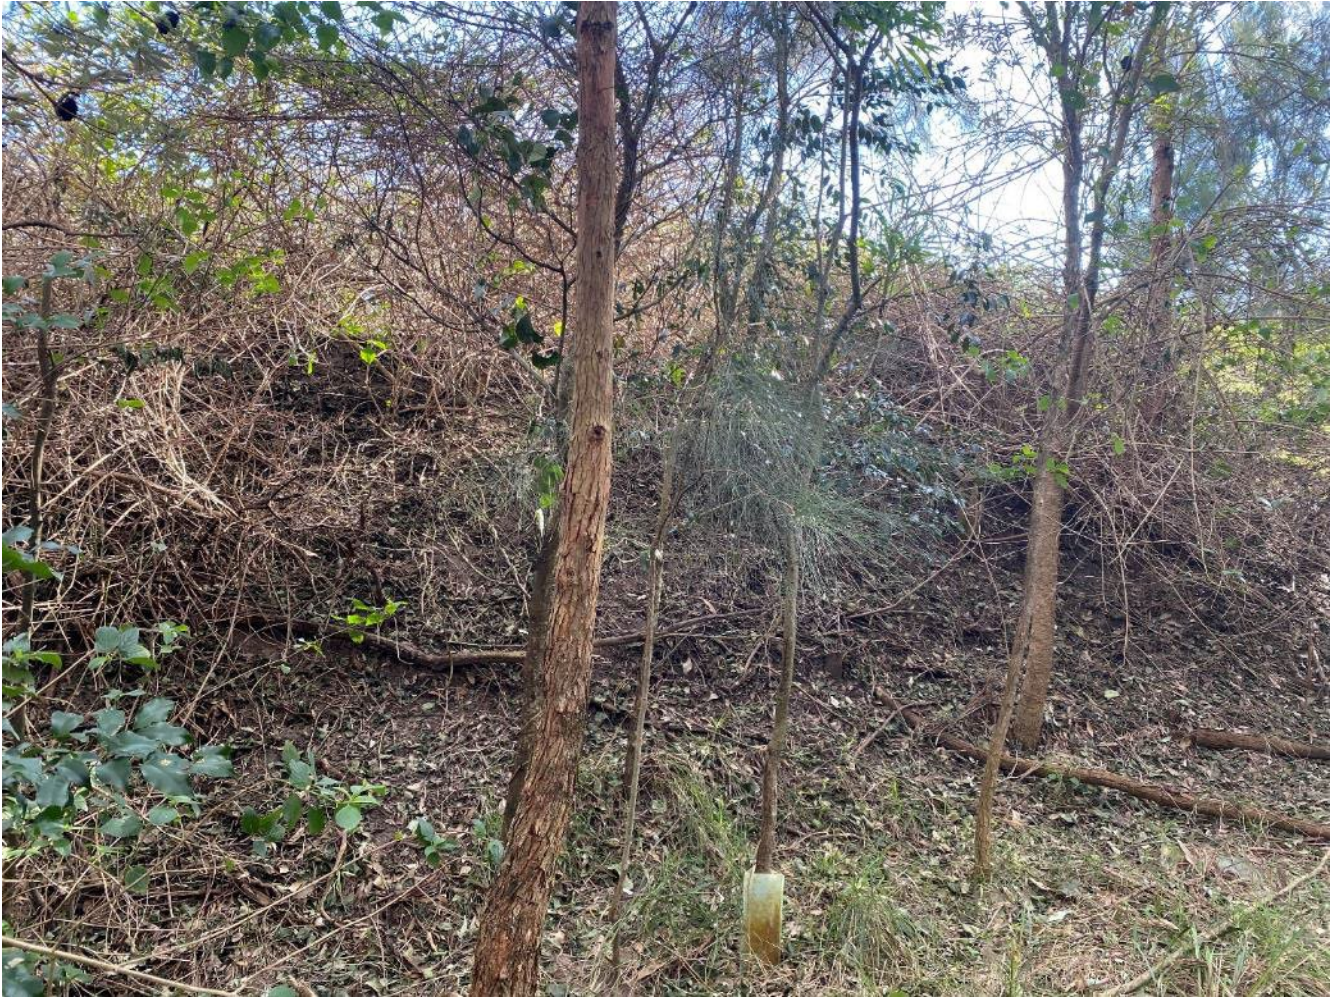
Plate 3: Old planting, remove tree guard to encourage future growth.

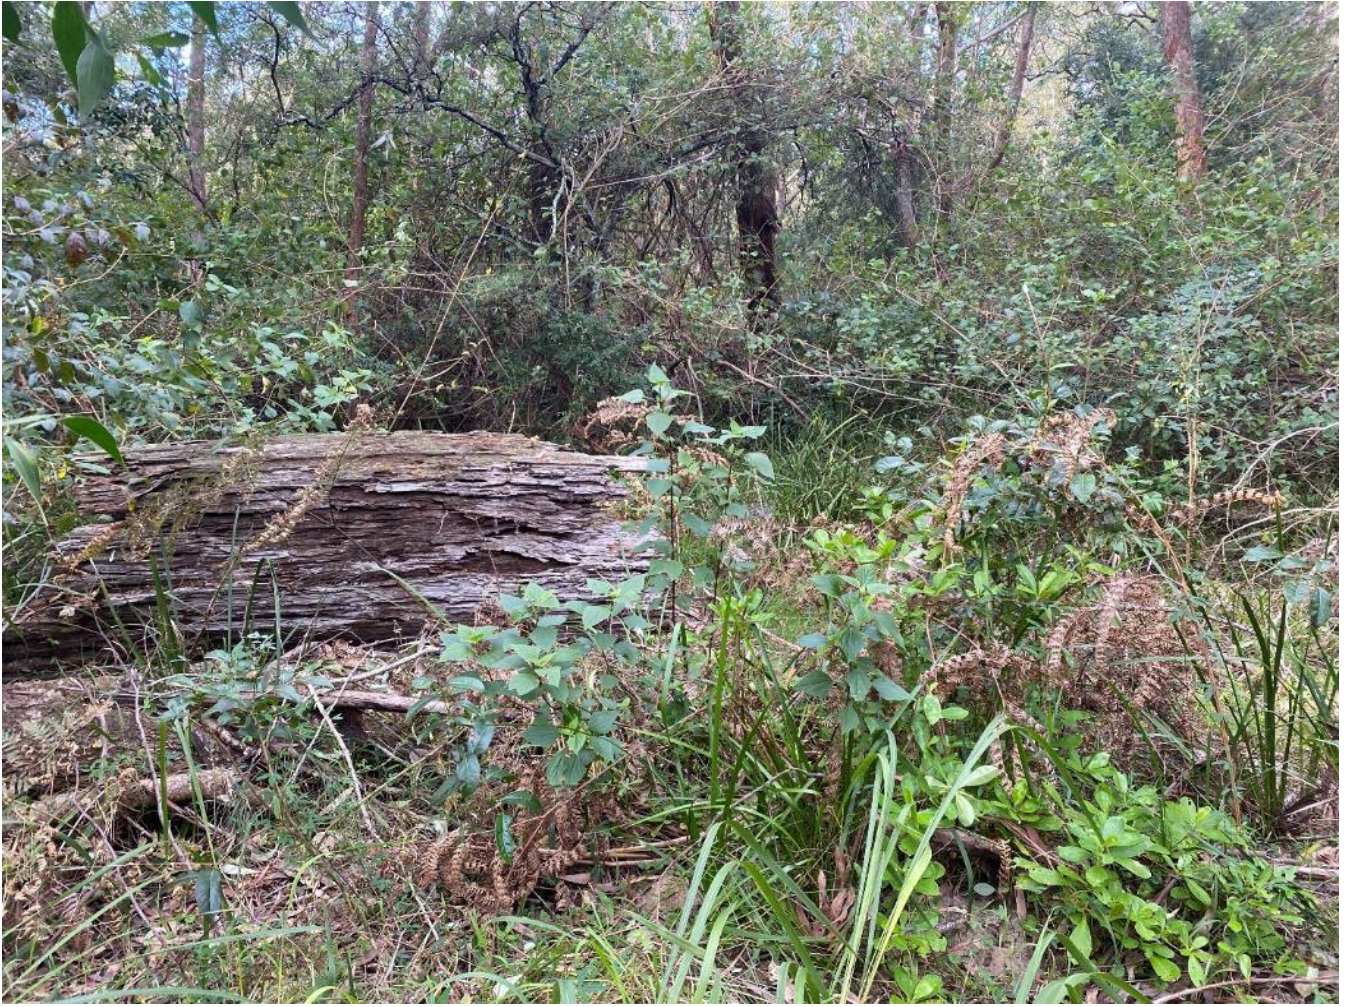
Plate 4: Crofton weed stands in subzone 1.2.

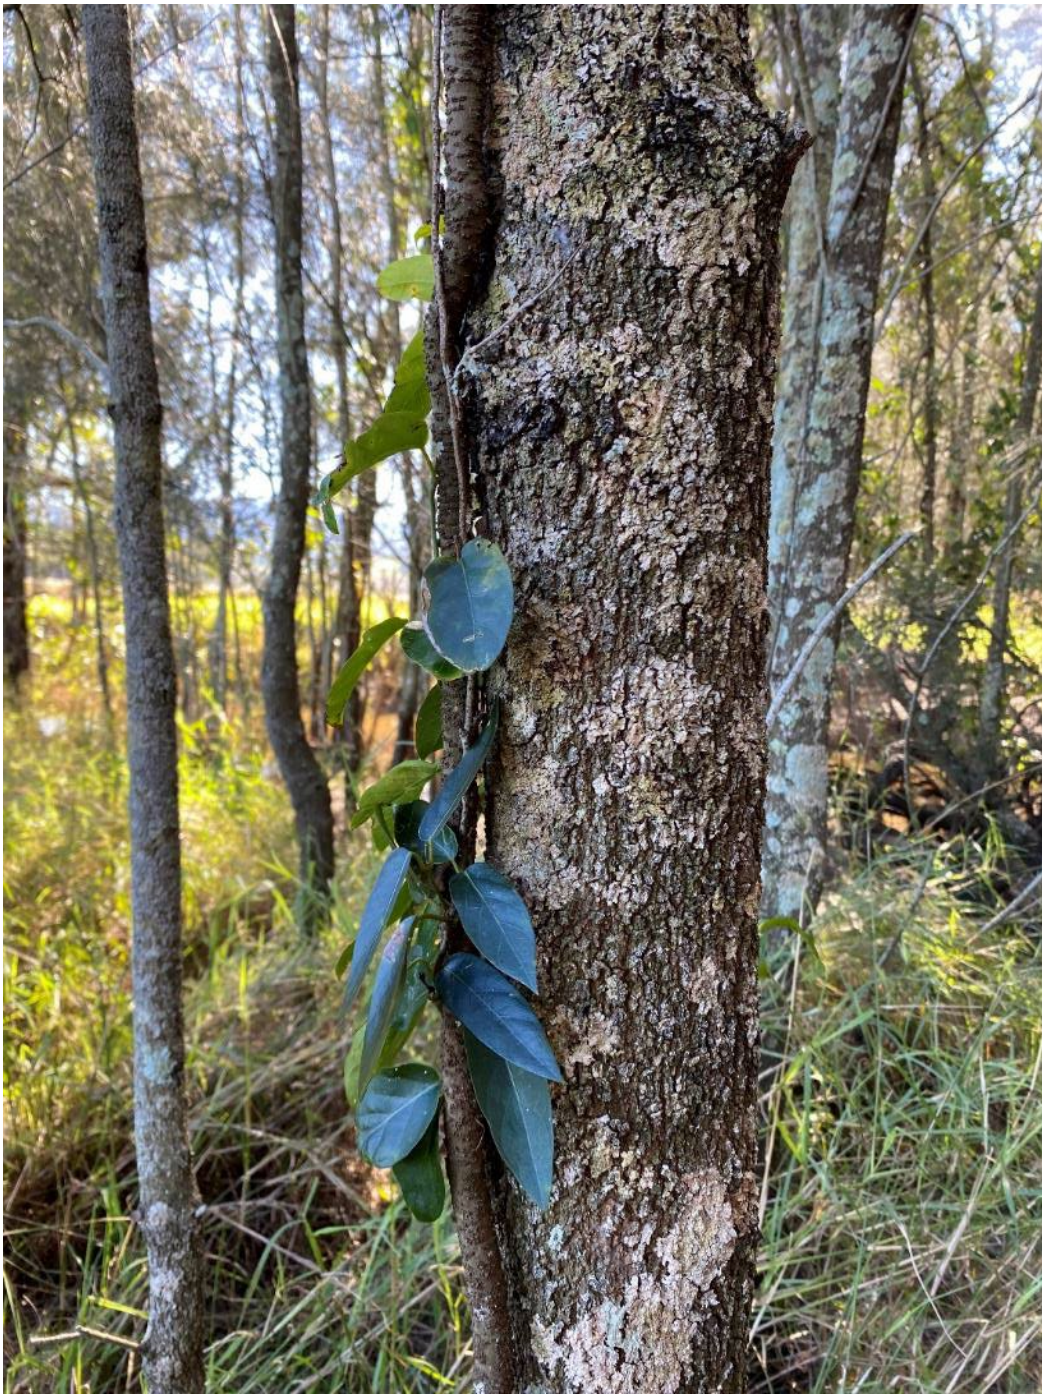
Plate 5: Native Common Silkpod (*Parsonia straminea*) not to be confused with Moth Vine (*Araujia sericifera*) when targeting Moth Vine in Zones 1.2, 1.4 and 5.

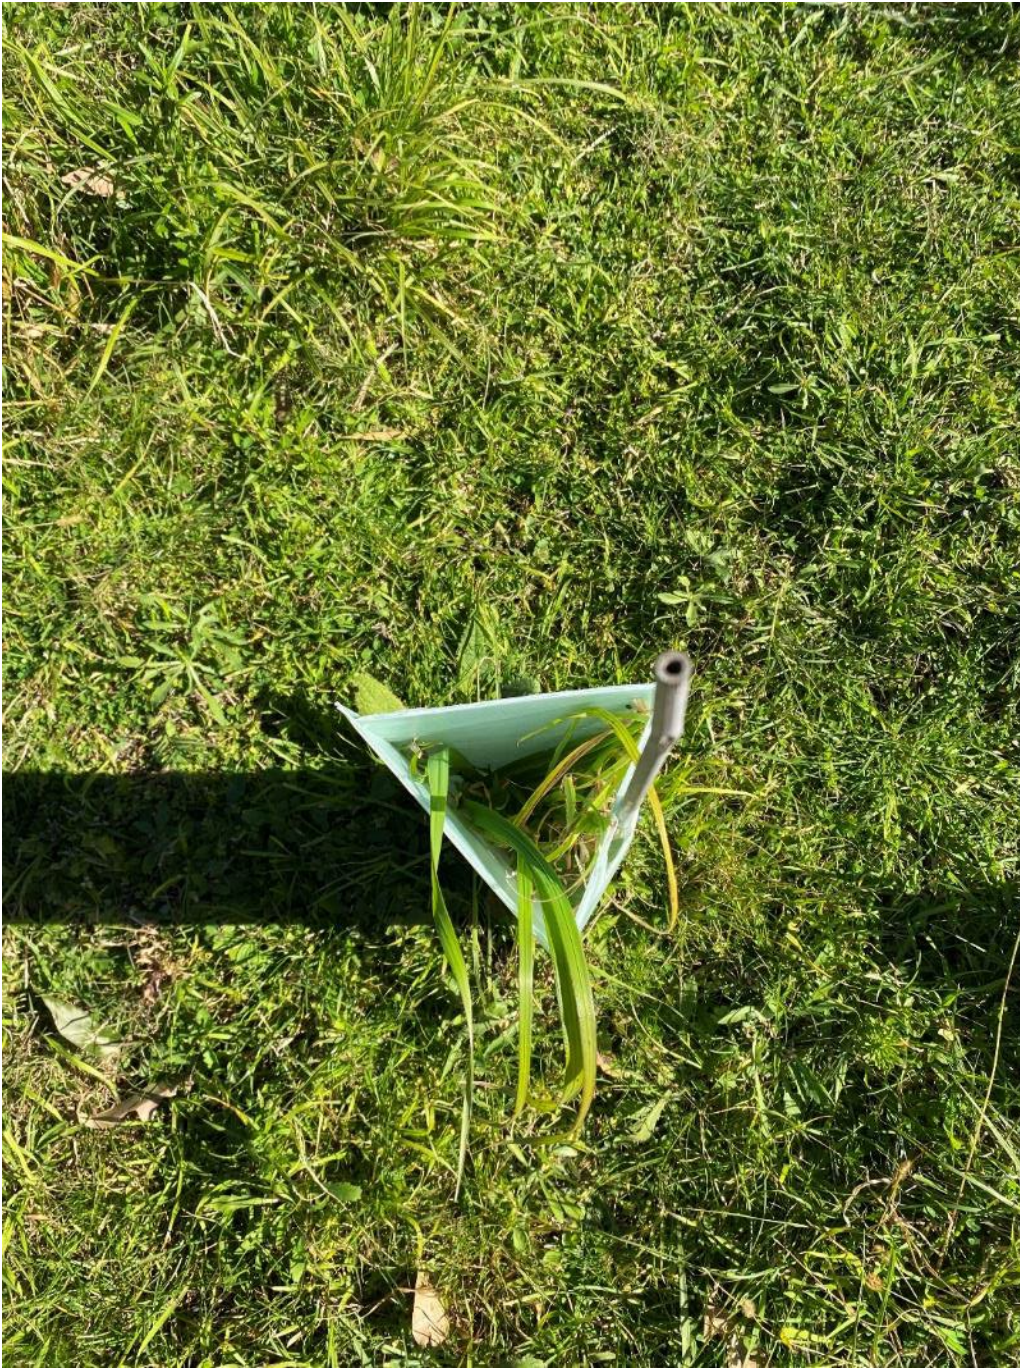
Plate 6: Grass growing through tree guard and strangling planting, avoidance via more frequent mowing and hand removal to improve revegetation success.

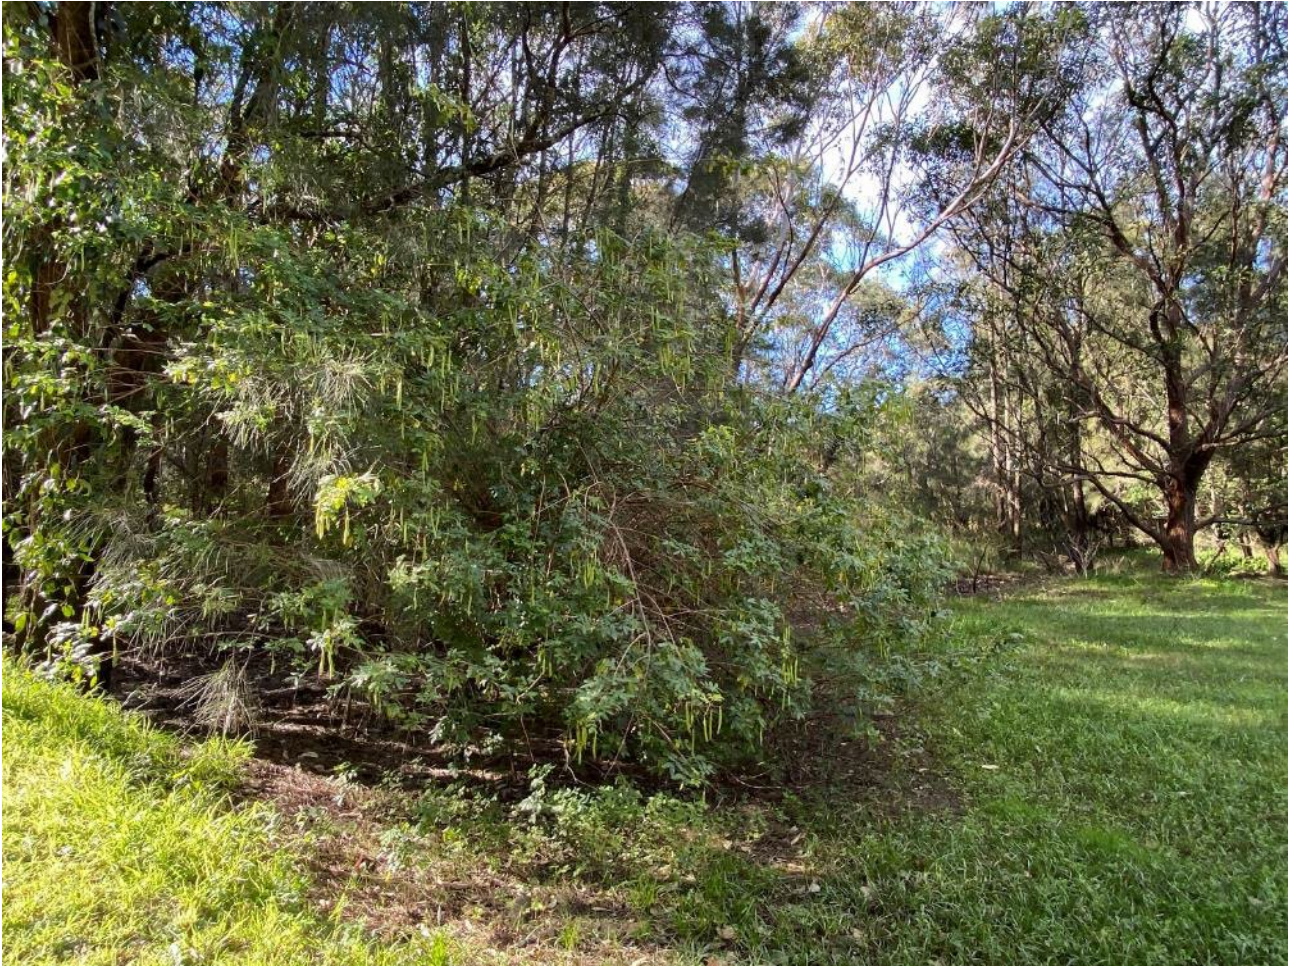
Plate 7: A fruiting Senna stand near Site entry. Stands like this should be removed and fruits bagged and disposed of correctly to avoid further seed dispersal.

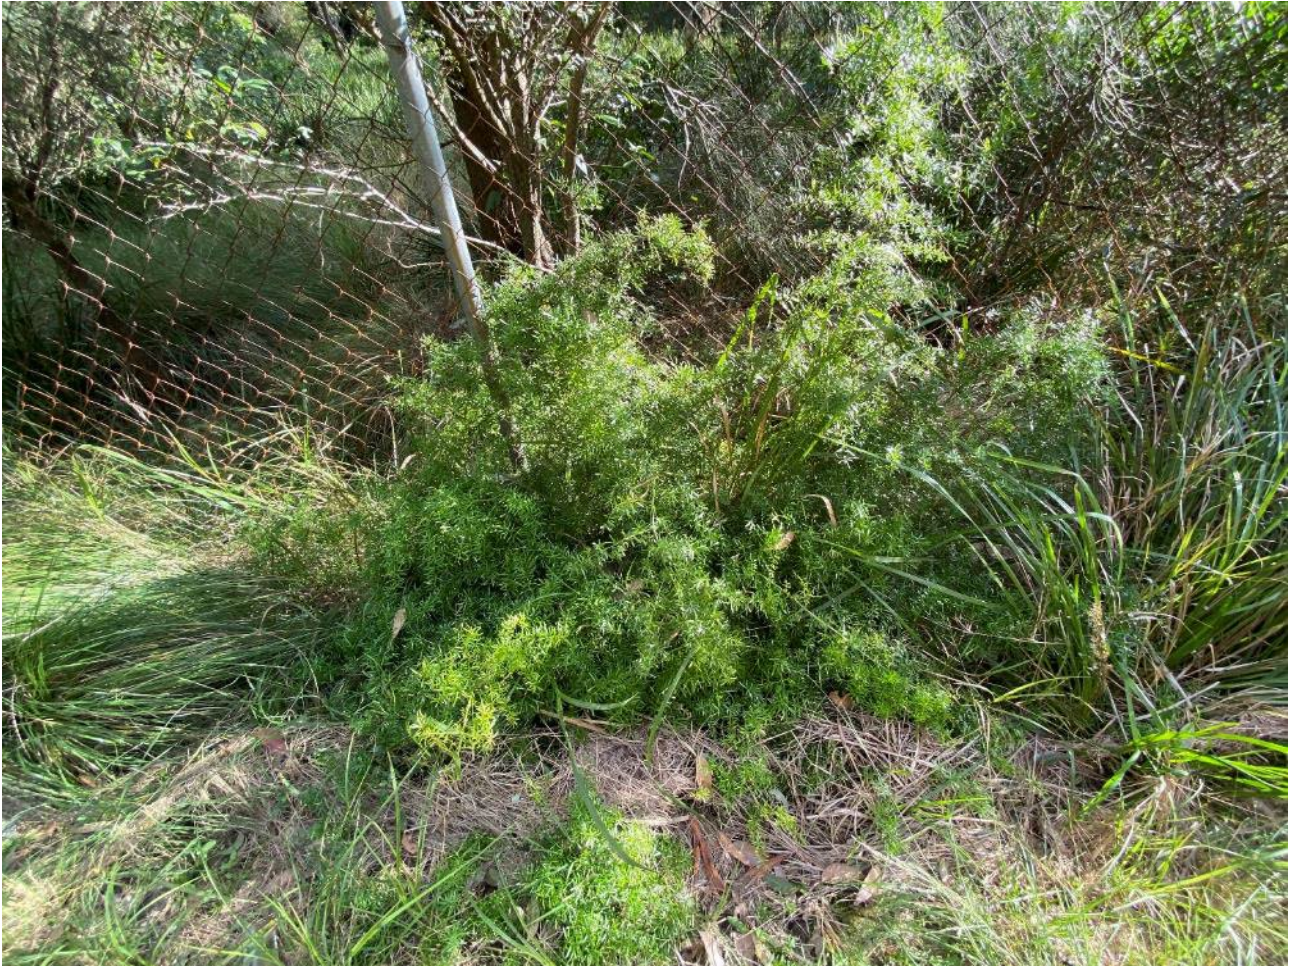
Plate 8: Asparagus fern encroaching on subzone 2A.1. Control methods to be put in place to stop spread throughout the Site.
