GERROA SAND RESOURCE

ANNUAL REVIEW

Period 01 July 2022 – 30 June 2023

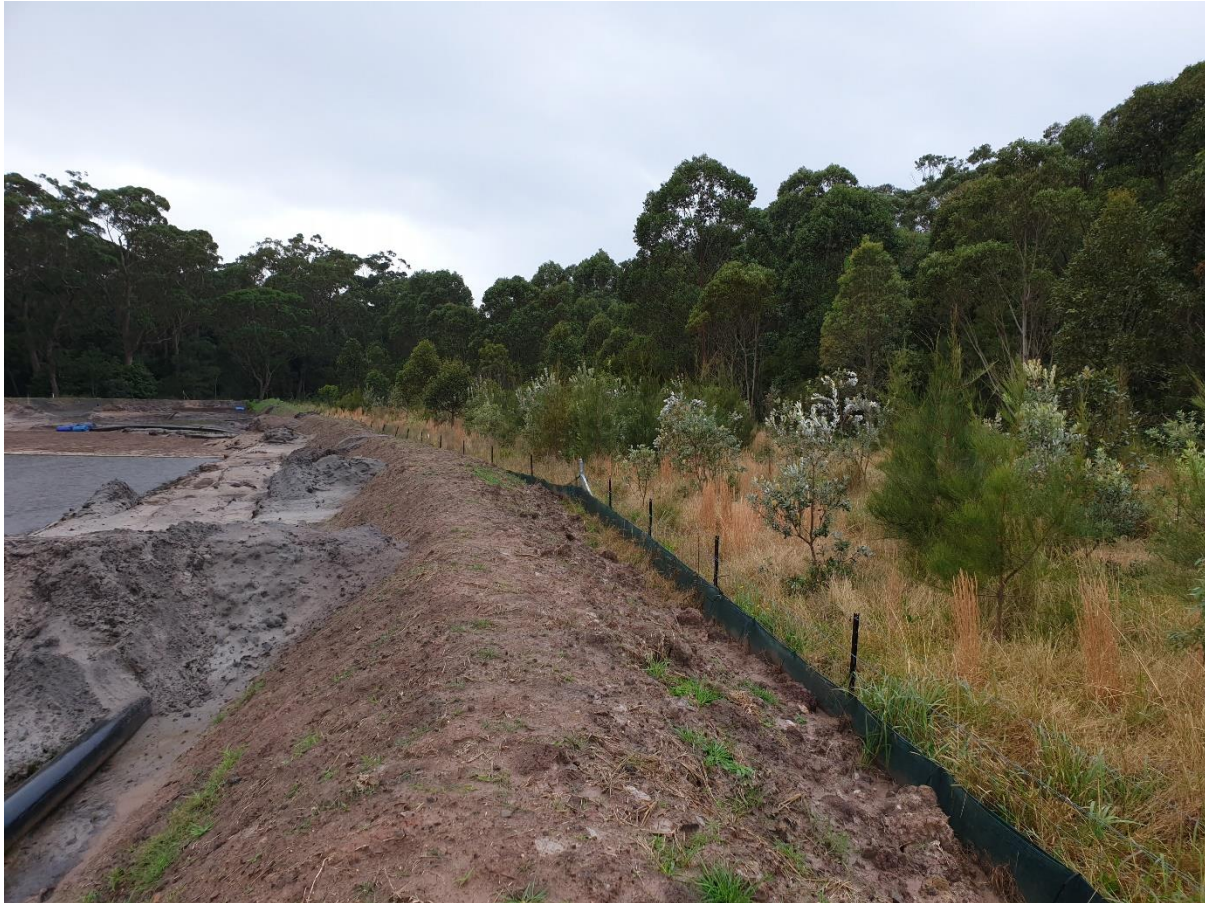
Figure 3 – Flood bund and sediment fence installed alongside perimeter of new dredge pond near zone 2C1

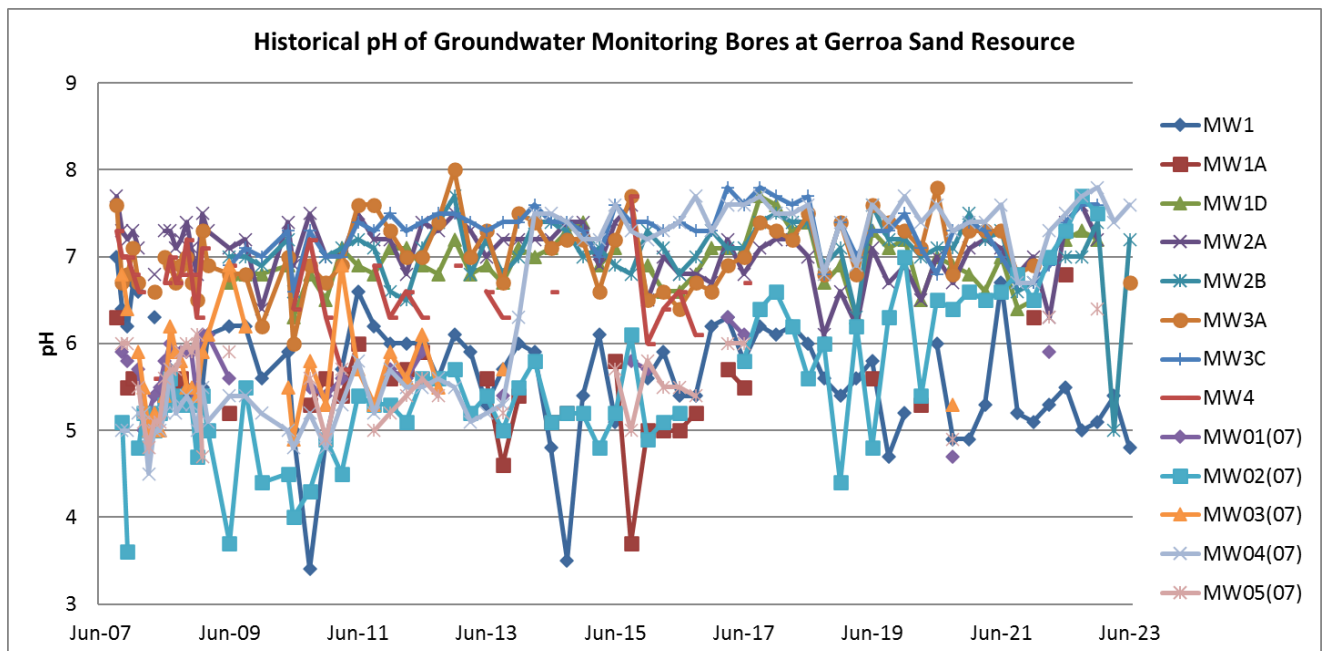
The pH values over the past 12 months have exhibited variability similar to that observed across the historical record. Most groundwater bores recorded pH levels in line with historical averages, with some bores recording slightly higher results, within the DC objectives, related to freshwater inflows associated with the higher rainfall experienced in the last three years. Monitoring bore MW2B recorded a single result below the historical range in March 2023, but as shown in the graph this was a once-off, with the pH returning to the average historical result in the following sample.

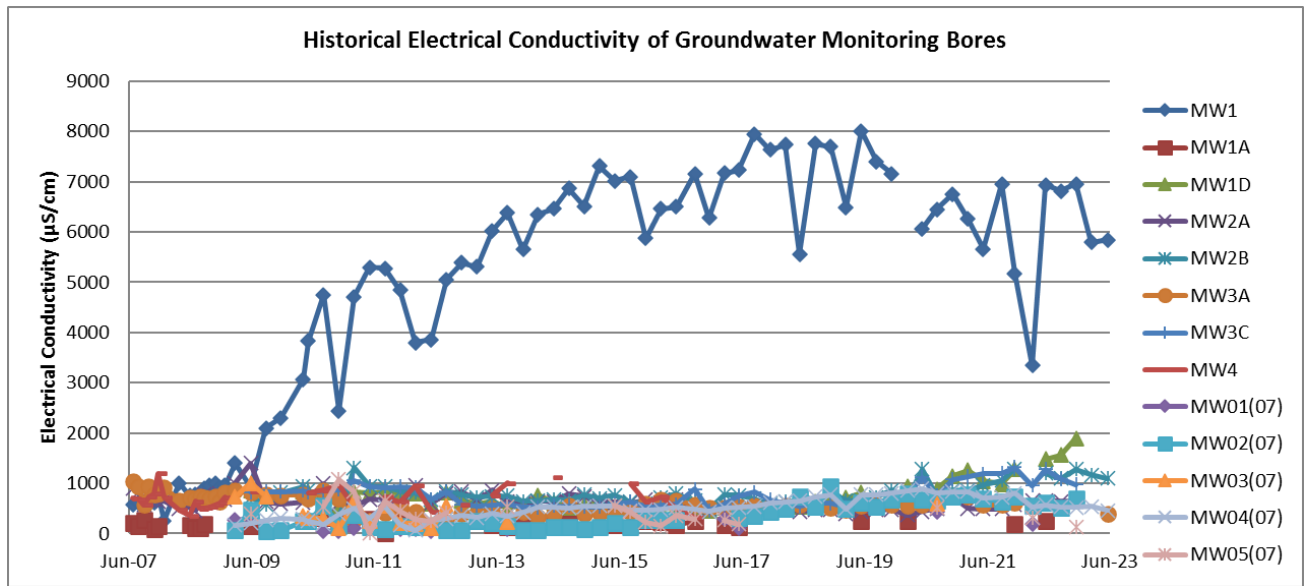
The results over the 12 month period show considerable variability in the Electrical Conductivity (EC) of the groundwater in the boreholes due to a third year of very wet conditions. Two bores recorded EC levels below their historical ranges (MW05(07) and NB2) while one bore recorded EC levels above the historical range (MW1D). With the exception of MW1 and MW1D, all results were within the objective levels. The brackish groundwater in MW1 has been attributed to the Berry Siltstone aquifer to the southwest, while it is likely the higher EC recorded in MW1D is due to some tidal influence from Blue Angle Creek.

The monitoring bores have continued to show significant variability in EC concentrations across the monitoring network, and with the exception of MW1, the southernmost and eastern bores generally showing slightly lower EC than those bores to the northwest, albeit amongst a pattern of ongoing variability. This variability has likely been enhanced at various times throughout the current reporting period with the increased rainfall infiltration to the aquifer.

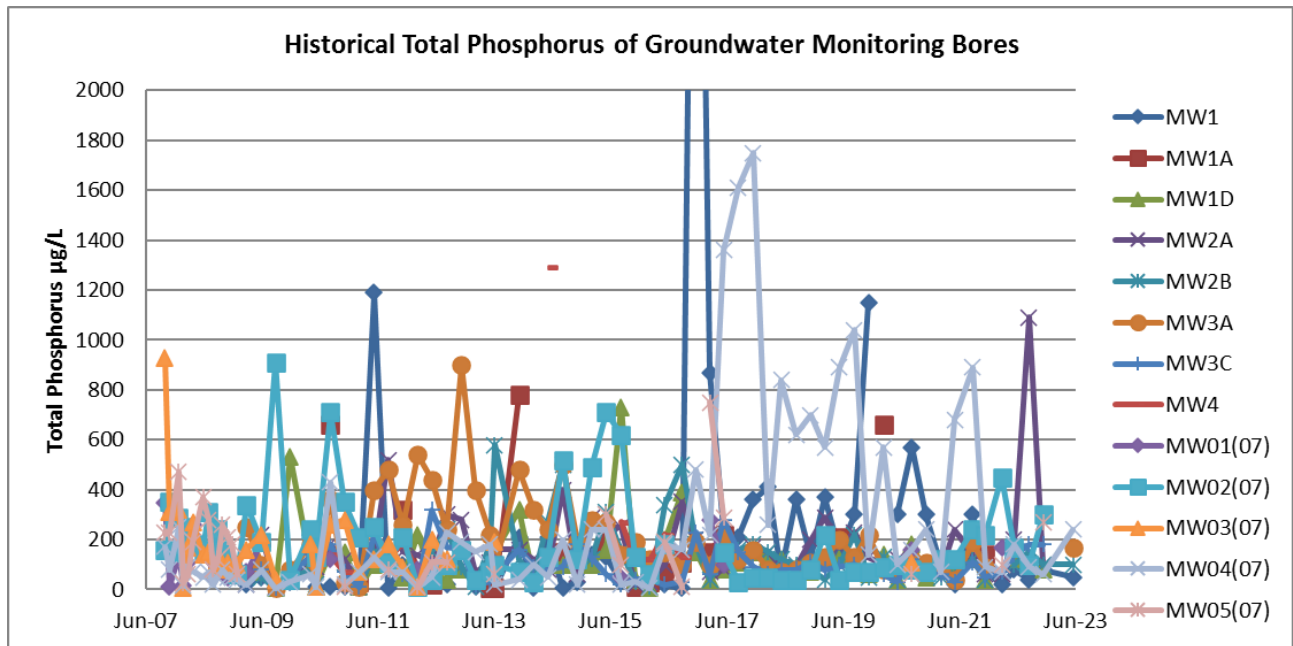
Total Phosphorus (µg/L)

Concentrations of total phosphorus in the boreholes were generally above the groundwater quality objective, however they were all within the historical range for their respective bores with the exception of a single isolated result for bore MW2A, and two results for NB3 recorded prior to any works in the Modification 1 area. During the reporting period, the concentration of total phosphorus in the existing dredge pond was generally less than that measured in all bores, suggesting the agricultural land uses surrounding the Gerroa Sand Resource may have contributed to the measurements of total phosphorus in all bores.

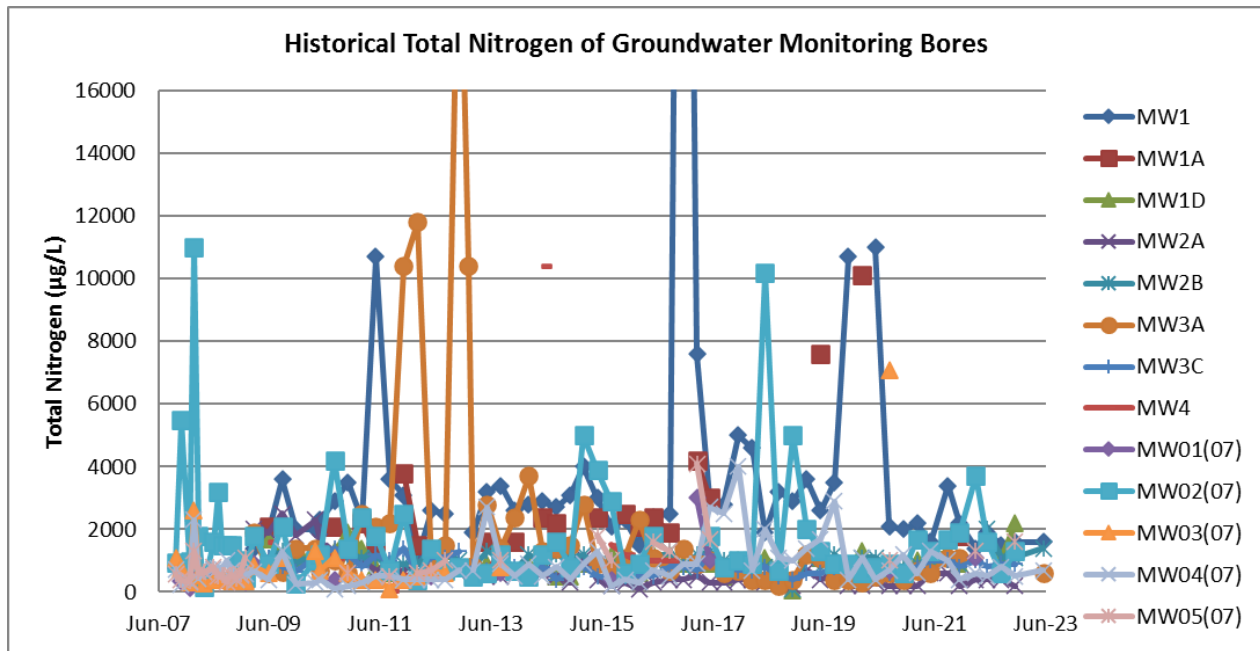
The concentrations of Total Nitrogen in all groundwater monitoring bores have consistently exceeded the objective level since monitoring of groundwater quality began. In the current reporting period, nitrogen concentrations were recorded within the historical range in all bores with the exception of the single result for bore MW1D, which was above the previous historical range. The presence of Total Nitrogen at those concentrations recorded in the bores are likely to be related to the presence of agricultural activities in the area surrounding the Gerroa Sand Resource. This is supported by an analysis of water quality within the existing dredge pond, which shows that nitrogen concentrations in the pond are consistently lower than that recorded across the broader groundwater monitoring network.

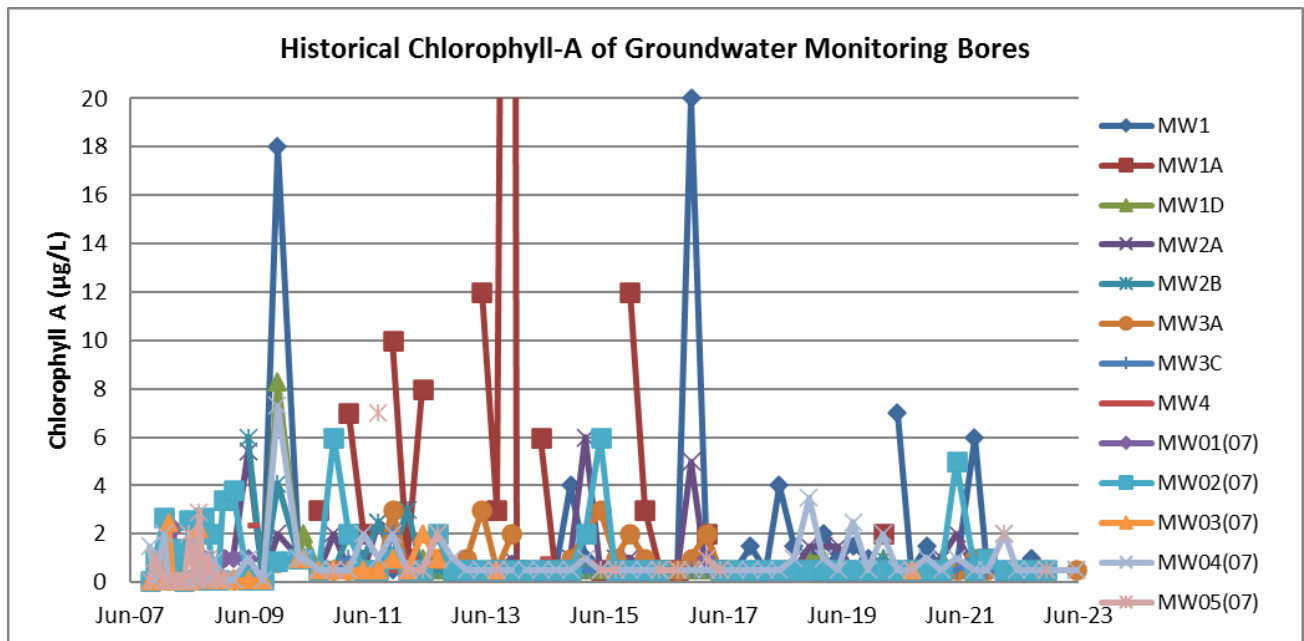
Chlorophyll A (µg/L)

Chlorophyll-A can fluctuate greatly with plant materials being flushed into the system and any results away from the low levels generally observed can be attributed to tree and leaf matter after windy or rainy periods. The chlorophyll-A levels for the reporting period were within the objective level and historical ranges for the respective bores and were all below the limit of reporting with the exception of one low result for MW1 in September 2023. As such, the summary table has not been included in this report.

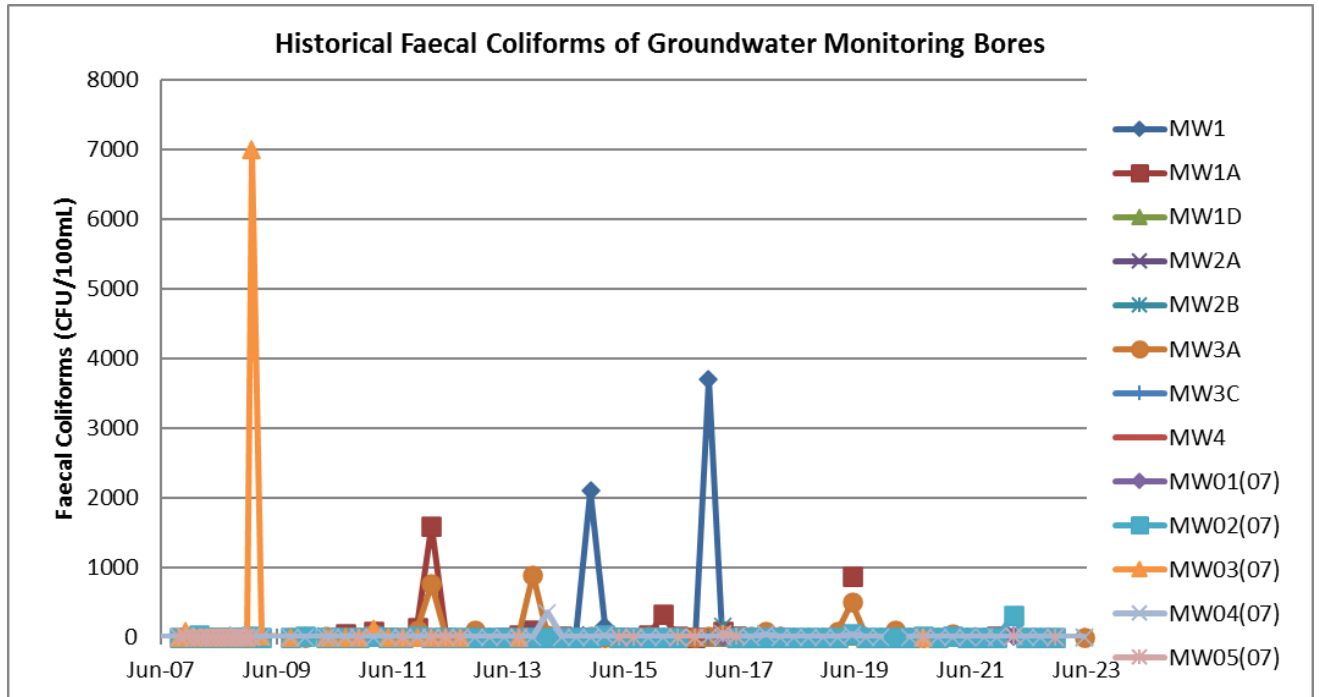
Faecal Coliforms (median number/100mL)

Faecal coliforms were within the objective levels and historical ranges during the reporting period, and were all below the limit of reporting with the exception of a single low result for NB3 in September 2023. As such, the summary table has not been included in this report.

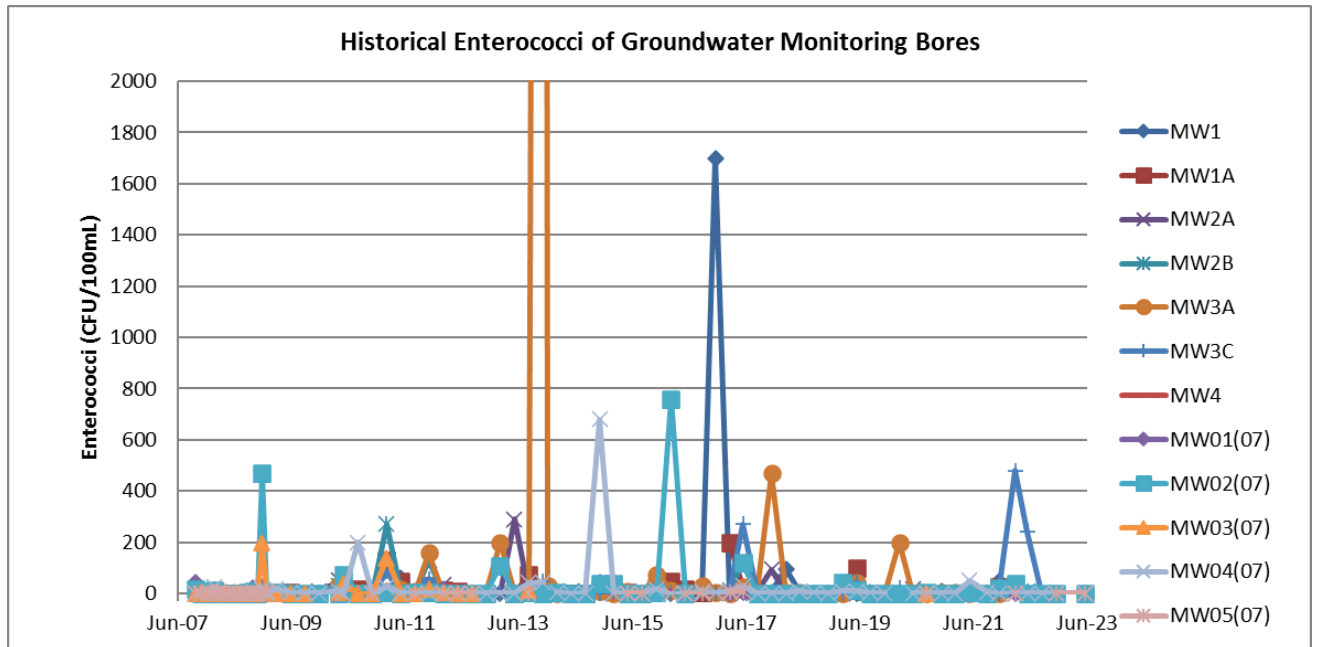
Enterococci (median number/100mL)

Enterococci concentrations were within the objective levels and the historical ranges during the reporting period, and were all either below or at the limit of reporting during the reporting period. As such, the summary table has not been included in this report.

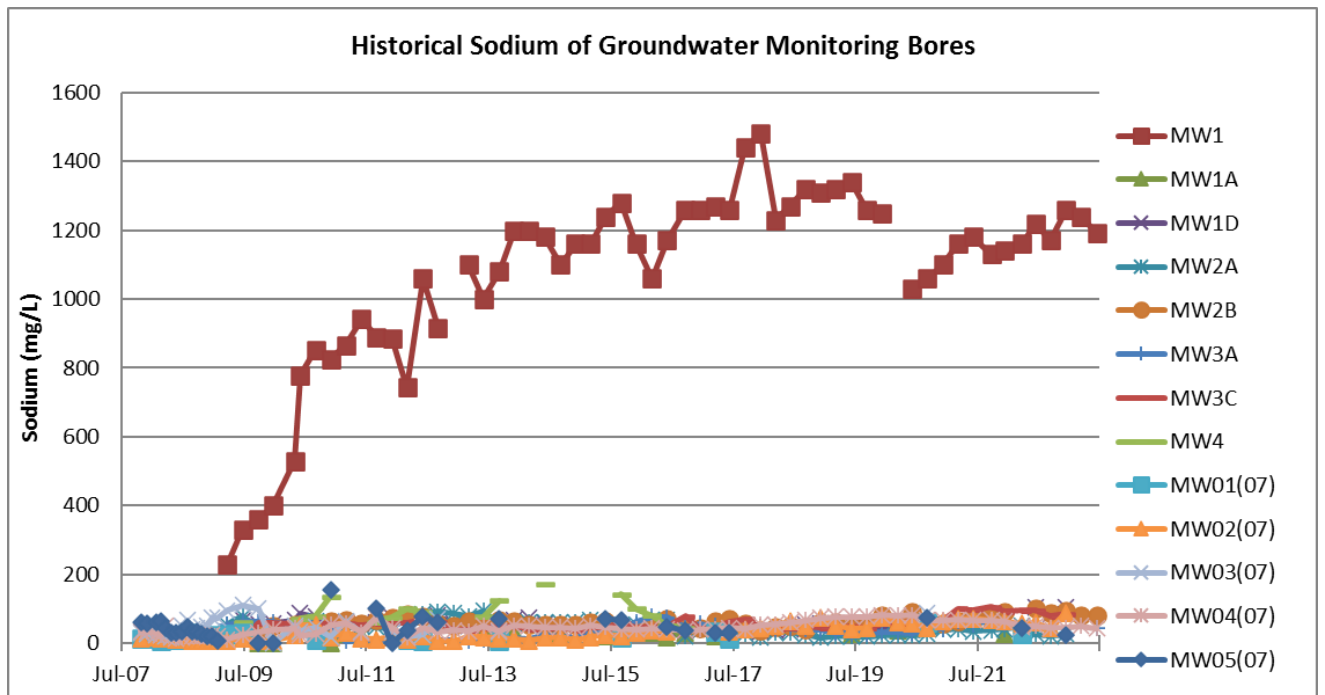
With the exception of borehole MW1, all sodium concentrations recorded in the original monitoring network were within the DC objective, and consistently at a low level. Concentrations in the new bores NB4 and MW7 were recorded significantly above the DC objective, however represent background levels for these sites. MW02(07) recorded sodium concentrations slightly above its historical range for a single sample.

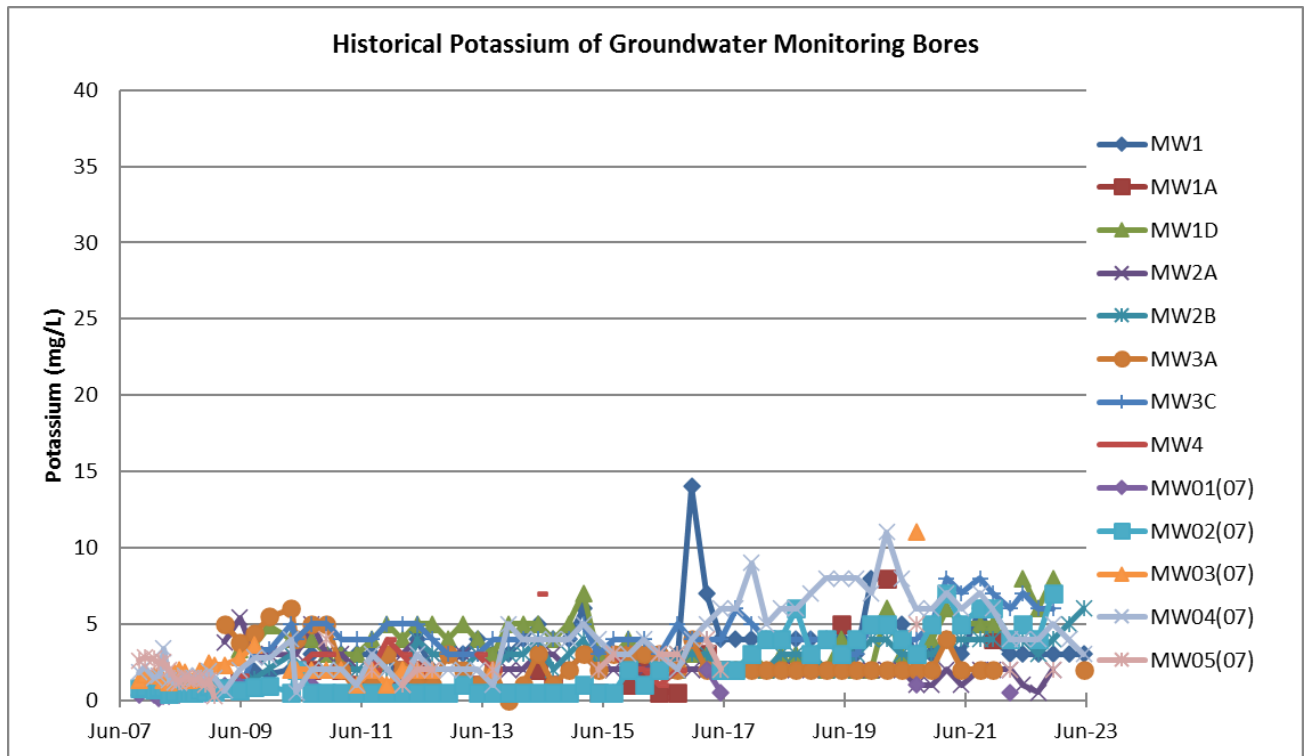
Potassium ion concentrations in the original monitoring network have remained well below the DC objective level and were generally consistent with historical concentrations in the current reporting period. The monitoring results indicate no deterioration in groundwater quality related to potassium ion concentrations in the current reporting year.

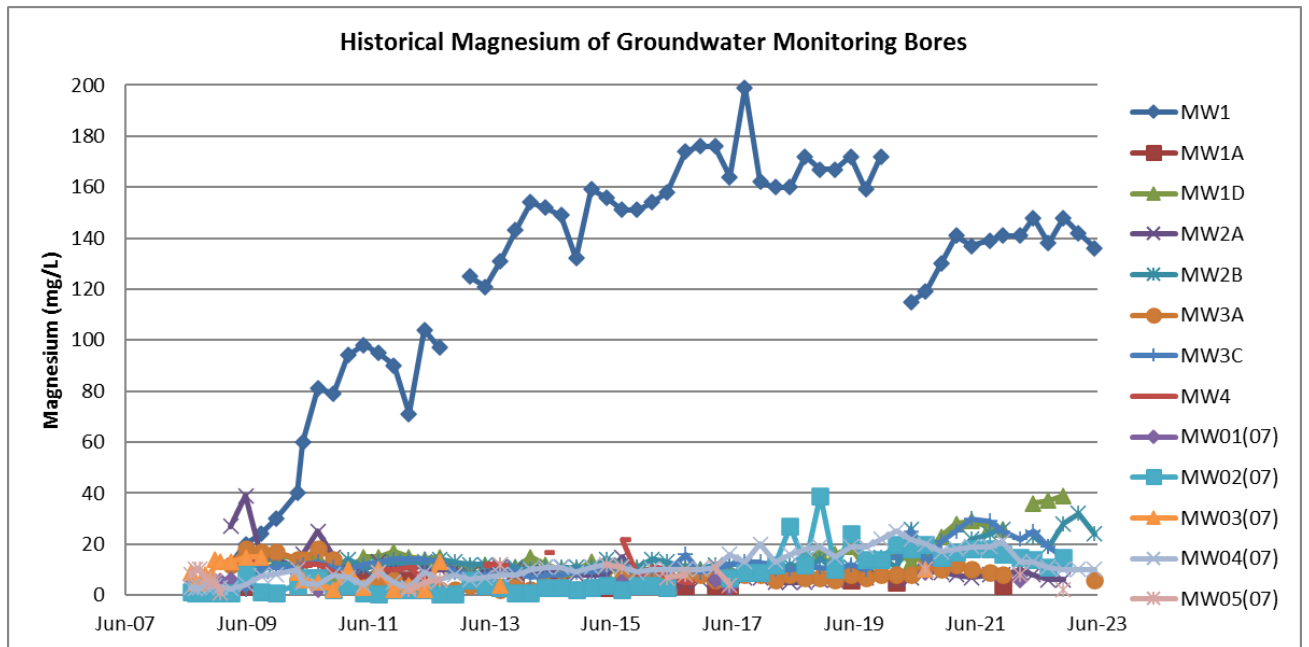
All magnesium ion concentrations in the original monitoring network were within the DC objective level with the exception of MW1, which has followed similar trends as for conductivity and sodium. All samples were within the historical ranges for the respective sites with the exception of samples from MW1D and MW2B which were above their historical range at times. Trends in magnesium concentration appear to be most closely linked with proximity to Blue Angle Creek, with those bores closest to Blue Angle Creek continuing to show increases in magnesium concentration while those furthest away showing reductions in response to the improved rainfall observed in the period. Bores NB4 and MW7 have recorded magnesium concentrations well above the objective level, which represents the baseline environment for these sites.

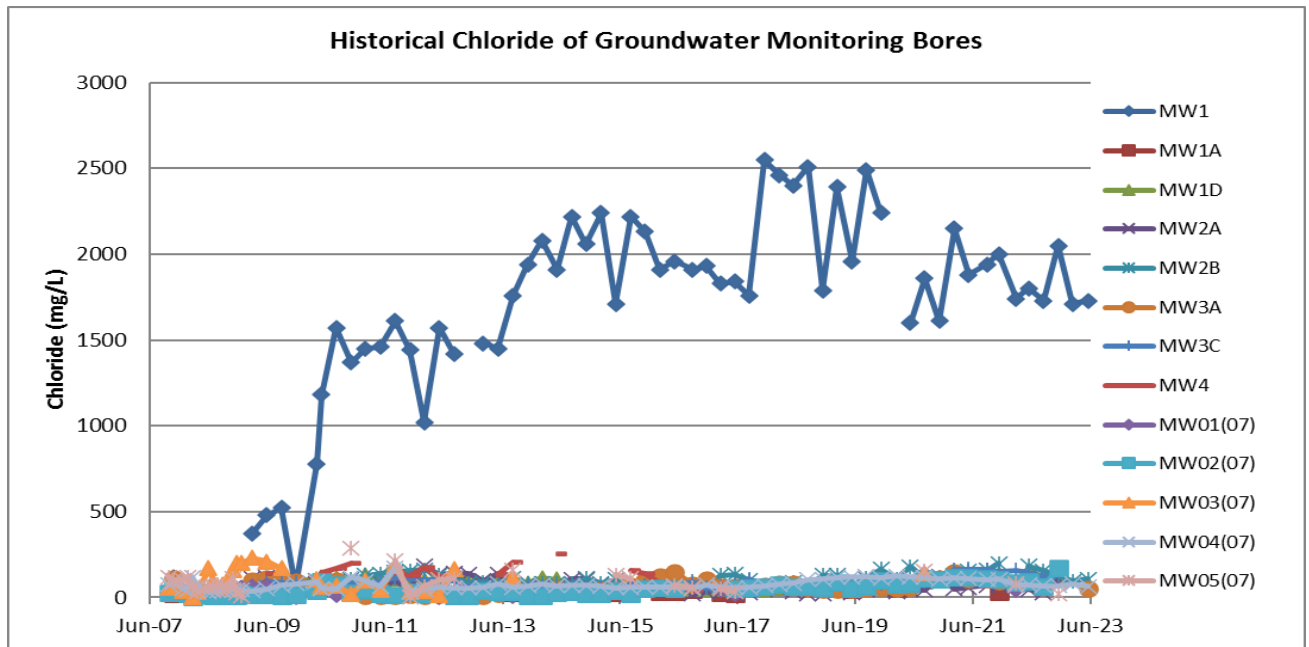
As for sodium, the concentration of chloride in all groundwater bores of the original monitoring network were within the DC objective with the exception of MW1. Chloride concentrations in MW1 have been variable within the reporting period, consistent with results from recent years. All samples from other bores were measured within the respective historical ranges during the current reporting period, with the exception of a single sample from MW02(07). Chloride concentrations in bores NB4 and MW7 are both well above the objective level, reflecting the baseline environment for these sites.

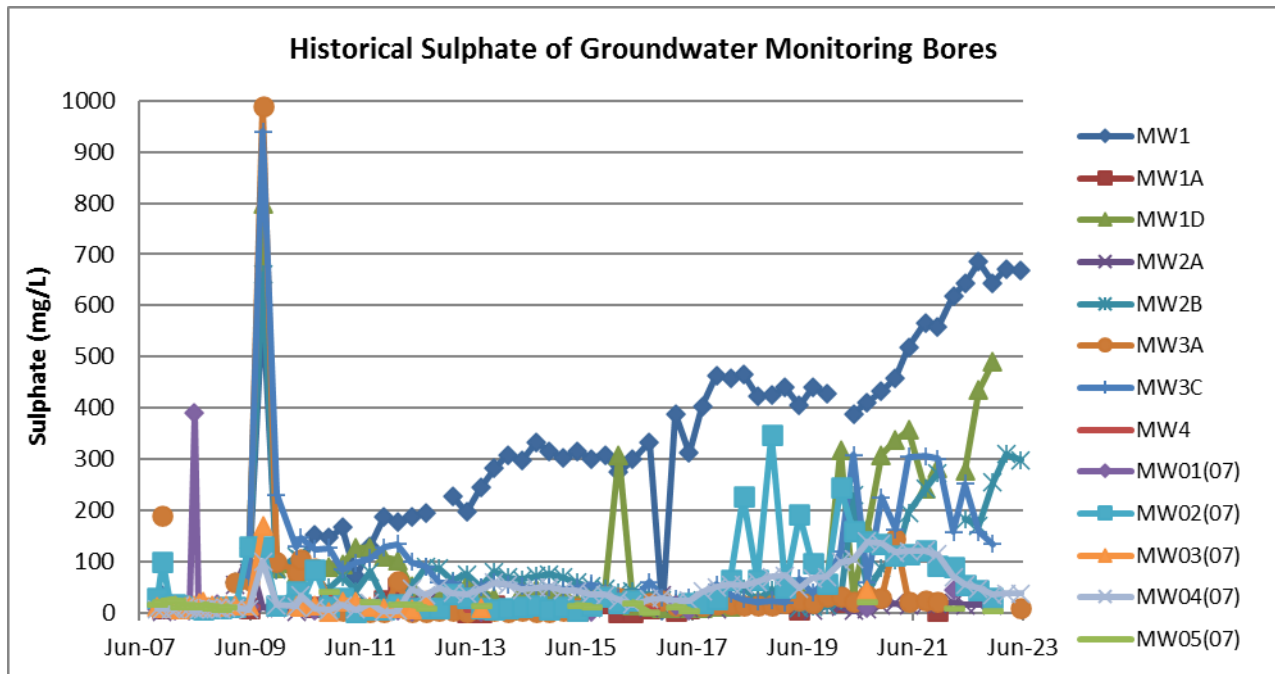
The concentration of sulphate in all groundwater bores were within the DC objective with the exception of results from MW1, MW1D, MW2B, NB4 and MW7. However with the exception of MW1, all results were within the historical ranges for the respective bores, while MW1 has continued to follow the trend of other major ions. Other bores have continued to show considerable variability in the current reporting period, which is likely related to rainfall infiltration to the groundwater table that has seen lower major ion concentrations in recent years.

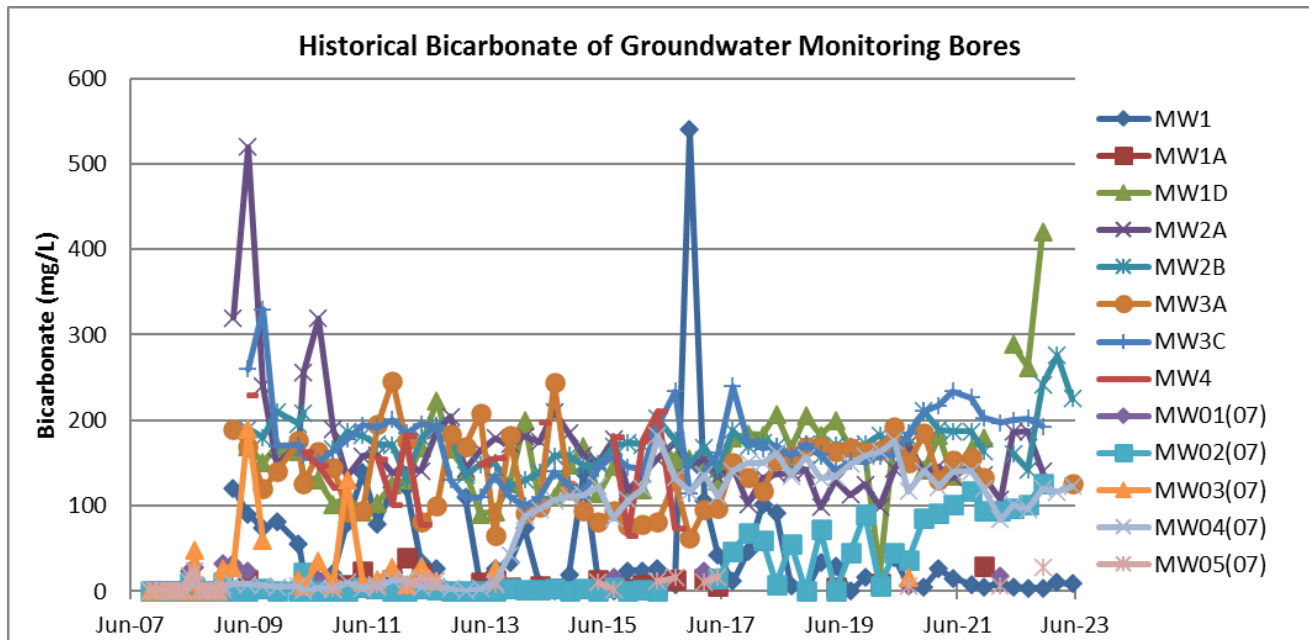
Bicarbonate concentrations remained below the objective level in all groundwater bores during the current reporting period. All bores have continued to show some inherent variability, with samples in bores MW1D, MW2B, MW02(07), and MW05(07) above the historical ranges. These are within expected and historical variabilities, and as such does not reflect a deterioration in groundwater quality.

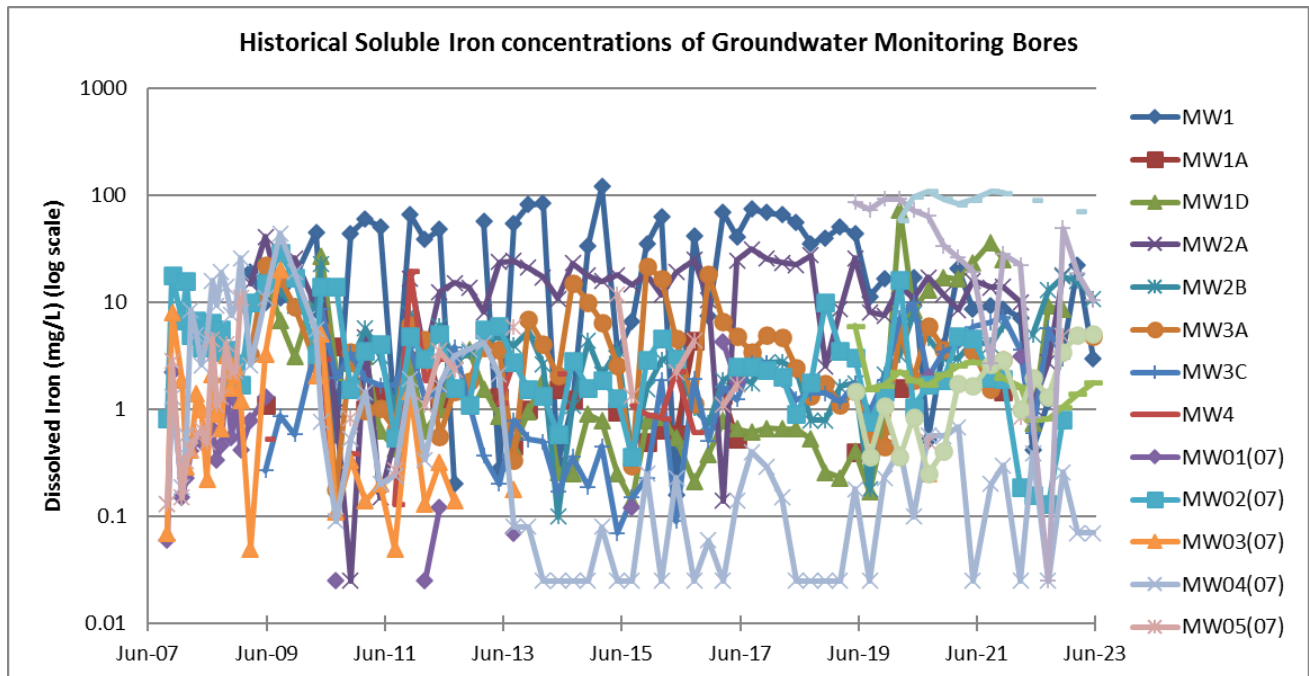
The dissolved iron concentrations were above the objective level for several bores at times during the current reporting period. This is a common phenomenon, with the graph above showing significant fluctuations throughout the historical period of monitoring for all bores. This historical trend has continued in the current reporting period. The concentrations of dissolved iron in all bores in the original monitoring network for the reporting period are within the historical range for the respective bores, which indicates no deterioration in groundwater quality as evident by soluble iron concentration across the monitoring network.

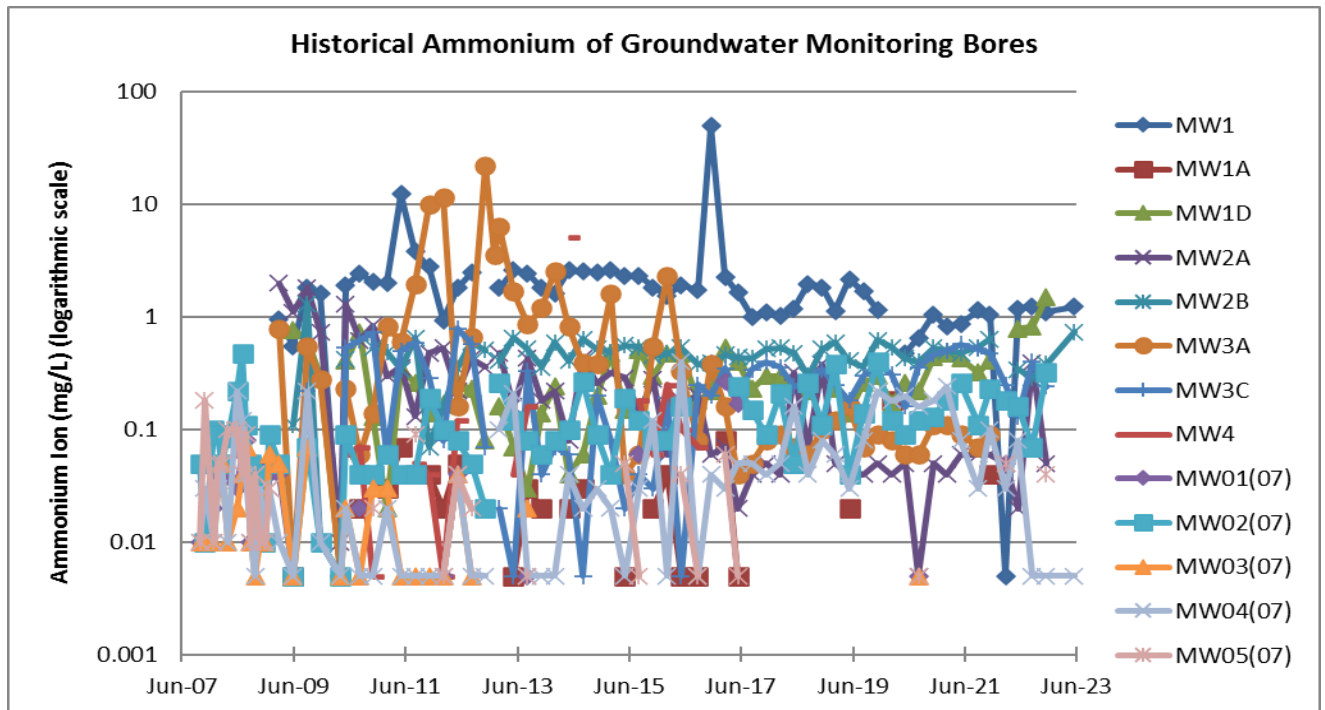
Ammonium ion concentrations were consistently above the objective level during the current reporting period, however within historical levels for all bores in the original monitoring network with the exception of results from MW1D. This indicates that there is no deterioration in groundwater quality as a result of dredging operations.

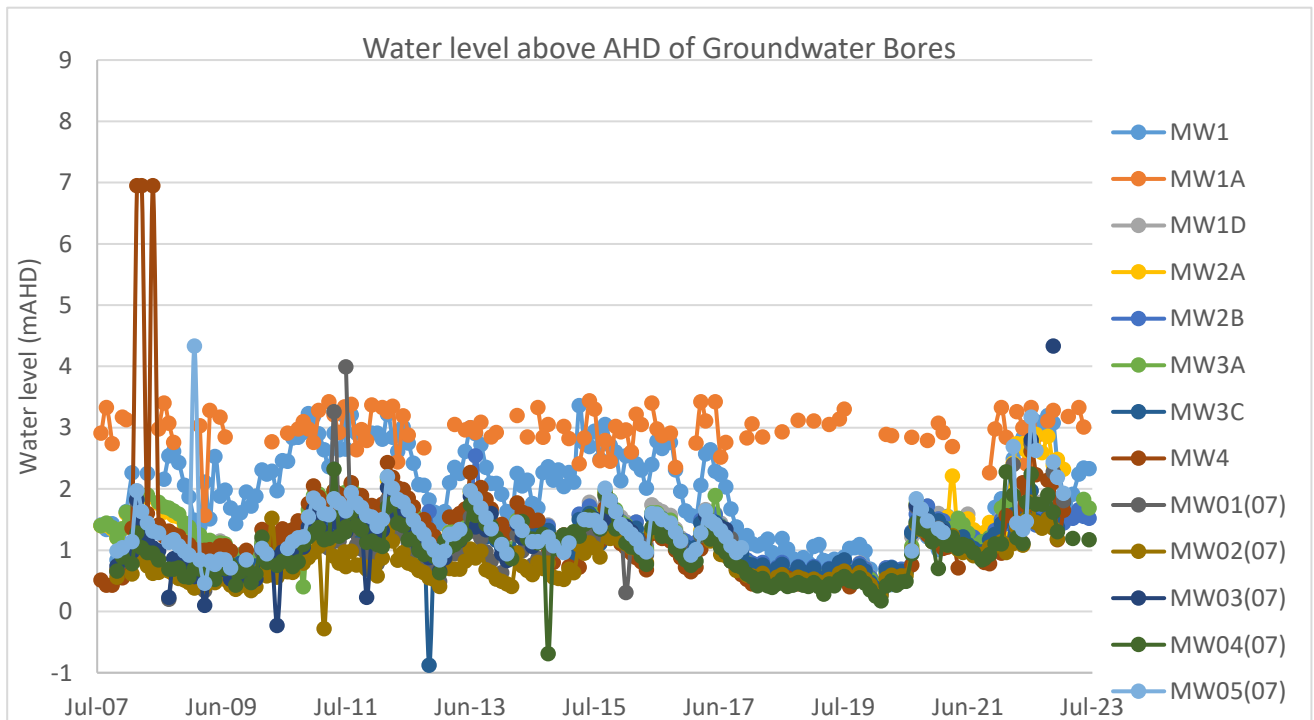
Groundwater levels have varied consistent with significant rainfall events during the current reporting period, increasing significantly since October - November 2021 due to the significantly above-average rainfall received during this time. While some bores have experienced greater fluctuations than others, all bores have recorded an increasing trend. These increases have come off a very low base in 2020 following an extended drought

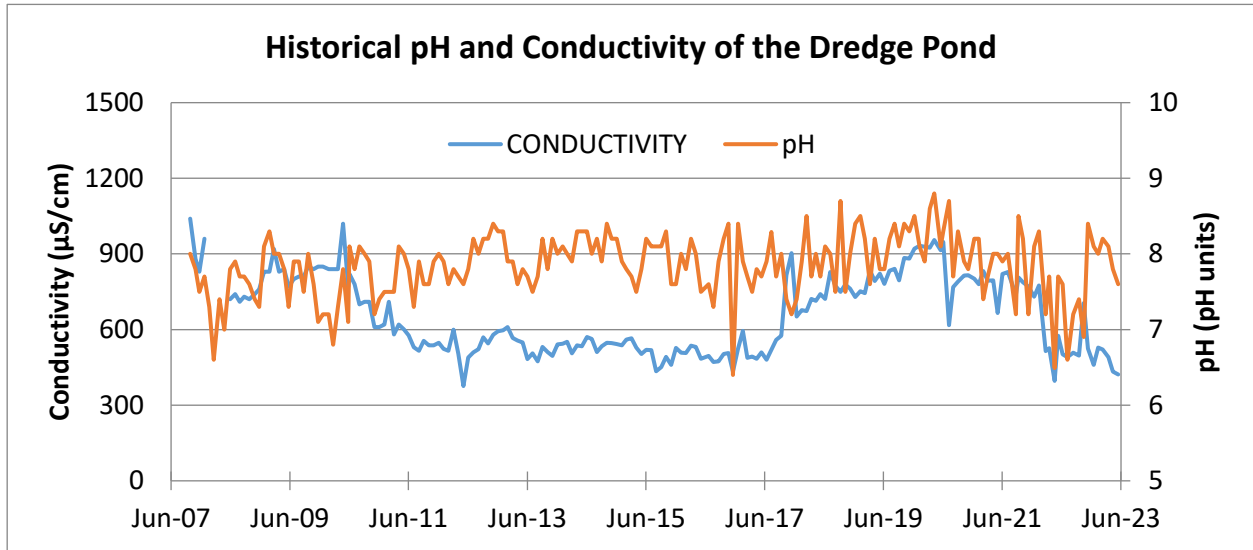
In the current reporting period, the dredge pond pH has returned to the historical average following a minor decline early in the reporting report. Meanwhile, EC has continued the steady decline from previous years in response to the consecutive years of above average rainfall, and is now at concentrations typical of the years prior to the 2017-2020 drought event. All pH and conductivity measurements were within the surface water quality objectives and the historical ranges during the reporting period.

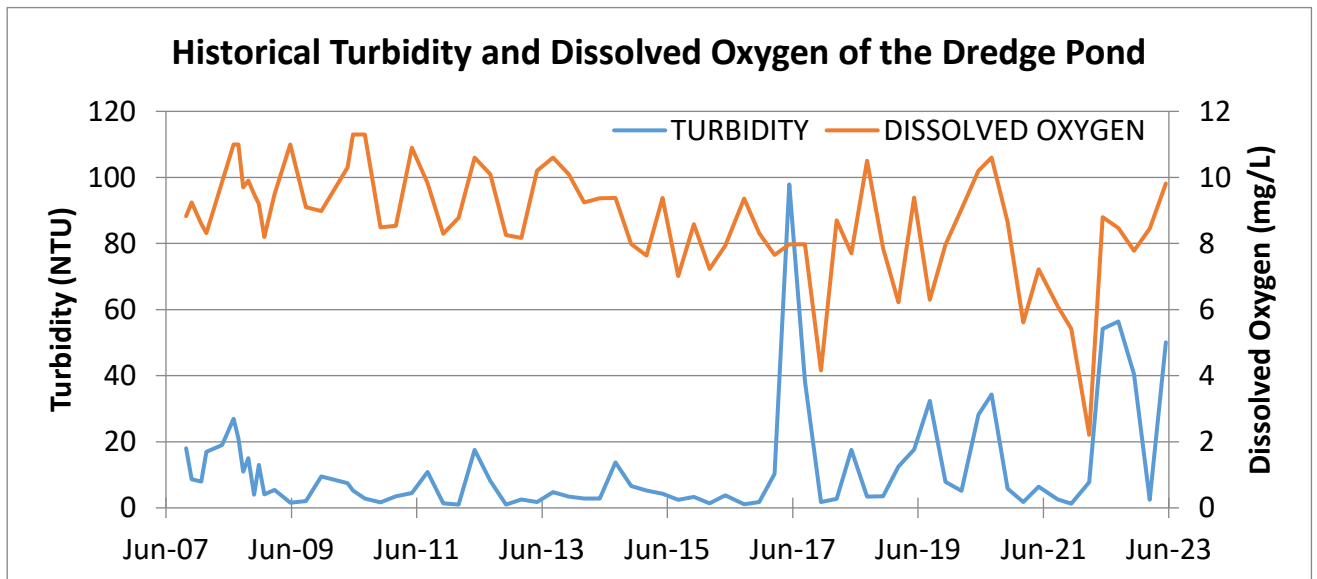
Turbidity has seen some fluctuations in the current reporting period, with dredging close to the sampling point which has skewed measurements, and as such was at times outside of the objective level. Dissolved Oxygen measurements were within the historical range and objective levels throughout the reporting period.

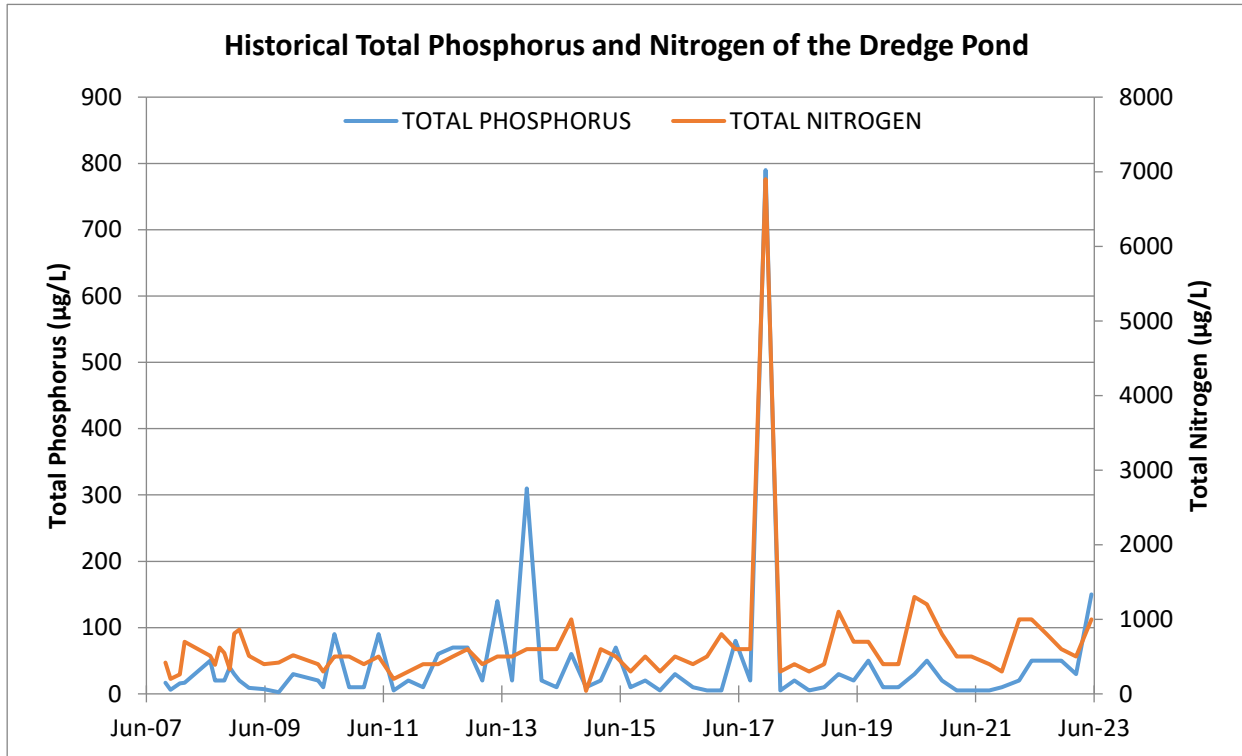
All nitrogen and phosphorus samples remained within the historical ranges for these analytes in the current reporting period, while concentrations of nitrogen and phosphorus were both above their respective objective levels at times during the reporting period. Nevertheless, concentrations of both nitrogen and phosphorus were consistent with longer term trends. This is reflective of the agricultural land use prevalent in the district, and unrelated to dredging operations.

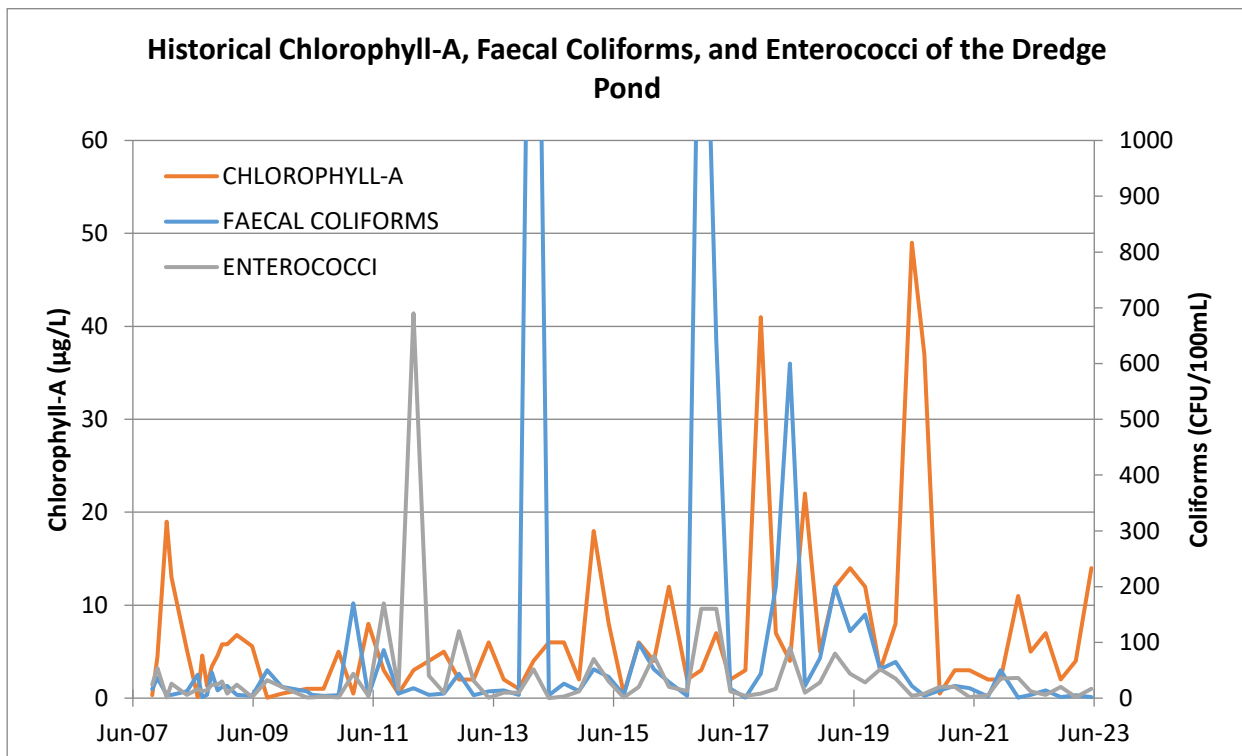
All chlorophyll-A, faecal coliform, and enterococci results were within the historical ranges for the respective analytes during the reporting period. Faecal coliforms and enterococci remained within the objective levels, while chlorophyll-A showed some variation, consistent with previous years, which can be attributed to the increased inflows to the dredge pond with the higher rainfall during the period.

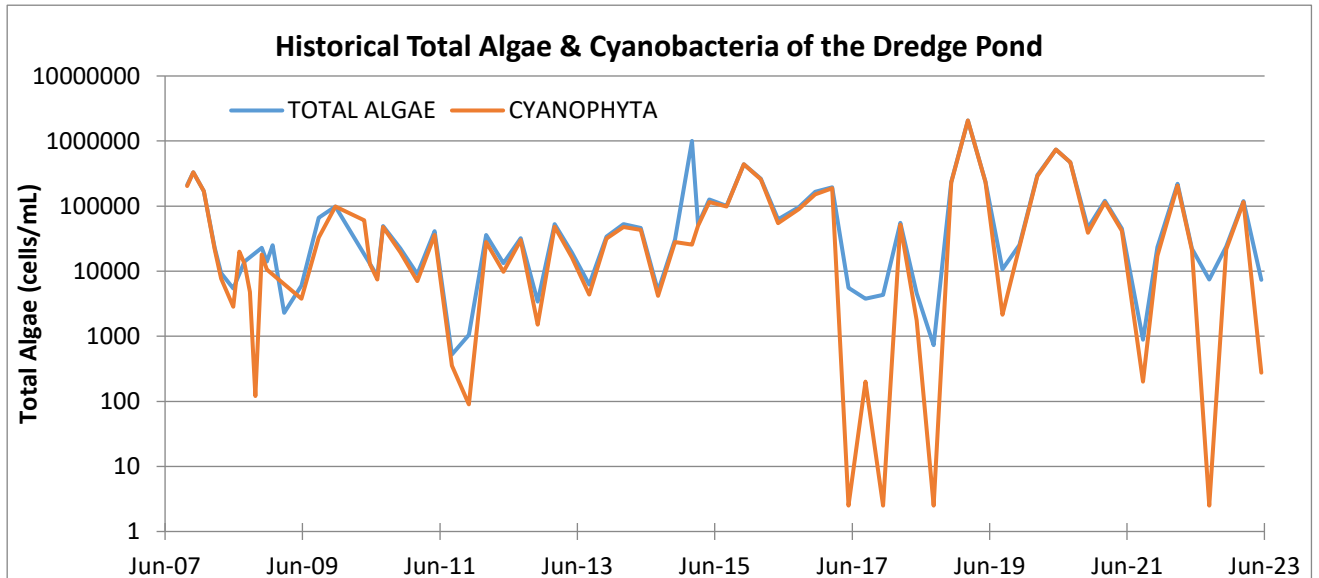
Total algae and cyanobacteria concentrations followed historical patterns, with seasonal fluctuations in concentrations of these microorganisms. Concentrations of both analytes were recorded above the objective levels during the year, which is consistent with historical results and does not reflect a decline in the water quality of the dredge pond.
