GERROA SAND RESOURCE

ANNUAL REVIEW

Period 01 July 2022 – 30 June 2023

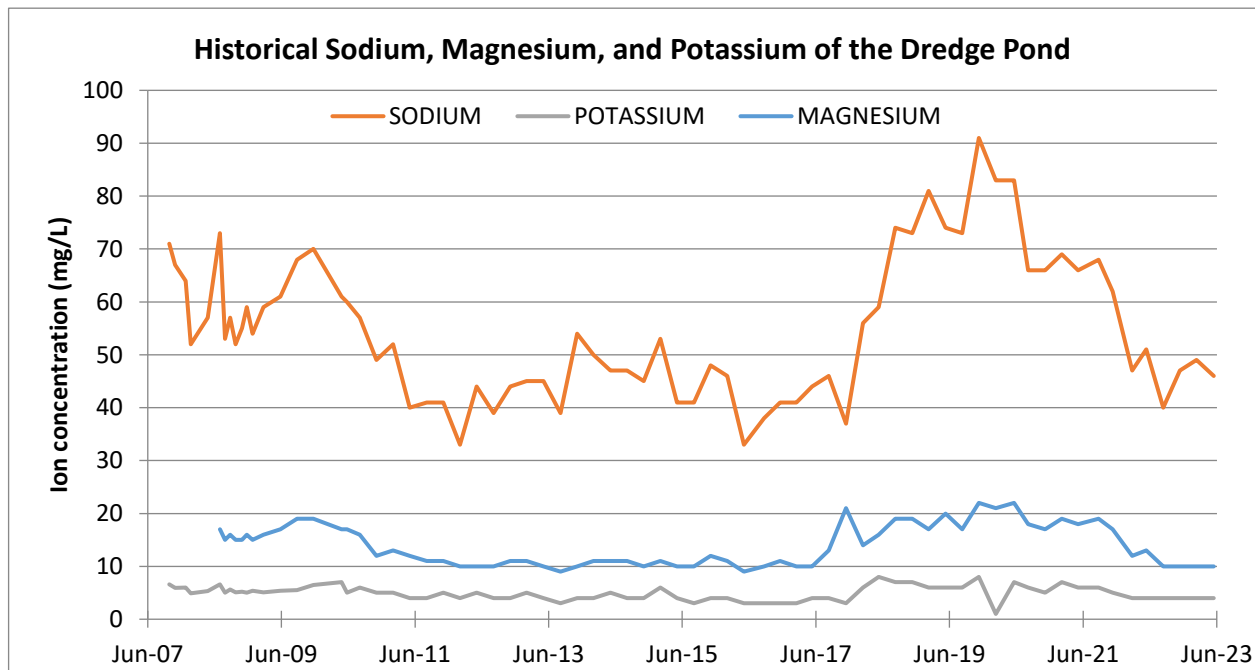
Sodium, magnesium, and potassium ion concentrations have followed the recent trends in electrical conductivity, showing an overall decline in recent years, although some stabilisation is evident in the current reporting period. All analytes remained within the objective levels and the historical ranges for the site during the reporting period.

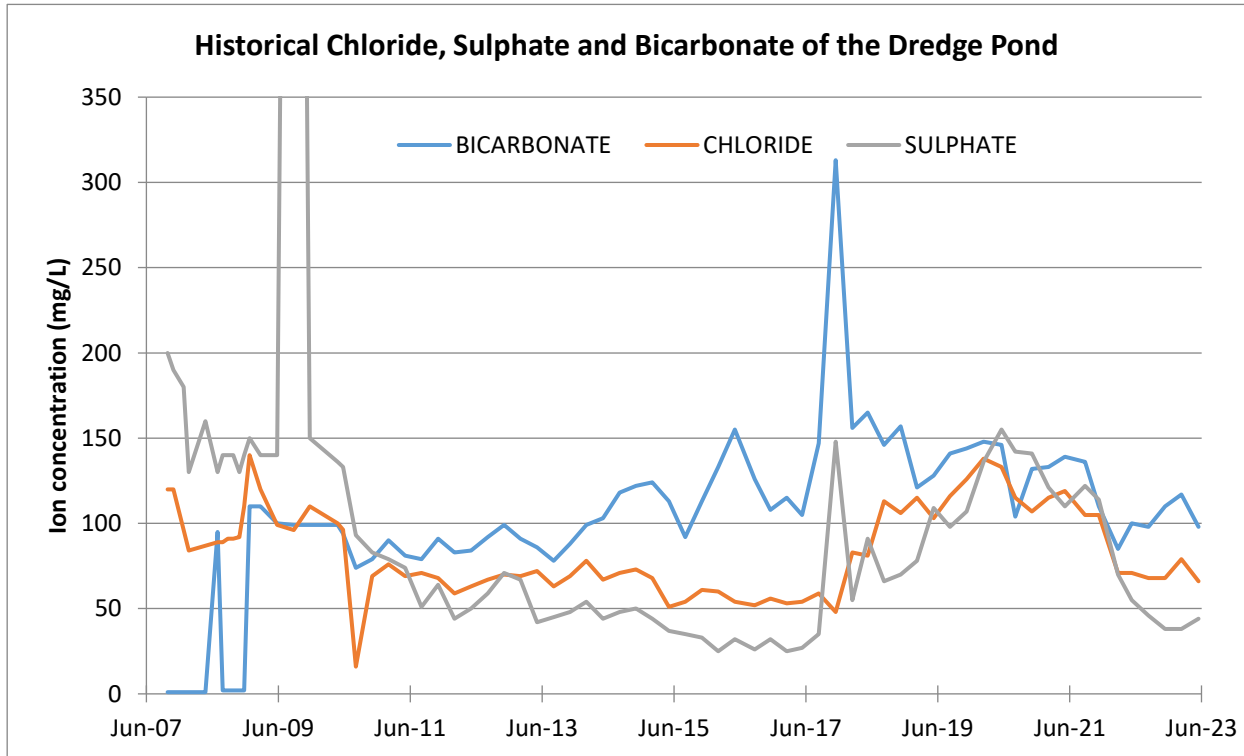
Concentrations of chloride, sulphate, and bicarbonate have remained well below the objective levels during the current reporting period and are consistent with historical levels. They have stabilised at recent lows in the current reporting period consistent with the patterns shown for major cations and electrical conductivity.

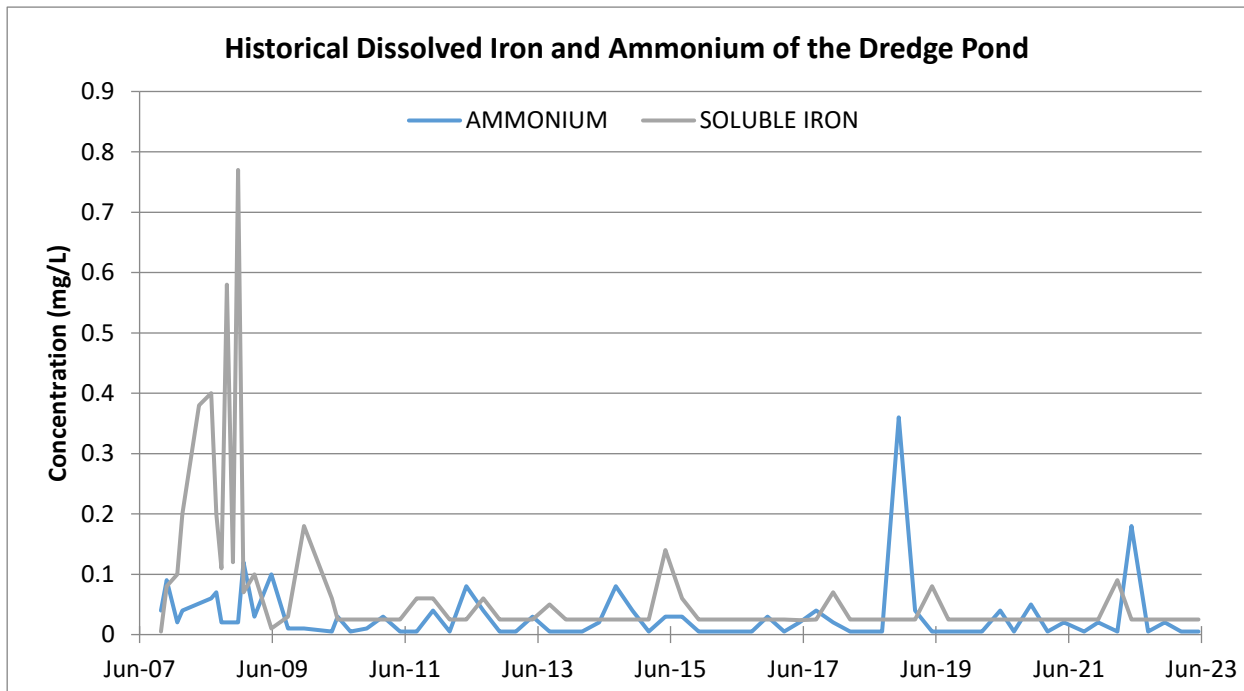
Soluble iron and ammonium ion concentrations have remained relatively stable and at low levels during the current reporting period, consistent with historical values, and within the objective levels. Concentrations of both analytes were below the standard laboratory limit of reporting for the majority of the reporting period.

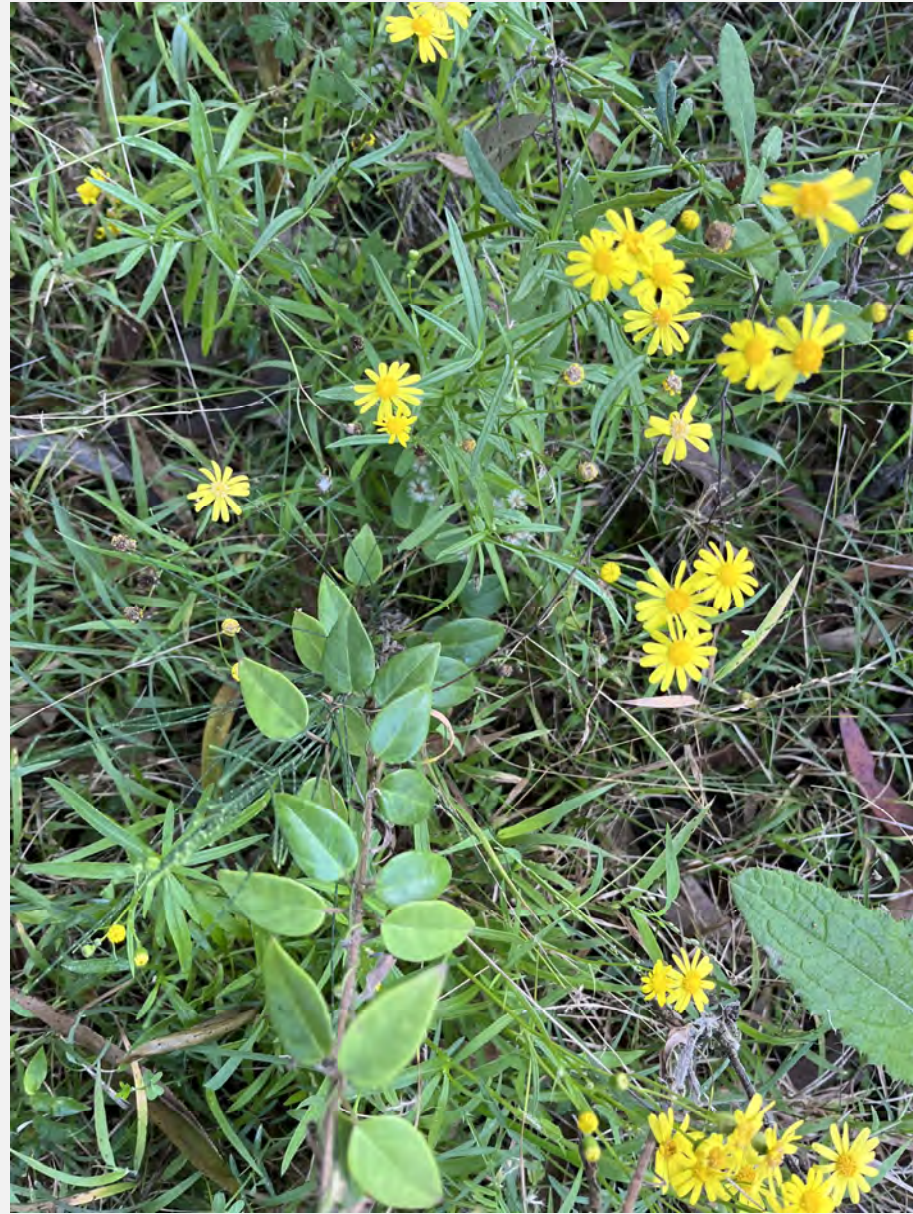
This is the main area of existing forest, extending from the southern to northern end of the property boundary.

Fireweed (*Senecio madagascariensis*) and Spear Thistle (*Cirsium vulgare*) prominent along roadside (pictured). Lantana (*Lantana camara*) weed in the south western portion. Giant Reed (*Arundo donax*) in the roadside veg and lower lying areas in north eastern section (Plate 1). Tobacco Bush (*Solanum mauritianum*) also present throughout subzone. Flaxleaf fleabane (*Conyza bonariensis*) (Plate 5) and Cobbler's pegs (*Bidens pilosa*) prominent along roadside

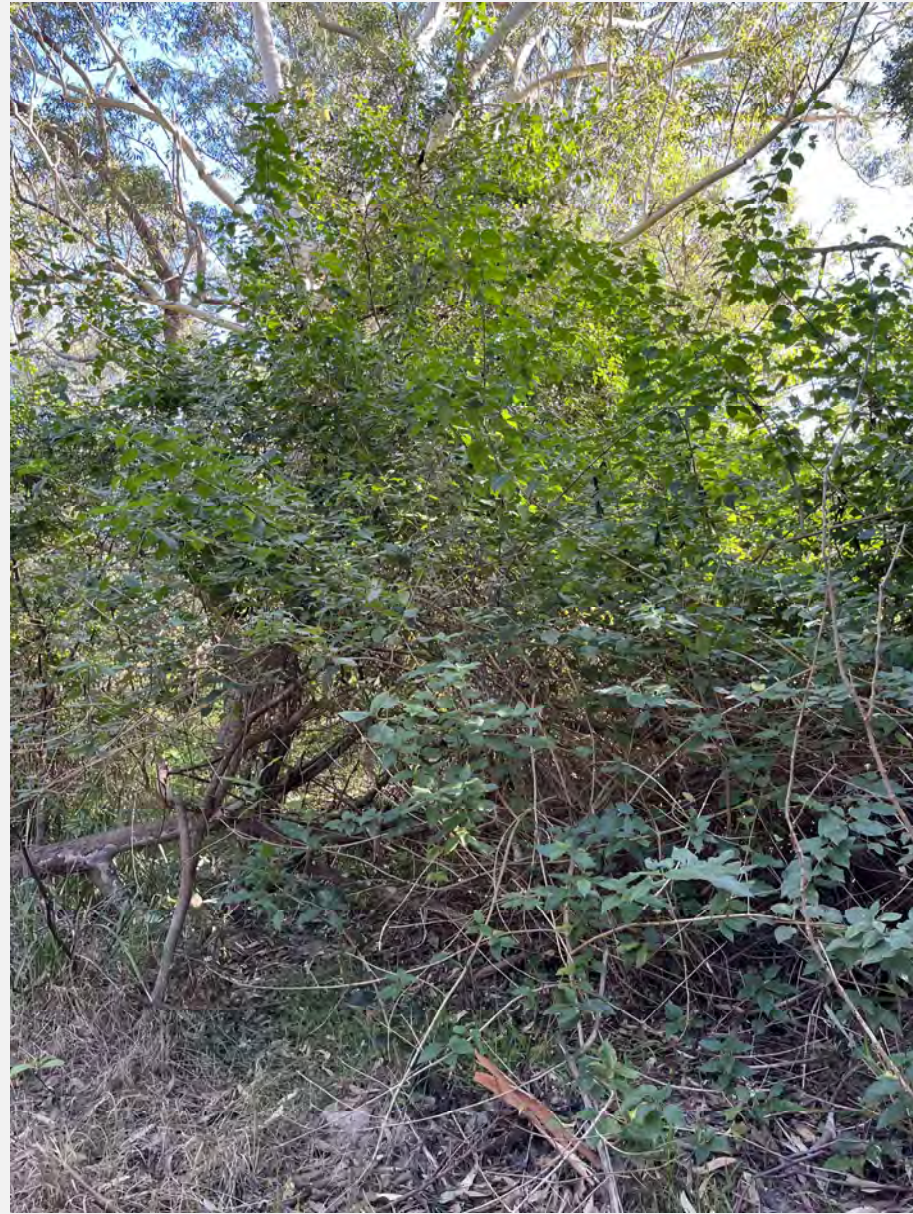
Subzone 1.2

This subzone covers the forest around the eastern and southern sides of the old dredge pond. This area was revegetated early in the rehabilitation program and is now well established.

Efforts of previous Lantana management are evident however large stands still persist, particularly in the eastern portion (pictured). Continue cut and paint control methods of woody weeds, specifically Lantana (*Lantana camara*). Control of herbaceous weeds such as Crofton weed (*Ageratina adenophora*) and Bidens (*Bidens pilosa*) that are encroaching from the roadside is required. Continue to promote native tree and shrub cover via planting of native species to lessen risk of weed reinvasion.

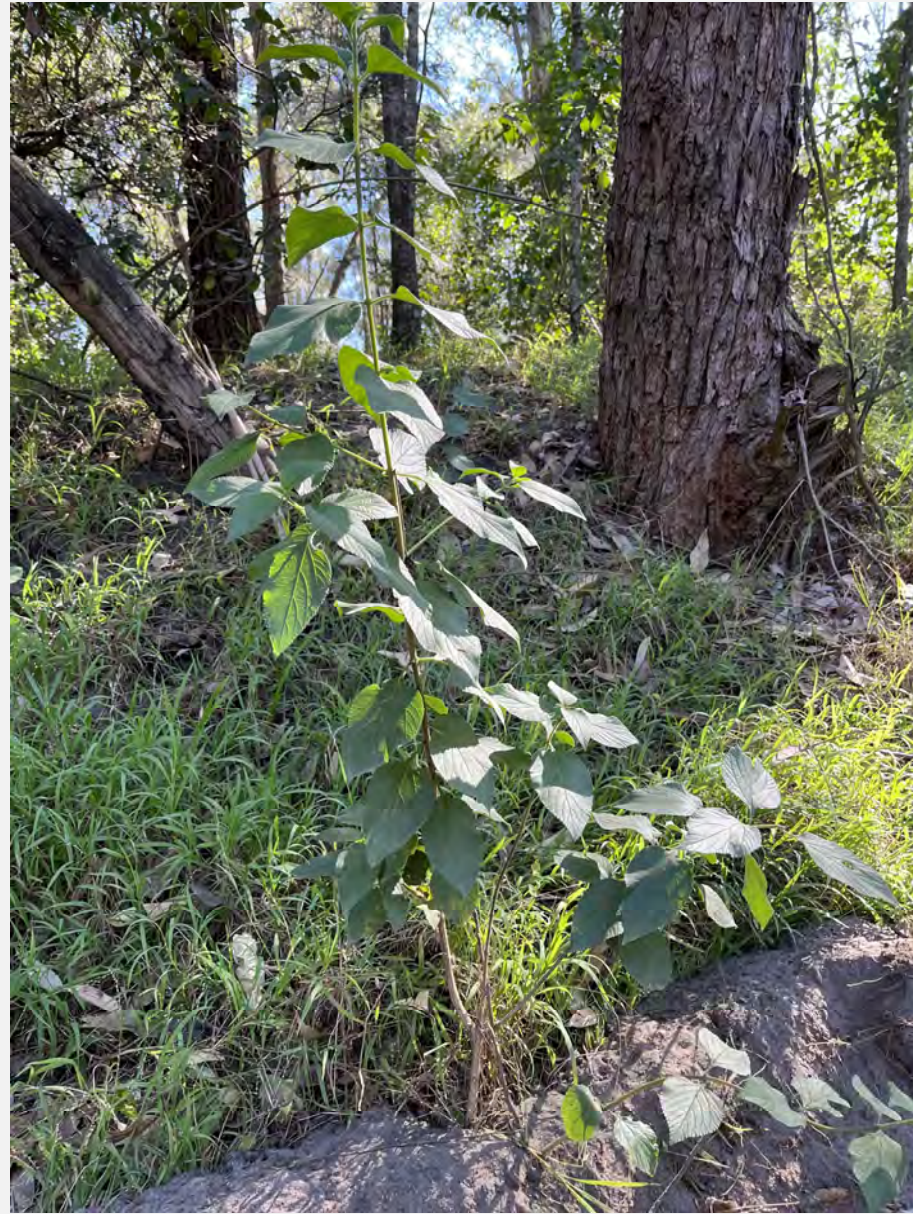
Subzone 1.3

Covers the old bund wall that was revegetated earlier in the rehabilitation program. This subzone is located behind the site office and towards the front gate.

Lantana thickets should be the priority weed in this area using cut and paint methods (pictured), however, Crofton weed (*Ageratina adenophora*) and Tobacco Bush (*Solanum mauritianum*) (Plate 4) should also be controlled to reduce spreading. Cobbler's pegs (*Bidens Pilosa*) and Flaxleaf fleabane (*Conyza bonariensis*) prominent along roadside.

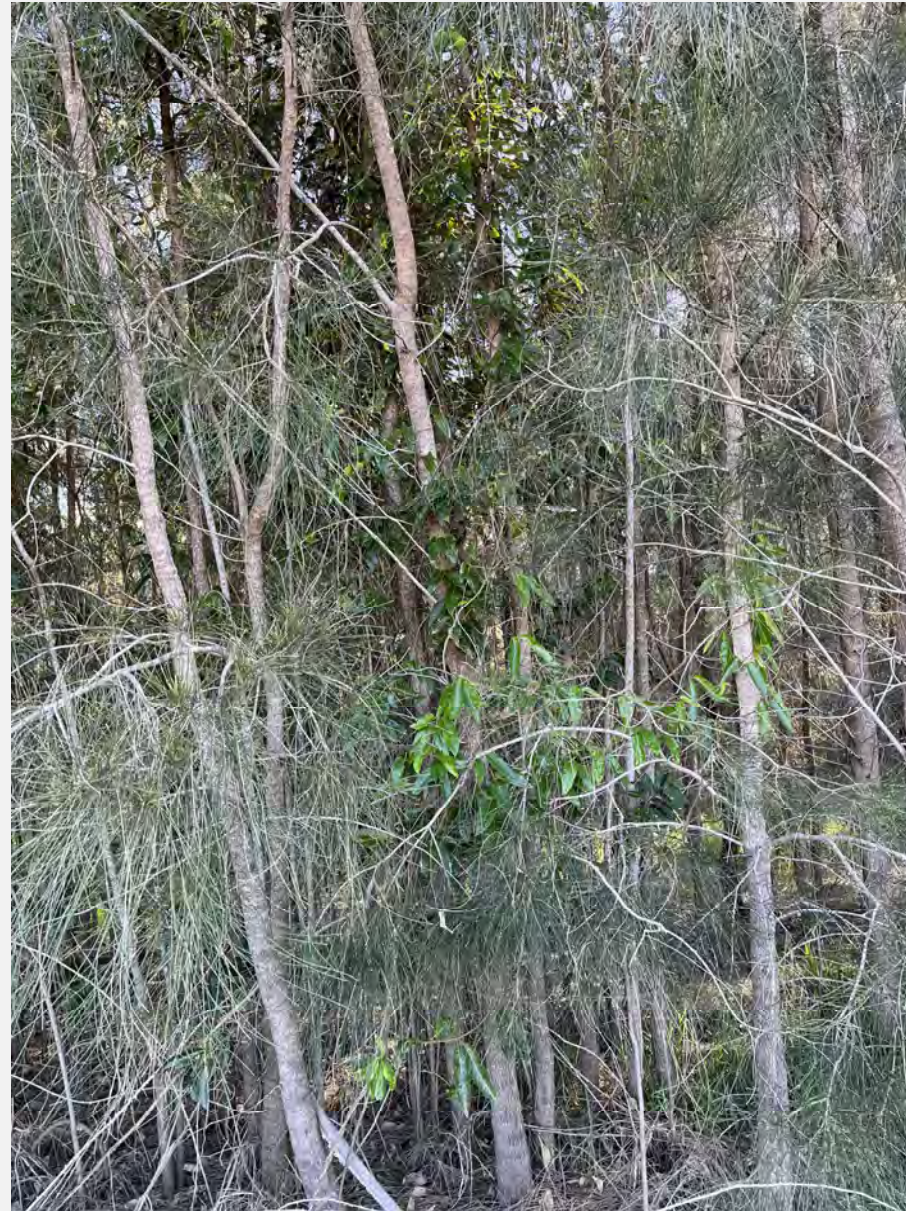
Subzone 1.4

A fenced patch of Swamp Oak within grazing land, which now has a planted link to the east (planting zone 2E). Vegetation is well established and requires very little ongoing work.

Good condition *Allocasuarina* stand, some dead lantana along edges. If any Lantana (*Lantana camara*) still present continue weed control efforts via cut and paint.

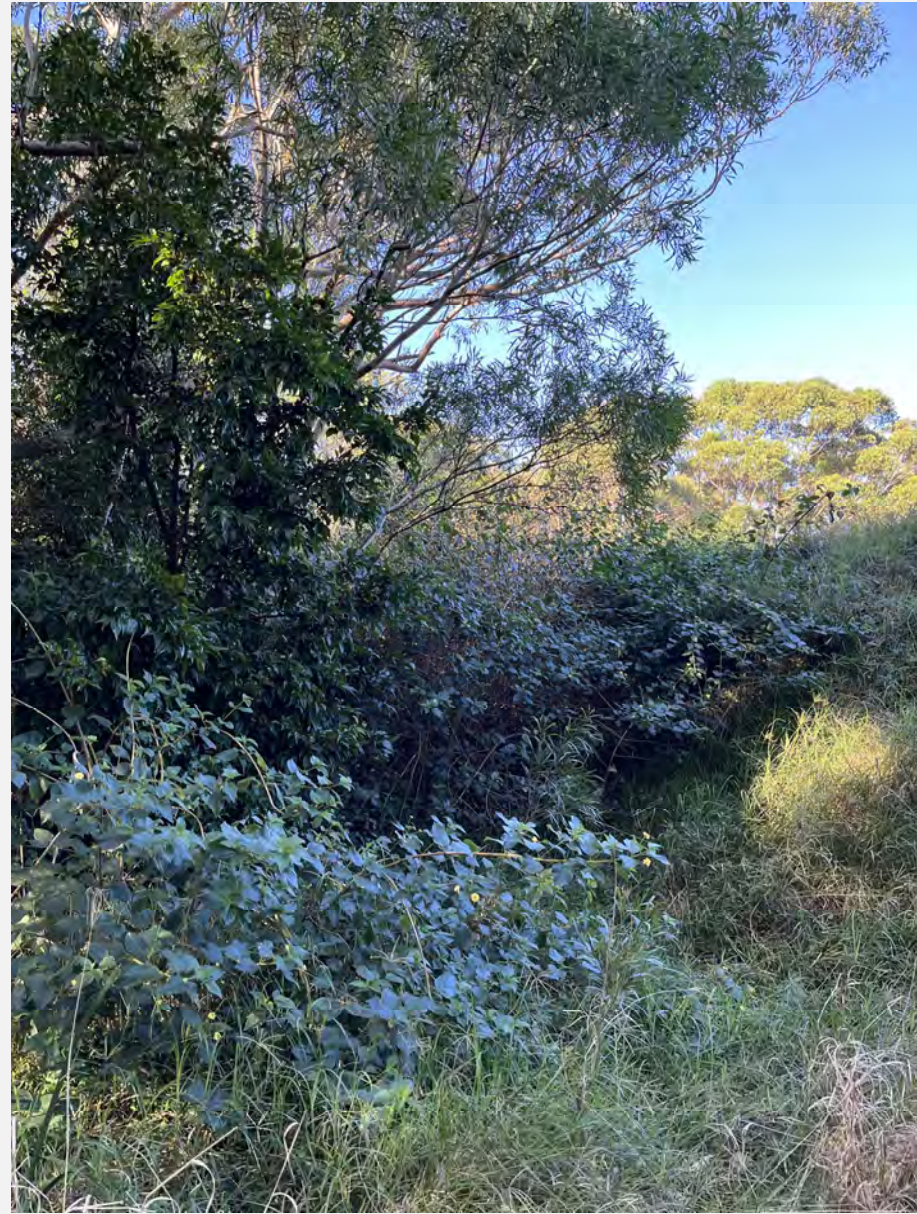
Subzone 2A.1

This is the main area that has been used to develop the forested link in the northeast corner of the Site. Extensive work has been carried out over the past twelve years to develop this area as habitat for native fauna.

This area is in generally good condition, however there are some stands of Lantana (*Lantana camara*), particularly to the south along the edge of the dredge pond (pictured). African Love Grass (*Eragrostis curvula*) found growing along eastern perimeter near the entry gate.

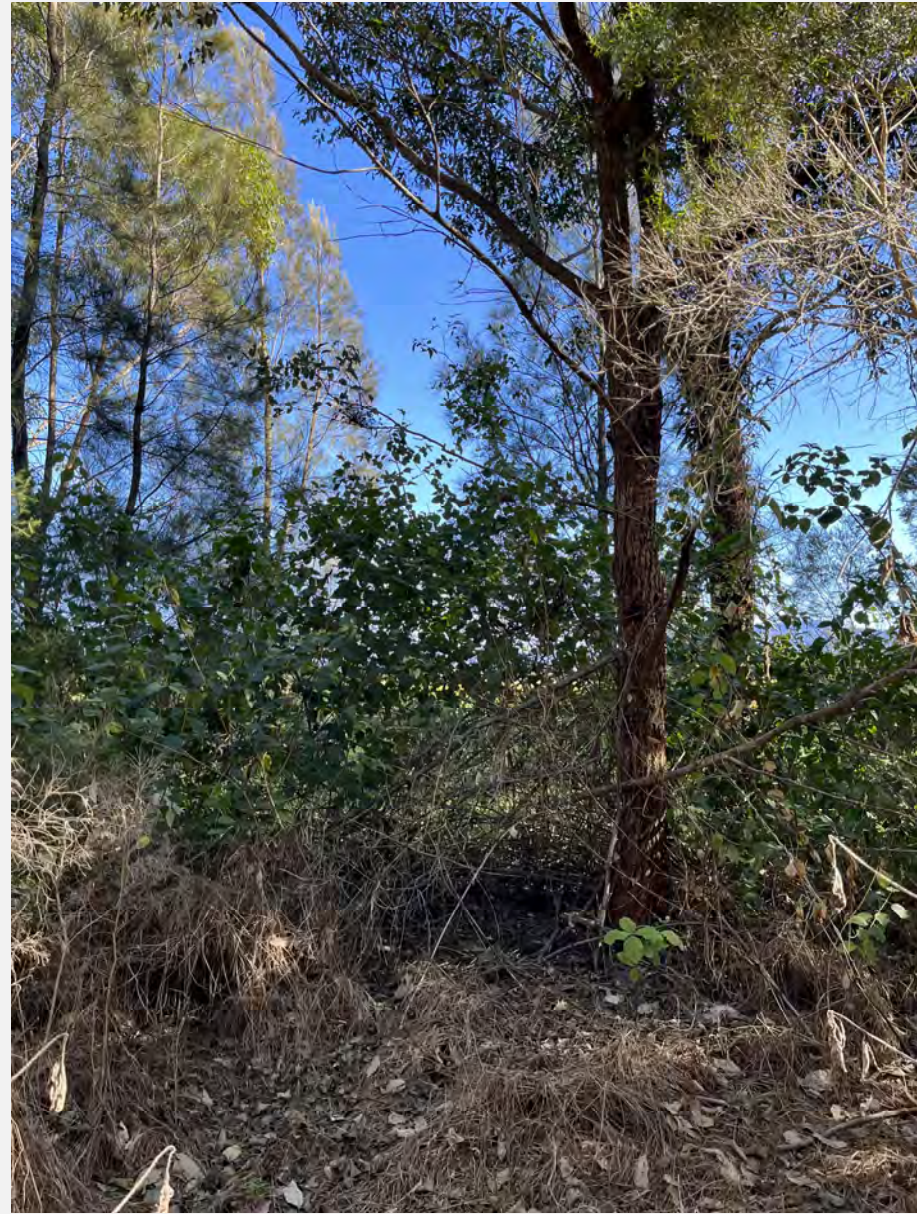
Subzone 2A.2

This area is important for the forest link to the south and into Seven Mile Beach National Park on the southern side of Beach Road. Planted trees are becoming well established in most places. Previously most of the planted Swamp Oak (*Casuarina glauca*) in the northern area died. A total of 24 replacement trees were subsequently planted in the following year to replace the trees that died (KMA 2018).

Large stand of Lantana (*Lantana camara*) found (pictured). Ongoing Lantana management required via cut and paint method. Spear thistle (*Cirsium vulgare*), Cobble's pegs (*Bidens Pilosa*) and Flaxleaf fleabane (*Conyza bonariensis*) prominent along roadside. Tobacco Bush (*Solanum mauritianum*) also recorded.

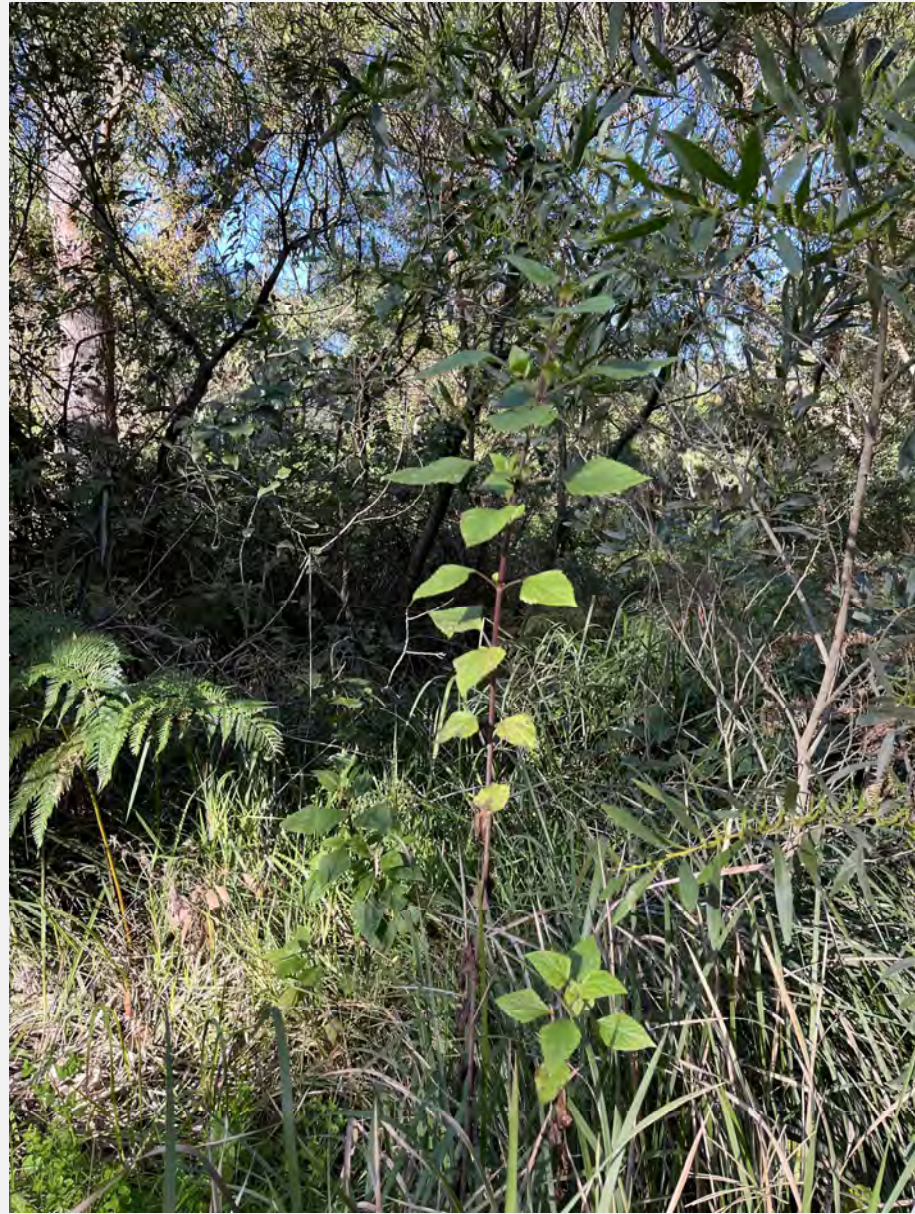
Subzone 2A.3

This area was revegetated early in the re-planting program. The plantings that have survived in this area have become well established despite previous impacts from grazing native fauna.

Removal of Crofton weed (*Ageratina Adenophora*) from roadside veg should be the priority (pictured). Minimal Lantana (*Lantana camara*) was also noted within this zone, continue to control via cut and paint methods.

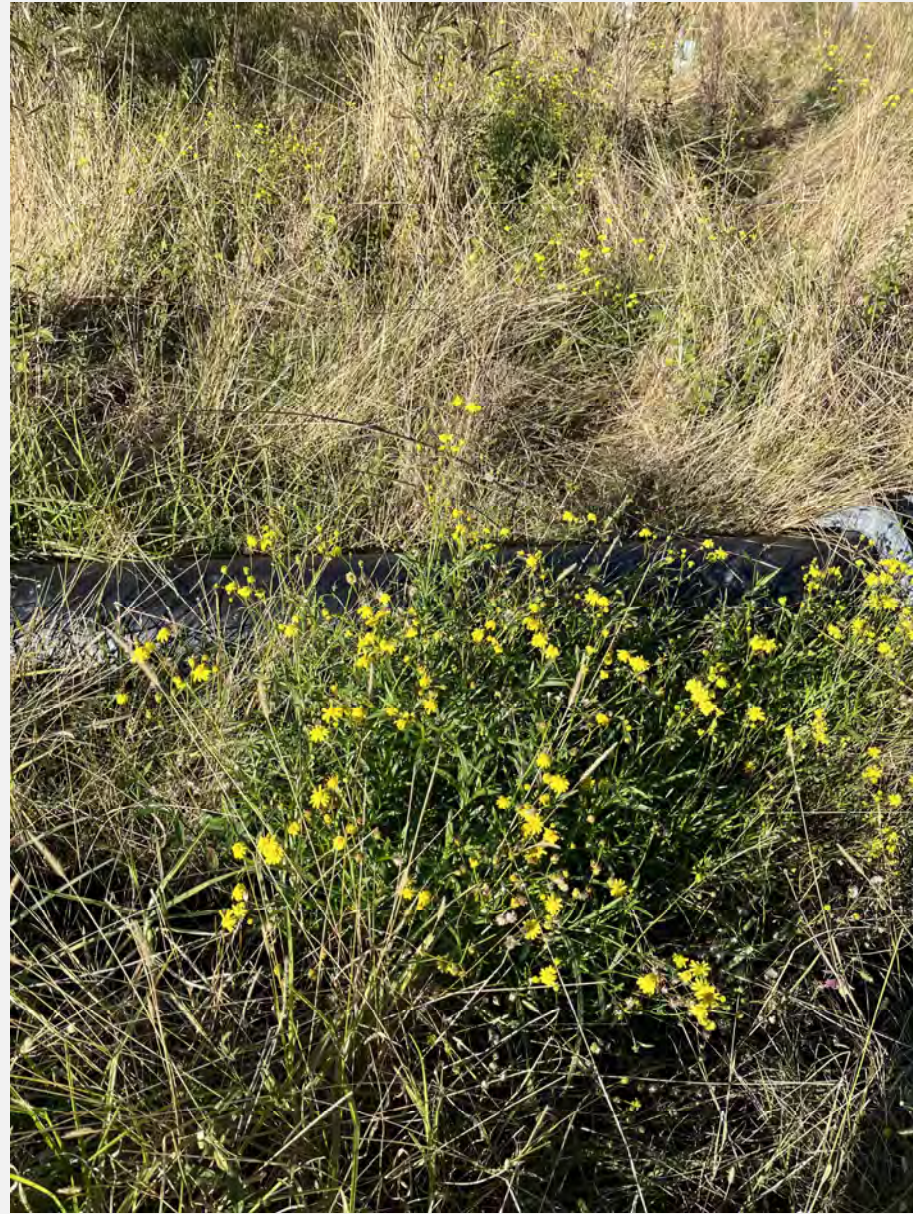
**Subzone 2C.1
(southern end)**

Small revegetation patch that was completed recently to link the forest with Zone 4, located roadside adjacent to subzone 1.1.

This subzone requires continued monitoring and management of herbaceous weed growth, such as Fireweed (*Senecio madagascariensis*) (pictured). The plantings are well established, however maintenance mowing around tree guards and removal of grass from within the guards is required (Plate 6). Continue to promote native tree and shrub cover via planting of more native species to lessen risk of weed reinvasion.

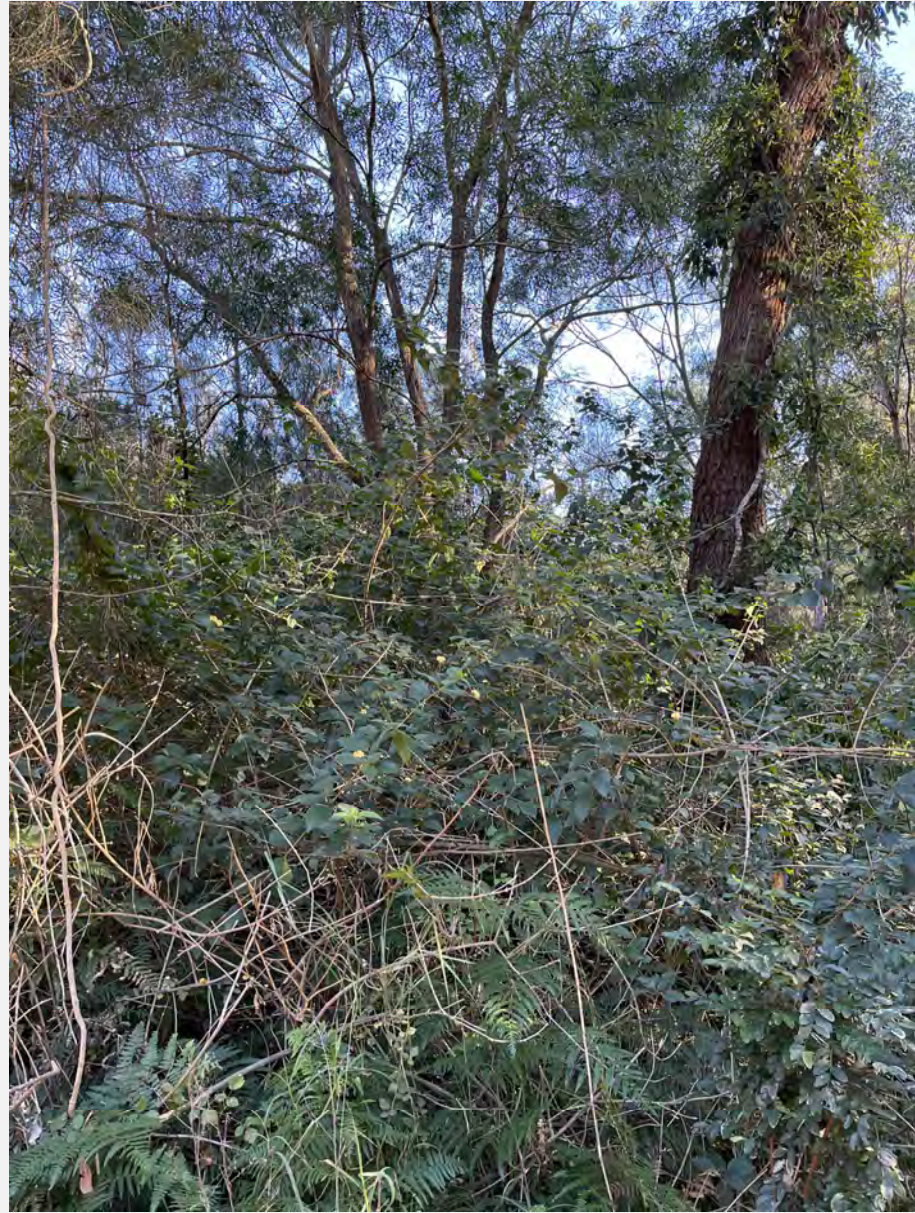
Subzone 2B.2

This area is located in a low-lying swamp and is being colonised by Swamp Oak. Some planting was carried out on a higher part of the subzone in the south and west in previous years (KMA 2018). The natural regeneration occurring in this subzone is adequate.

The understorey in this subzone is largely made up of native ferns, with some pasture grass. Some large lantana stands were recorded (pictured), and a few small stands of Tobacco Bush. These should be managed via cut and paint methods.

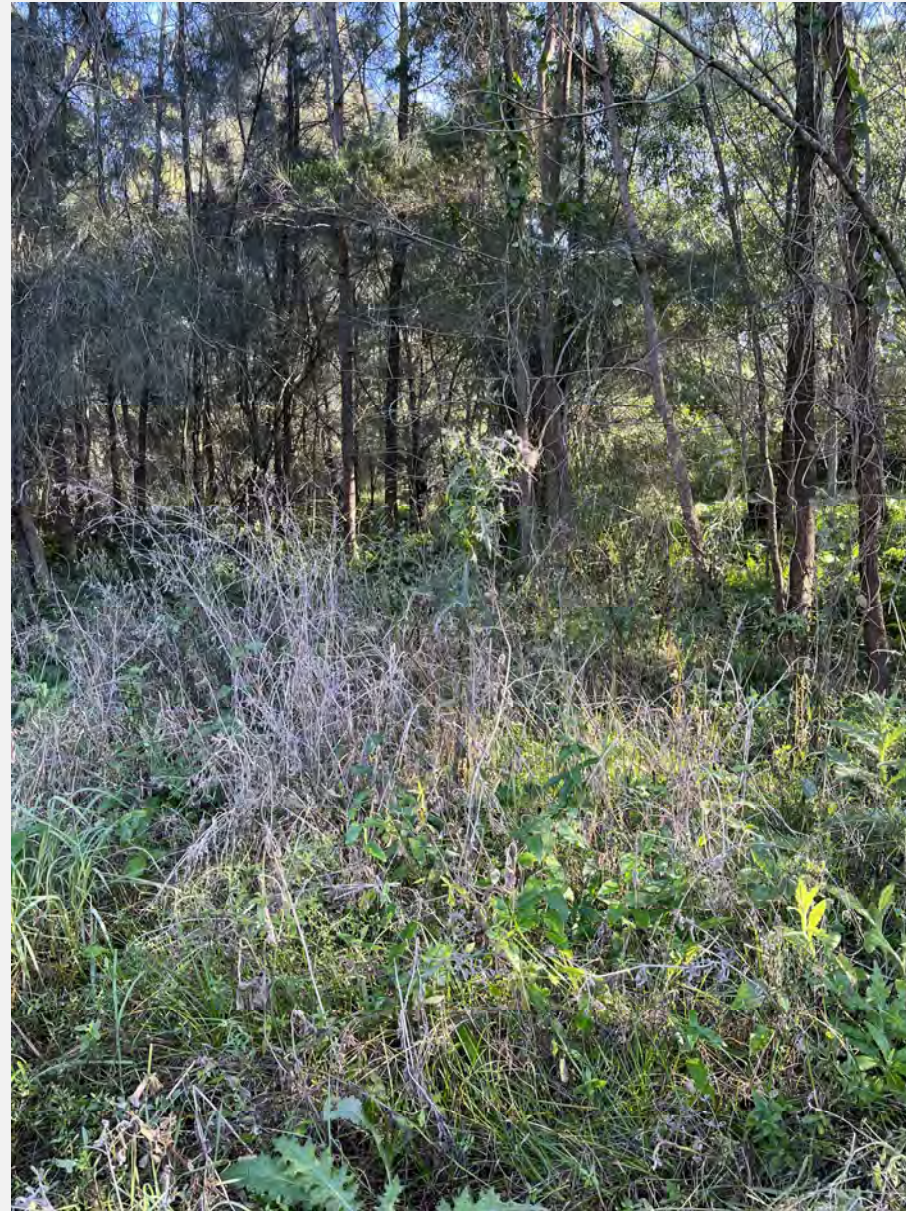
Subzone 2B.1

This subzone is a narrow area that was regenerated to link the creek-side forest to that within Zone 4. The subzone was spread with topsoil and timber debris, and plantings were undertaken. Considerable growth of the plantings has since been noted.

Area free from high threat weeds. However, Spear thistle (*Cirsium vulgare*), Cobbler's pegs (*Bidens Pilosa*) and Flaxleaf fleabane (*Conyza bonariensis*) were all recorded along the roadside. These can be managed with herbicides and persistent mowing to reduce spread to surrounding forest.

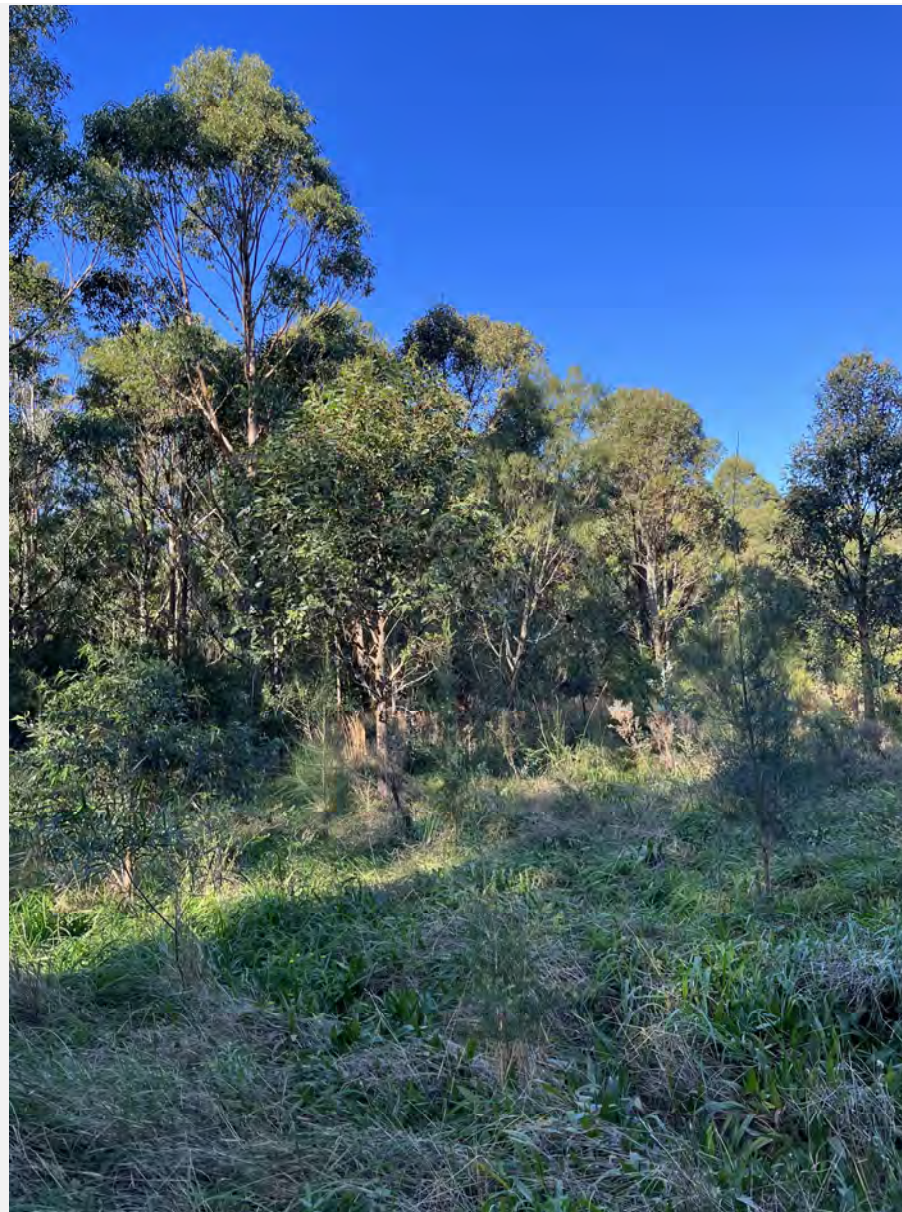
Zone	Location/description	Recommendations for ongoing works 2023/24	Reference Images
Subzone 2C.2	A long narrow area supporting some well-established plantings.	This area was too wet to access however appeared to be in similar condition to subzone 1.4. The previous report noted some plantings were impacted by last years flooding events. Further planting is required to replace plants that were impacted and to promote growth of surrounding native plants. Management of weeds and pasture grasses should be completed once area is dry enough to access.	N/A

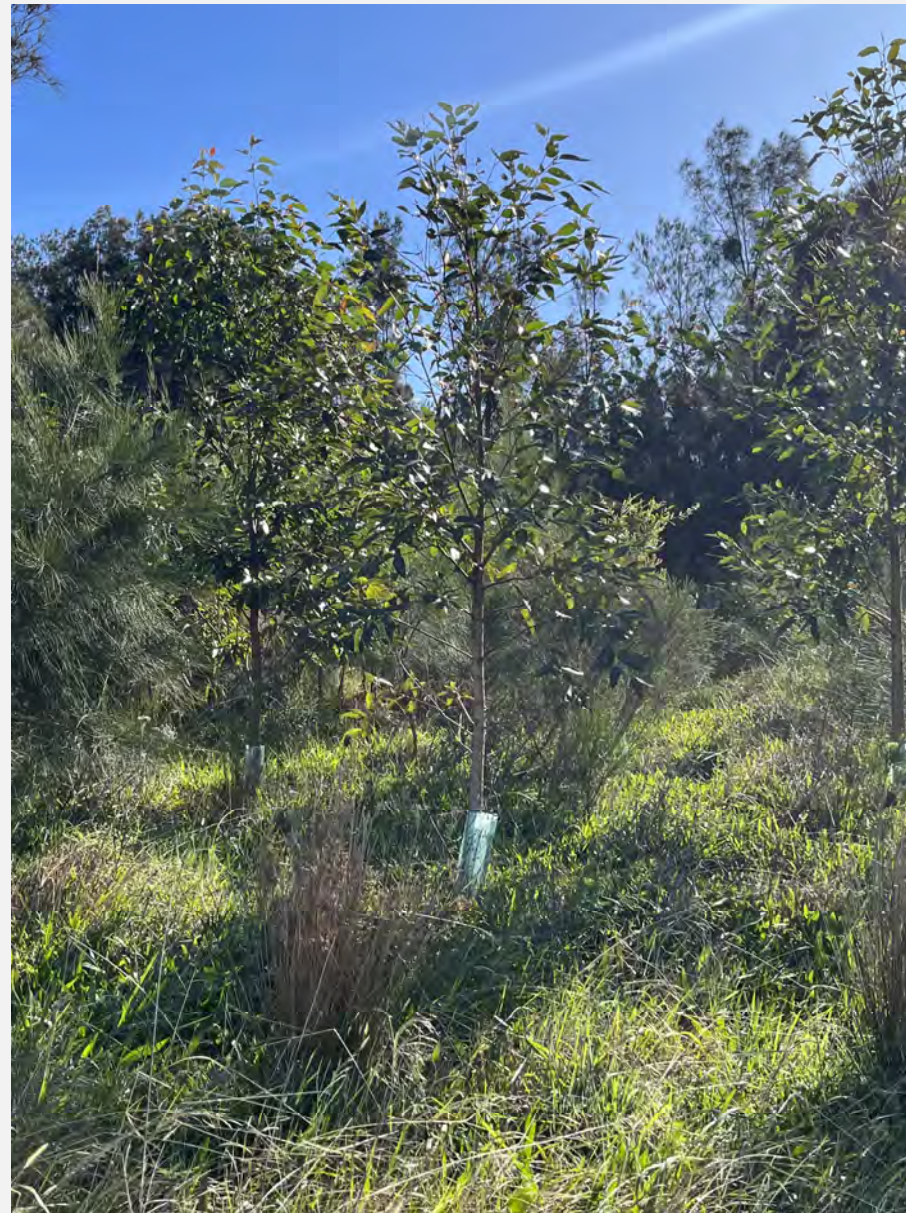
Zone	Location/description	Recommendations for ongoing works 2023/24	Reference Images
Subzone 2E	Plantings in this area have become well established and tree growth continues to be progressing well. This narrow strip of trees extends into subzone 1.4, an established area of trees.	This area was too wet to access however appeared to be in similar condition to subzone 1.4. The previous report noted this area was in overall good condition. Continue to treat woody weeds such as Lantana (<i>Lantana camara</i>) that reappear.	N/A
Zone 3: Screen Planting Zone Objectives (0.42 ha) <ul style="list-style-type: none"> Establish a screen of native vegetation along the eastern edge of pond extension Maintain existing trees on south eastern boundary, remove Lantana and replace with native plantings.

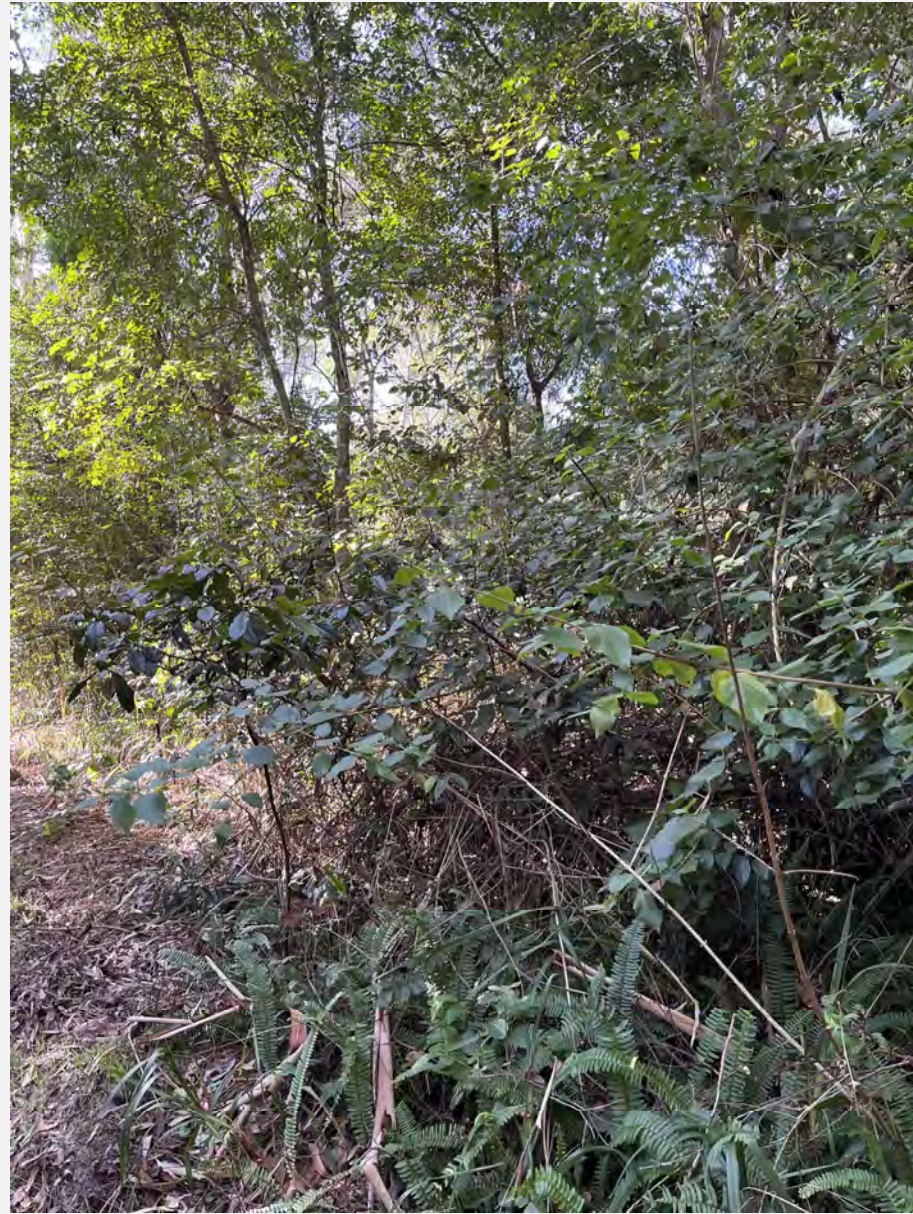
This zone includes the bund wall which reached its final height early in 2015. A screen of native vegetation was established along the eastern edge of the pond extension. The sand bund is currently stabilised by growth of plants, the majority of which are weeds.

Continue removal of Lantana using spraying and cut and paint methods, as large stand persist along bund wall (pictured). Planting is required to encourage native growth to stabilise bund wall.

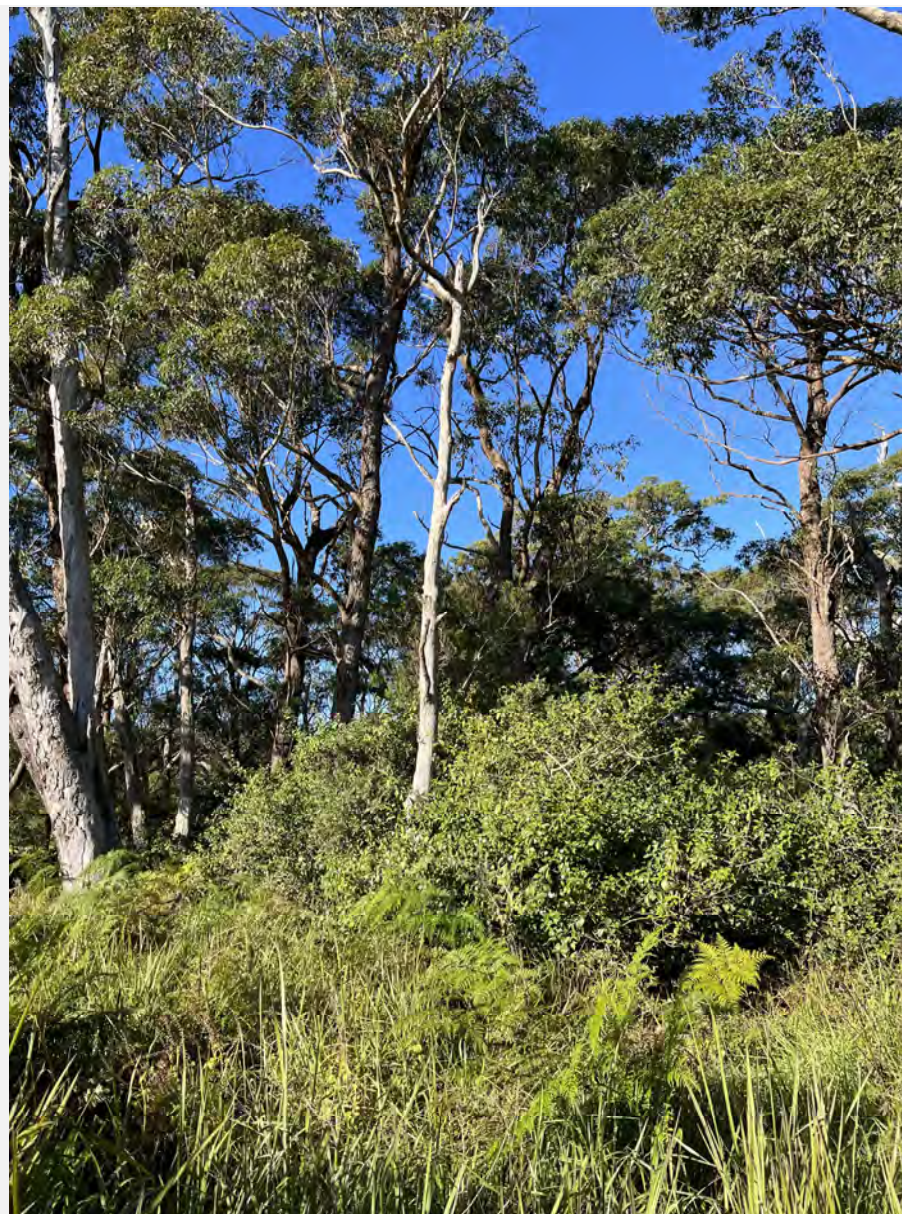
Zone 4

This zone is remnant Bangalay Sand Forest vegetation. This area has an intact Bangalay and Blackbutt canopy and is of high habitat value. Lantana has been heavily targeted in this zone and continued maintenance has been completed.

Canopy in excellent condition, however this zone still contains large patches of Lantana (*Lantana camara*) that require management. Some herbaceous weeds such as Fireweed (*Senecio madagascariensis*) and Flaxleaf fleabane (*Conyza bonariensis*) growing along perimeter fence (Plate 2). These should be managed to ensure they don't spread to the woodland.

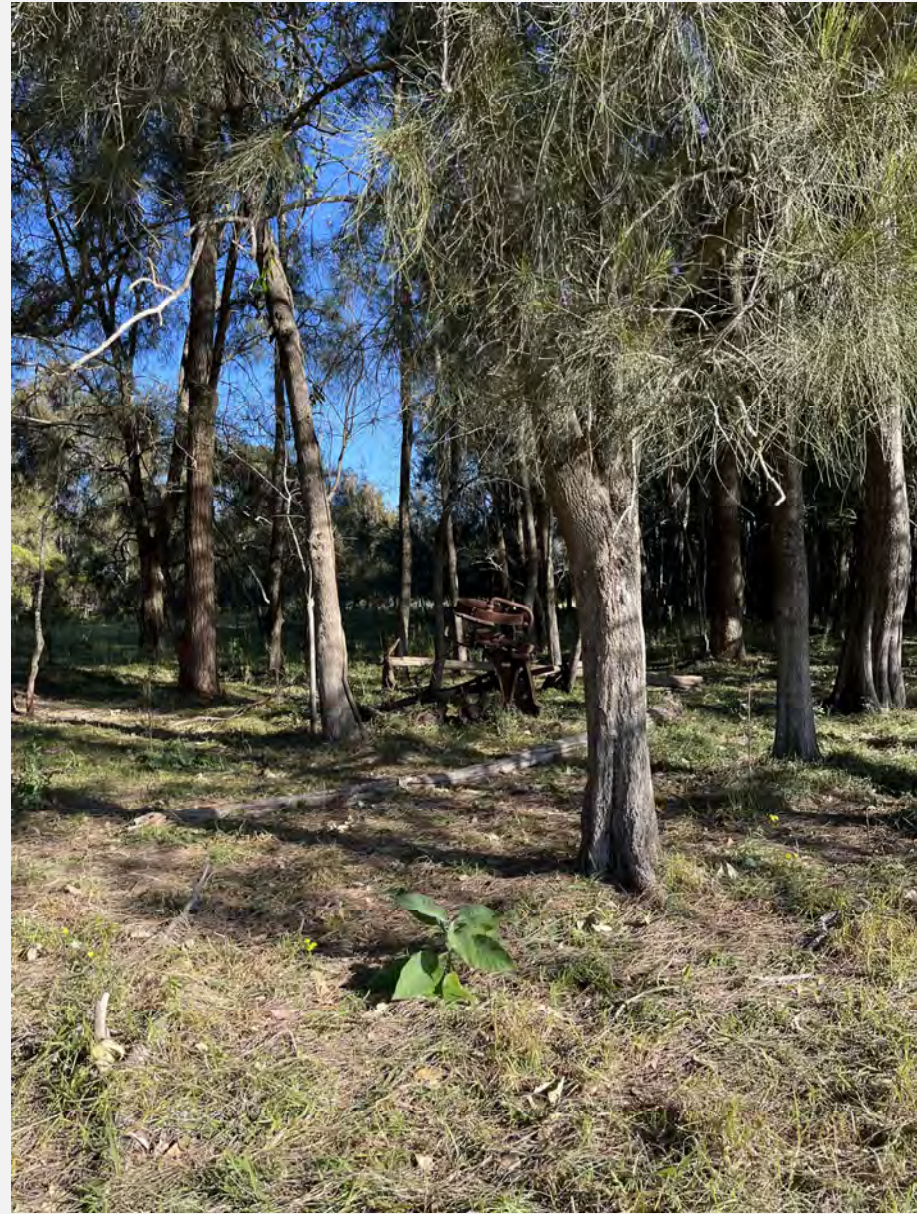
Zone 5

This zone includes remnant Swamp Oak Forest. Area is overall in good condition with a relatively open mid/understorey.

Continue to maintain perimeter fencing to stop stock from grazing on plantings. Undertake weed control to remove scattered Tobacco Bush (*Solanum mauritianum*) (pictured) and Lantana (*Lantana camara*) throughout subzone.

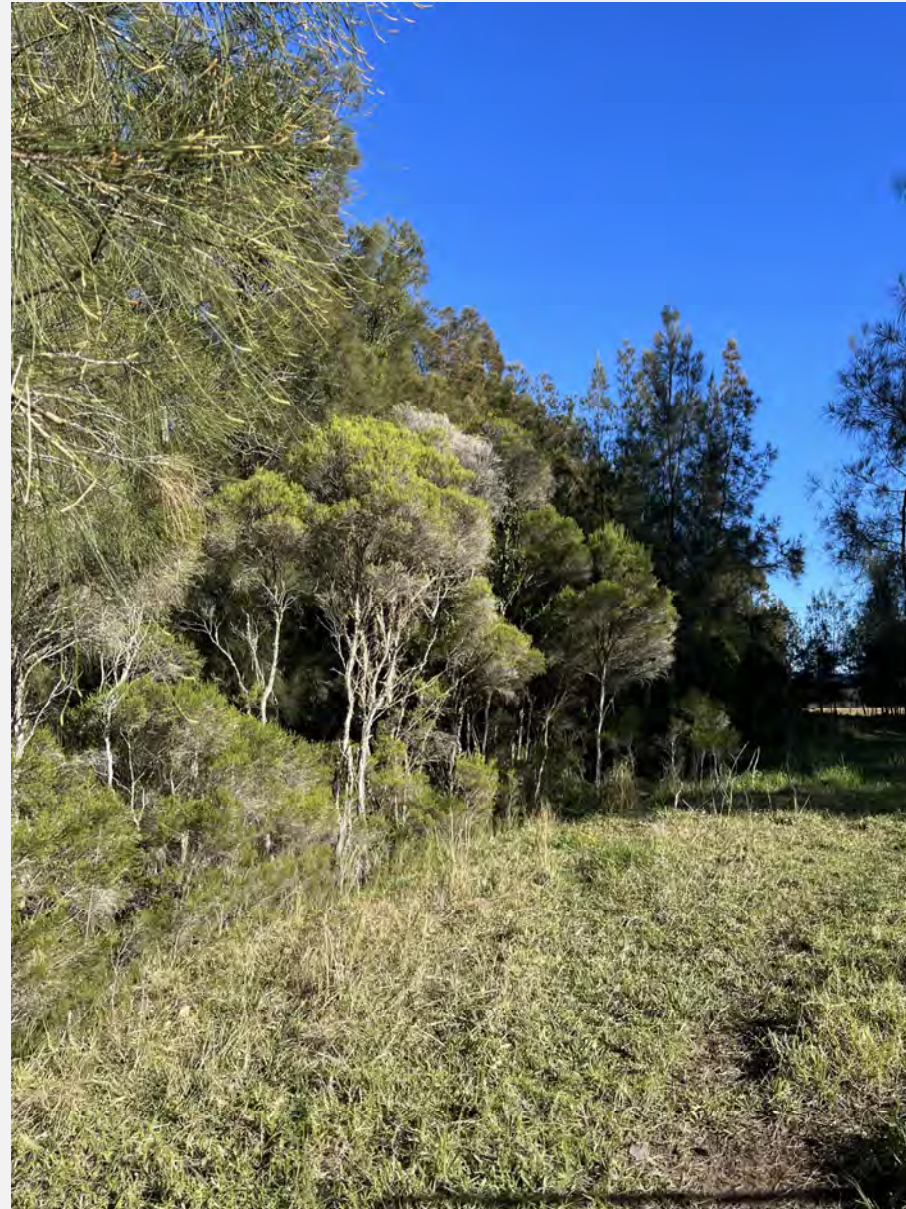
Zone 5C.1

Occurs between the Swamp Oak Forest in zone 5 and the creek that has been planted. The area is dominated by Kikuyu Grass. The shrub *Melaleuca ericifolia* is continuing to expand from the creek-side.

This area is in good condition with minimal weeds. Further planting of native tube stocks (e.g. *Casuarina* spp.) will help establish connection to nearby subzone 5.
