GERROA SAND RESOURCE

ANNUAL REVIEW

Period 01 July 2022 – 30 June 2023

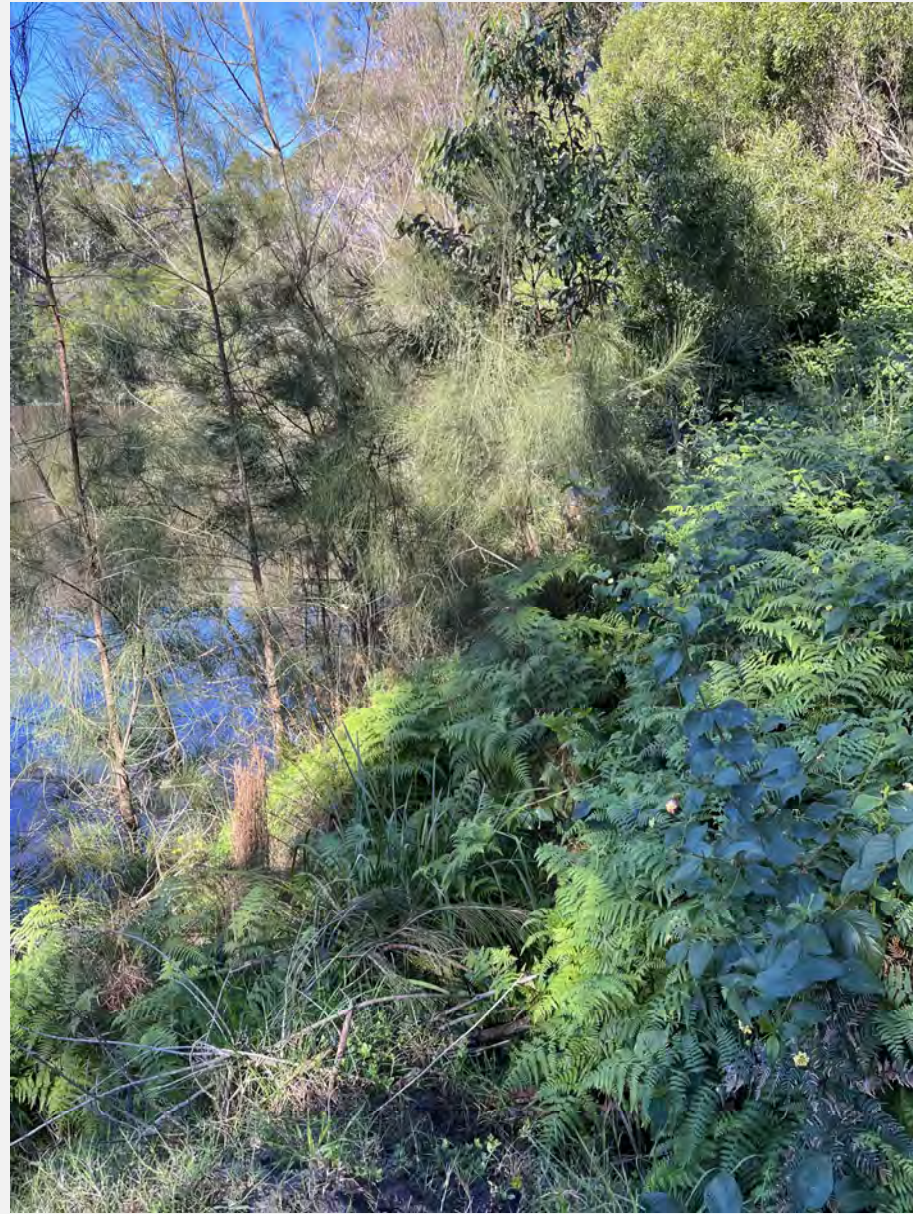
Zone 6

This zone occurs within the foreshore areas of the Dredge Pond. The foreshore has been previously shaped, had topsoil spread and planted as the dredge pond has expanded northwards. Overall, the pond bank is stable with little to no erosion evident. Natural regeneration and pre-existing native growth have helped to stabilise area.

Monitor and control of priority weeds such as Lantana (*Lantana camara*) (pictured) and Tobacco Bush (*Solanum mauritanum*) using cut and paint method as necessary. Avoid spraying in this area to ensure native species retain dredge pond bank stability. Additional plantings may be beneficial to encourage native growth and to control herbaceous weeds such as Fireweed (*Senecio madagascariensis*), annual weeds and invasive grasses (Plate 3) from dominating.

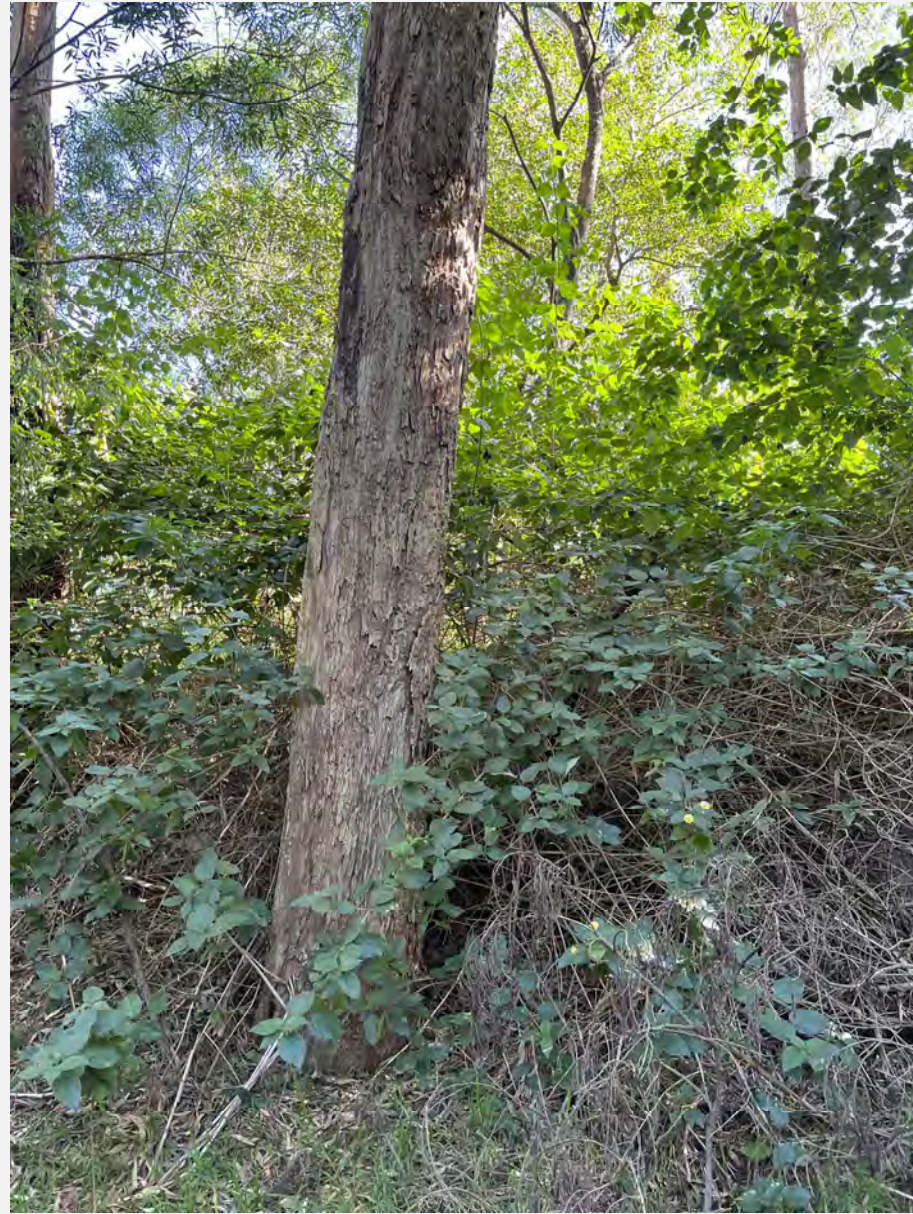
Zone 7

This zone occurs along the eastern edge of the Site between zones 3 and 1.2. This zone has cultural significance, therefore only minor control of Lantana has been conducted over time.

SW end of zone is well maintained with minimal Lantana present. Presence of Lantana increases in the NE section of the zone (pictured). Monitor and control Lantana and Tobacco Bush as necessary using the mosaic methods of weed removal (i.e. working in patches).

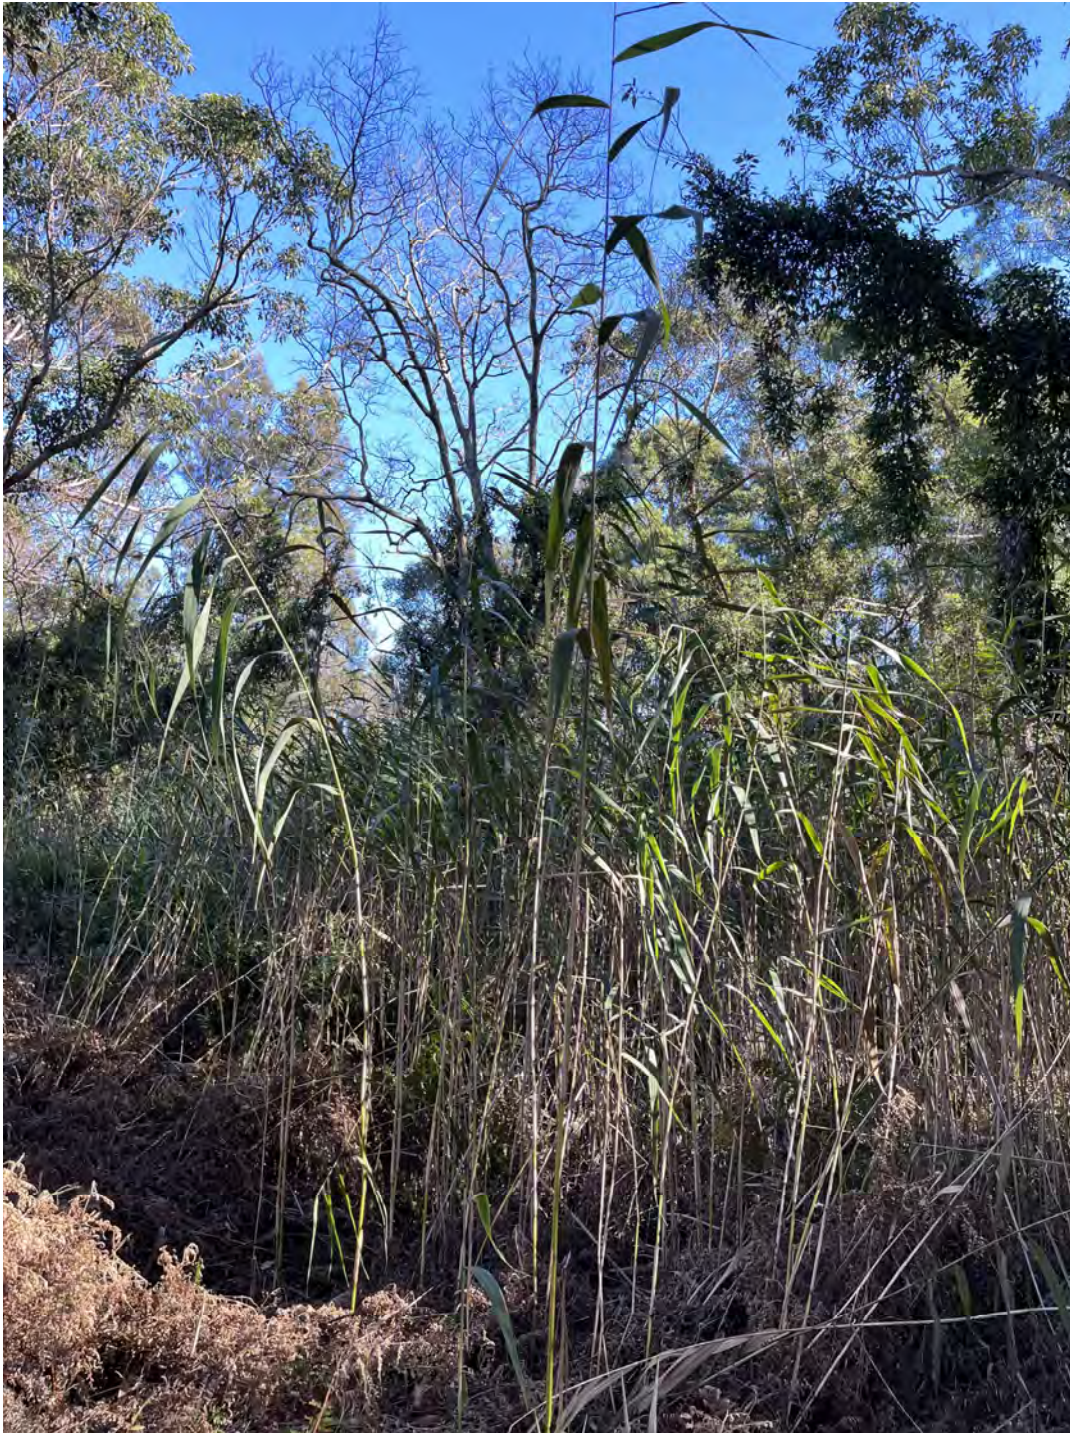
Plate 1: Giant Reed (*Arundo donax*) found growing along the northern perimeter of subzone 1.1.

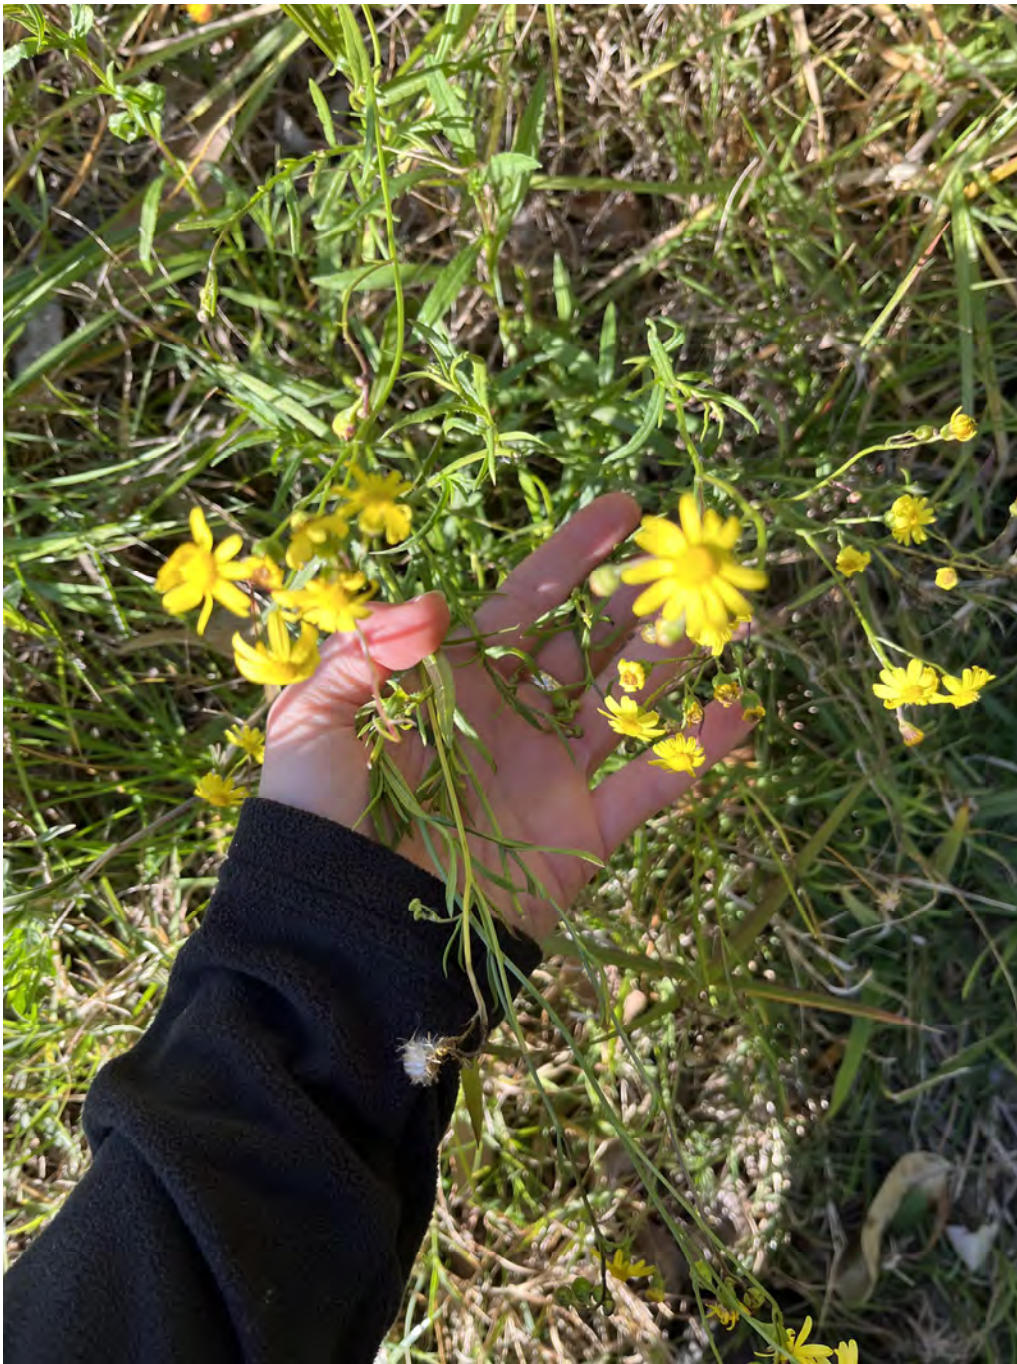
Plate 2: Fireweed (*Senecio madagascariensis*) growing along perimeter fence of subzone 4.

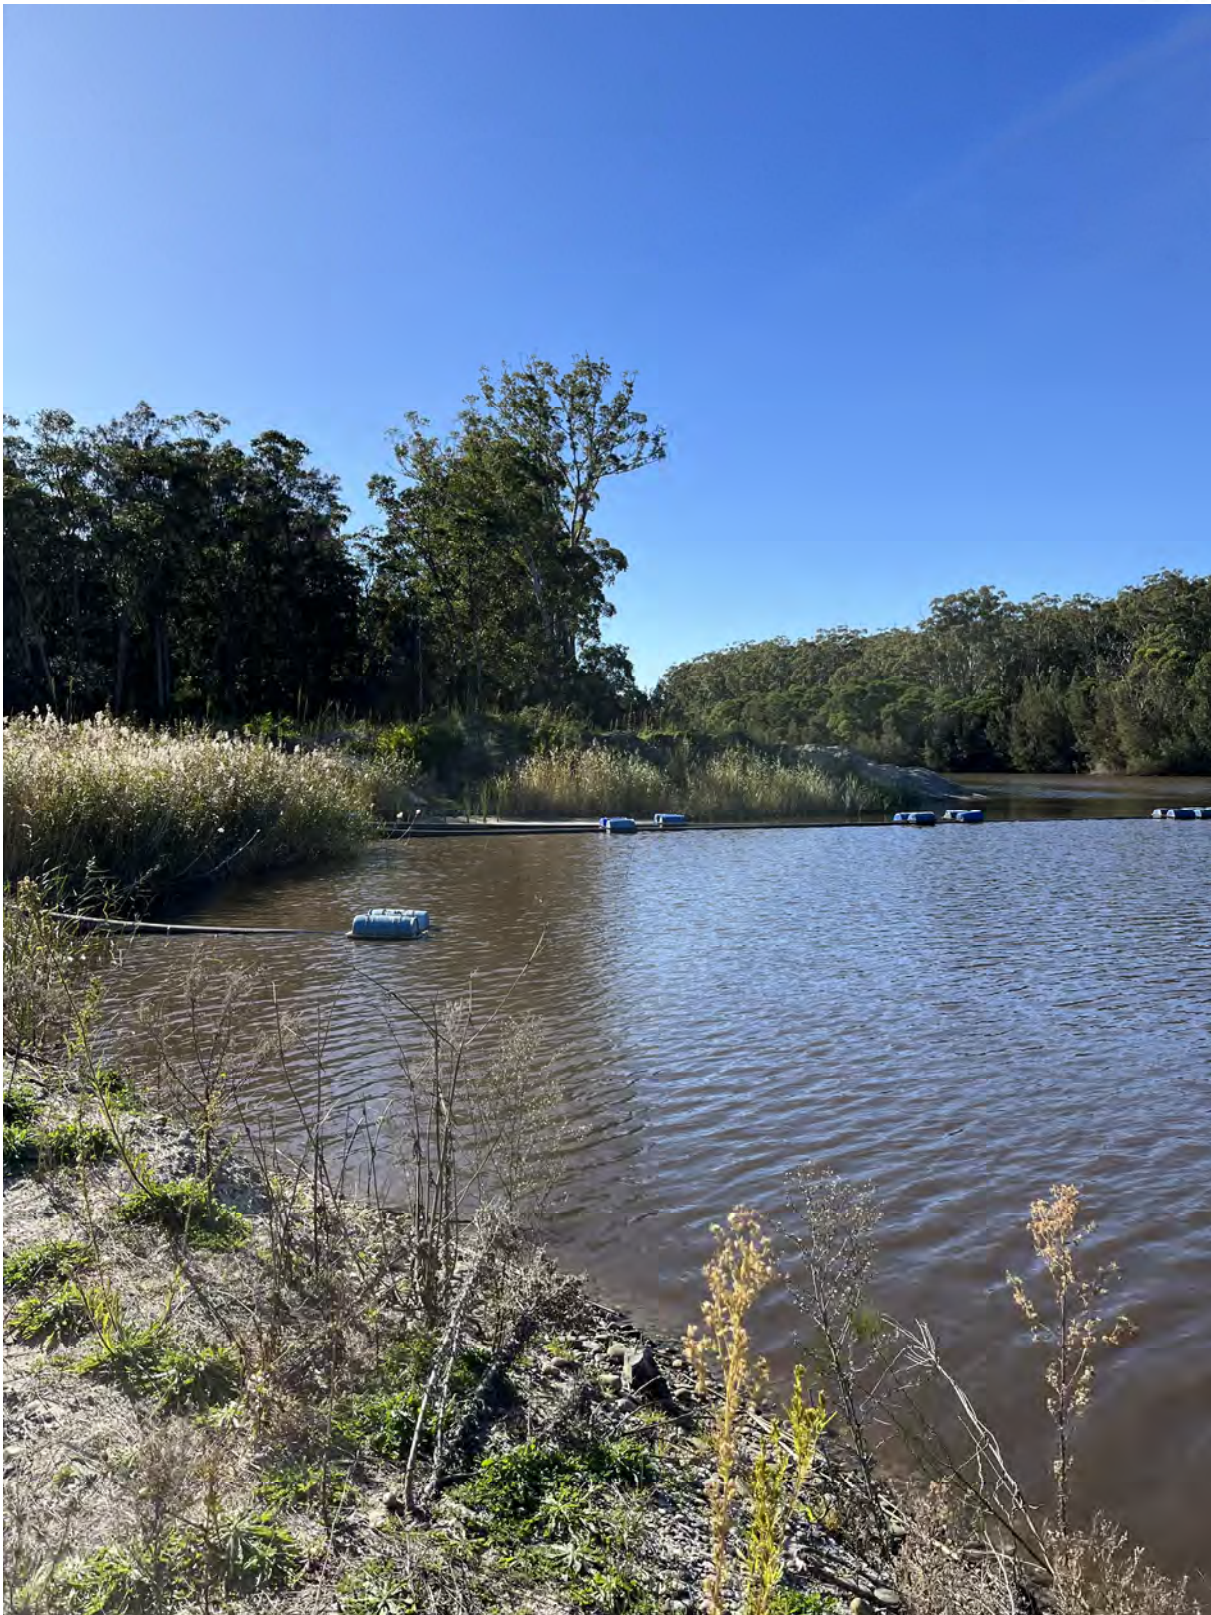
Plate 3: Weeds such as Flaxleaf fleabane (*Conyza bonariensis*) along the edge of subzone 6.

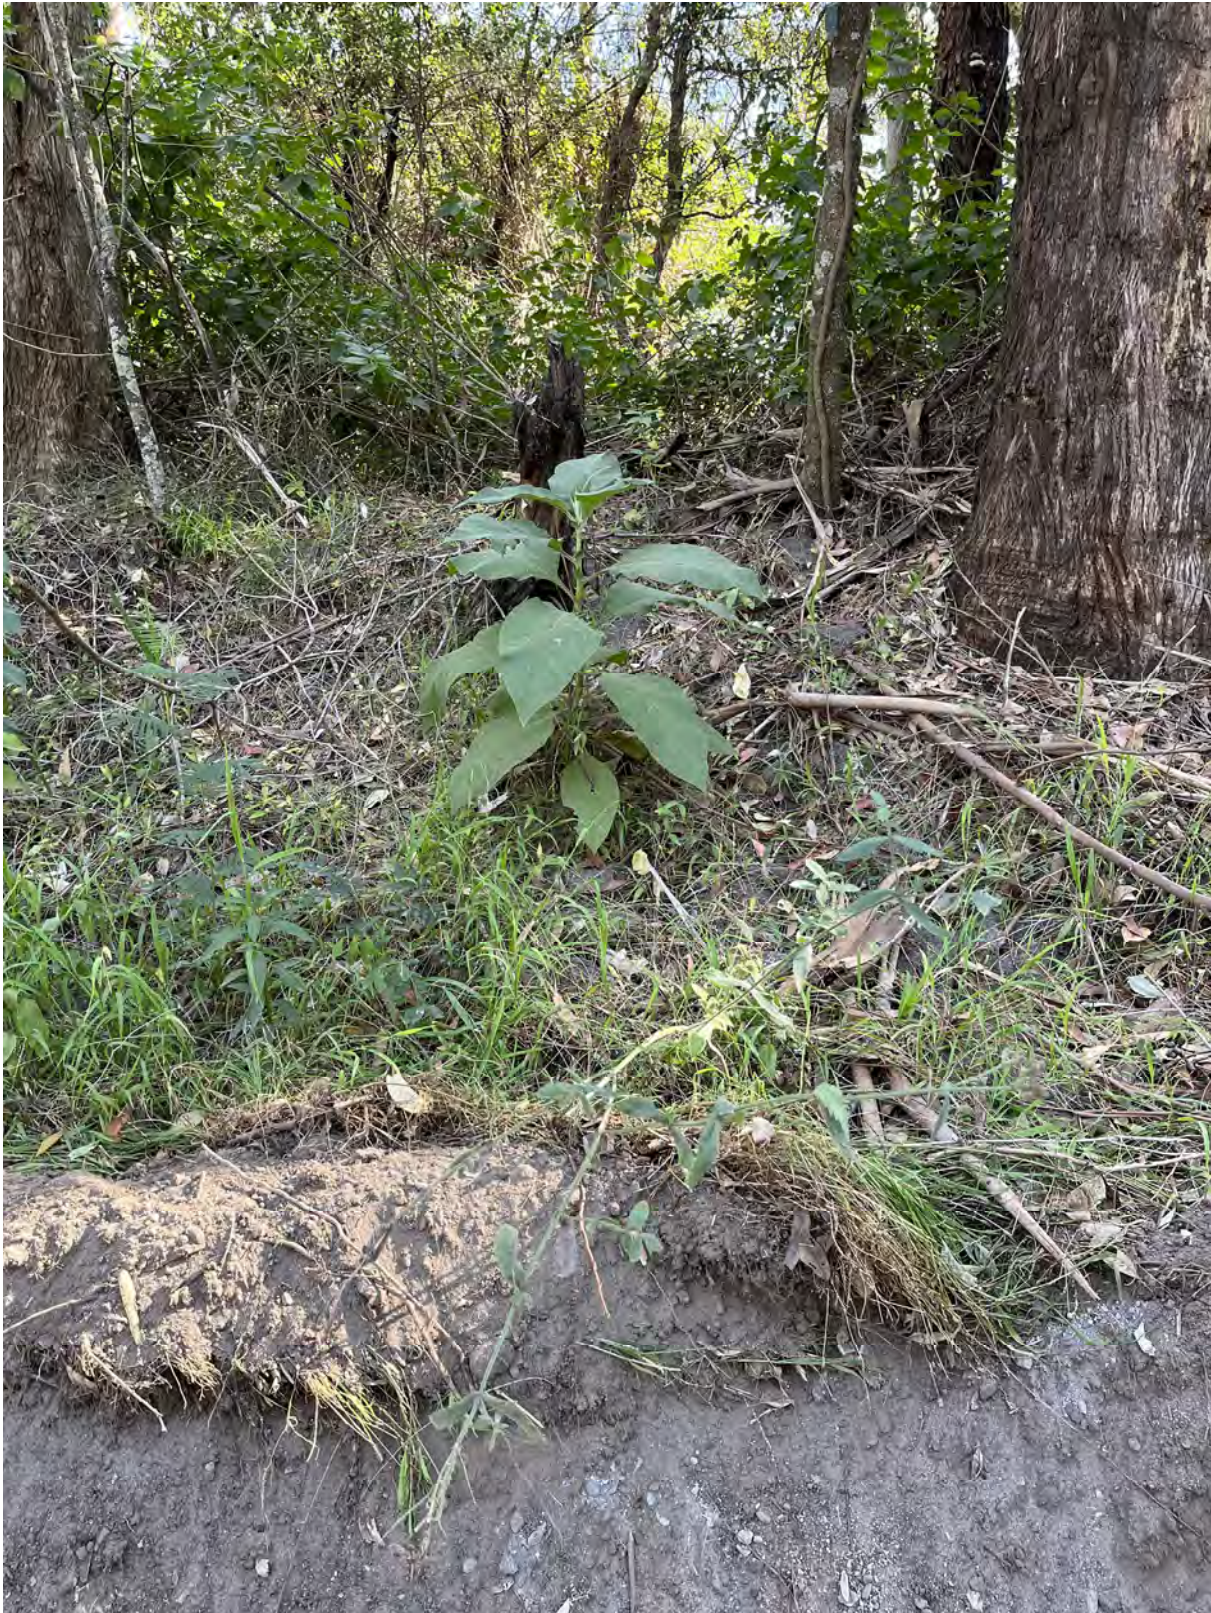
Plate 4: Tobacco Bush (*Solanum mauritianum*) in subzone 1.3.

To achieve revegetation successes, such as those exhibited in the northern portions of the Gerroa Sand Quarry, mature weeds such as Wild Tobacco Bush (found in Zone 1.1, 1.3 and 2A.3) and Lantana stands (found in most zones) should be targeted to limit further seed dispersal given their higher fecundity. Weed removal should be undertaken using cut and paint methods for these woody weeds since it offers a higher kill rate and avoids indirect poisoning of adjacent native species.

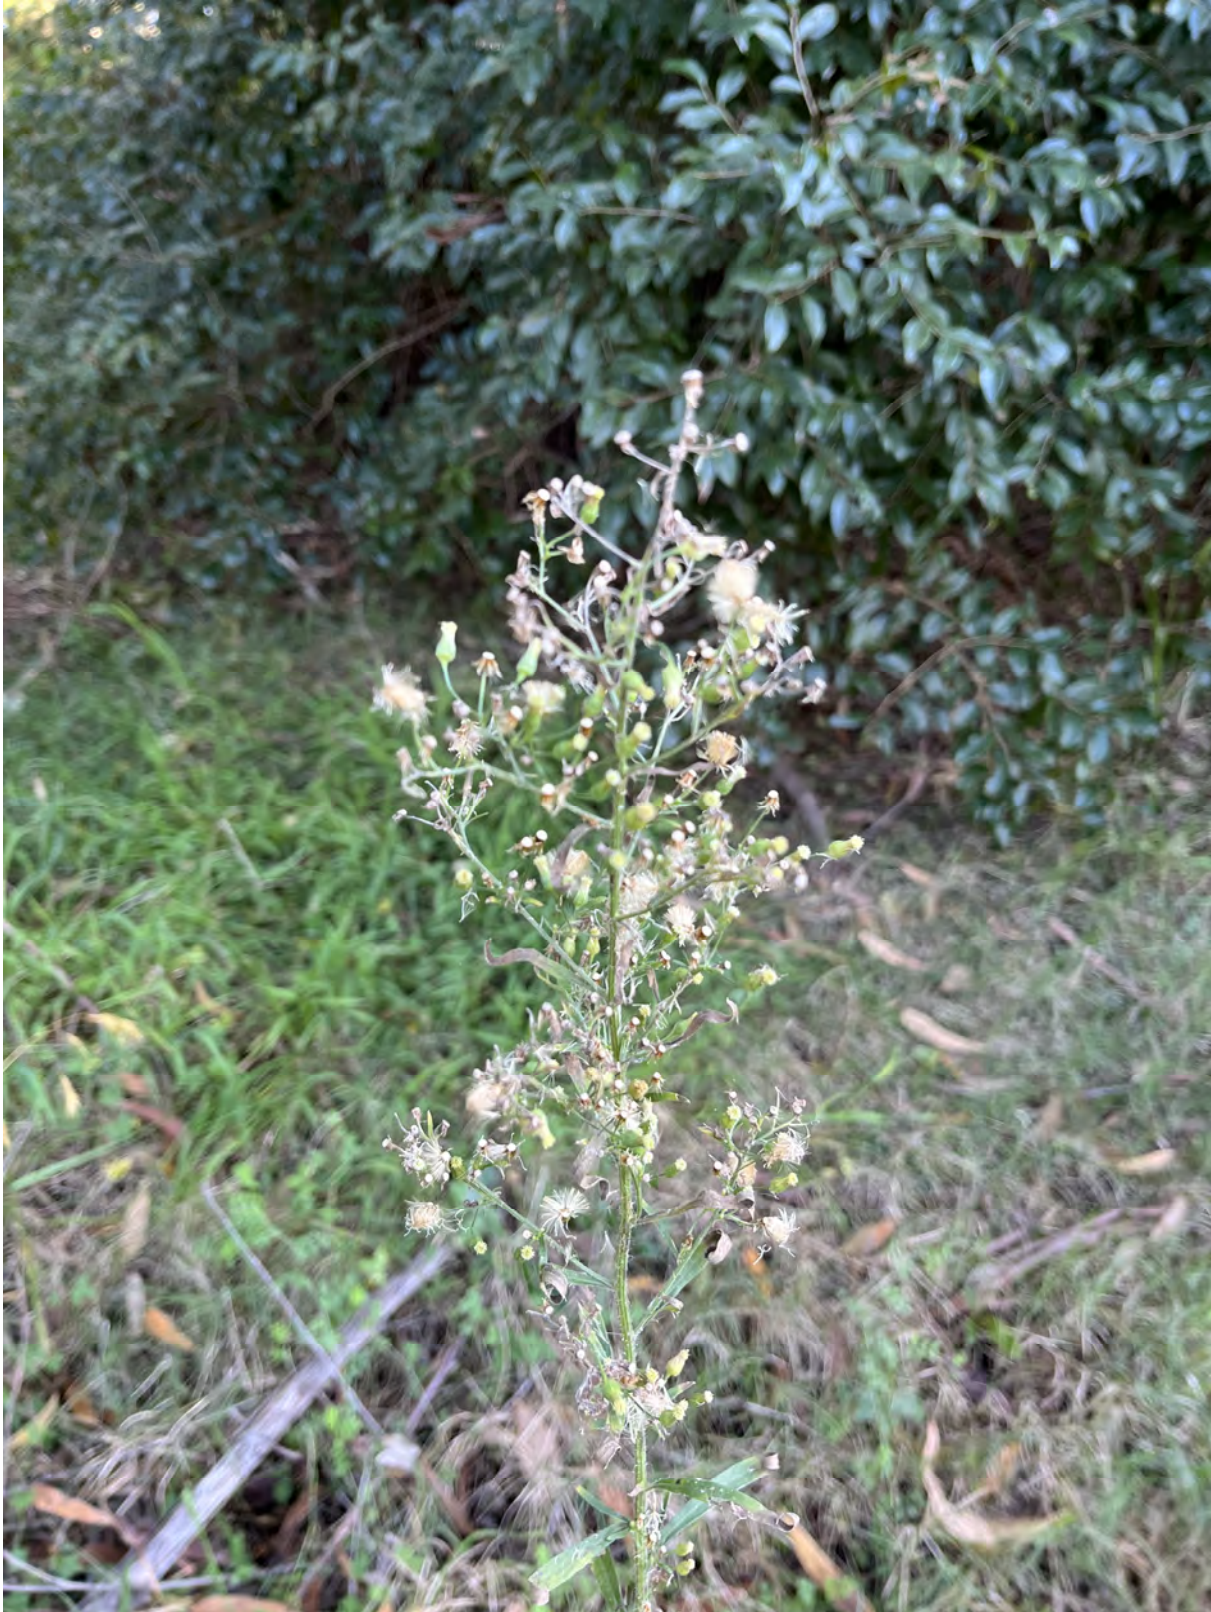
Plate 5: Flaxleaf fleabane (*Conyza bonariensis*) growing along roadside of subzone 1.1.

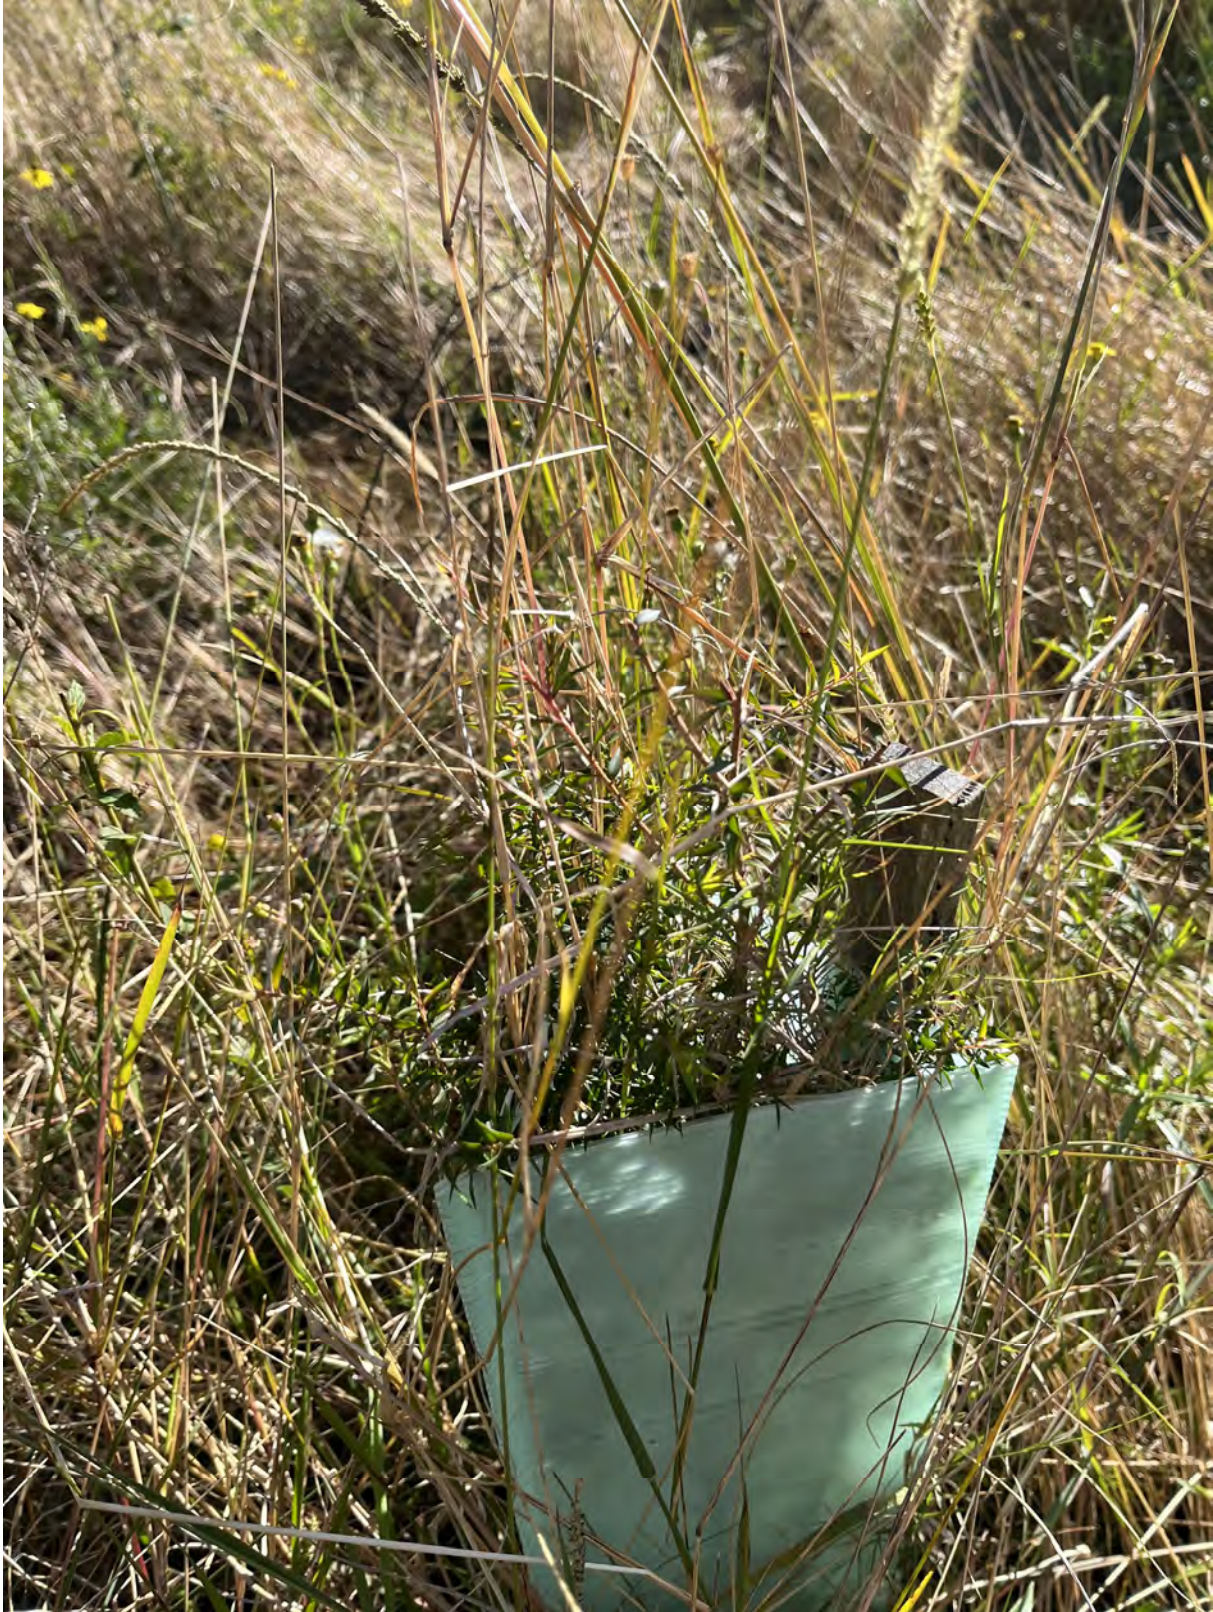
Plate 6: Pigeon grass (*Setaria parviflora*) growing through tree guard and strangling planting in subzone 2C.1.
