GERROA SAND RESOURCE

ANNUAL REVIEW

Period 01 July 2024 – 30 June 2025

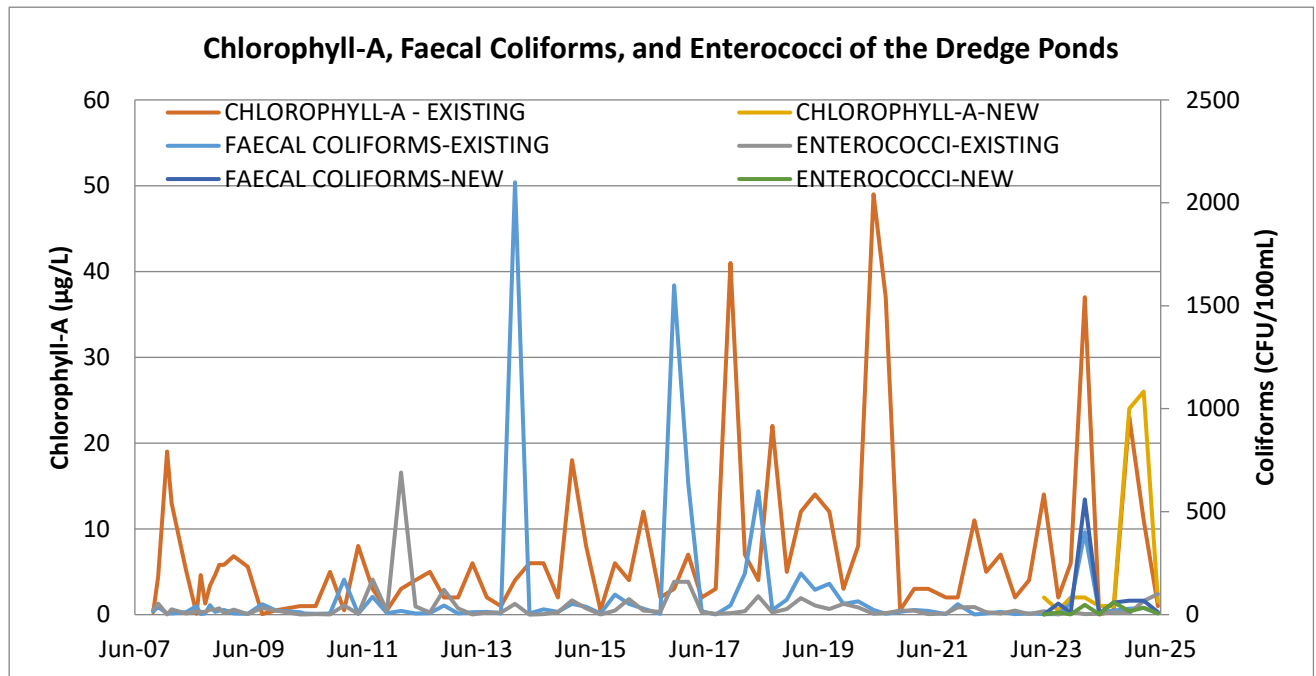
Chlorophyll-A, Faecal Coliforms, and Enterococci

Chlorophyll-A, faecal coliform, and enterococci results for both dredge ponds were within the historical ranges for the respective analytes of the existing dredge pond during the reporting period. Faecal coliforms and enterococci remained within the objective levels, while chlorophyll-A showed some seasonal variation, consistent with previous years, with concentrations higher during the warmer months, and associated with increased inflows to the dredge pond with the higher rainfall during these periods.

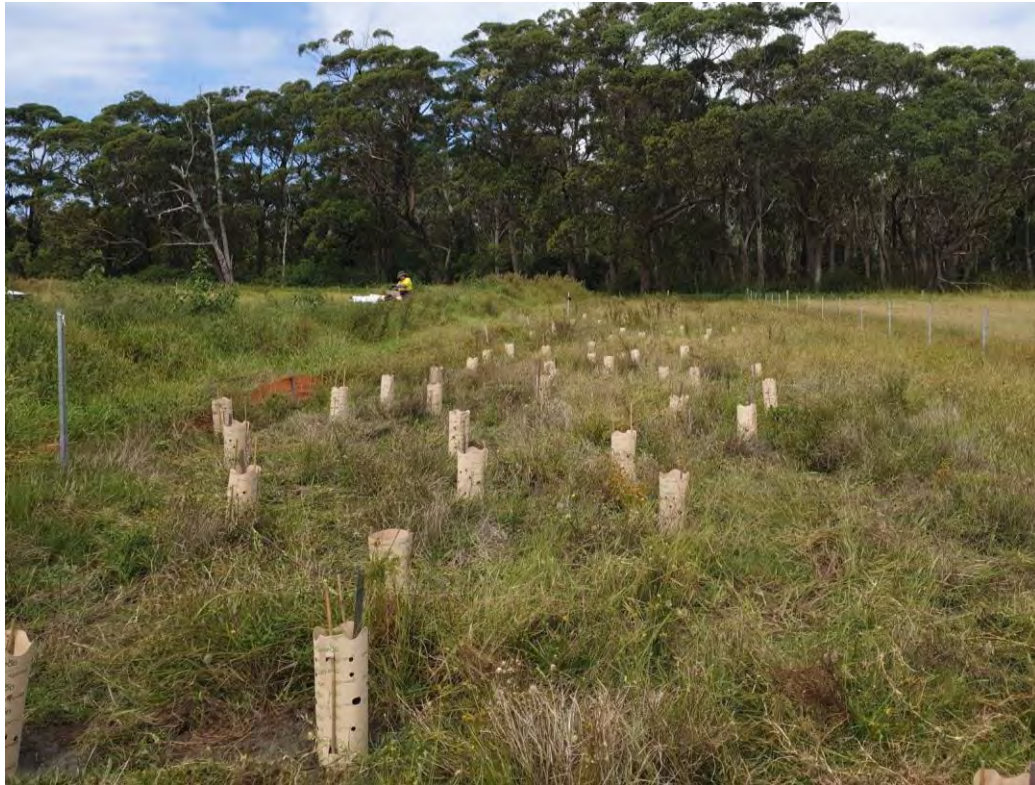
Primary planting has been completed for all areas of revegetation. Approximately 600 *Casuarina glauca* plants consisting of 580 tubestock and 20 mature stock (200mm pots) were planted in the tree screen during Spring 2024 to replace lost plants. Plants were observed to be subject to heavy grazing, with a trail camera installed noting native macropods to be the dominant cause. Following this observation, biodegradable tree guards were installed around each plant in March 2025 to reduce these grazing pressures (see below figure). Since this time, plants have shown rapid growth within the tree guard, although continue to be grazed above the guard. It is expected that the tree guards will continue to provide the support needed to outcompete these grazing pressures in time, as has been observed in other sites where a similar strategy was successfully employed.

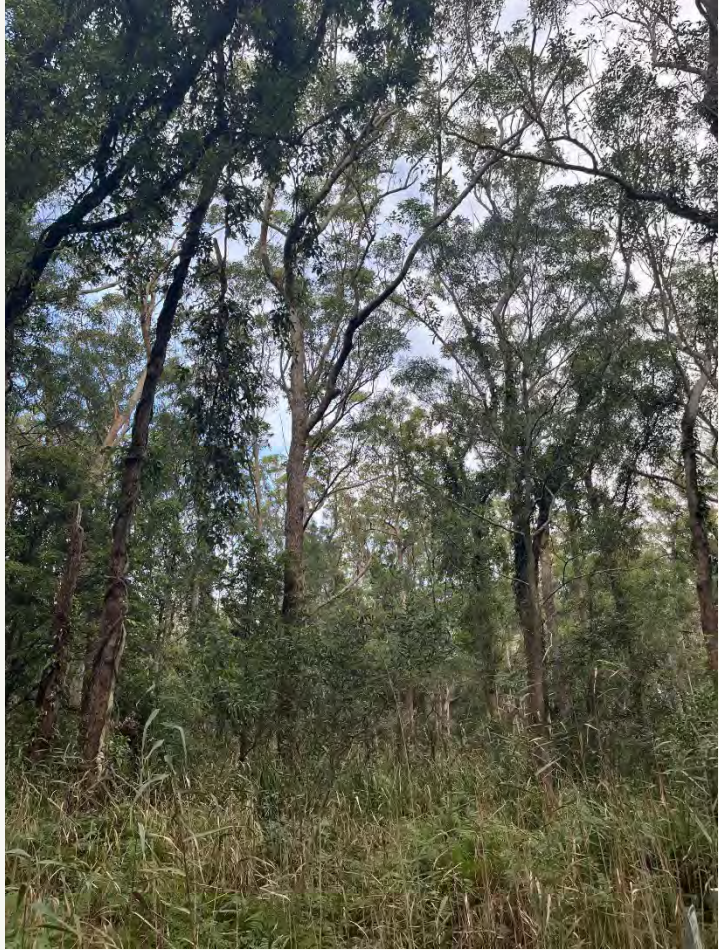
Zone	Location / description	Recommendations for ongoing works 2025/2026	Reference Images
Subzone 1.1	This is the main area of existing forest, extending from the southern to northern end of the property boundary.	Both the northern and southern areas appear to be in high condition, with Lantana (<i>Lantana camara</i>) being observed throughout. Rhodes Grass (<i>Chloris gayana</i>) and Tobacco Bush (<i>Solanum mauritianum</i>) were prominent in sections of the southern area. Giant Reed (<i>Arundo donax</i>) was found in the eastern section where it was more wet underfoot. Fireweed (<i>Senecio madagascariensis</i>) and Cobbler's Pegs (<i>Bidens pilosa</i>) were recorded in both the northern and southern areas along the roadside.

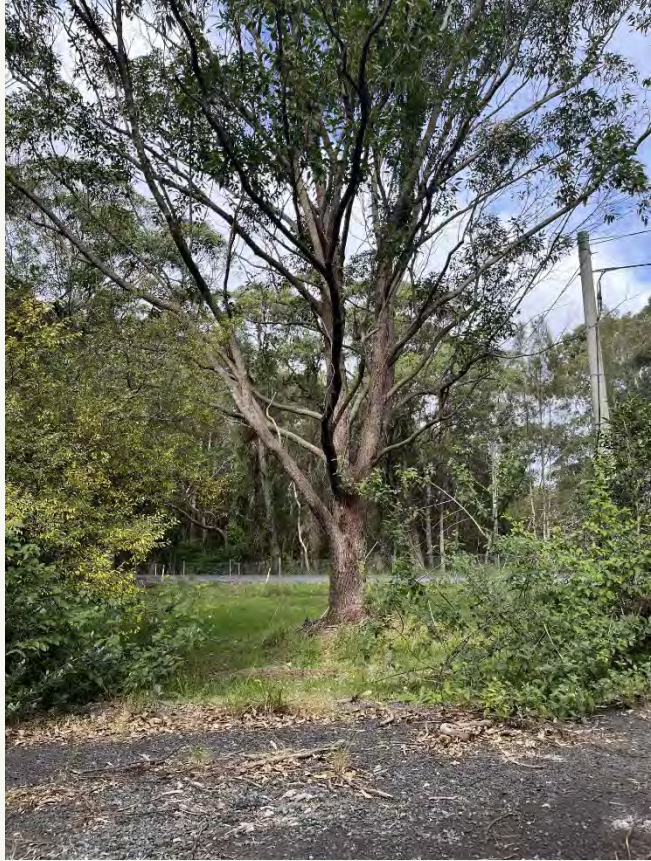
Zone	Location / description	Recommendations for ongoing works 2025/2026	Reference Images
Subzone 1.3	Covers the old bund wall. This subzone is located behind the site office and towards the front gate.	In this small zone, there were stands of Lantana (<i>Lantana camara</i>), and vines of Moth Vine (<i>Araujia sericifera</i>) which can be controlled using the cut and paint method. The zone was in good condition, except for the weeds, Cobbler's Pegs (<i>Bidens pilosa</i>) and Fireweed (<i>Senecio madagascariensis</i>), being observed along the roadside.

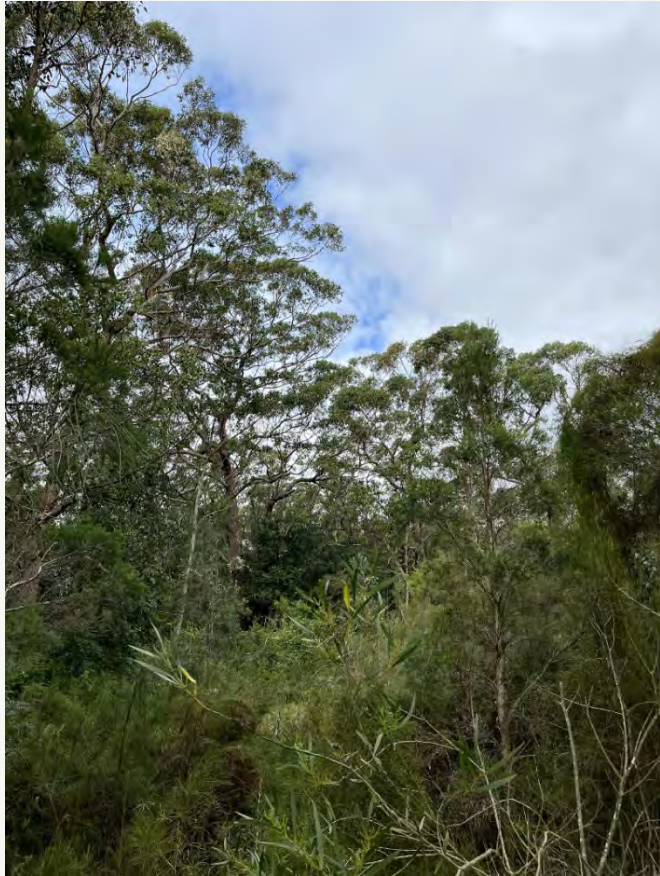
Zone	Location / description	Recommendations for ongoing works 2025/2026	Reference Images
Subzone 2A.3	This area was revegetated early in the re-planting program. The plantings that have survived in this area have become well established despite previous impacts from grazing native fauna.	Scattered Lantana (<i>Lantana camara</i>) was present throughout the zone. Cobbler's Pegs (<i>Bidens pilosa</i>) and Spear Thistle (<i>Cirsium vulgare</i>) were observed growing along the roadside.

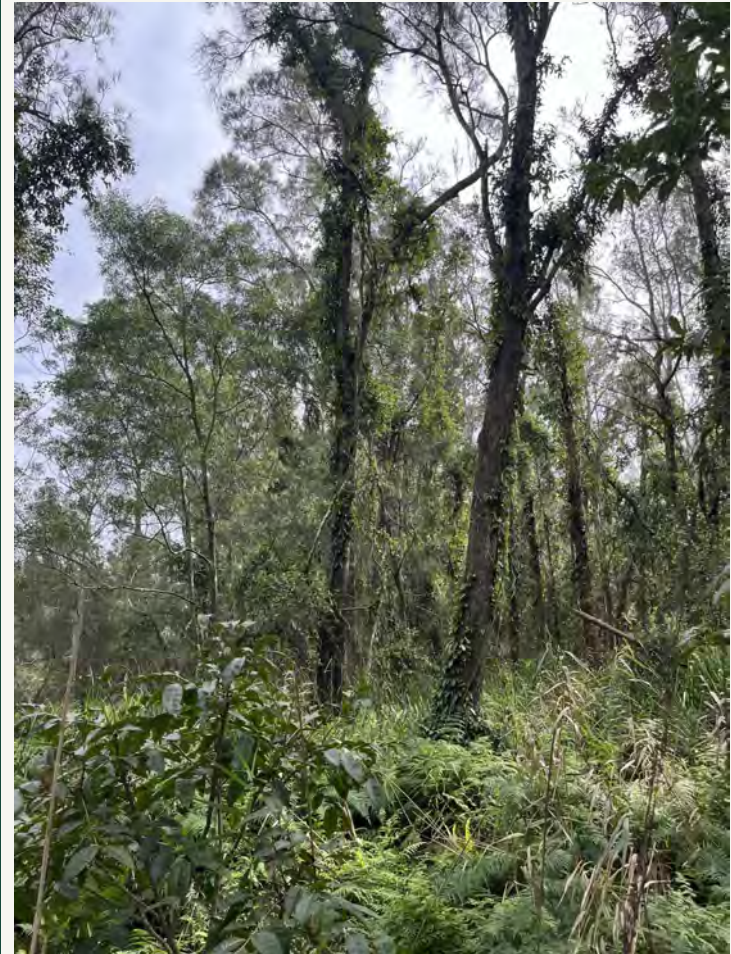
Subzone 2B.1

Significant doses of Moth Vine (*Araujia sericifera*) and Giant Reed (*Arundo donax*) were recorded throughout this zone, particularly near the roadside and along the creek line. Cobbler's Pegs (*Bidens pilosa*), Spear Thistle (*Cirsium vulgare*) and Pigeon Grass (*Setaria pumilia*) were also observed along the roadside.

The overall condition of this zone will continue to increase with the adoption of management techniques, such as cut and paint.

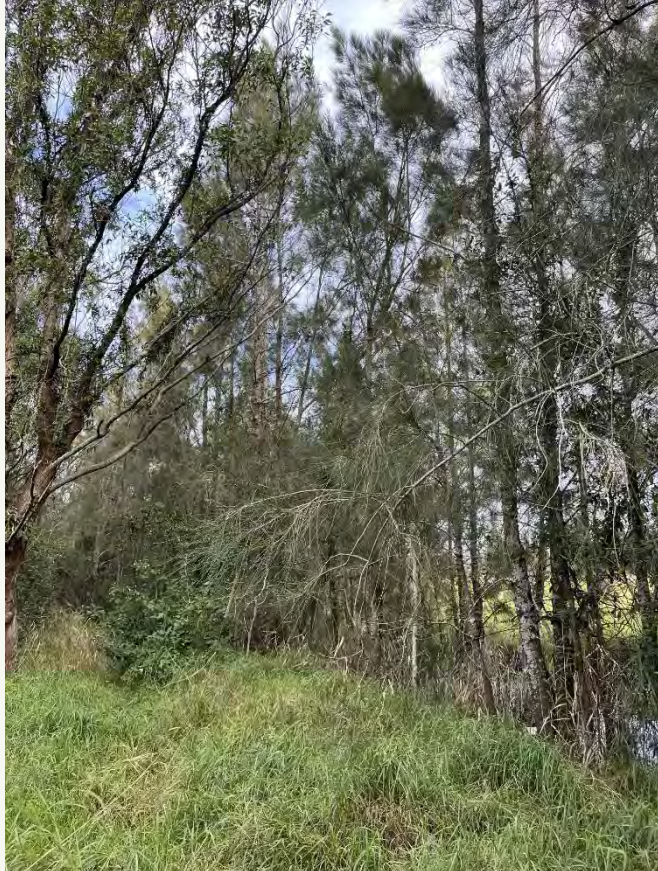
Zone	Location / description	Recommendations for ongoing works 2025/2026	Reference Images
Subzone 2C.2	A long narrow area supporting some well-established plantings.	<p>The western section of this zone was not accessible as it was too wet. From last year's report, the maintenance of the Swamp Oak (<i>Casuarina glauca</i>) plantings should continue to prevent weeds becoming prevalent.</p> <p>Lantana (<i>Lantana camara</i>) was observed in patches in the northeastern section of this zone, while Fireweed (<i>Senecio madagascariensis</i>) and Pigeon Grass (<i>Setaria pumilia</i>) were more prominent in the southeast section.</p>

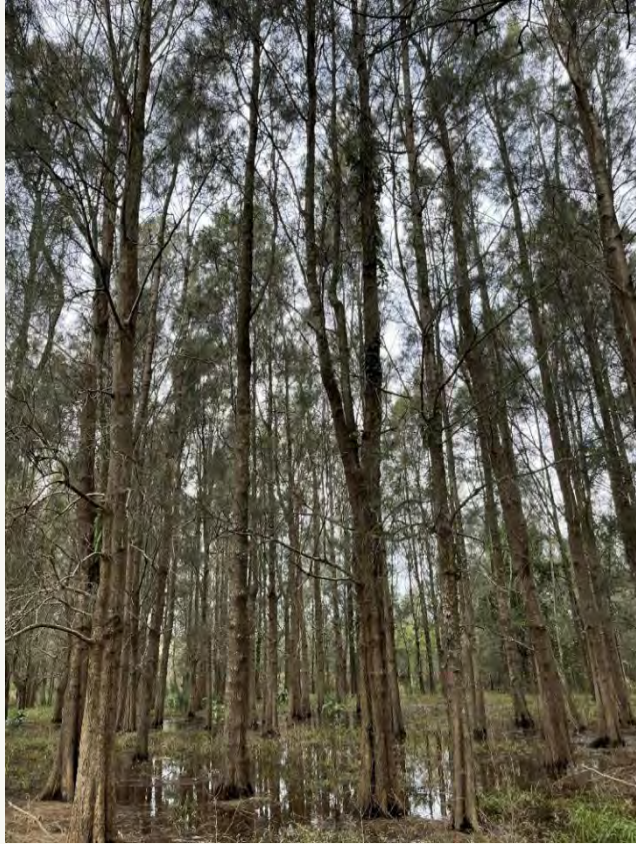
Zone	Location / description	Recommendations for ongoing works 2025/2026	Reference Images
Subzone 2D	Modified some time ago to a triangular area between subzones 2E and 2D. This area was originally sprayed and partly spread with timber mulch prior to plantings. This area is prone to water inundation during wetter months, limiting some access to areas.	<p>The centre of the zone appeared to exhibit good health with a wet underground, whereas the outskirts exhibited multiple weeds.</p> <p>Tobacco Bush (<i>Solanum mauritianum</i>) and Purpletop Vervain (<i>Verbena bonariensis</i>) were recorded throughout the outskirts of this zone - particularly on the western boundary near the access road. Paddy's Lucerne (<i>Sida rhombifolia</i>) was observed near the roadside.</p>

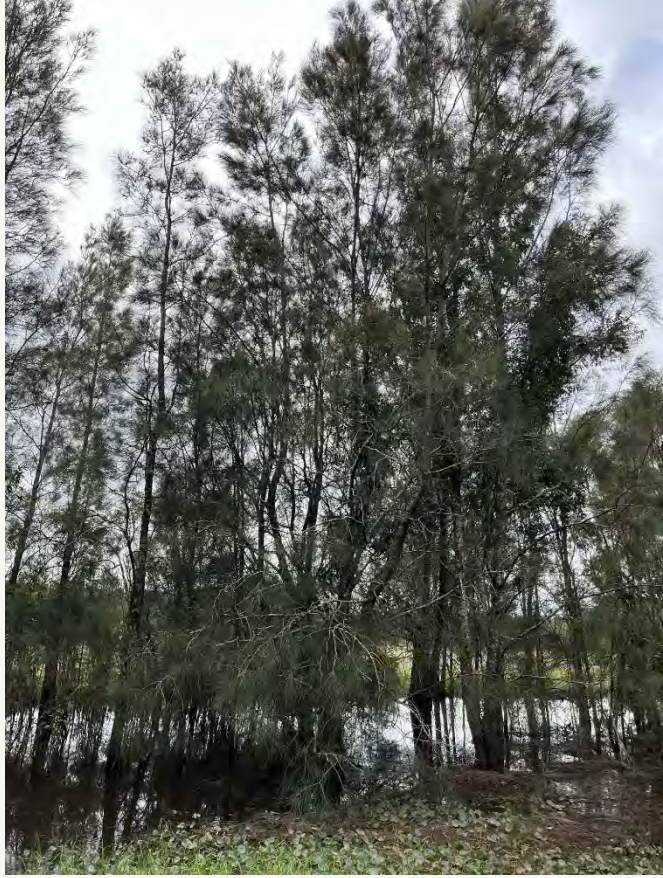
Zone	Location / description	Recommendations for ongoing works 2025/2026	Reference Images
Subzone 2E	Plantings in this area have become well established and tree growth continues to be progressing well. This narrow strip of trees extends into subzone 1.4, an established area of trees.	Despite being wet, this zone was accessible this year. Tall canopies of Swamp Oak (<i>Casuarina glauca</i>) were observed on the western boundary of the zone. Moth vine (<i>Araujia sericifera</i>) was recorded in multiple areas which will need to be managed and controlled when necessary.

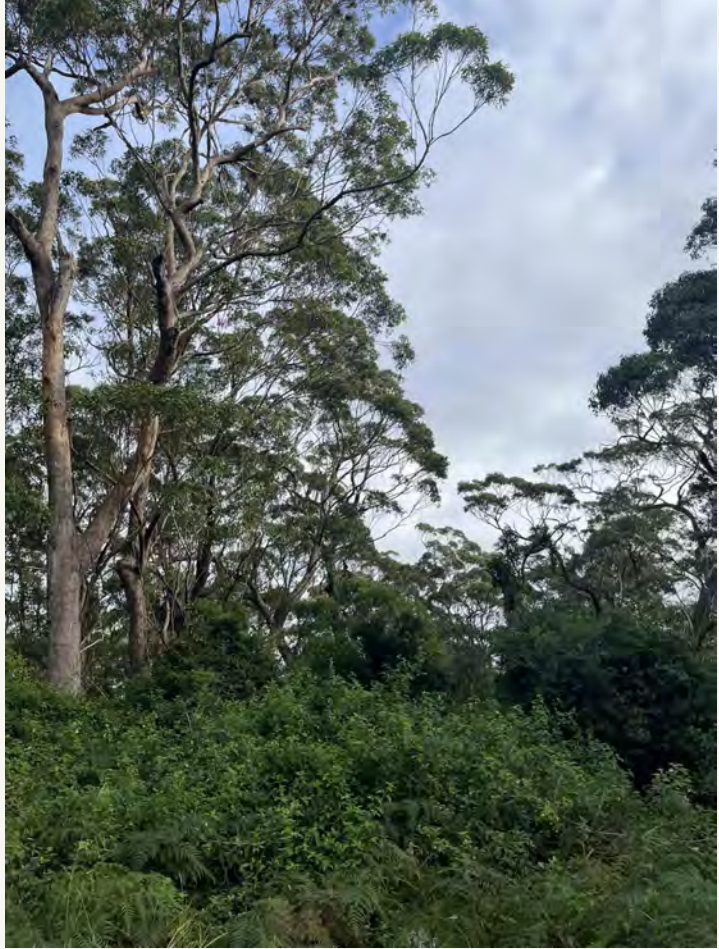
Zone	Location / description	Recommendations for ongoing works 2025/2026	Reference Images
Zone 4	<p>This zone is remnant Bangalay Sand Forest vegetation. This area has an intact Bangalay and Blackbutt canopy and is of high habitat value. Lantana has been heavily targeted in this zone and continued maintenance has been completed.</p>	<p>Small areas of Lantana (<i>Lantana camara</i>) were recorded, particularly on the boundary of the woodland. Pigeon Grass (<i>Setaria pumlia</i>), Fireweed (<i>Senecio madagascariensis</i>) and a couple of individual Tobacco Bush (<i>Solanum mauritianum</i>) plants were observed in areas near the roadside.</p> <p>Overall, the vegetation is of a high condition and the areas of Lantana (<i>Lantana camara</i>) should be closely monitored and managed via the cut and paint method to prevent further encroachment.</p>

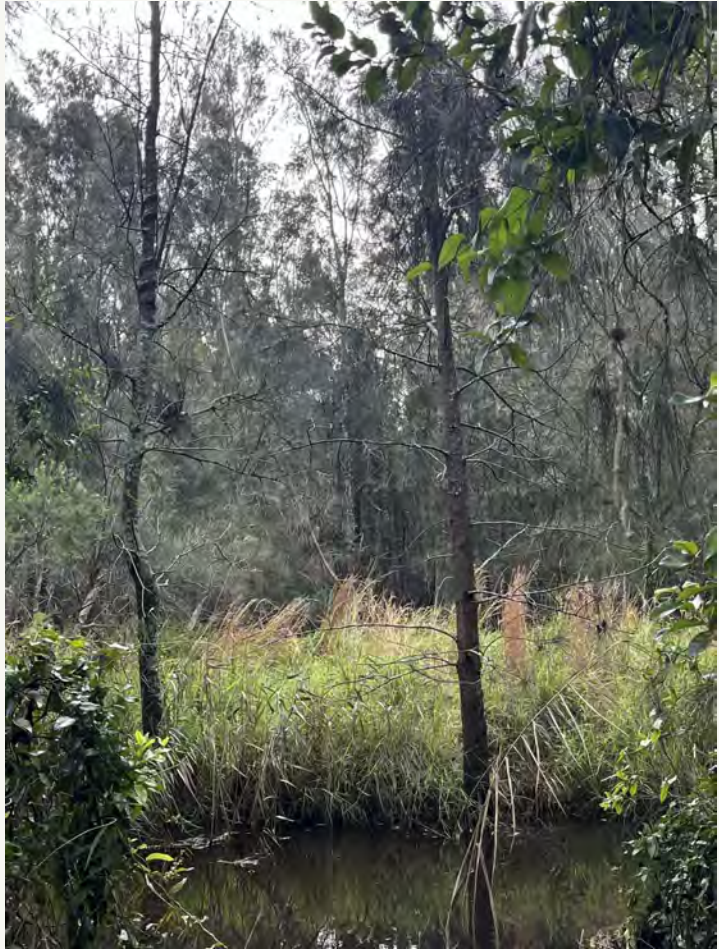
Zone	Location / description	Recommendations for ongoing works 2025/2026	Reference Images
Zone 5C.1	Occurs between the Swamp Oak Forest in zone 5 and the creek that has been planted. The area is dominated by Kikuyu Grass (<i>Cenchrus clandestinus</i>). The shrub <i>Melaleuca ericifolia</i> is continuing to expand from the creek-side.	This area is located across a creek which made it difficult to access. The photo taken in this area was from the other side of the creek and illustrates the presence of consistent ground layer species. Management considerations should remain consistent as per previous years' reports. Planting of native species such as Swamp Oak (<i>Casuarina glauca</i>) is recommended.

A photograph showing a swampy area with tall, dense grass (Kikuyu Grass) and several trees. The water is visible in the foreground, reflecting the surrounding vegetation. The trees appear to be Swamp Oaks (Casuarina glauca).

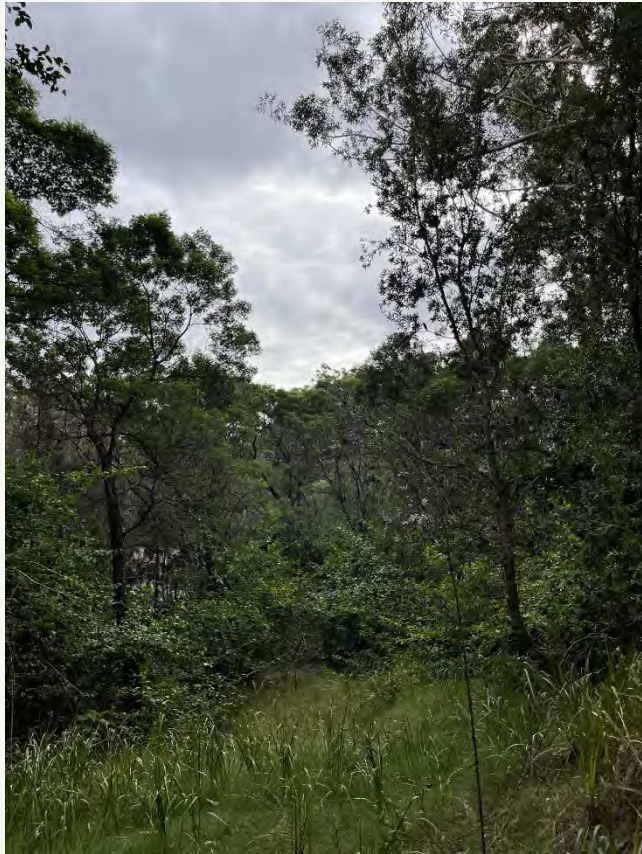
Zone	Location / description	Recommendations for ongoing works 2025/2026	Reference Images
Zone 7	<p>This zone occurs along the eastern edge of the Site between zones 3 and 1.2. This zone has cultural significance, therefore only minor control of Lantana (<i>Lantana camara</i>) has been conducted over time.</p>	<p>Lantana (<i>Lantana camara</i>) and Tobacco Bush (<i>Solanum mauritianum</i>) were again prominent, with thickets of Lantana (<i>Lantana camara</i>) found in several parts of the zone. Removal is encouraged by the cut and paint method to encourage natural regeneration of native flora.</p>

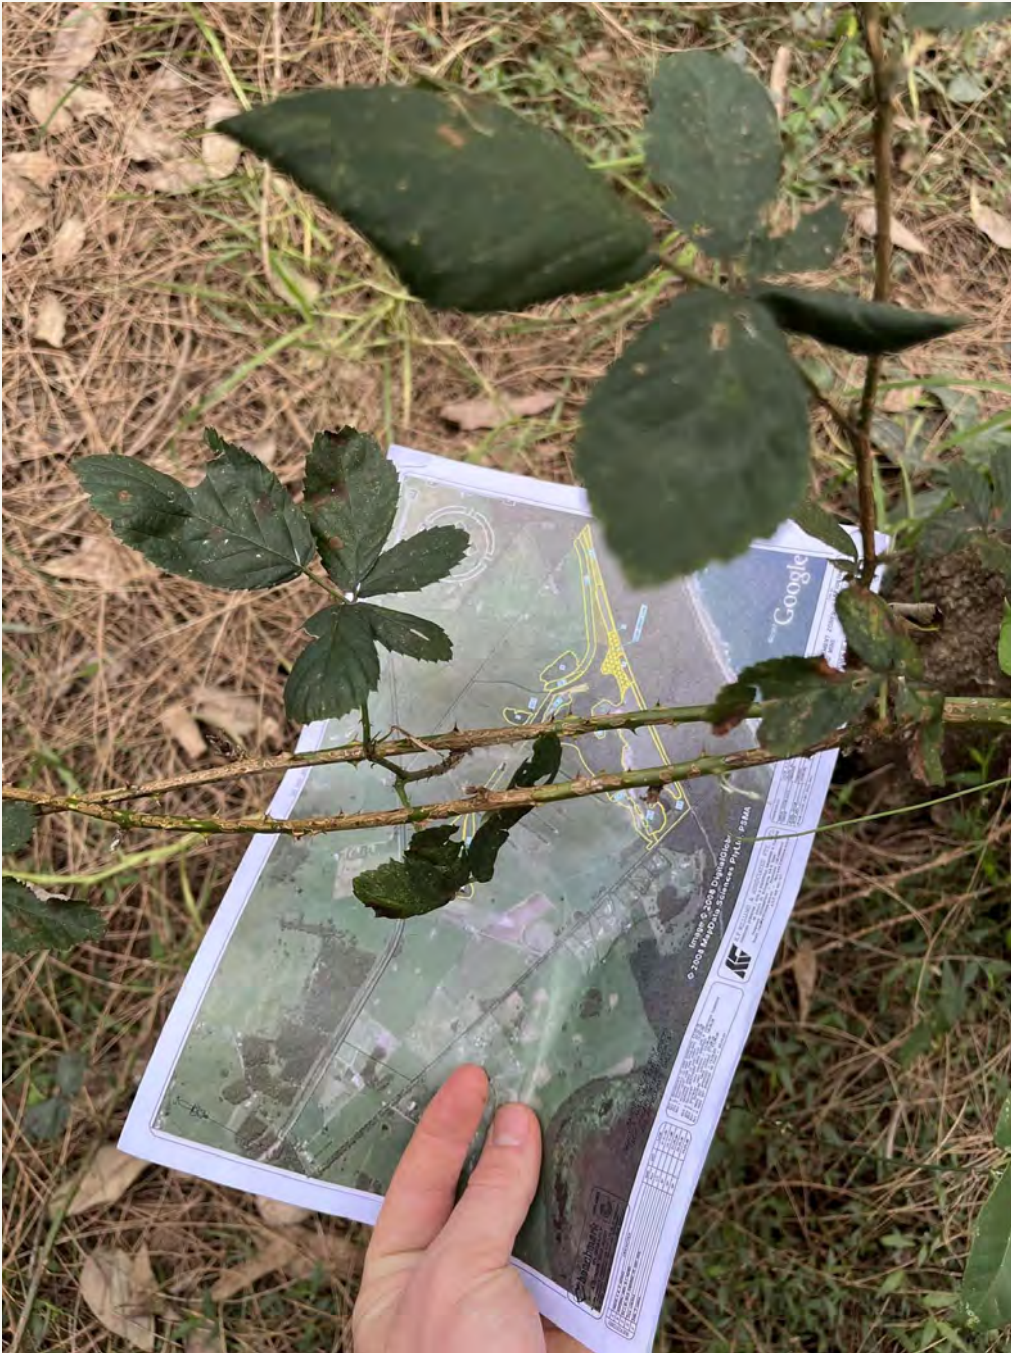
Plate 1: Blackberry Bush (*Rubus fruticosus* spp. *aggregate*) growing within Subzone 1.4

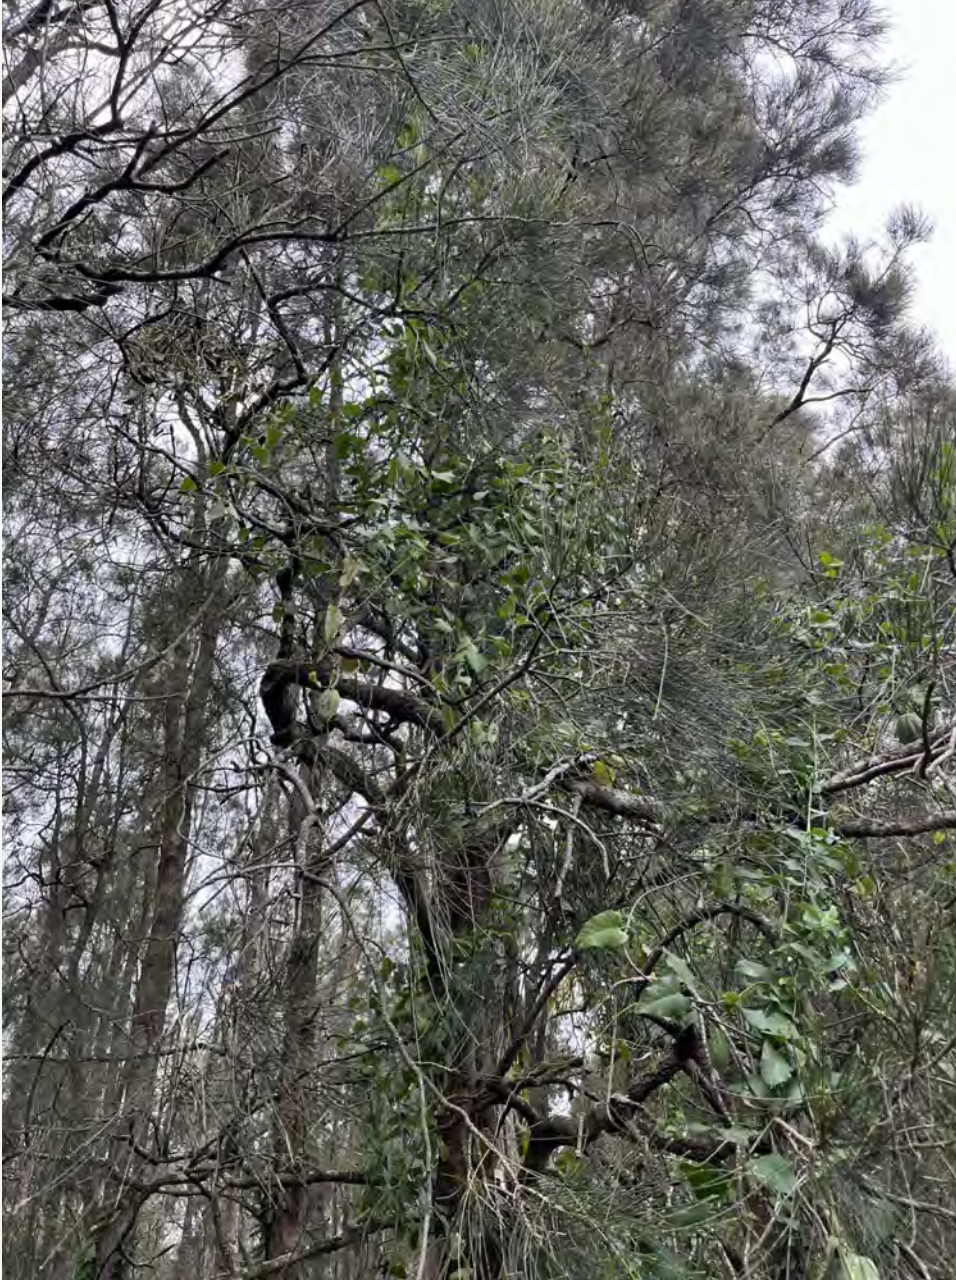
Plate 2: Moth Vine (*Araujia sericifera*) growing on a Swamp Oak (*Casuarina glauca*) tree, found within Subzone 1.4

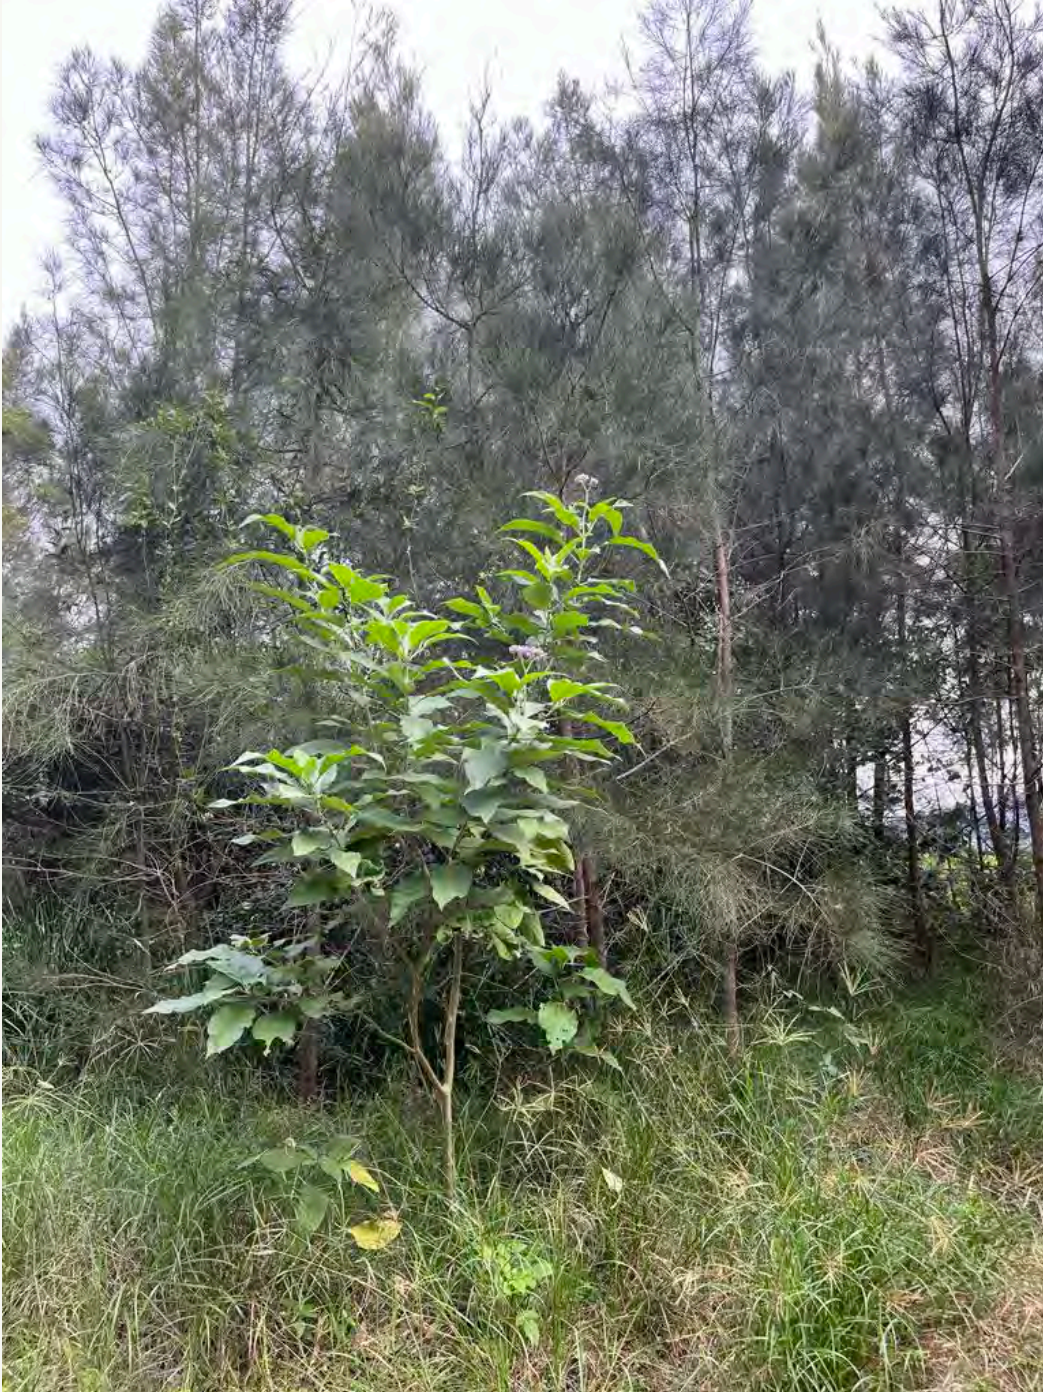
Plate 3: Wild Tobacco Bush (*Solanum mauritianum*) found within Subzone 2A.2

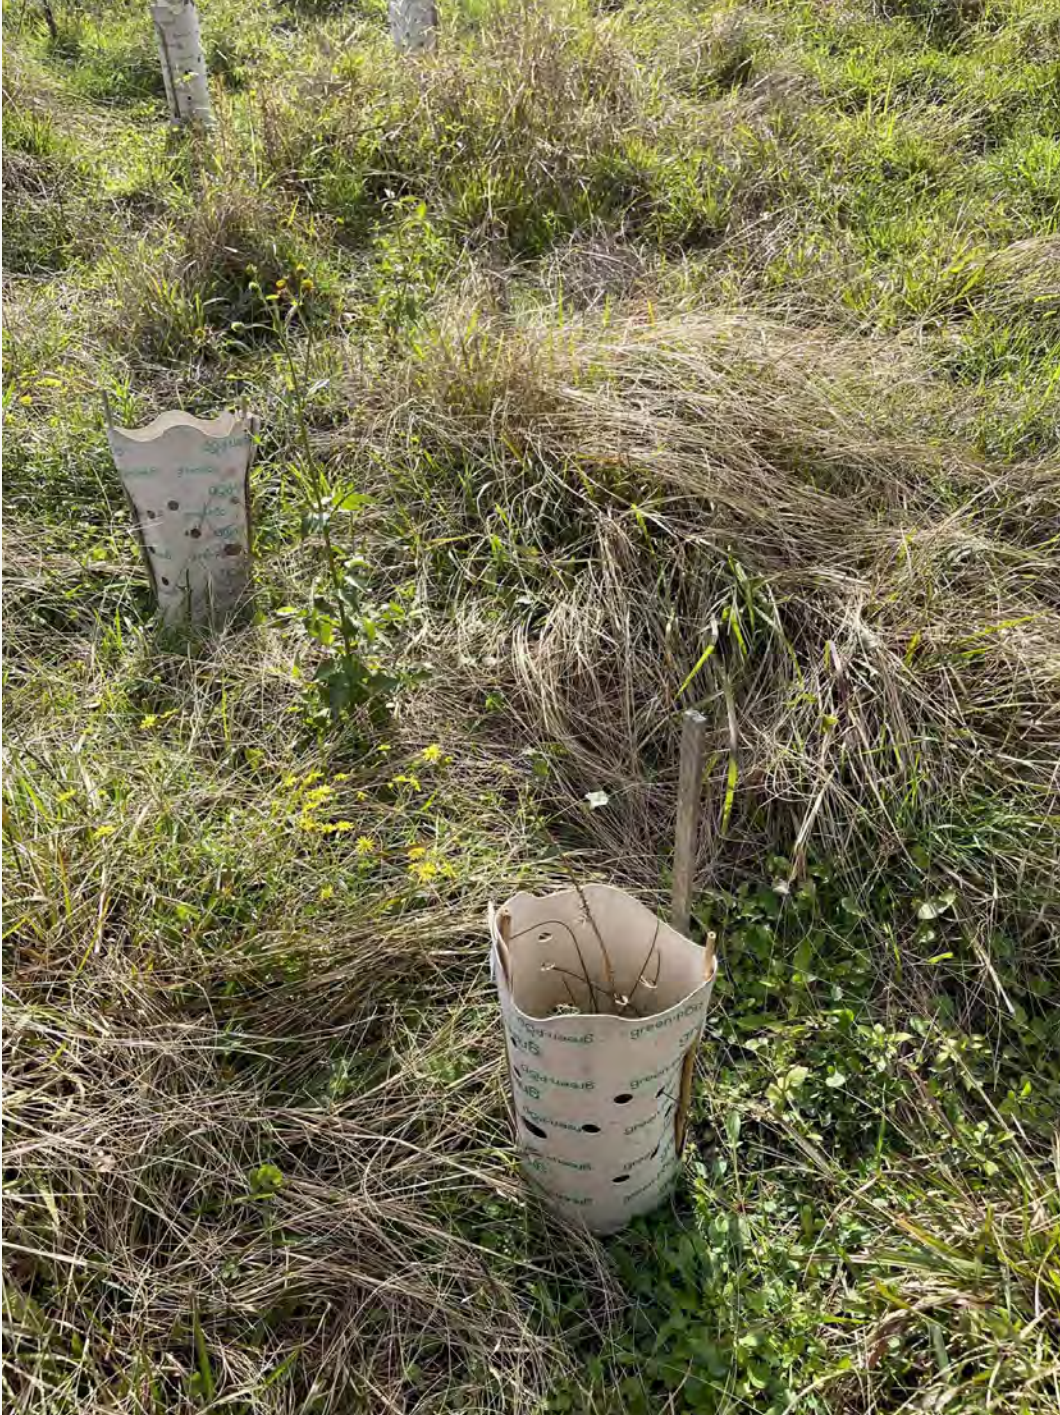
Plate 4: Swamp Oak (*Casuarina glauca*) planting that has been grazed, with the tree guard still in place, Subzone 2C.1

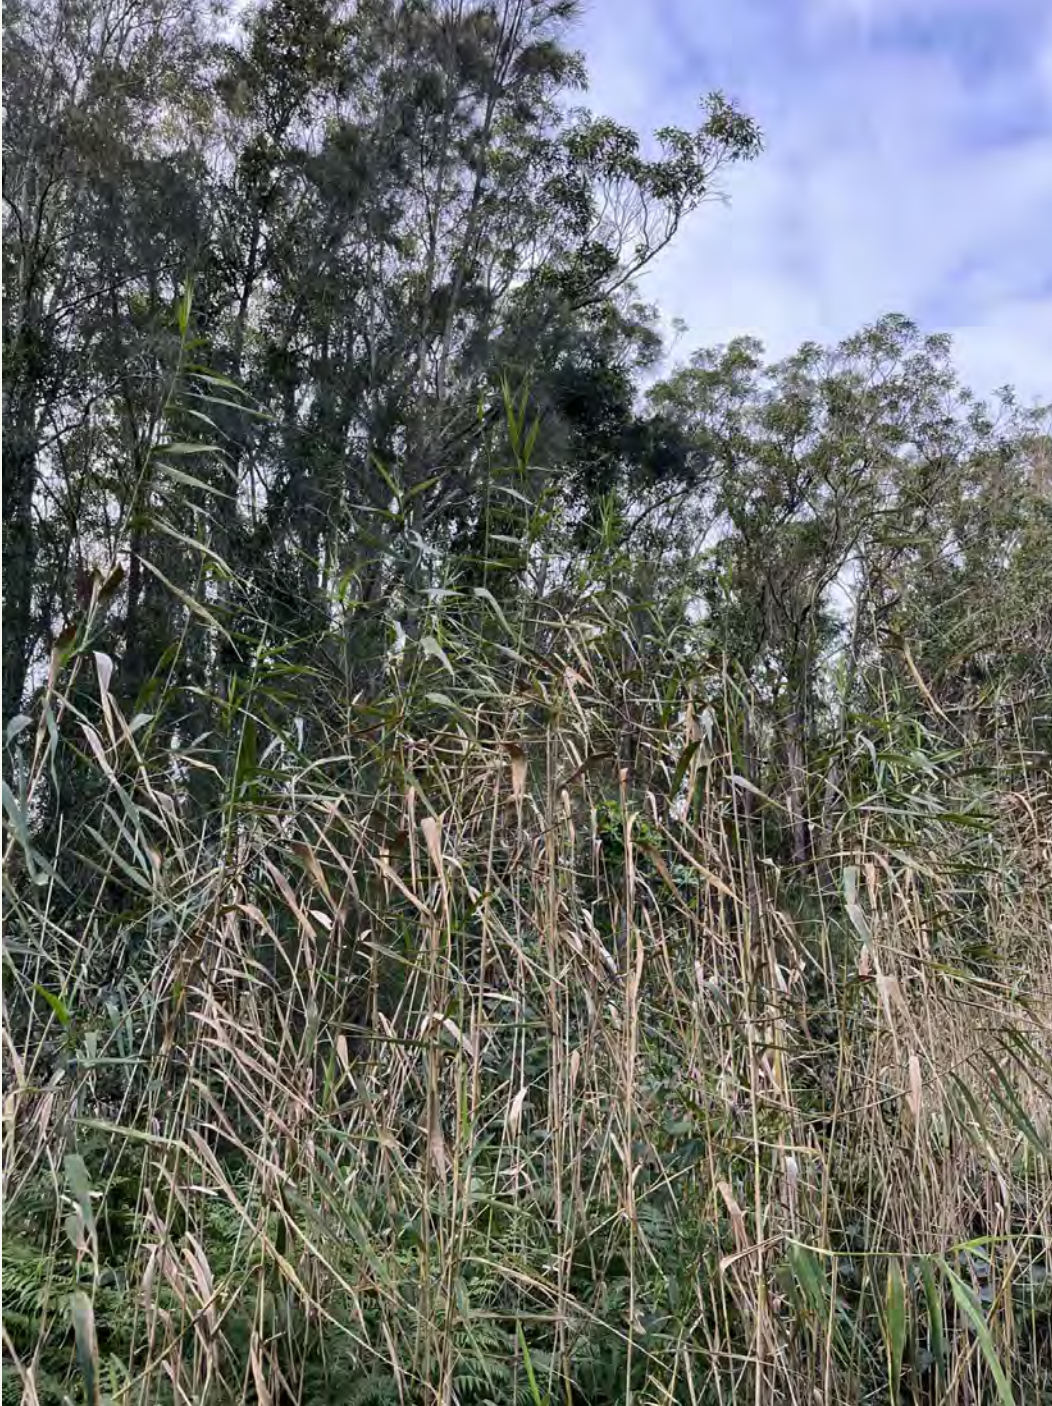
Plate 5: Giant Reed (*Arundo donax*) growing along the trackside within Zone 1.1 and 2C.1

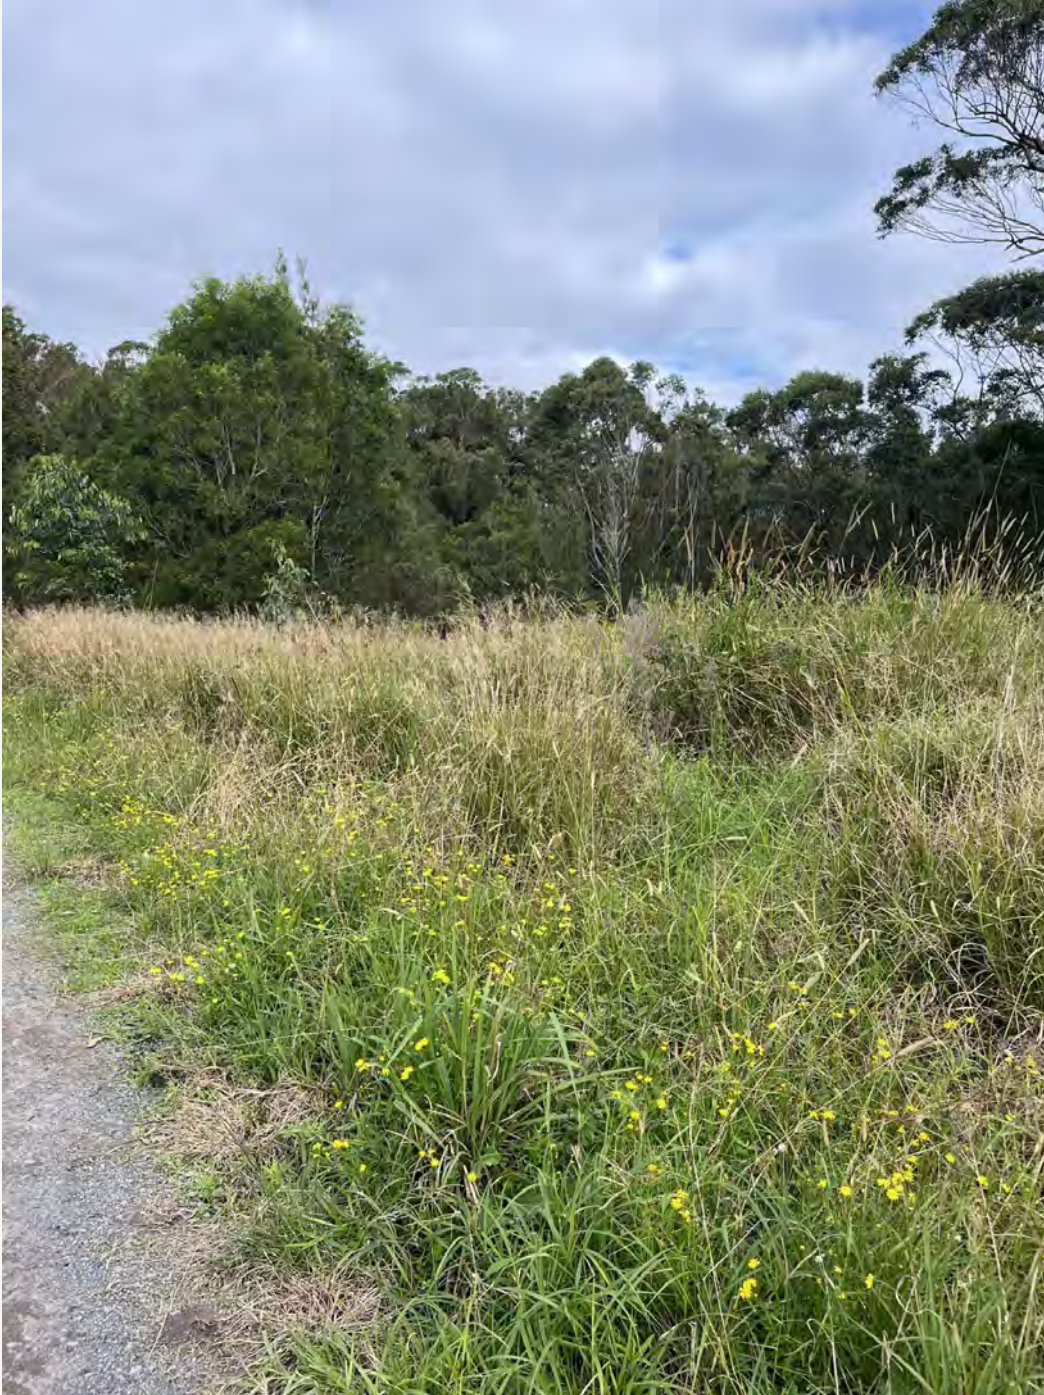
Plate 6: Fireweed (*Senecio madagascariensis*) growing along the roadside within Zone 4
