# **GERROA SAND RESOURCE**

## **ANNUAL REVIEW**

**Period 01 July 2025 – 30 June 2026**

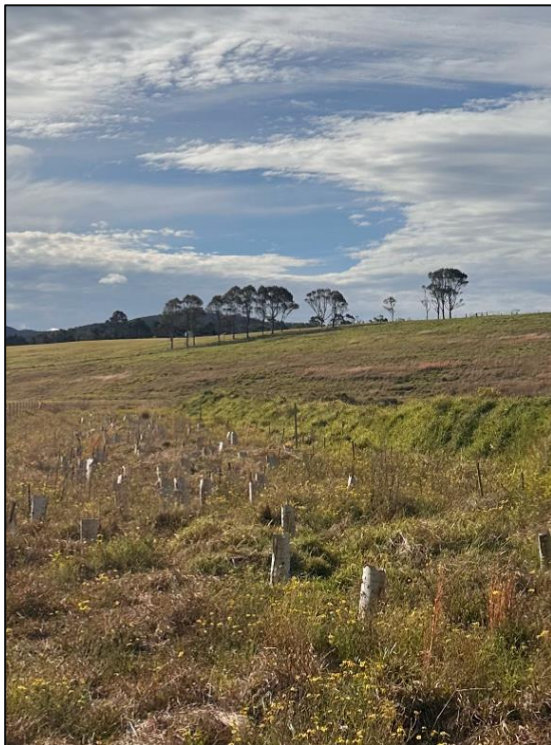
Figure 3: Western tree screen

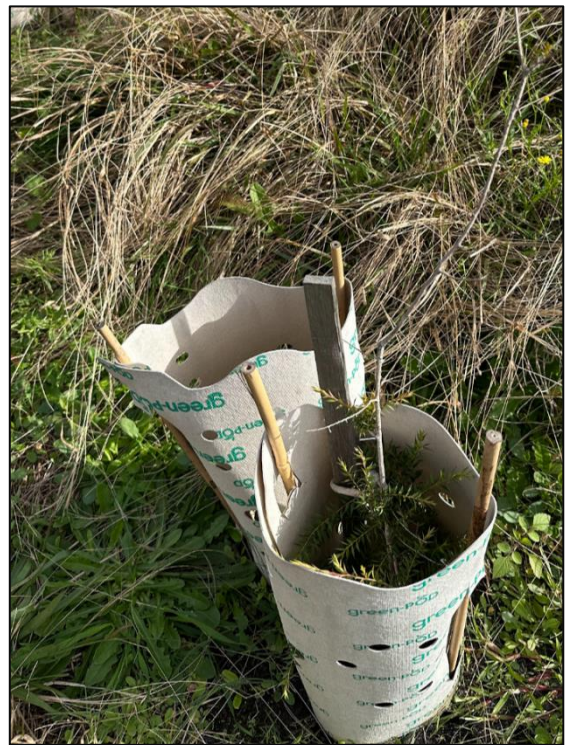
Figure 4: Tree protection

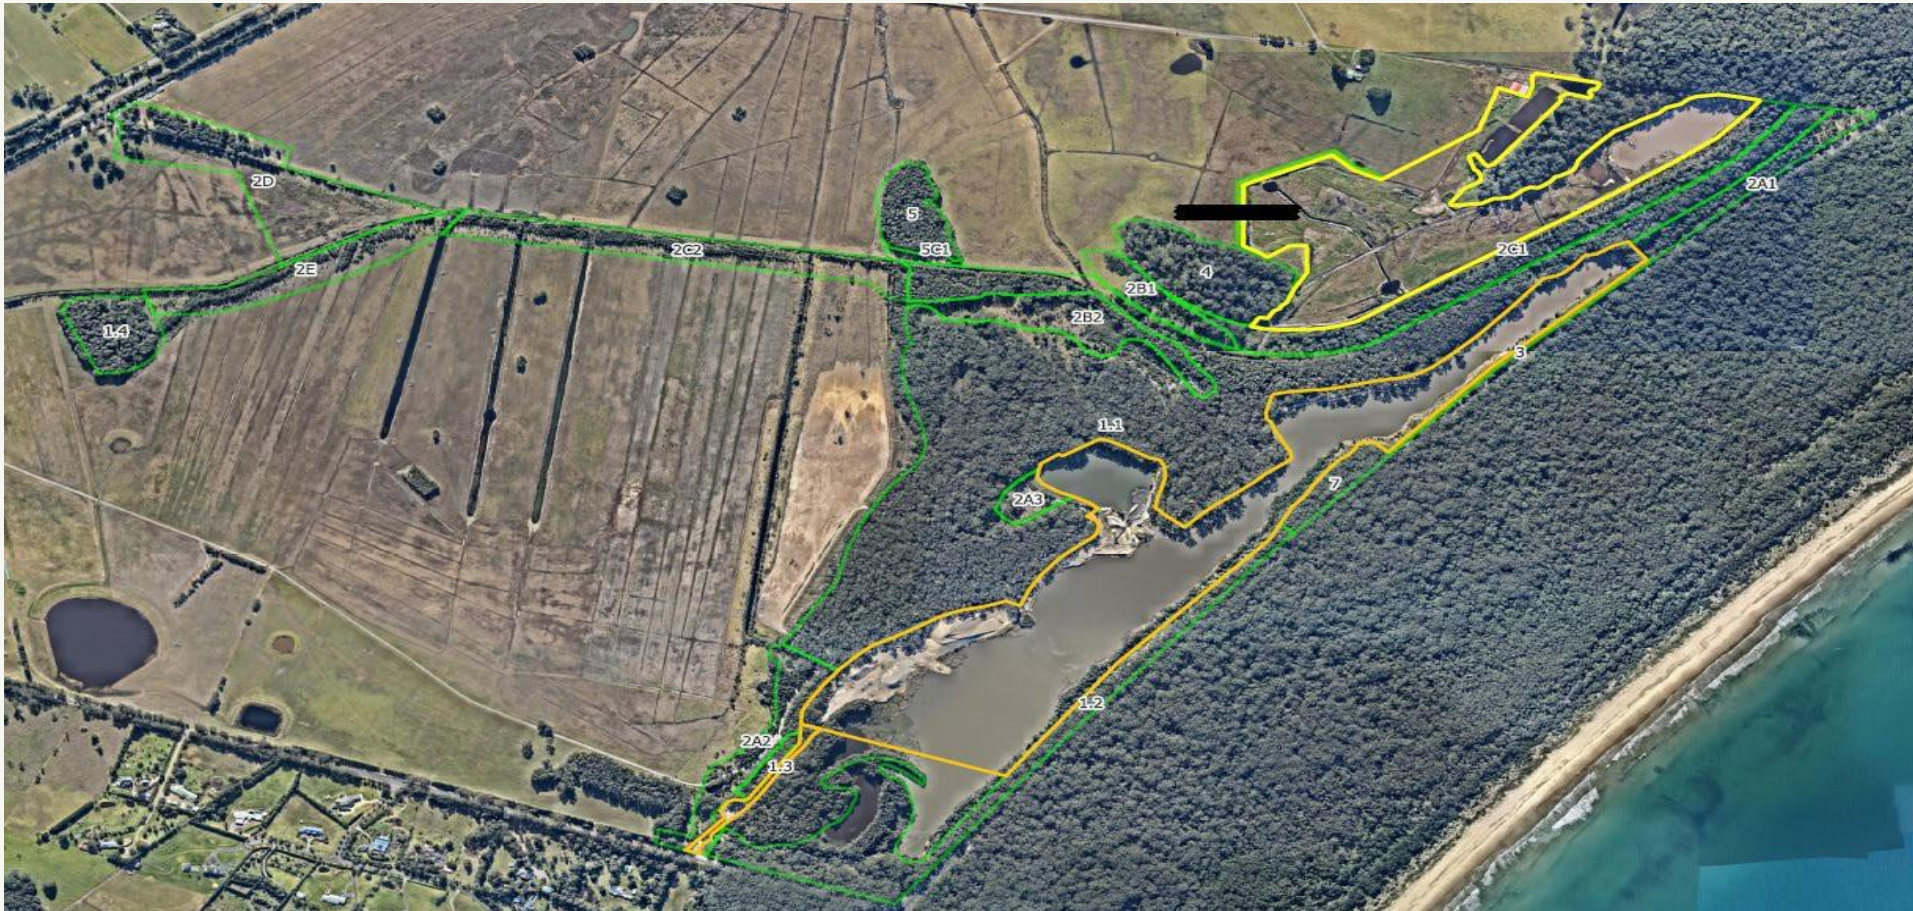
Figure 1: Map of Gerroa Sand Quarry Vegetation Management Zones

Niche was commissioned by Regional Quarries and Concrete Pty Ltd (t/a Cleary Bros) to complete the Gerroa Sand Quarry Annual Monitoring Report (the Project), located at the corner of Beach Road and Crooked River Road, Gerroa, New South Wales (NSW) (the Site). A map of Gerroa Sand Quarry Vegetation Management Zones is provided in Figure 1.

Most of the plantings were completed at each zone early in the monitoring program and are now in the maintenance phase. The most recent plantings have occurred in Subzone 2B.1, 2C.1, 2C.2 and 2D (see Figure 1) to expand the vegetation buffer along Blue Angle Creek, creating suitable habitat for local fauna. Focus needs to be on the southwestern end of Subzone 2C.1 (situated west of the access track), as these areas are experiencing grazing and most new plantings are struggling to grow (Plate 4). Vegetation in Subzone 2B.1, 2C.2 and 2D are well-established and are in the maintenance phase.

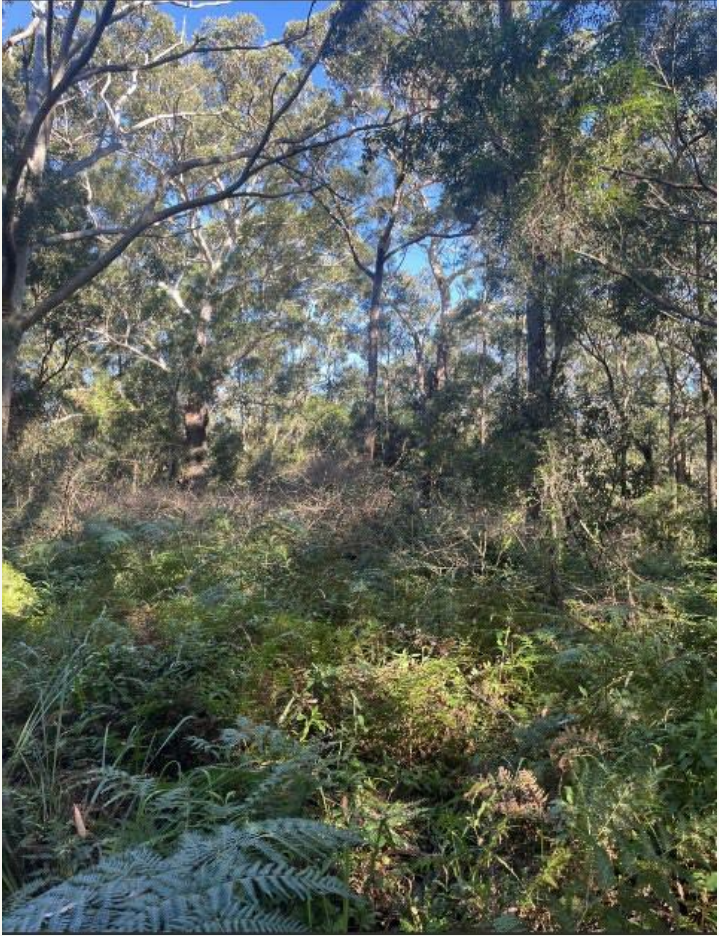
| Zone / Location | Observations | Recommendations for ongoing works 2026/2027 | Reference Images |
|---|---|---|---|
| <p>Subzone 1.1</p> <p>This is the main area of existing forest and largest coverage of vegetation of any subzone. It extends from the southern to the northern end of the property boundary.</p> | <p>Excellent condition.</p> <p>Dead stands of Lantana are present throughout.</p> <p>Tobacco Bush, Rhodes Grass, Fireweed and Cobbler's Pegs are mainly restricted to the roadside areas.</p> <p>Healthy canopy of <i>Eucalyptus botryoides</i> with well-developed midstory including <i>Acacia longifolia</i> and <i>Pittosporum spp.</i> Understorey consists predominantly of <i>Hypolepis muelleri</i> and <i>Lomandra longifolia</i>.</p> | <p>Requires minimal management intervention. Ongoing monitoring should continue to ensure the health and structural integrity of the native vegetation.</p> <p>Dead stand of Lantana should be monitored for regrowth and treated as required.</p> | |

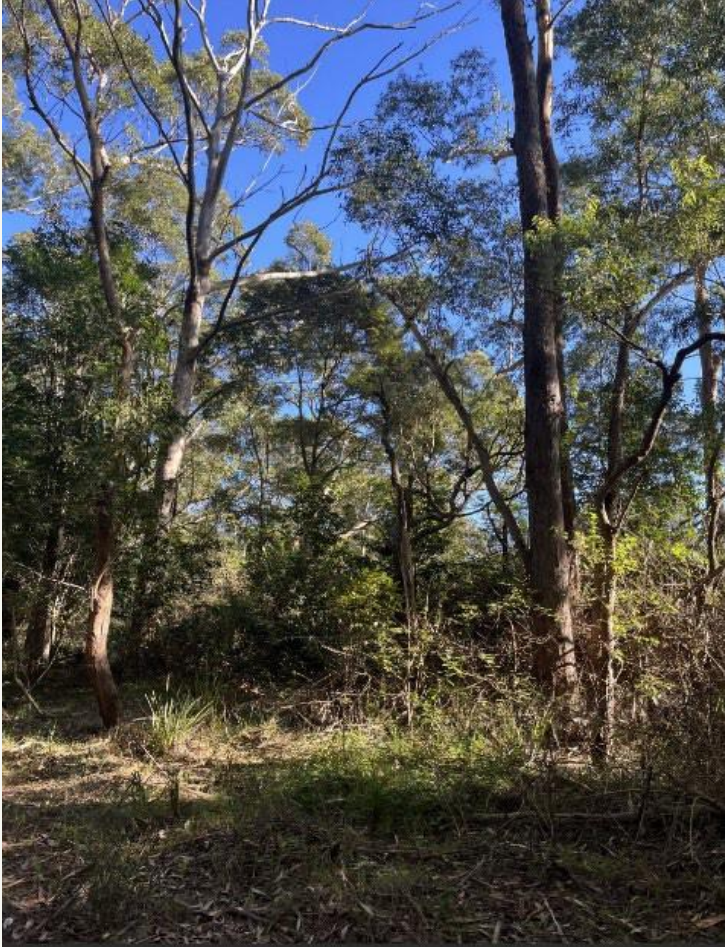
| Zone / Location | Observations | Recommendations for ongoing works 2026/2027 | Reference Images |
|---|---|---|---|
| <p>Subzone 1.2</p> <p>This subzone covers the forest around the eastern and southern sides of the old dredge pond.</p> | <p>Good condition.</p> <p>Dead stands of Lantana occur throughout.</p> <p>Rhodes Grass and Fireweed are prevalent near the roadside.</p> <p>Boundary fencing is flattened or damaged in several locations.</p> | <p>Dead stands of Lantana should be monitored for regrowth and treated as required.</p> <p>Manage roadside weeds and monitor for encroachment on native vegetation.</p> <p>Consider upgrading fence to prevent unauthorised access from roadside.</p> | |

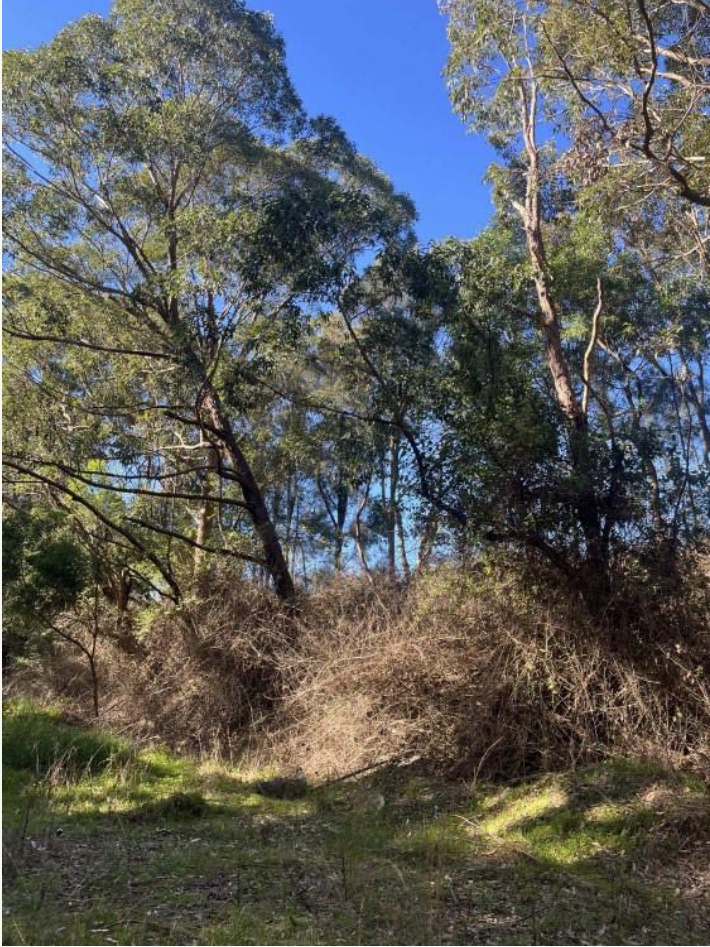
| Zone / Location | Observations | Recommendations for ongoing works 2026/2027 | Reference Images |
|---|---|---|---|
| <p>Subzone 1.3</p> <p>Covers the old bund wall. This subzone is located behind the site office and towards the front gate.</p> | <p>Good condition.</p> <p>Native vegetation well established.</p> <p>Most Lantana has been successfully managed.</p> <p>Moth Vine, Spear Thistle, Cobbler's Pegs and Fireweed are present – mostly along roadside.</p> | <p>Monitor stands of Lantana for regrowth.</p> <p>Continue targeted control of Moth Vine and other roadside weed species to improve vegetation condition.</p> | |

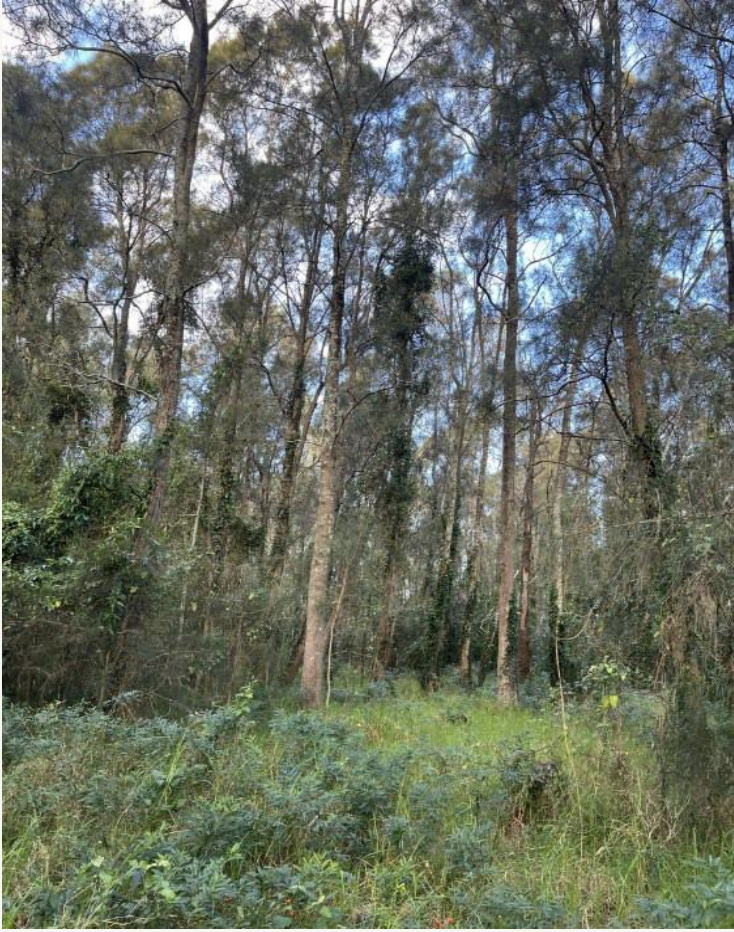
| Zone / Location | Observations | Recommendations for ongoing works 2026/2027 | Reference Images |
|---|---|---|---|
| <p>Subzone 1.4</p> <p>A fenced patch of Swamp Oak (<i>Casuarina glauca</i>) within grazing land. It is in the western most part of the Site and conjoins onto Subzone 2E.</p> | <p>Excellent condition.</p> <p>No Lantana and Blackberry recorded.</p> <p>Moth vine is present.</p> <p>Vegetation is well established and healthy.</p> | <p>Vegetation is well established and requires minimal intervention.</p> <p>Continue routine monitoring and undertake targeted control of Moth Vine where necessary to maintain the excellent condition of the subzone and prevent spread into adjoining rehabilitation areas.</p> | |

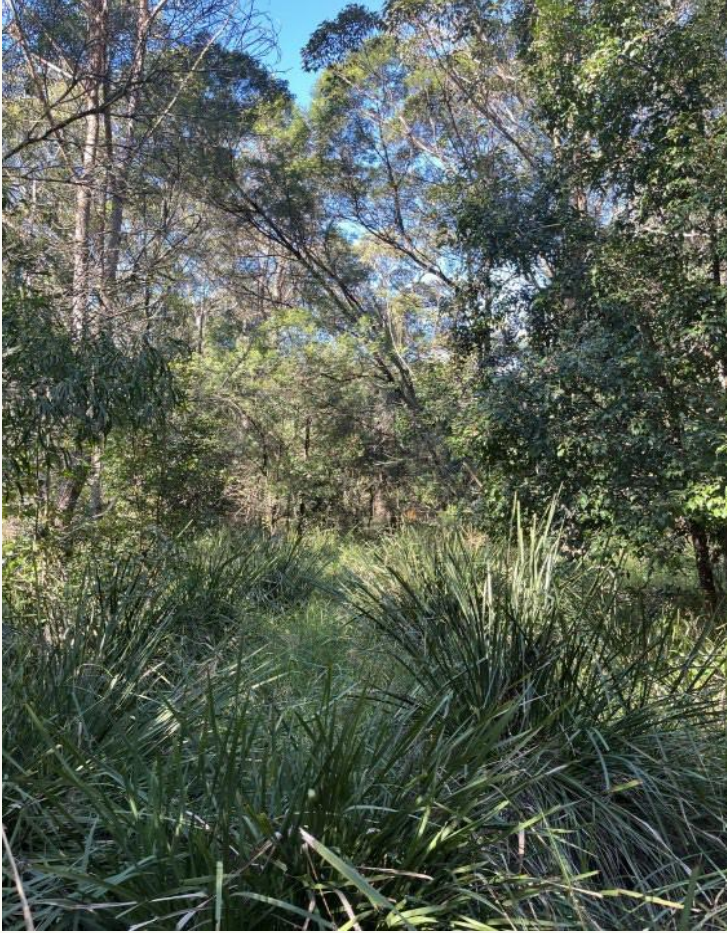
| Zone / Location | Observations | Recommendations for ongoing works 2026/2027 | Reference Images |
|---|---|---|---|
| <p>Subzone 2A.1</p> <p>This is the main area that has been used to develop the forested link in the northeast corner of the Site.</p> | <p>Northern portion is in excellent condition; southern portion in good condition.</p> <p>The northern area is largely weed free apart from Rhodes Grass. The southern area contains Moth Vine and patches of Cobbler's Pegs.</p> | <p>Continue targeted weed management within the southern portion of the subzone, focusing on Moth Vine and Cobbler's Pegs.</p> <p>Monitor the developing forest corridor to ensure ongoing vegetation establishment and connectivity between adjoining habitat areas.</p> <p>Maintain the northern section through routine inspections and weed management as required.</p> | |

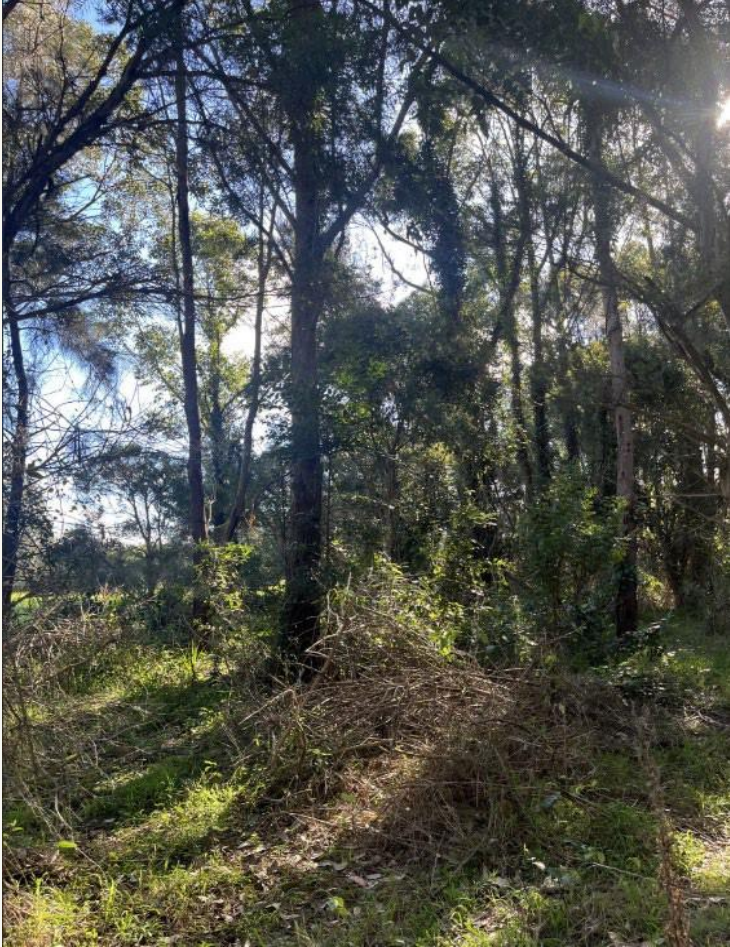
| Zone / Location | Observations | Recommendations for ongoing works 2026/2027 | Reference Images |
|---|---|---|---|
| <p>Subzone 2A.2</p> <p>This area is important for the forest link to the south and into Seven Mile Beach National Park on the southern side of Beach Road.</p> | <p>Moderate condition.</p> <p>Most Lantana has been successfully treated.</p> <p>Rhodes Grass and Moth Vine dominate the weed layer, with Tobacco Bush, Fireweed and Cobbler's Pegs present.</p> <p>Native canopy and shrub layers are established.</p> | <p>This subzone should remain a priority for weed management.</p> <p>Targeted control of Rhodes Grass, Moth Vine and Tobacco Bush is recommended to reduce competition with native vegetation and improve habitat connectivity.</p> <p>Continue monitoring treated Lantana infestations and encourage natural regeneration within canopy gaps.</p> | |

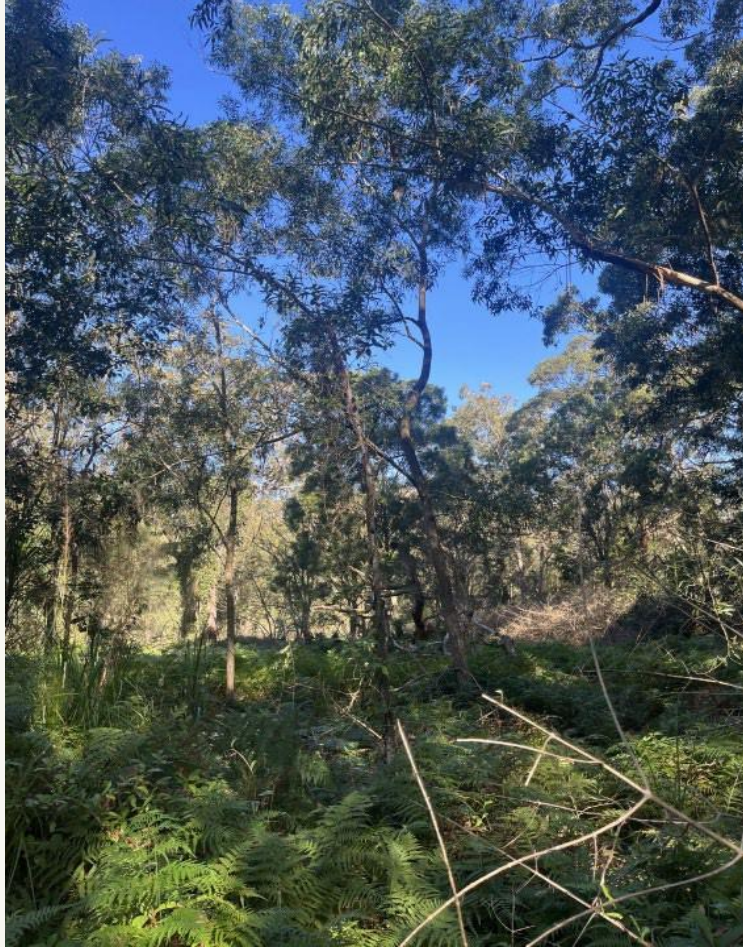
| Zone / Location | Observations | Recommendations for ongoing works 2026/2027 | Reference Images |
|---|---|---|---|
| <p>Subzone 2A.3</p> <p>This area is located south of the dredge pond and is encompassed by Subzone 1.1 and a road.</p> | <p>Good condition.</p> <p>Roadside weeds include Cobbler's Pegs and Spear Thistle.</p> <p>All Lantana observed was dead.</p> <p>Healthy native understory regeneration is occurring.</p> | <p>Continue routine roadside weed control to prevent further spread into rehabilitated areas.</p> <p>Monitor natural regeneration and undertake maintenance only where necessary to support the continued development of native vegetation.</p> | |

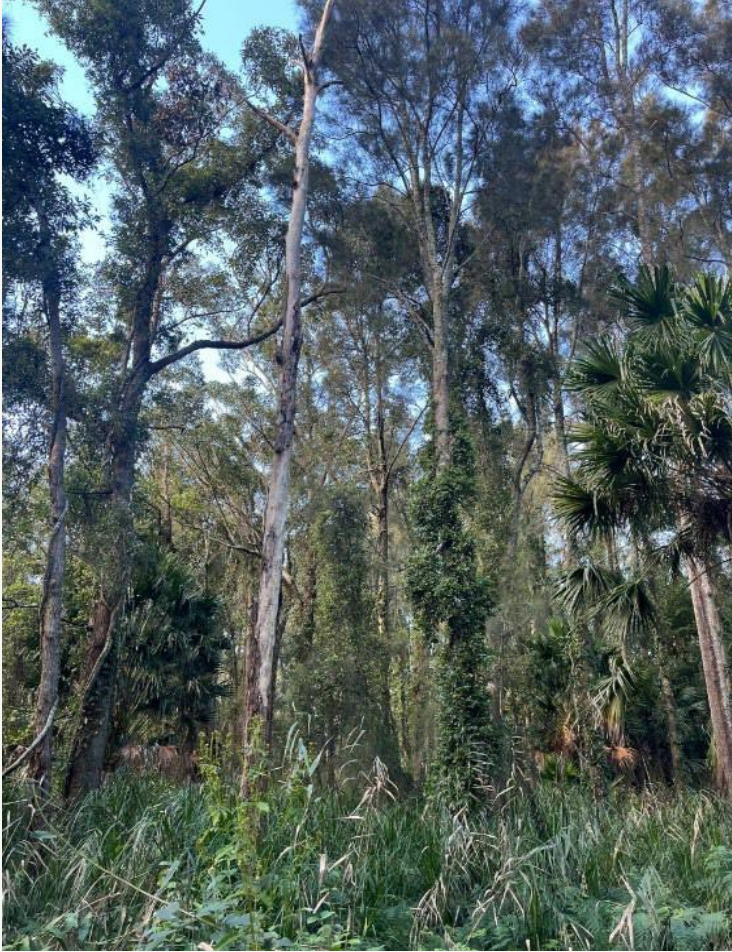
| Zone / Location | Observations | Recommendations for ongoing works 2026/2027 | Reference Images |
|---|---|---|---|
| <p>Subzone 2B.2</p> <p>This subzone is located north of the main area of Subzone 1.1 and there is a low-lying swamp present.</p> | <p>Good condition.</p> <p>Most Lantana has been successfully treated.</p> <p>Moth Vine and Giant Reed occur in wetter areas.</p> <p>Healthy Swamp Oak-dominated vegetation is present.</p> | <p>Continue targeted weed management within wetter areas, focusing on Moth Vine and Giant Reed infestations.</p> <p>Monitor the health and expansion of the Swamp Oak community and undertake maintenance as required to ensure weed species do not become dominant.</p> | |

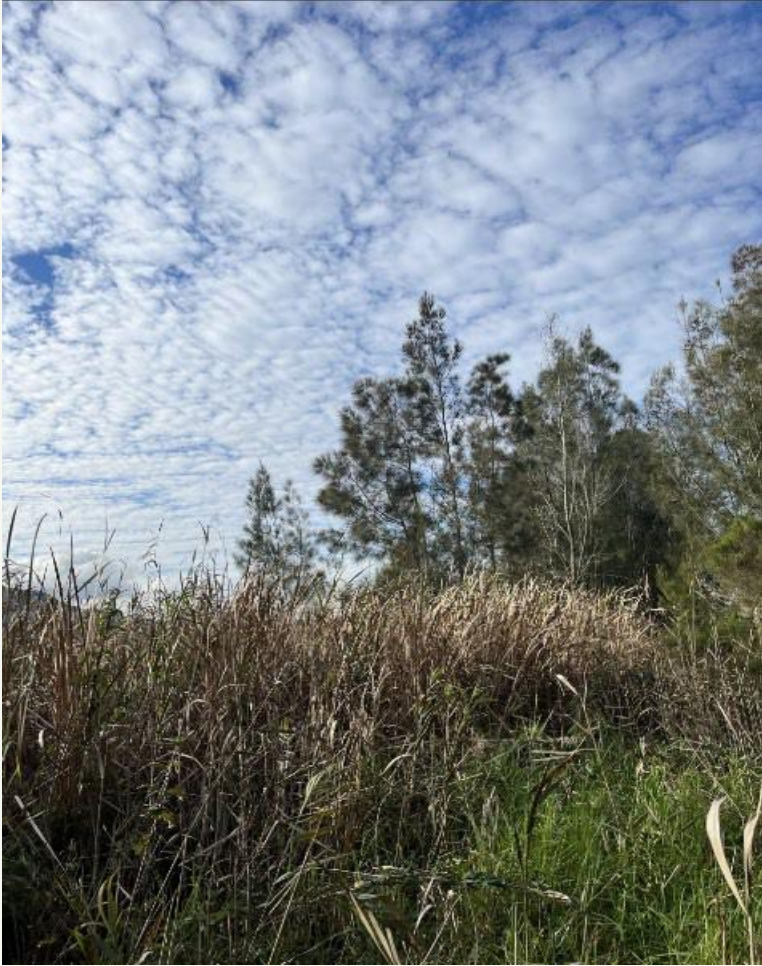
| Zone / Location | Observations | Recommendations for ongoing works 2026/2027 | Reference Images |
|---|---|---|---|
| <p>Subzone 2C.2</p> <p>A long narrow area supporting some well-established plantings.</p> | <p>Only the eastern and western boundary were accessible due to creek lines.</p> <p>Accessible areas are in good condition with extensive Swamp Oak stands.</p> <p>Giant Reed occurs along the creek lines.</p> | <p>Continue monitoring of Swamp Oak stands where and when access permits.</p> <p>Undertake targeted control of Giant Reed.</p> | |

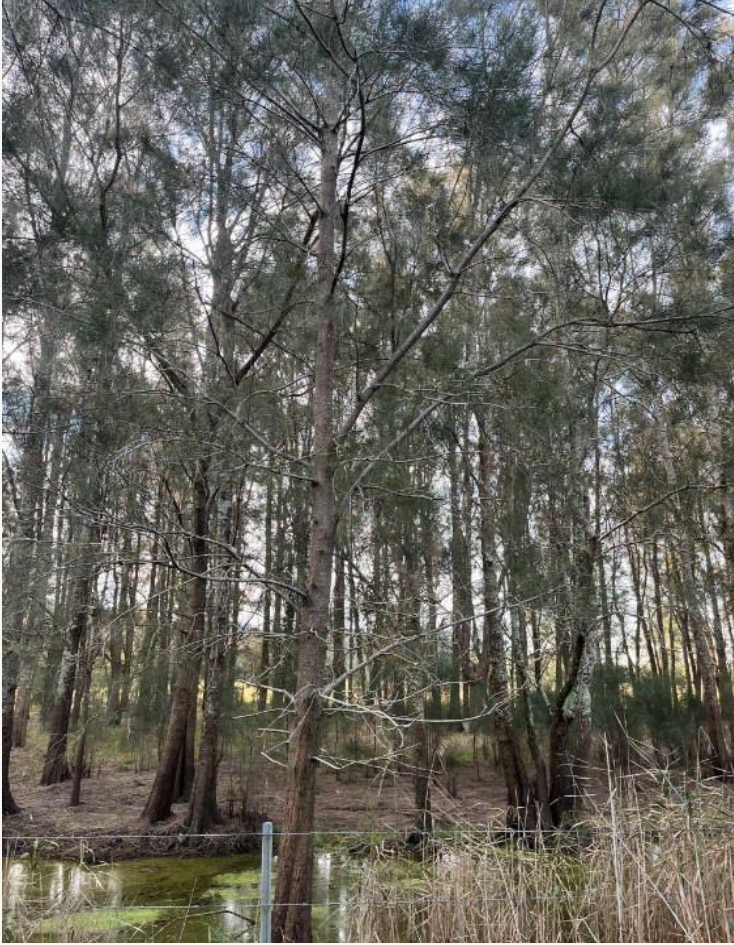
| Zone / Location | Observations | Recommendations for ongoing works 2026/2027 | Reference Images |
|---|---|---|---|
| <p>Subzone 2D</p> <p>Located west of Subzone 2C.1 and north of Subzone 2E and 1.4. This area is prone to water inundation during wetter months, limiting access to some areas.</p> | <p>Moderate condition.</p> <p>Older plantings (<i>Leptospermum spp.</i>, <i>Casuarina spp.</i>) are thriving.</p> <p>Weed abundance is greatest along roads, fences and creek lines.</p> <p>Tobacco Bush, Purpletop and Paddy's Lucerne were recorded.</p> | <p>Continue targeted weed control along disturbed boundaries and access tracks.</p> <p>Monitor the performance of established plantings and maintain as required.</p> | |

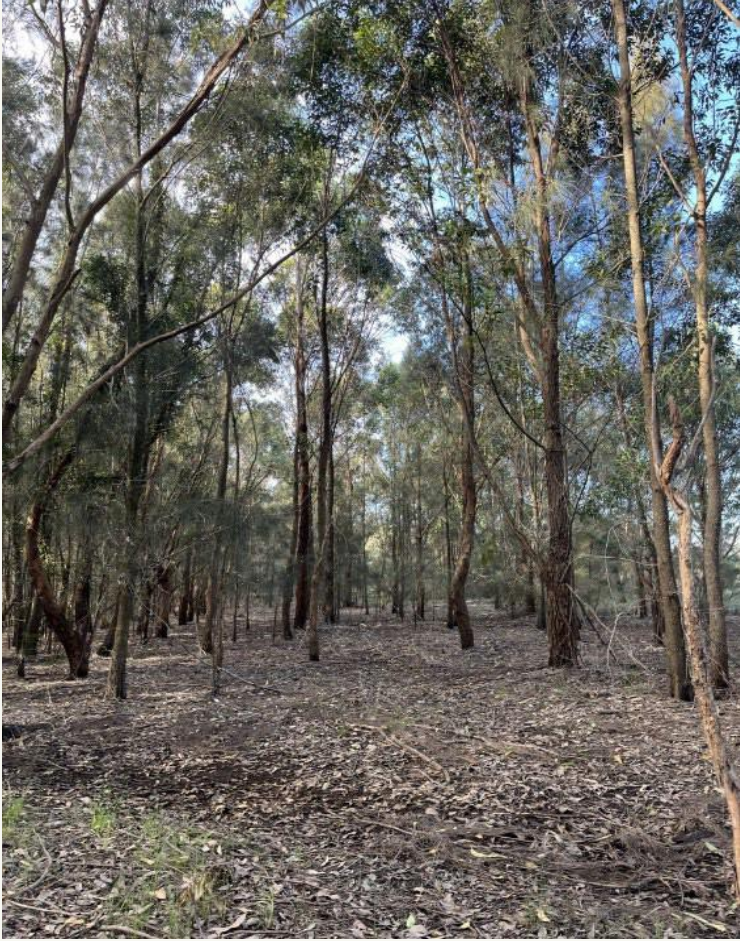
| Zone / Location | Observations | Recommendations for ongoing works 2026/2027 | Reference Images |
|---|---|---|---|
| <p>Subzone 2E</p> <p>This narrow strip of trees extends into Subzone 1.4, an established area of trees.</p> | <p>Mostly good condition, although the southeastern end is in poor condition (Plate 9).</p> <p>Native canopy is well established.</p> <p>Moth Vine is widespread. Fireweed, Cobbler's Pegs and Wild Tobacco occur in open areas.</p> | <p>Prioritise weed control within the southeastern end to encourage further native vegetation establishment.</p> <p>Continue monitoring of Moth Vine and any other priority weeds.</p> | |

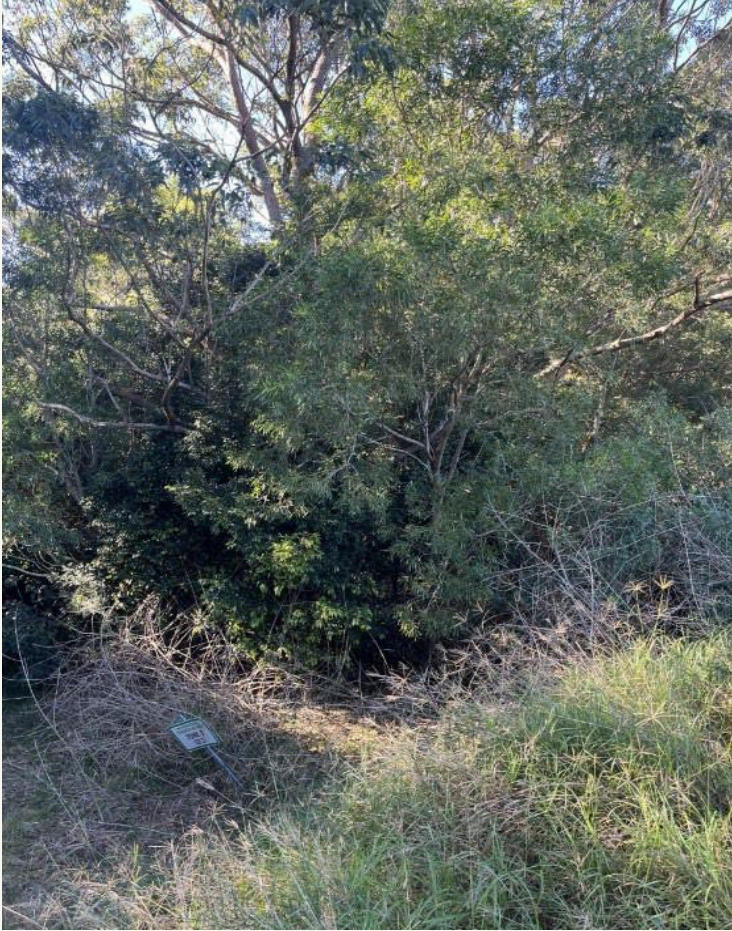
| Zone / Location | Observations | Recommendations for ongoing works 2026/2027 | Reference Images |
|---|---|---|---|
| <p>Zone 3</p> <p>This zone includes the bund wall which reached its final height early in 2015.</p> | <p>Moderate to poor condition.</p> <p>Although some dead Lantana was observed, it remains extensive throughout the zone. Rhodes Grass, Giant Reed and Fireweed are also common, more so to the southern end.</p> <p>Vegetation assists in stabilising the bund wall.</p> | <p>Continue targeted Lantana control while minimising disturbance to bund wall stability.</p> <p>Consider supplementary native planting where weed removal creates large gaps.</p> | |

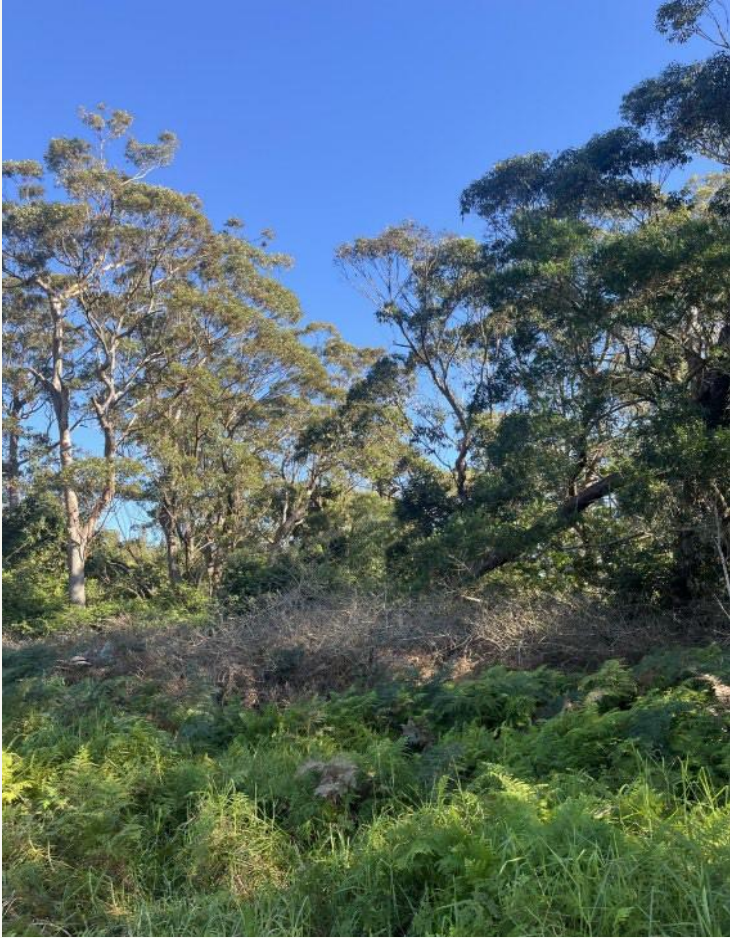
| Zone / Location | Observations | Recommendations for ongoing works 2026/2027 | Reference Images |
|---|---|---|---|
| <p>Zone 4</p> <p>This zone is remnant Bangalay Sand Forest vegetation.</p> | <p>Excellent condition.</p> <p>Healthy multi-layered native vegetation community.</p> <p>Most Lantana has been successfully controlled.</p> <p>Minor roadside weeds remain present.</p> | <p>Continue routine monitoring and maintenance of treated Lantana infestations.</p> <p>Undertake roadside weed control as required.</p> | |

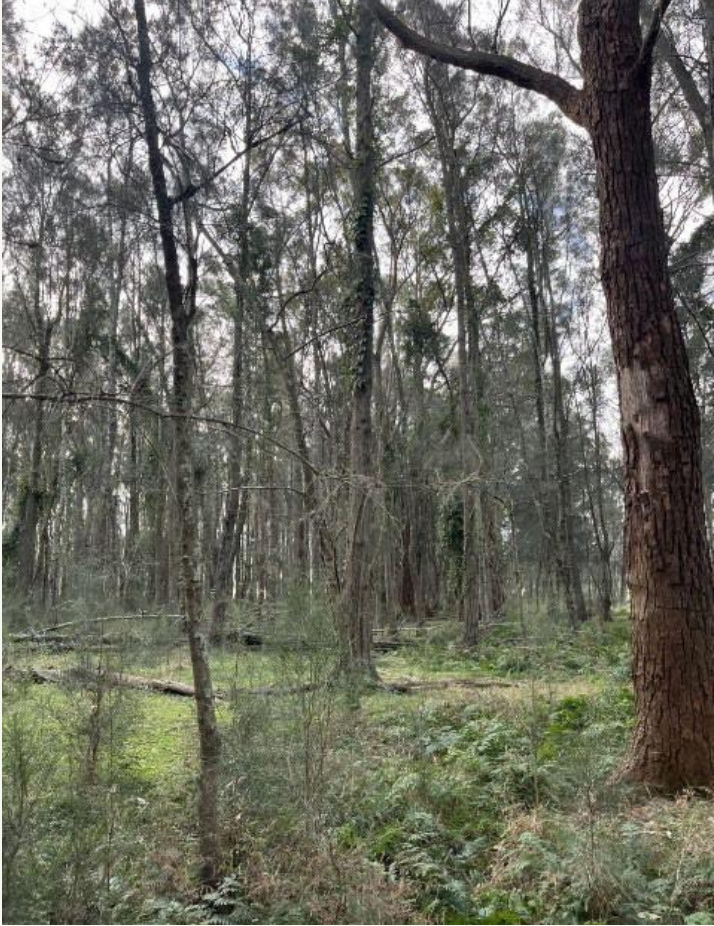
| Zone / Location | Observations | Recommendations for ongoing works 2026/2027 | Reference Images |
|---|---|---|---|
| <p>Zone 5</p> <p>This zone is located north of the main creek, mostly surrounded by grazing paddocks. It is difficult to drive/walk to due to fence and creek lines.</p> | <p>Excellent condition.</p> <p>Open understorey with healthy Swamp Oak and Bangalay canopy.</p> <p>Moth Vine present.</p> | <p>Minimal management required.</p> <p>Continue monitoring for Moth Vine and undertake weed control if infestations expand.</p> | |

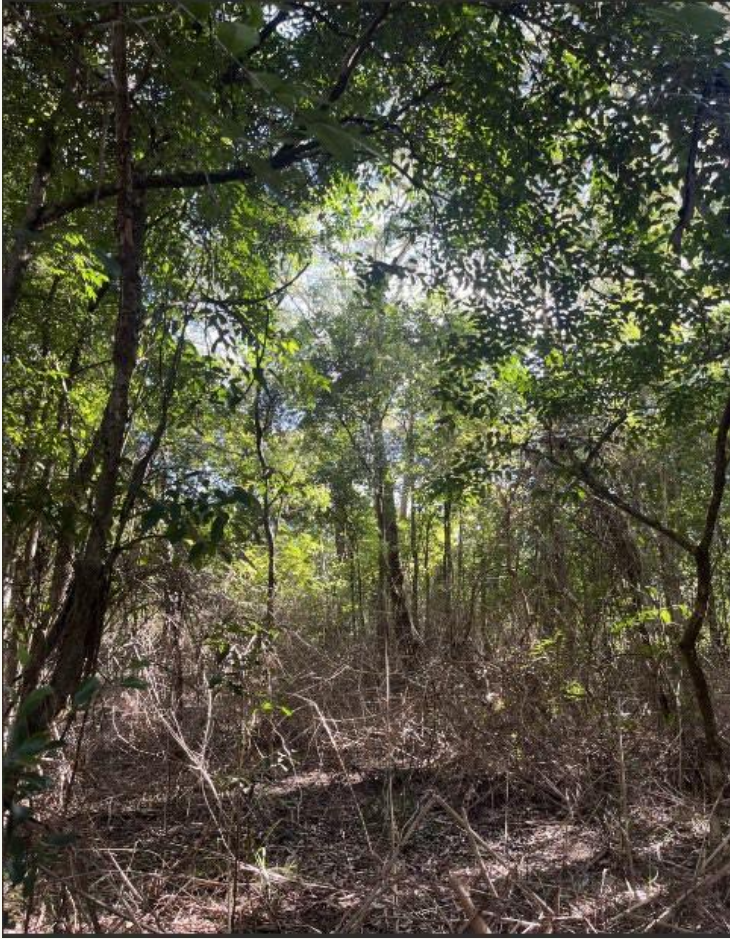
| Zone / Location | Observations | Recommendations for ongoing works 2026/2027 | Reference Images |
|---|---|---|---|
| <p>Zone 7</p> <p>This zone occurs along the eastern edge of the Site between zones 3 and 1.2. This zone has cultural significance; therefore, only minor control of Lantana has been conducted over time.</p> | <p>Moderate condition.</p> <p>Fence adjacent to the road is damaged.</p> <p>Most Lantana has been treated successfully.</p> <p>Fireweed, Spear Thistle and Moth Vine remain present.</p> | <p>Continue monitoring treated Lantana areas for regrowth and treat as required.</p> <p>Undertake control of roadside weeds and Moth Vine as required.</p> <p>Consider repairing damaged fencing to prevent unauthorised access from roadside.</p> | |

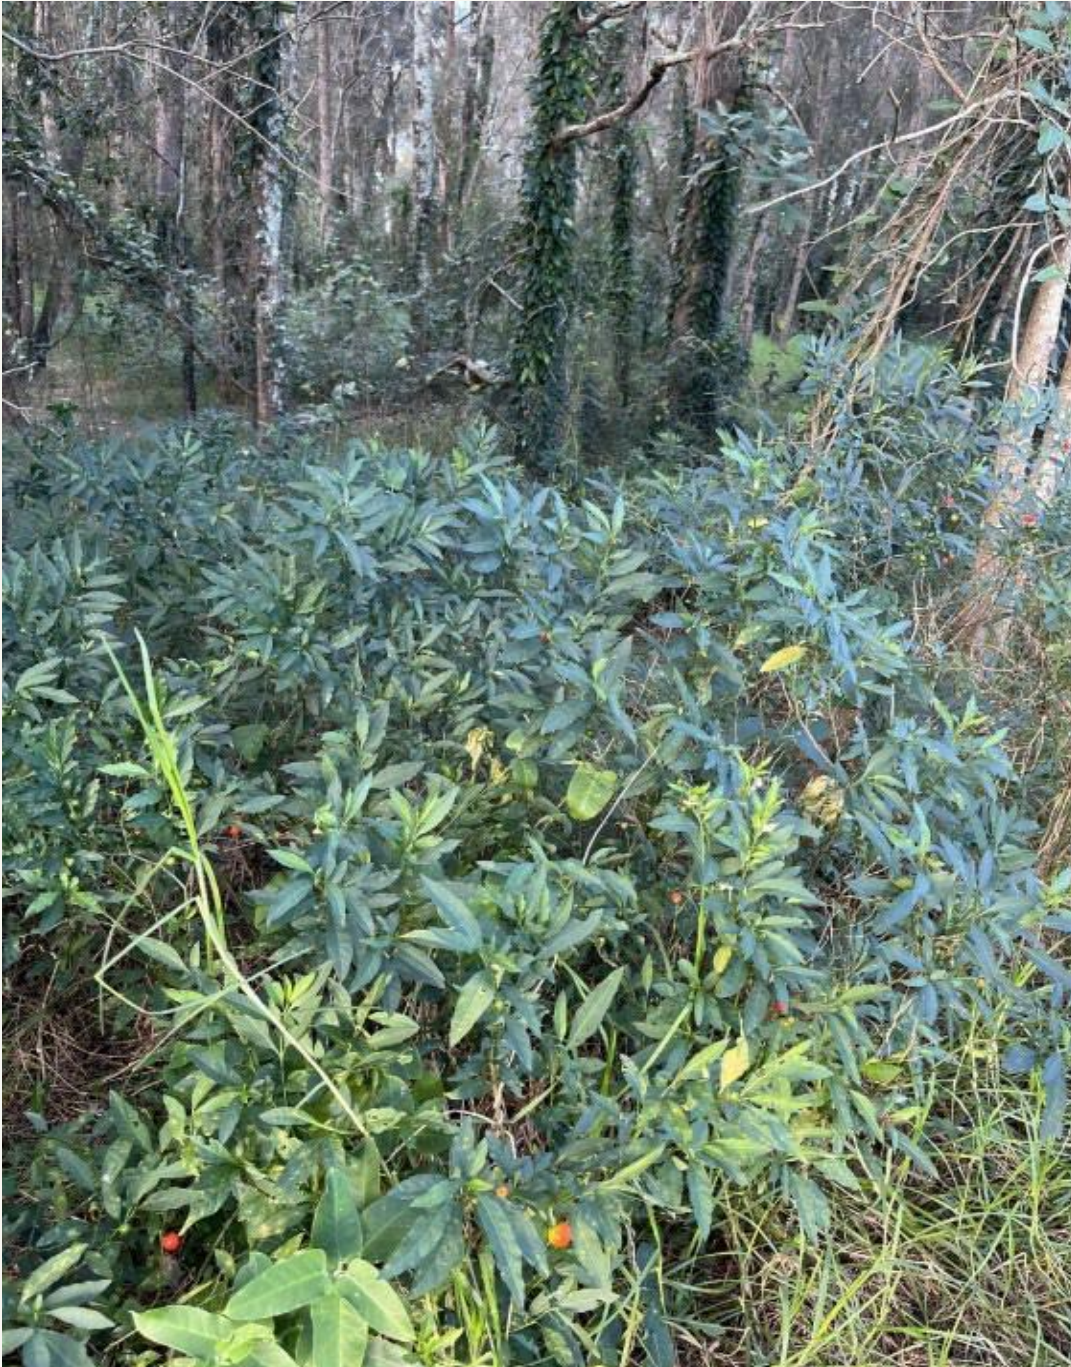
Plate 1: Madeira Winter Cherry Bush growing within Subzone 1.4

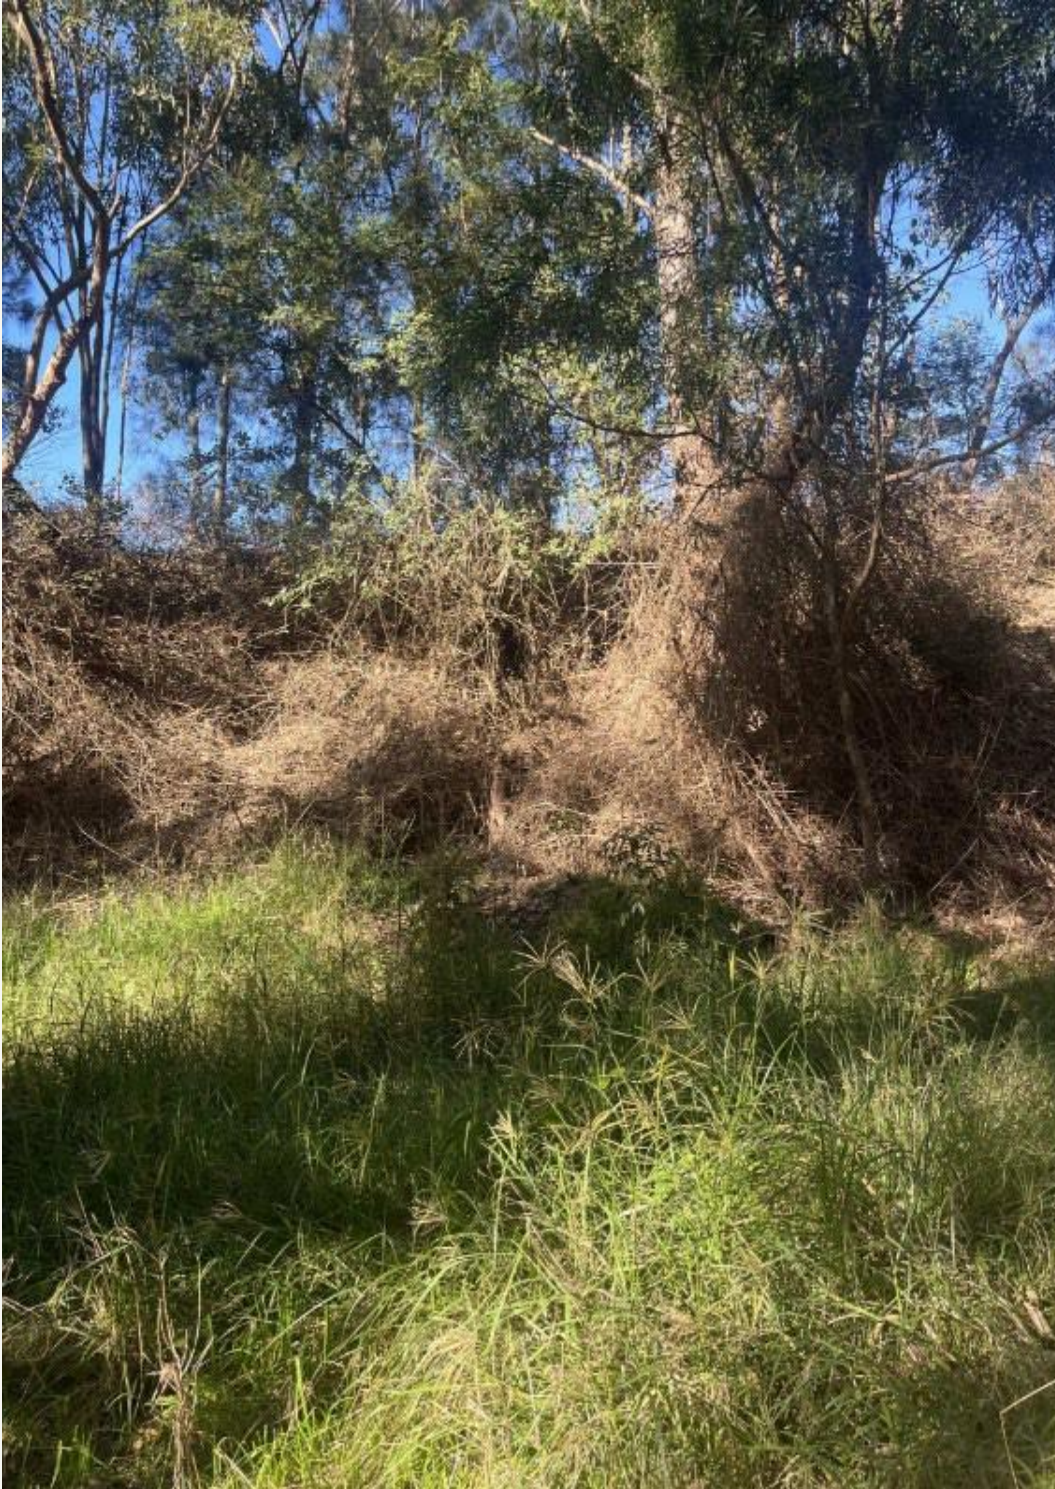
Plate 2: Rhodes Grass (*Chloris gayana*) growing in front of a dead stand of Lantana (*Lantana camara*) found on the western boundary of Subzone 1.3.

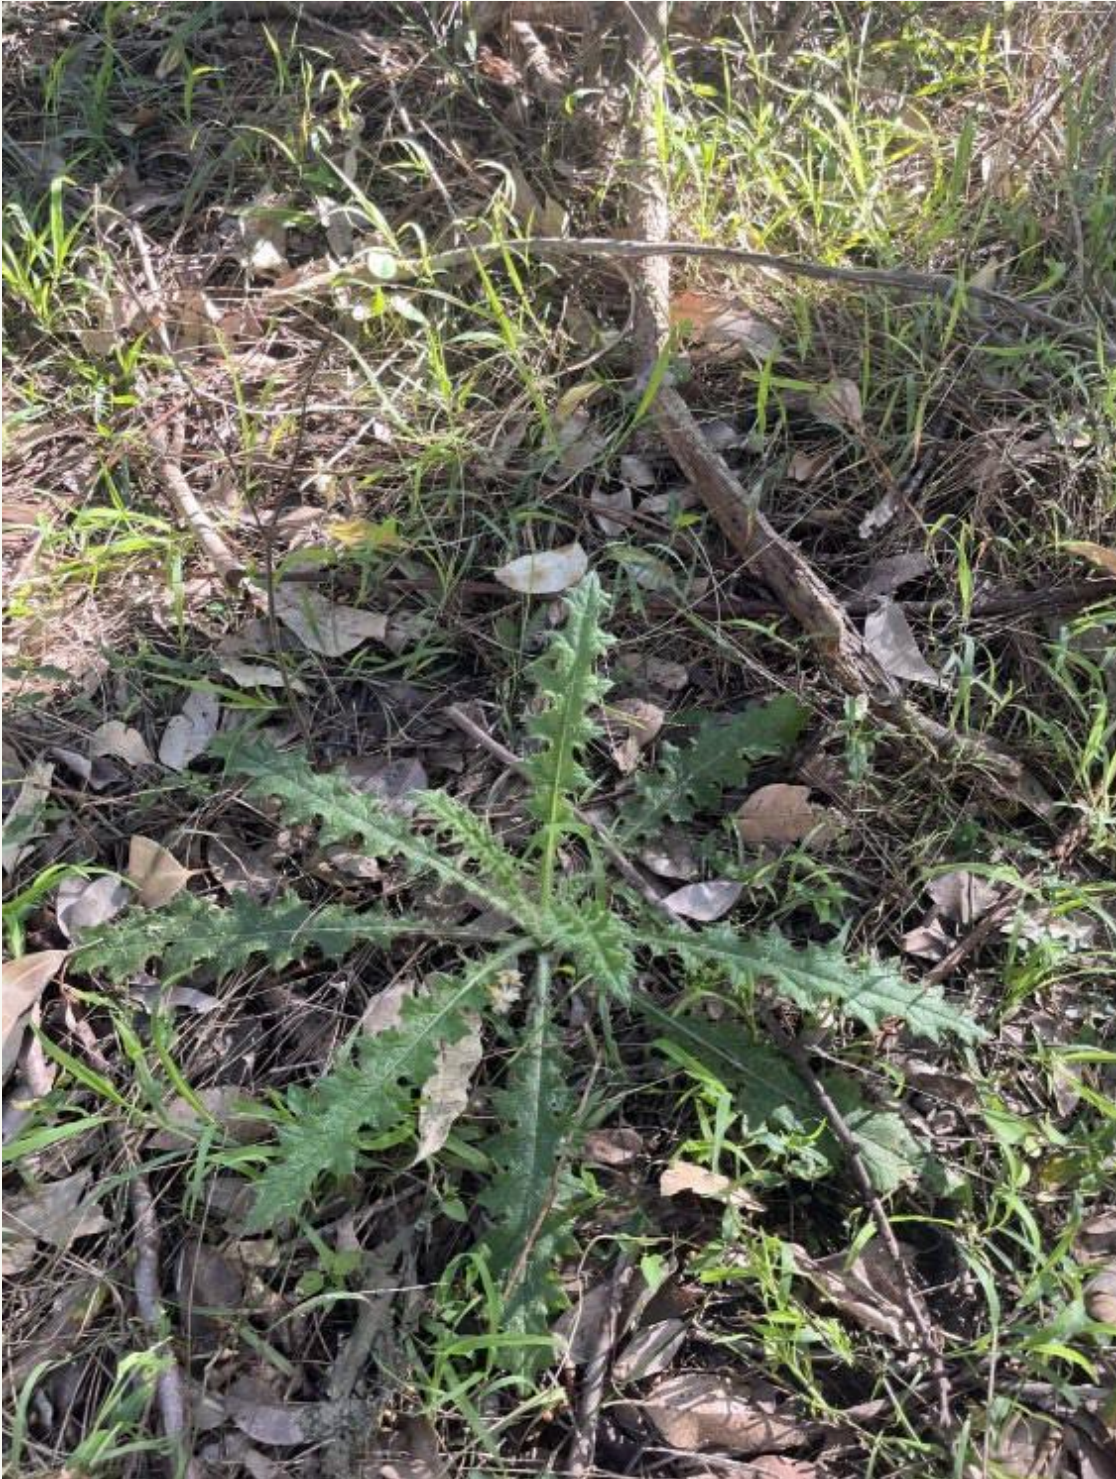
Plate 3: Spear Thistle (*Cirsium vulgare*) found within Subzone 2A.2.

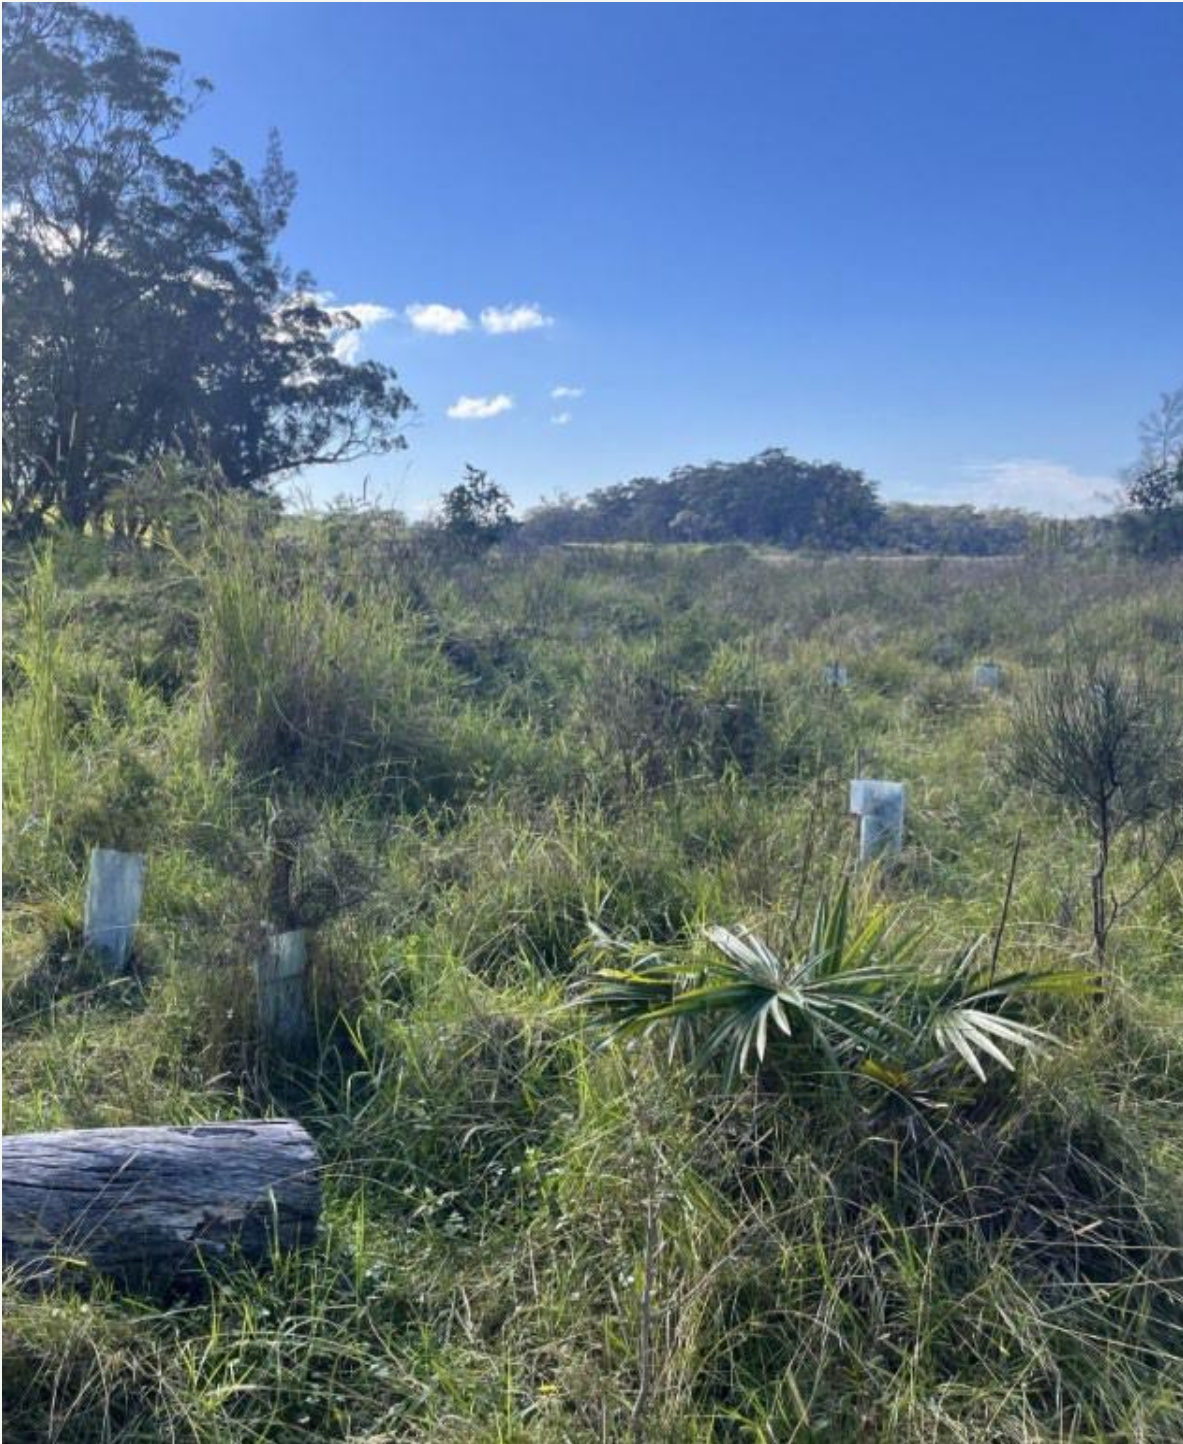
Plate 4: Overgrown exotic vegetation in the southwestern end of Subzone 2C.1. Some native plantings are establishing themselves – Swamp Oak (*Casuarina glauca*) and Cabbage Palm (*Livistona australis*).
