# **GERROA SAND RESOURCE**

## **ANNUAL REVIEW**

**Period 01 July 2025 – 30 June 2026**

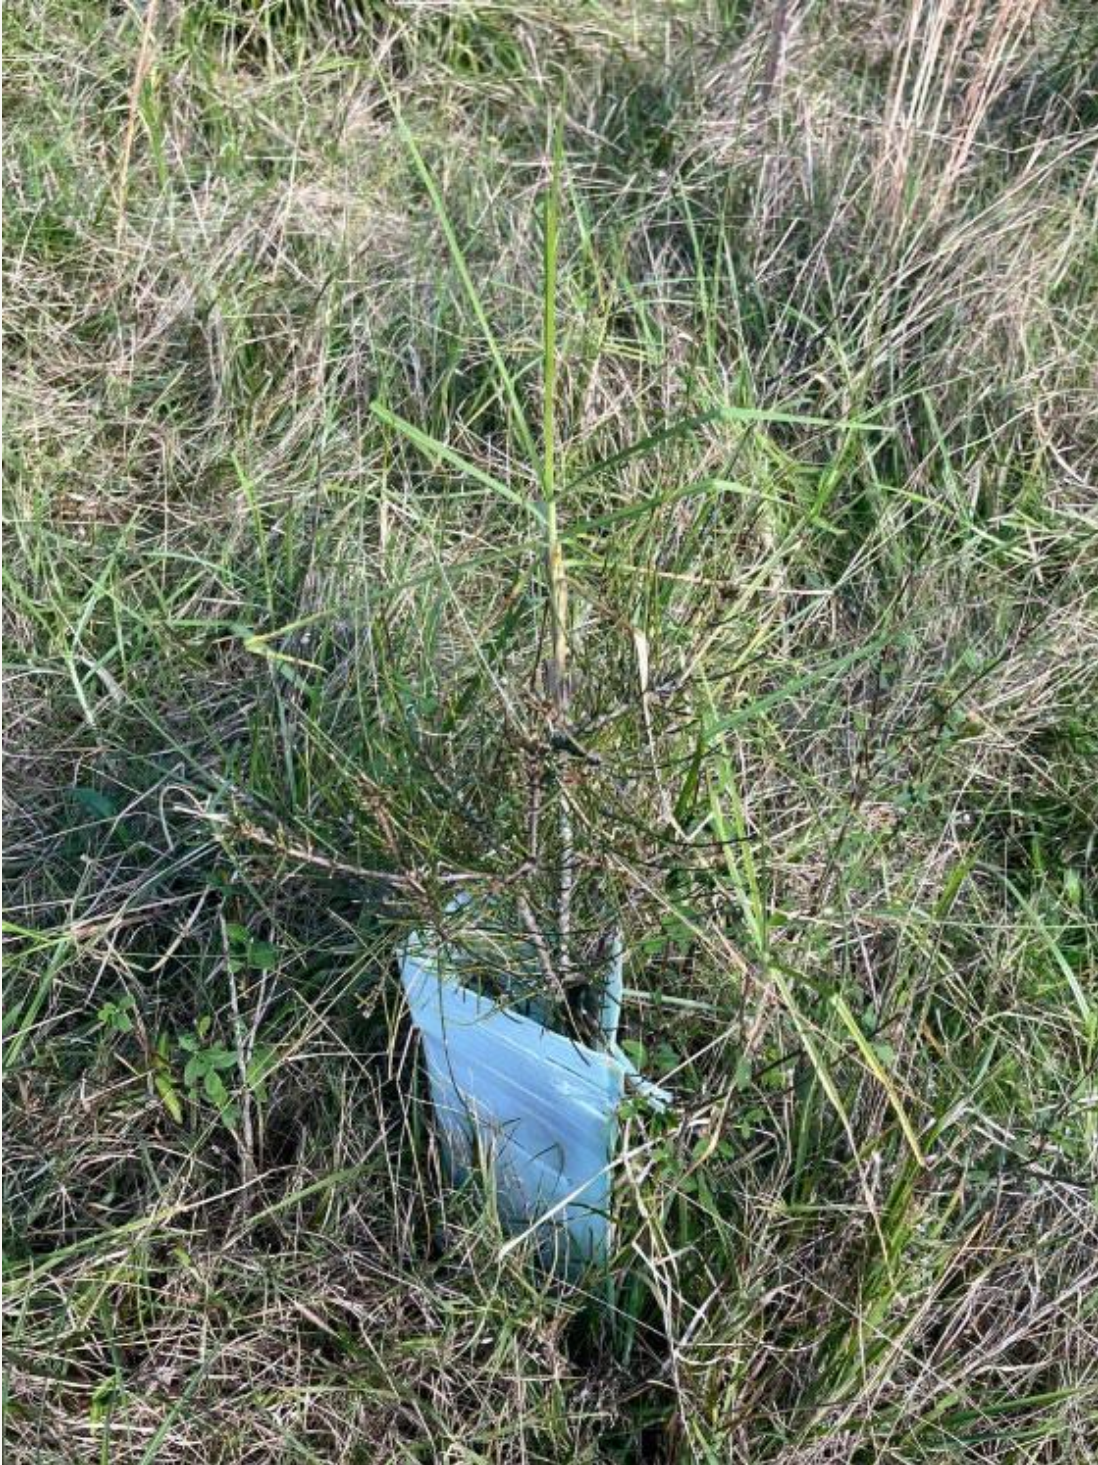
Plate 5: Grazed Swamp Oak (*Casuarina glauca*) planting in the southwestern end in Subzone 2C.1.

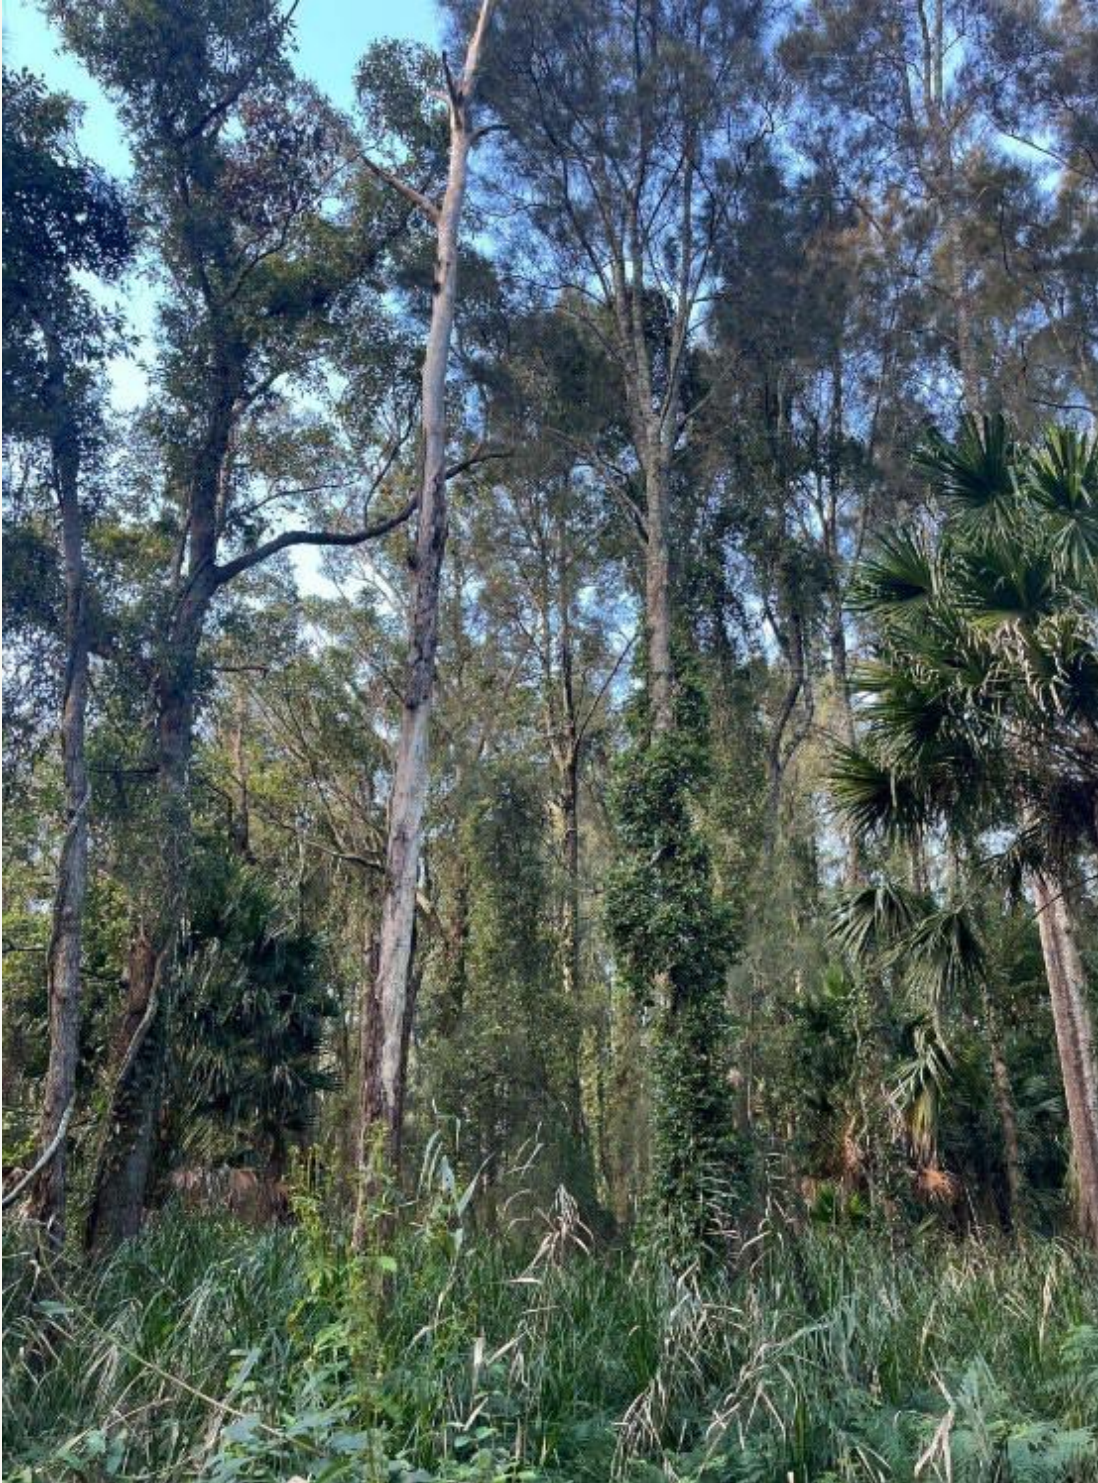
Plate 6: Giant Reed (*Arundo donax*) growing in Subzone 2B.2.

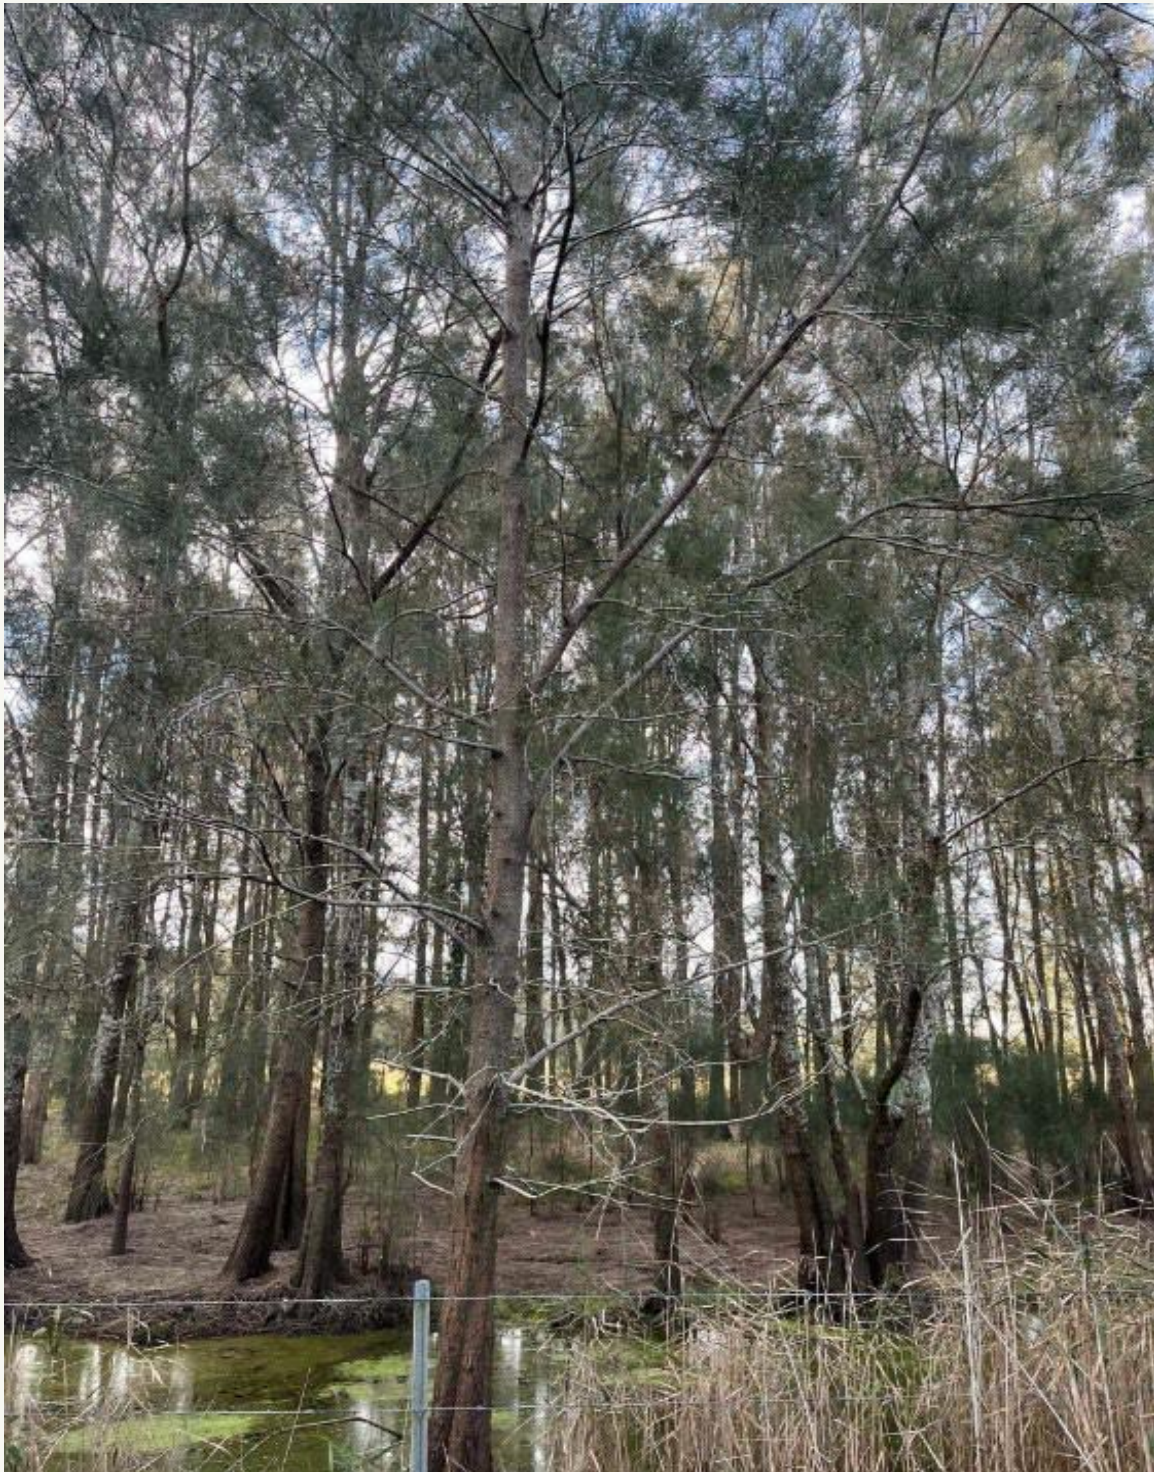
Plate 7: Giant Reed (*Arundo donax*) growing next to a creek, near a well-established Swamp Oak forest in Subzone 2D.

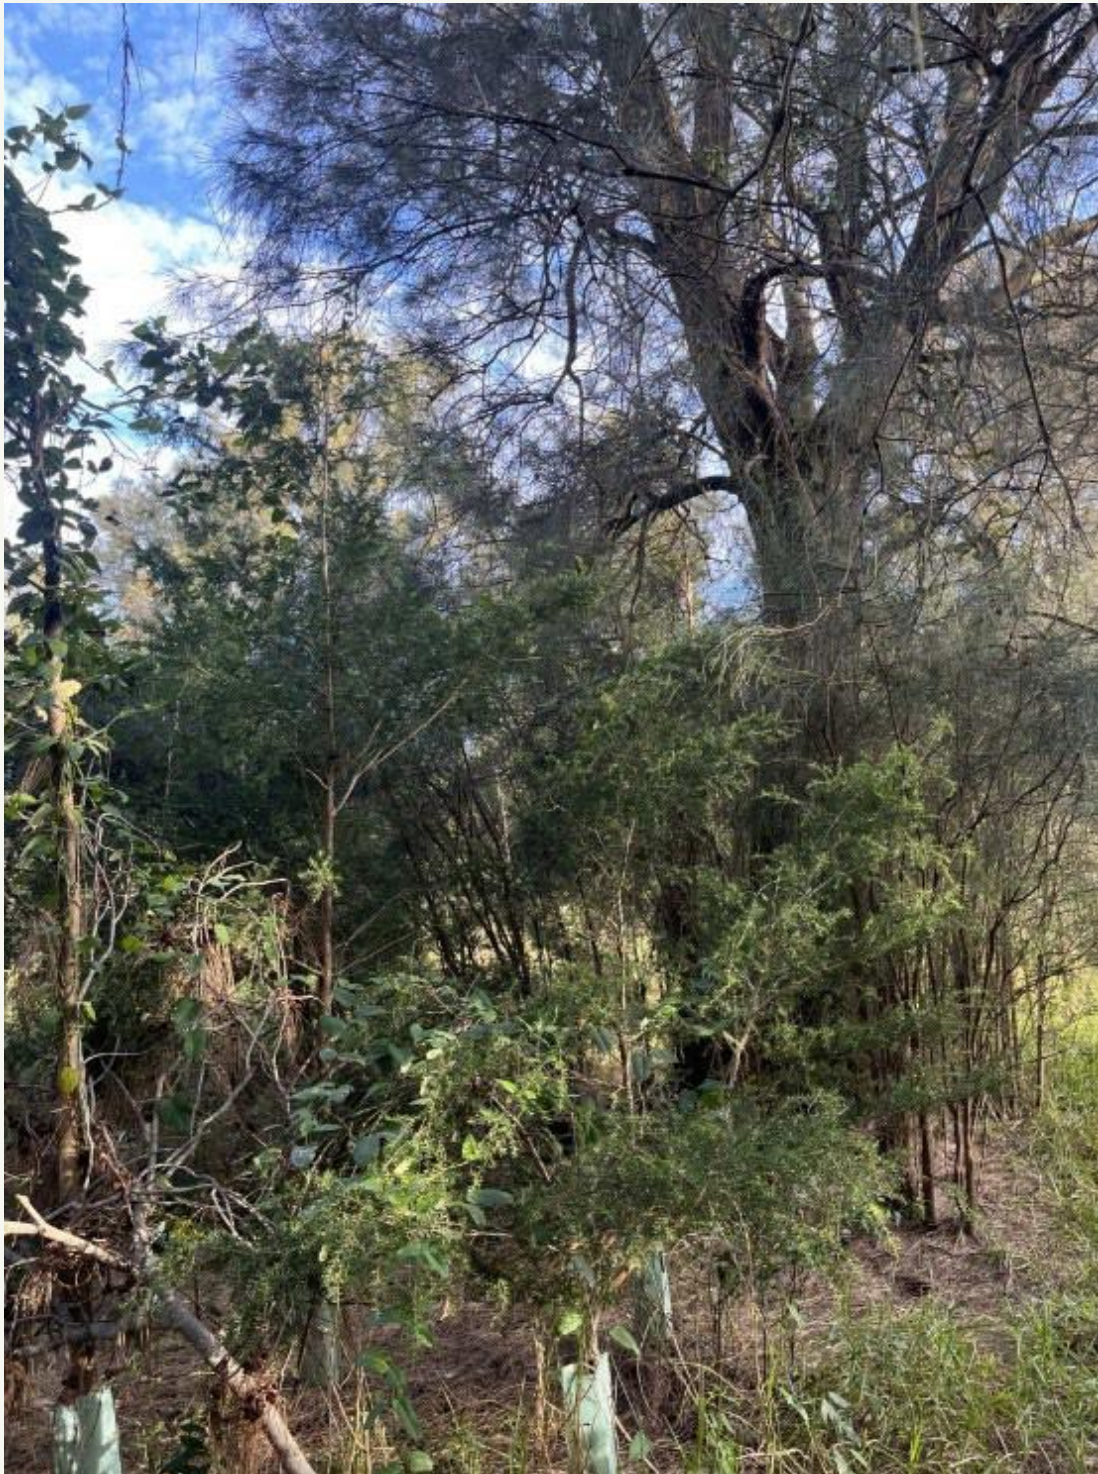
Plate 8: Native plantings with plastic sleeves that are establishing well in Subzone 2D.

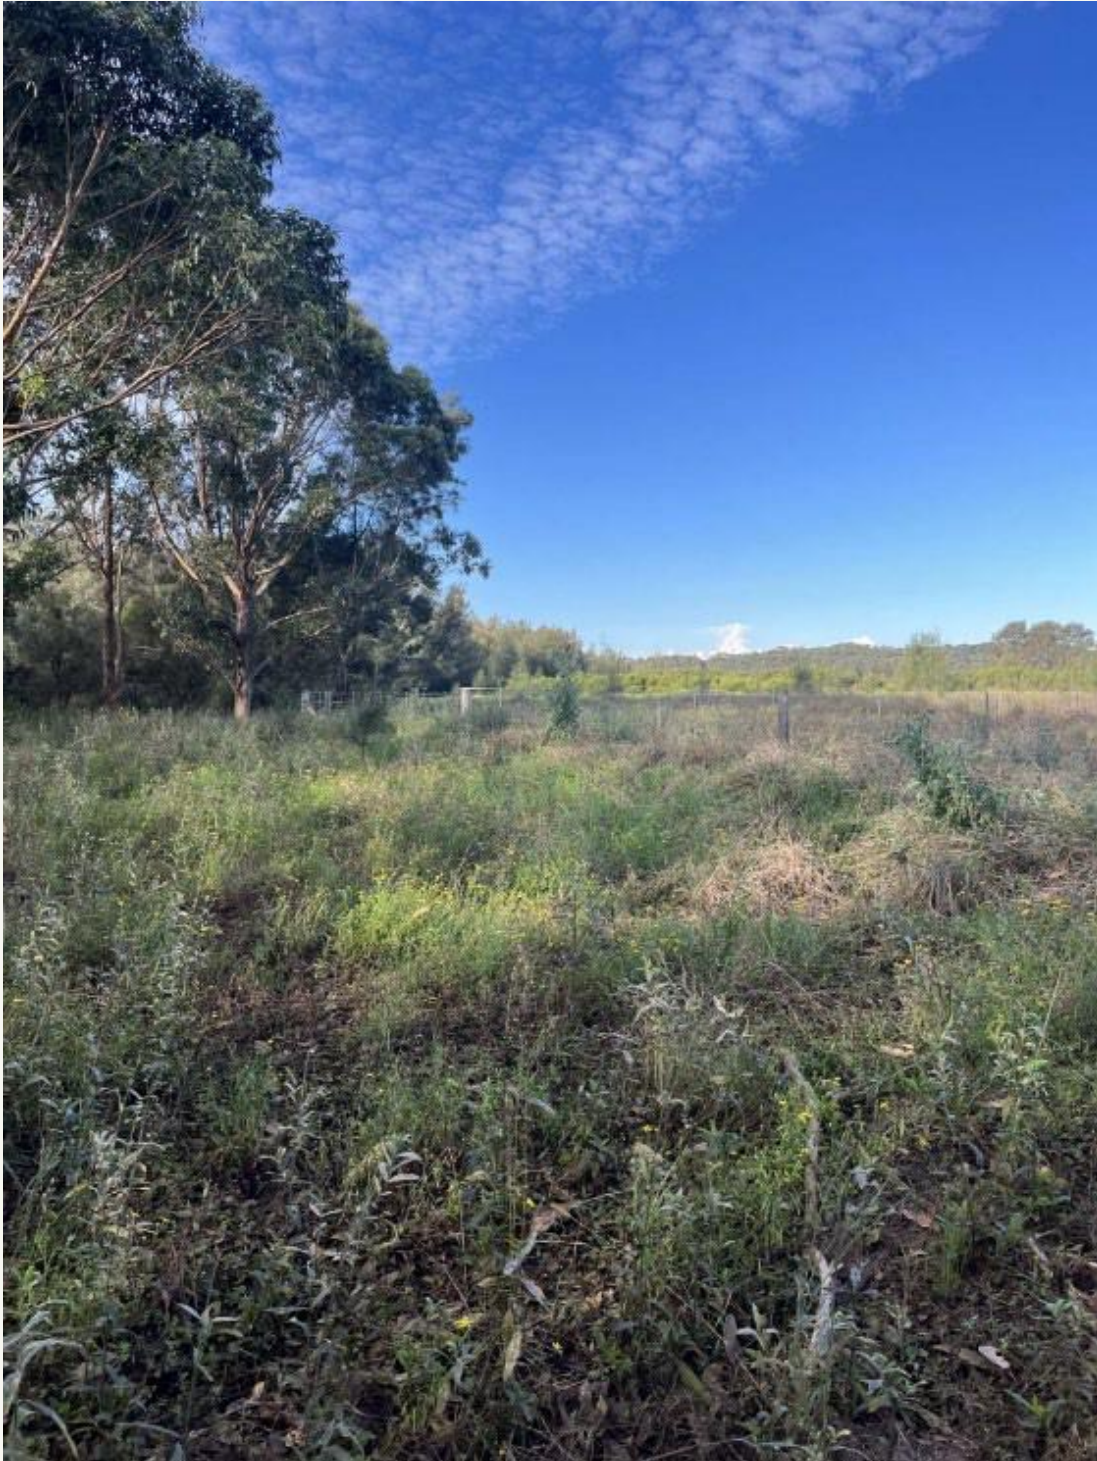
Plate 9: Fireweed, Tobacco Bush and Crofton Weed spreading throughout the southeastern corner of Subzone 2E.

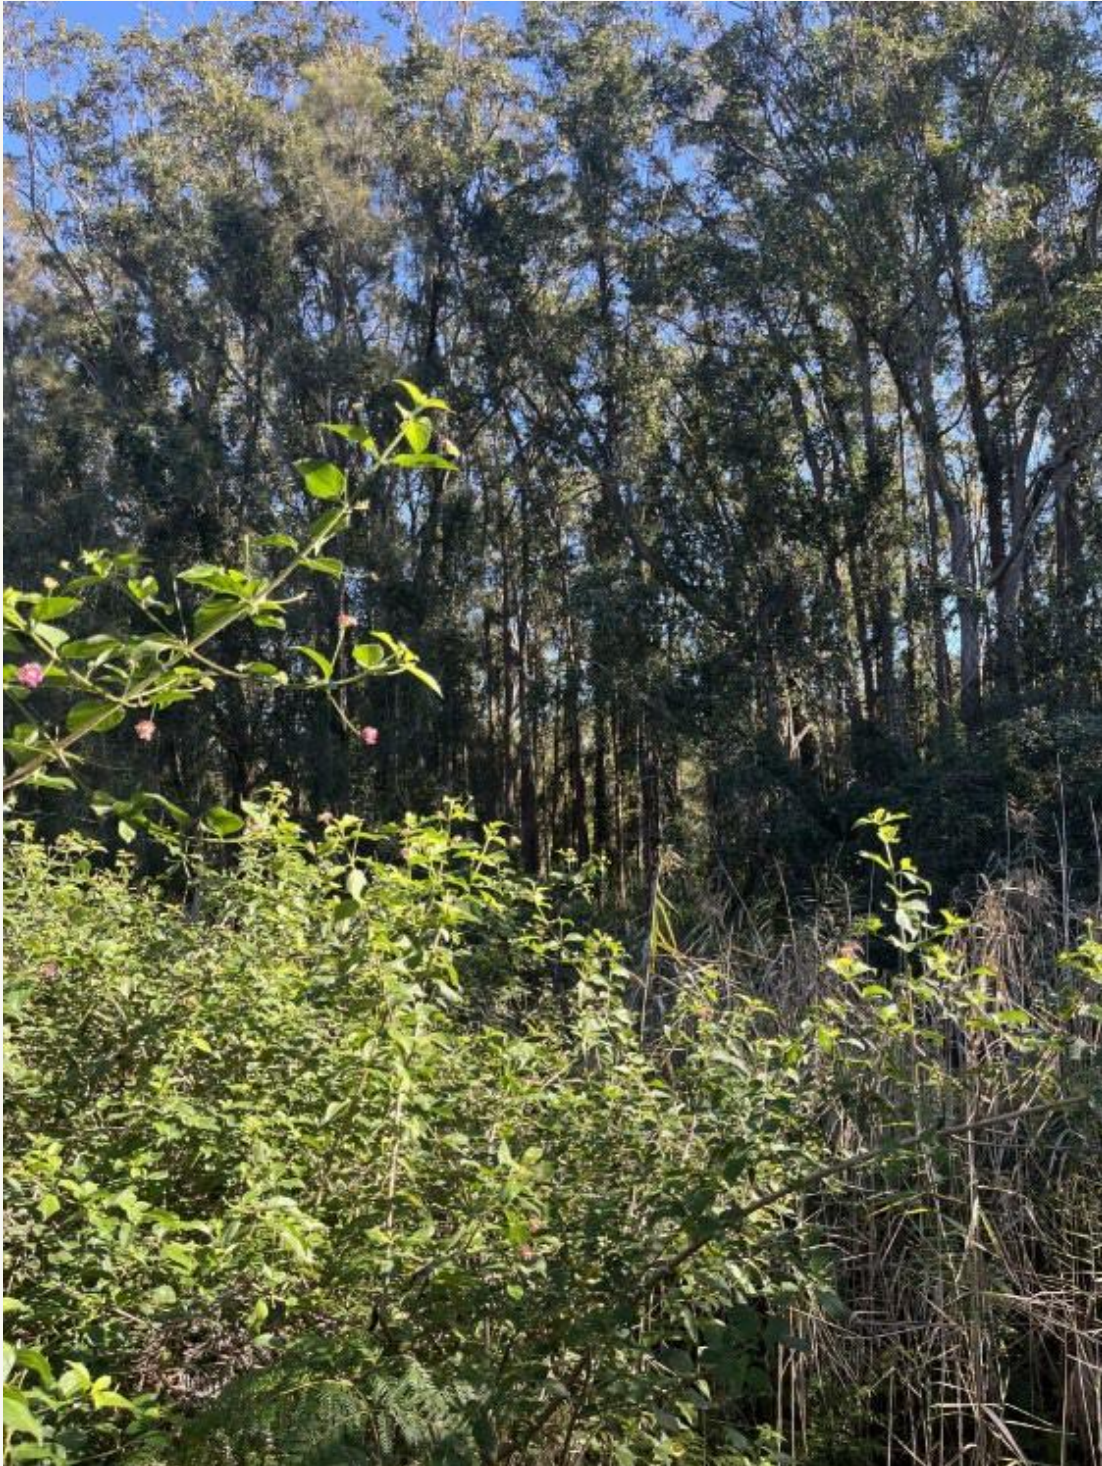
Plate 10: Lantana (*Lantana camara*) and Giant Reed (*Arundo donax*) are the dominate vegetation at the southern end of Zone 3.

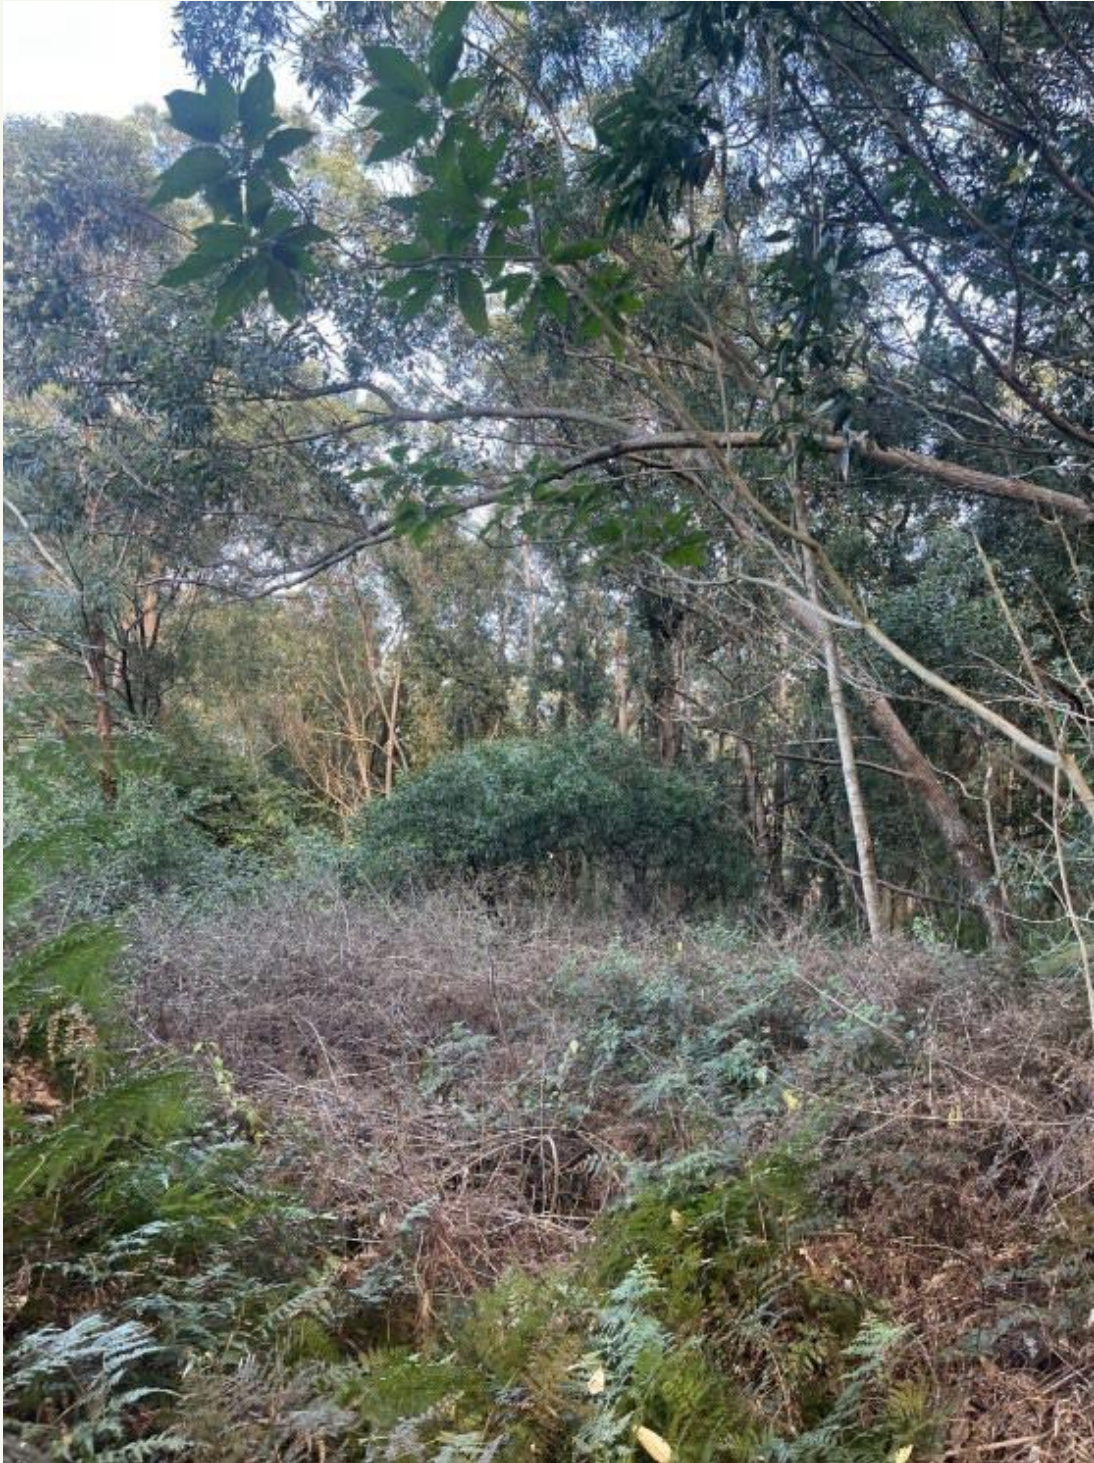
Plate 11: Tobacco Bush (*Solanum mauritianum*) and Lantana (*Lantana camara*) growing in Zone 6.
