Gerroa Sand Resource

Quarry Environmental Management Plan

19 January 2017

Cleary Bros (Bombo) Pty Ltd

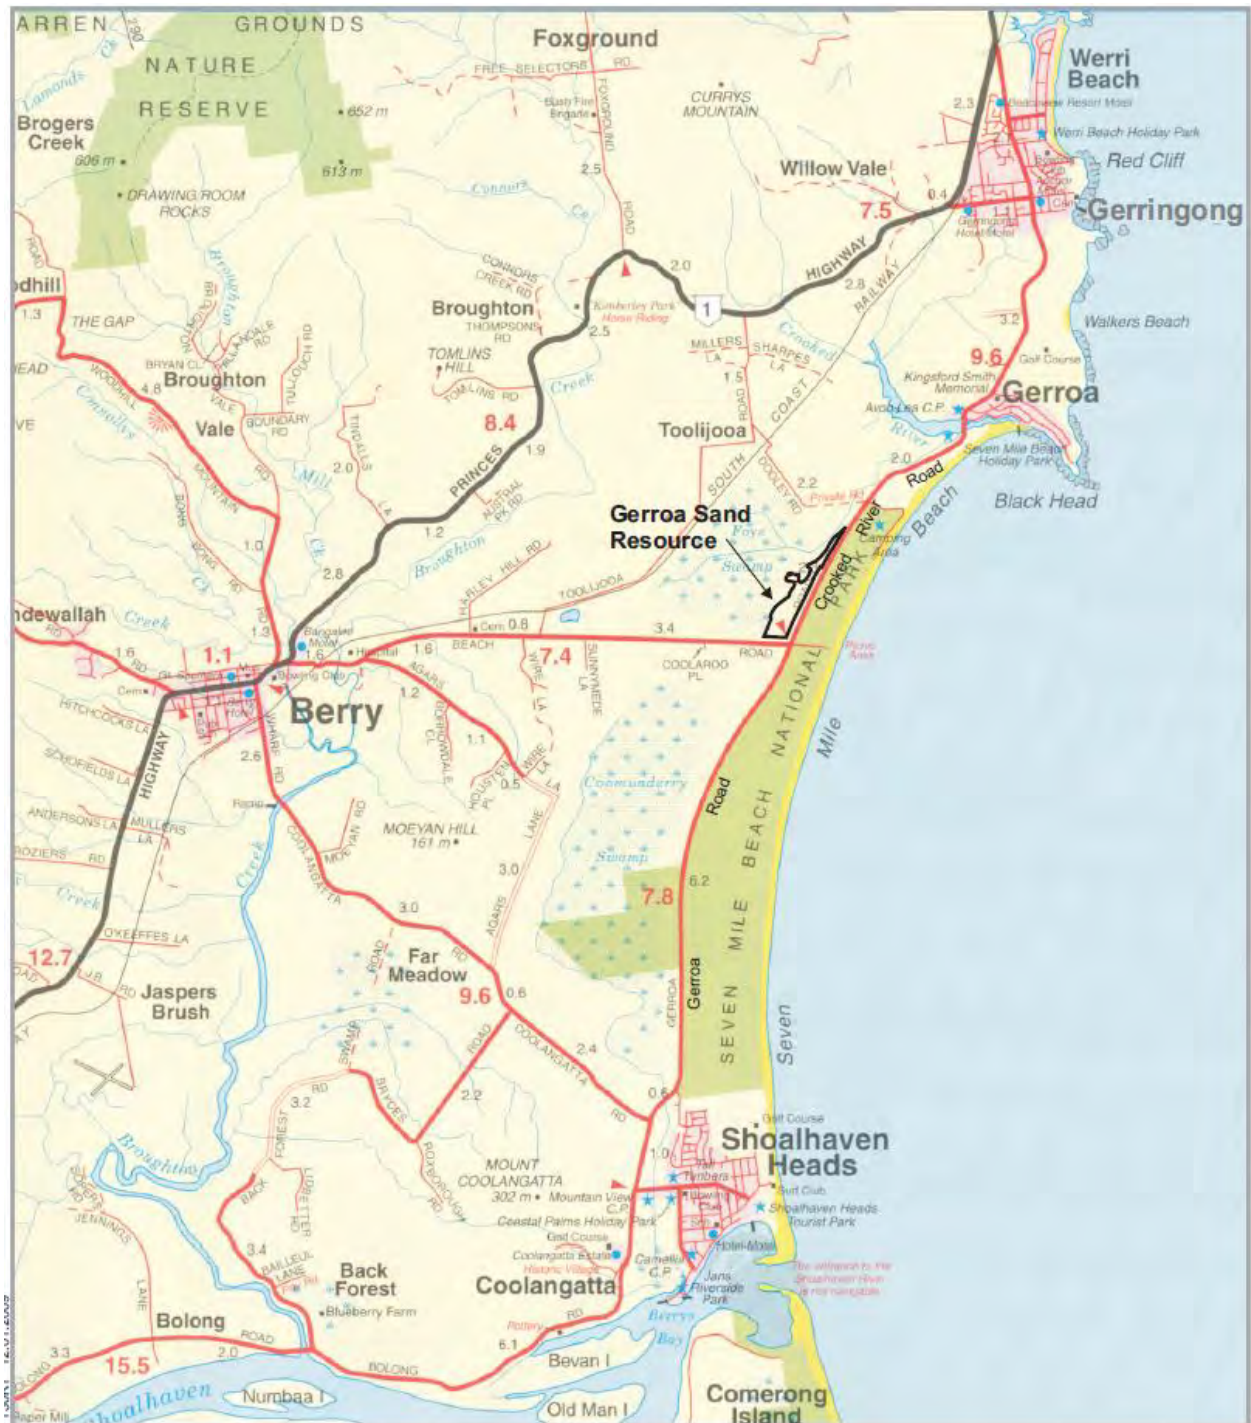
Figure 1-1 Locality Plan

The location of the property is shown on *Figure 1-1*. Details of the site are presented in Section 2.

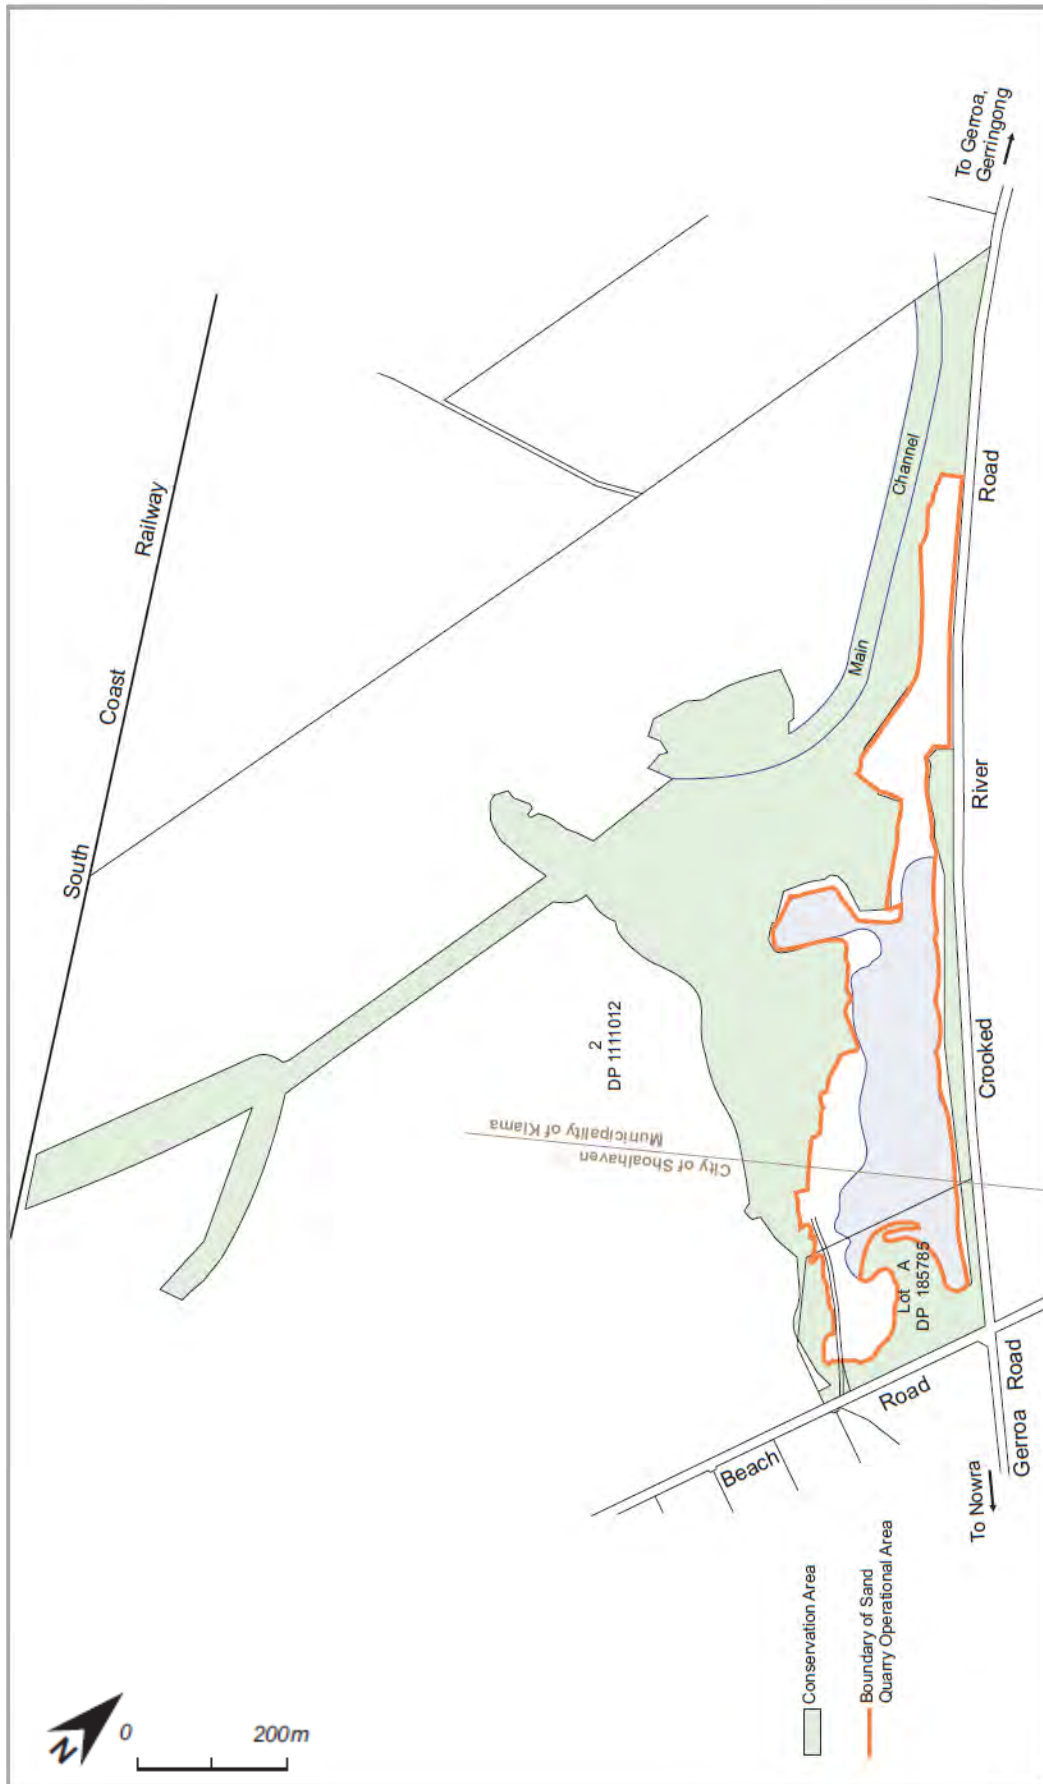
Figure 2-3 Conservation Area

The Conservation Area is defined in the project approval as the land shown on the surveyor's plan in Appendix 4 of the project approval. *Figure 2-3* has been derived from the surveyor's plan and shows the Conservation Area. The Conservation Area is located outside the quarry operational area and includes existing bushland, areas of the property to be planted in accordance with the project approval (Compensatory Planting) and land that has been rehabilitated following earlier quarrying activities.

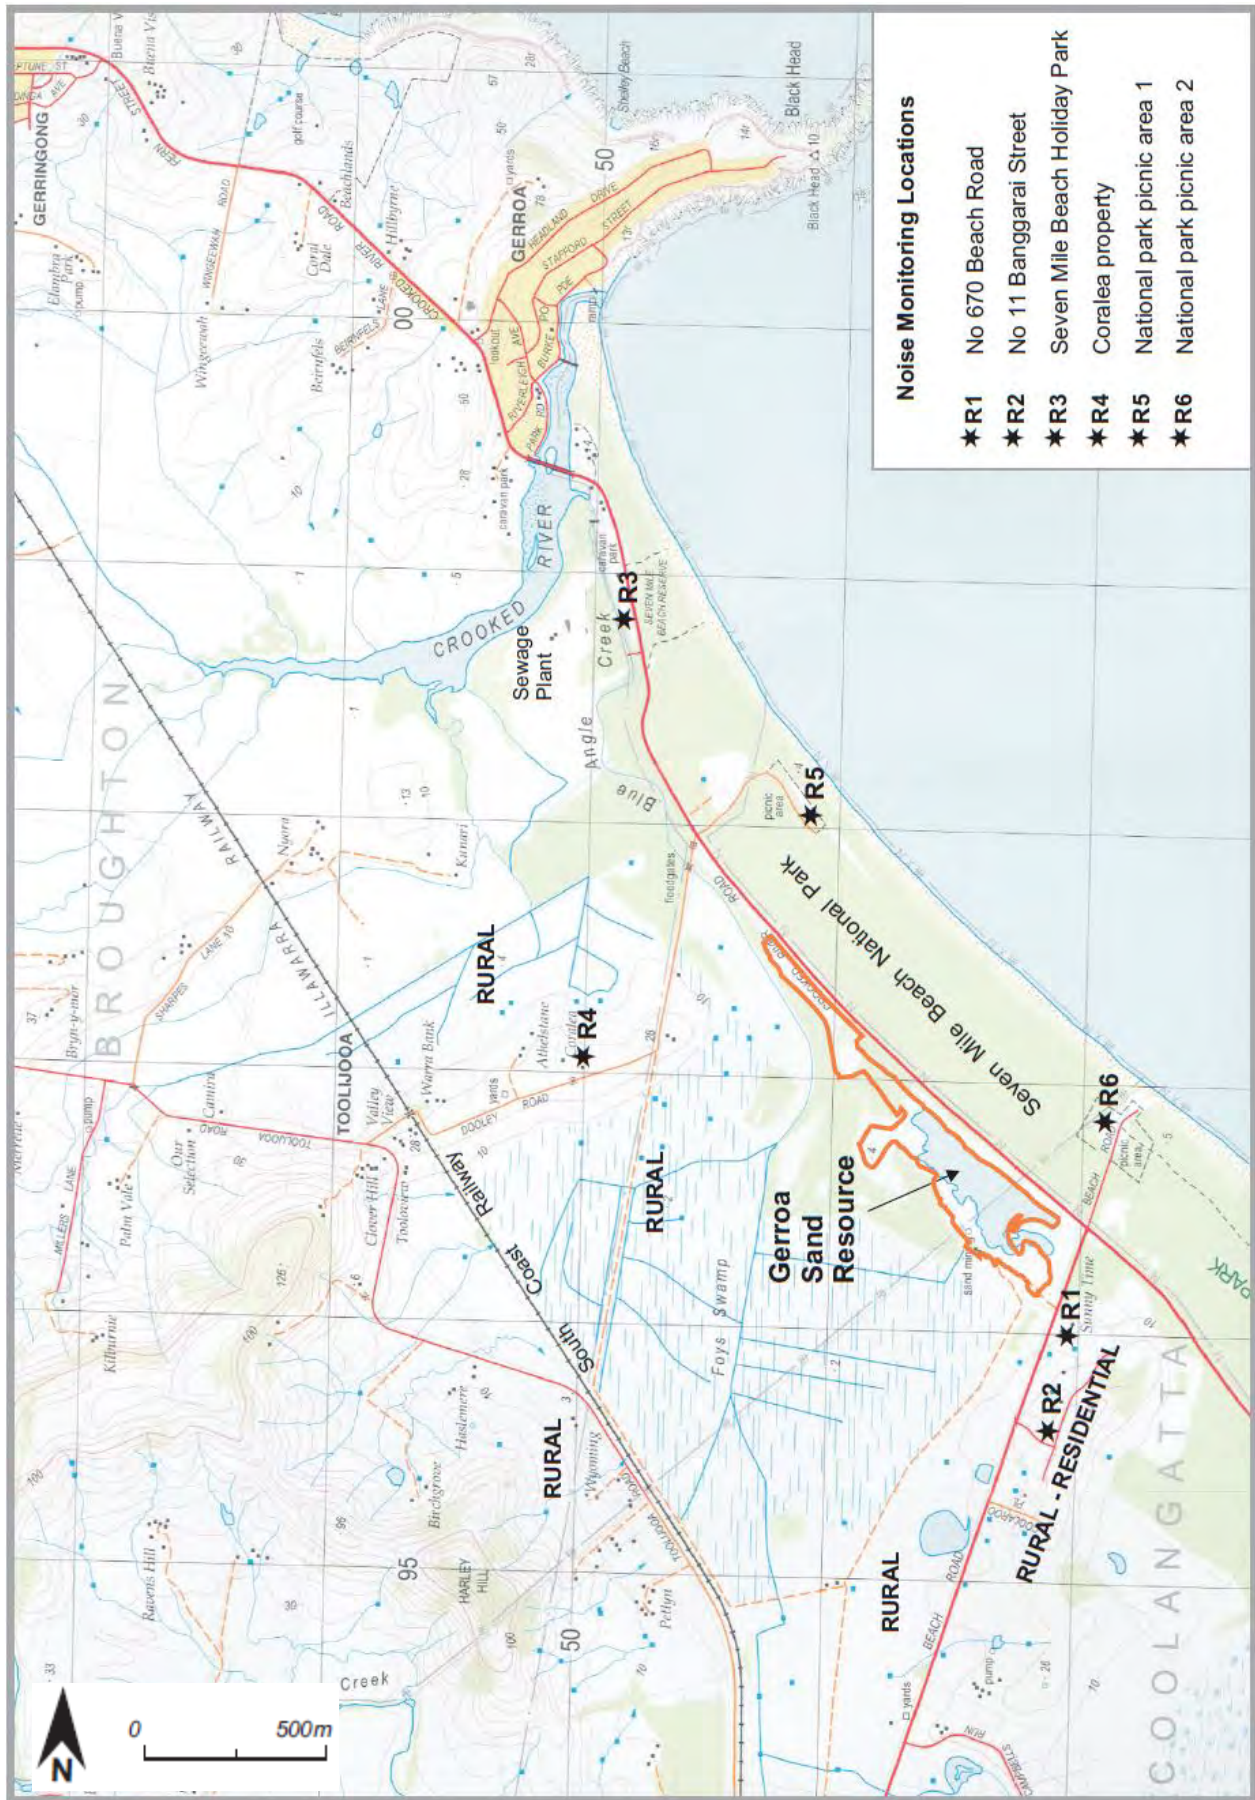
Figure 2-4 Surrounding Land Use

In August 2005 Renzo Tonin & Associates measured existing ambient noise levels at residences and other localities in the vicinity of the site, shown on *Figure 2-4*. The measured daytime L_{A90} background level and L_{Aeq} noise levels are summarised in *Table 2.2*.

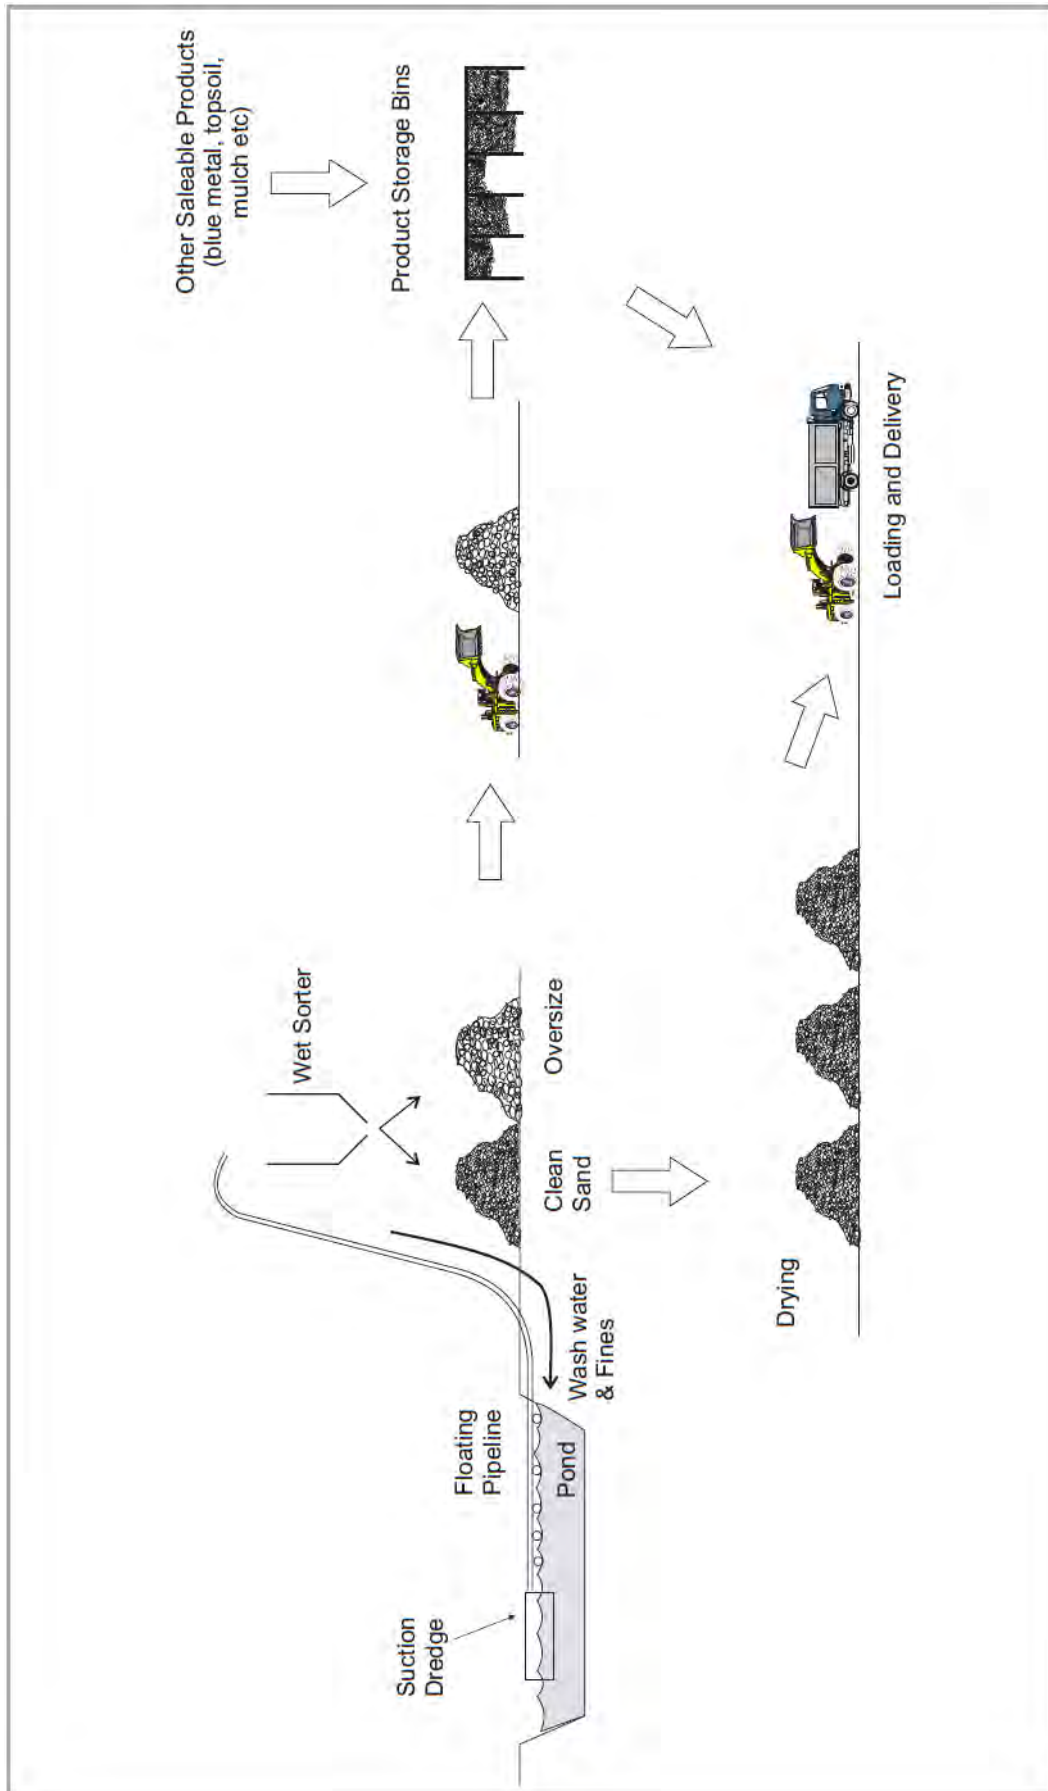
Figure 5-1 Process Flow Diagram

Material is extracted from the base and leading edge of the dredge pond using a floating suction dredge. The resulting slurry is piped to the shore and passed through various screens in the wet sorter and cyclone, as required. The wet sorter separates sand from stone and finer particles. Screened sand is pushed away from the sorter and allowed to drain back to the dredge pond, subject to acid sulphate soil procedures (see section 6.6). Heavier materials may be further screened to grade into saleable size ranges to meet market requirements. Fine particles return directly to the dredge pond with the wash water.

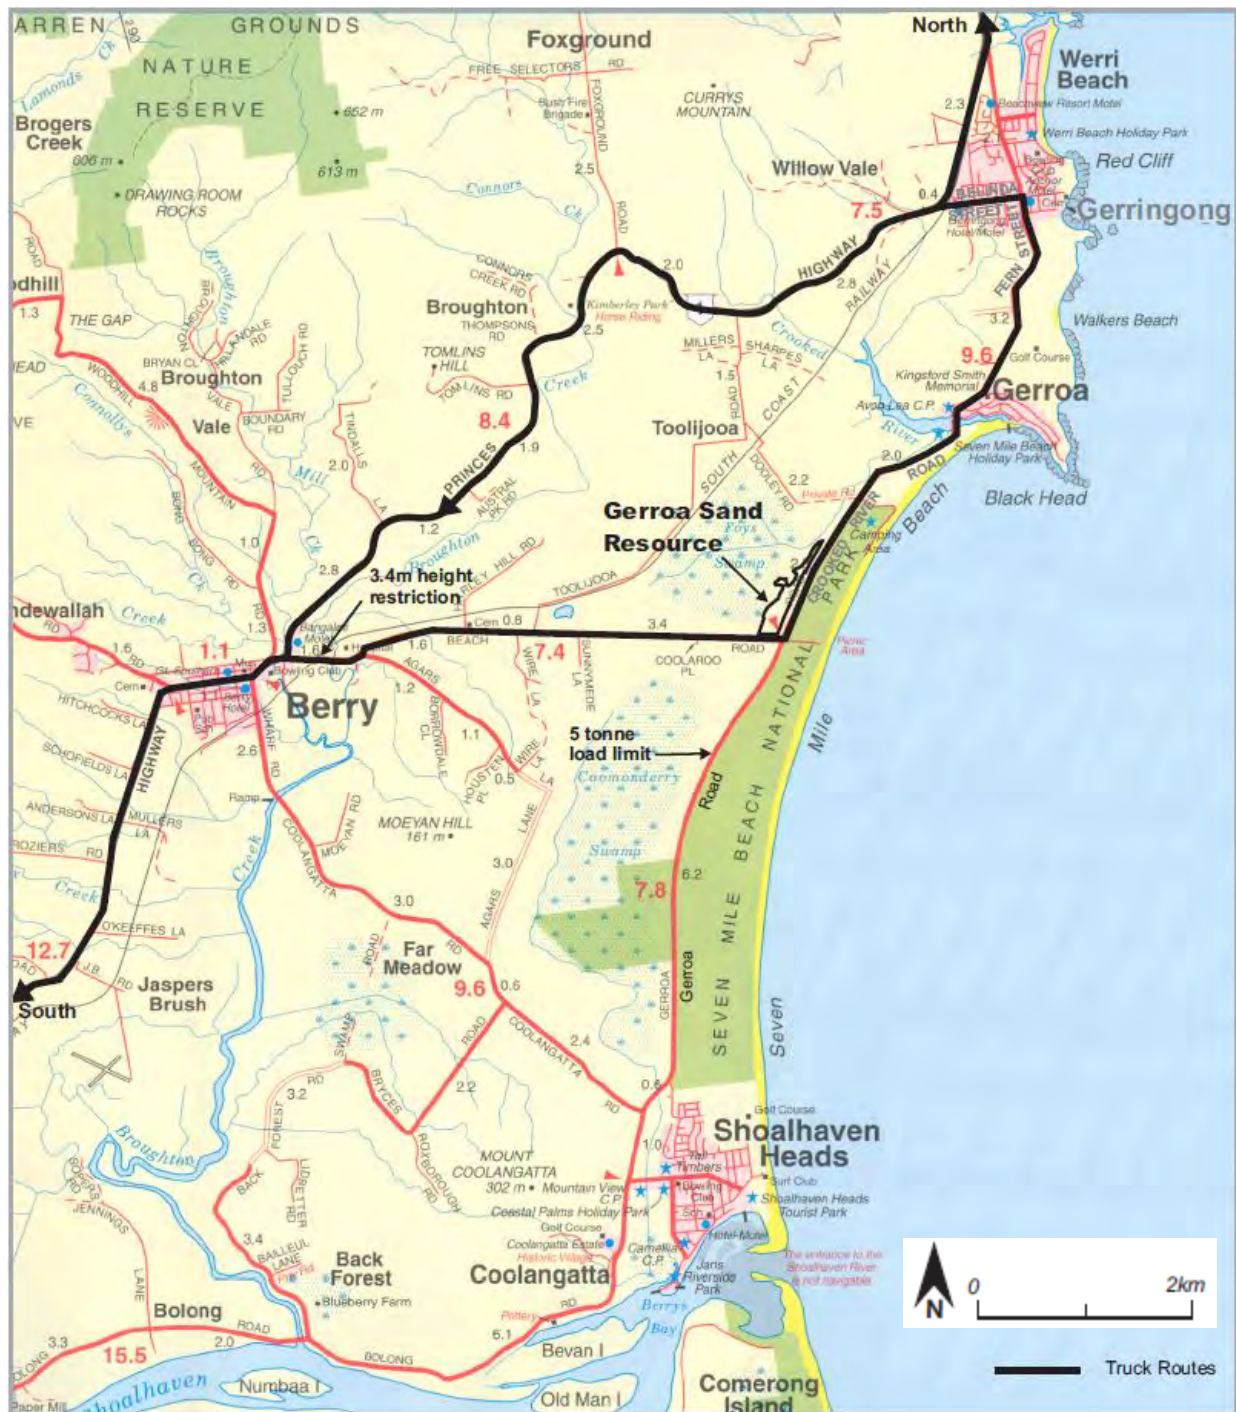
Figure 6-2 Approved Truck Routes

- iv. Quarry trucks may travel on Gerroa Road only when the destination is accessed from that road and there is no other practical route.
- v. The following restrictions are in place on roads in the area and will be observed:
 - o Beach Road – 3.4 metre height limit at the railway underpass;
 - o Gerroa Road – 5-tonne load limit.
- vi. The approved truck routes are shown on *Figure 6-2*.
- vii. All loaded vehicles entering or leaving the site are to have covered loads.
- viii. Prior to departure, all loaded vehicles leaving the site are to be cleaned of materials that might fall to the road.

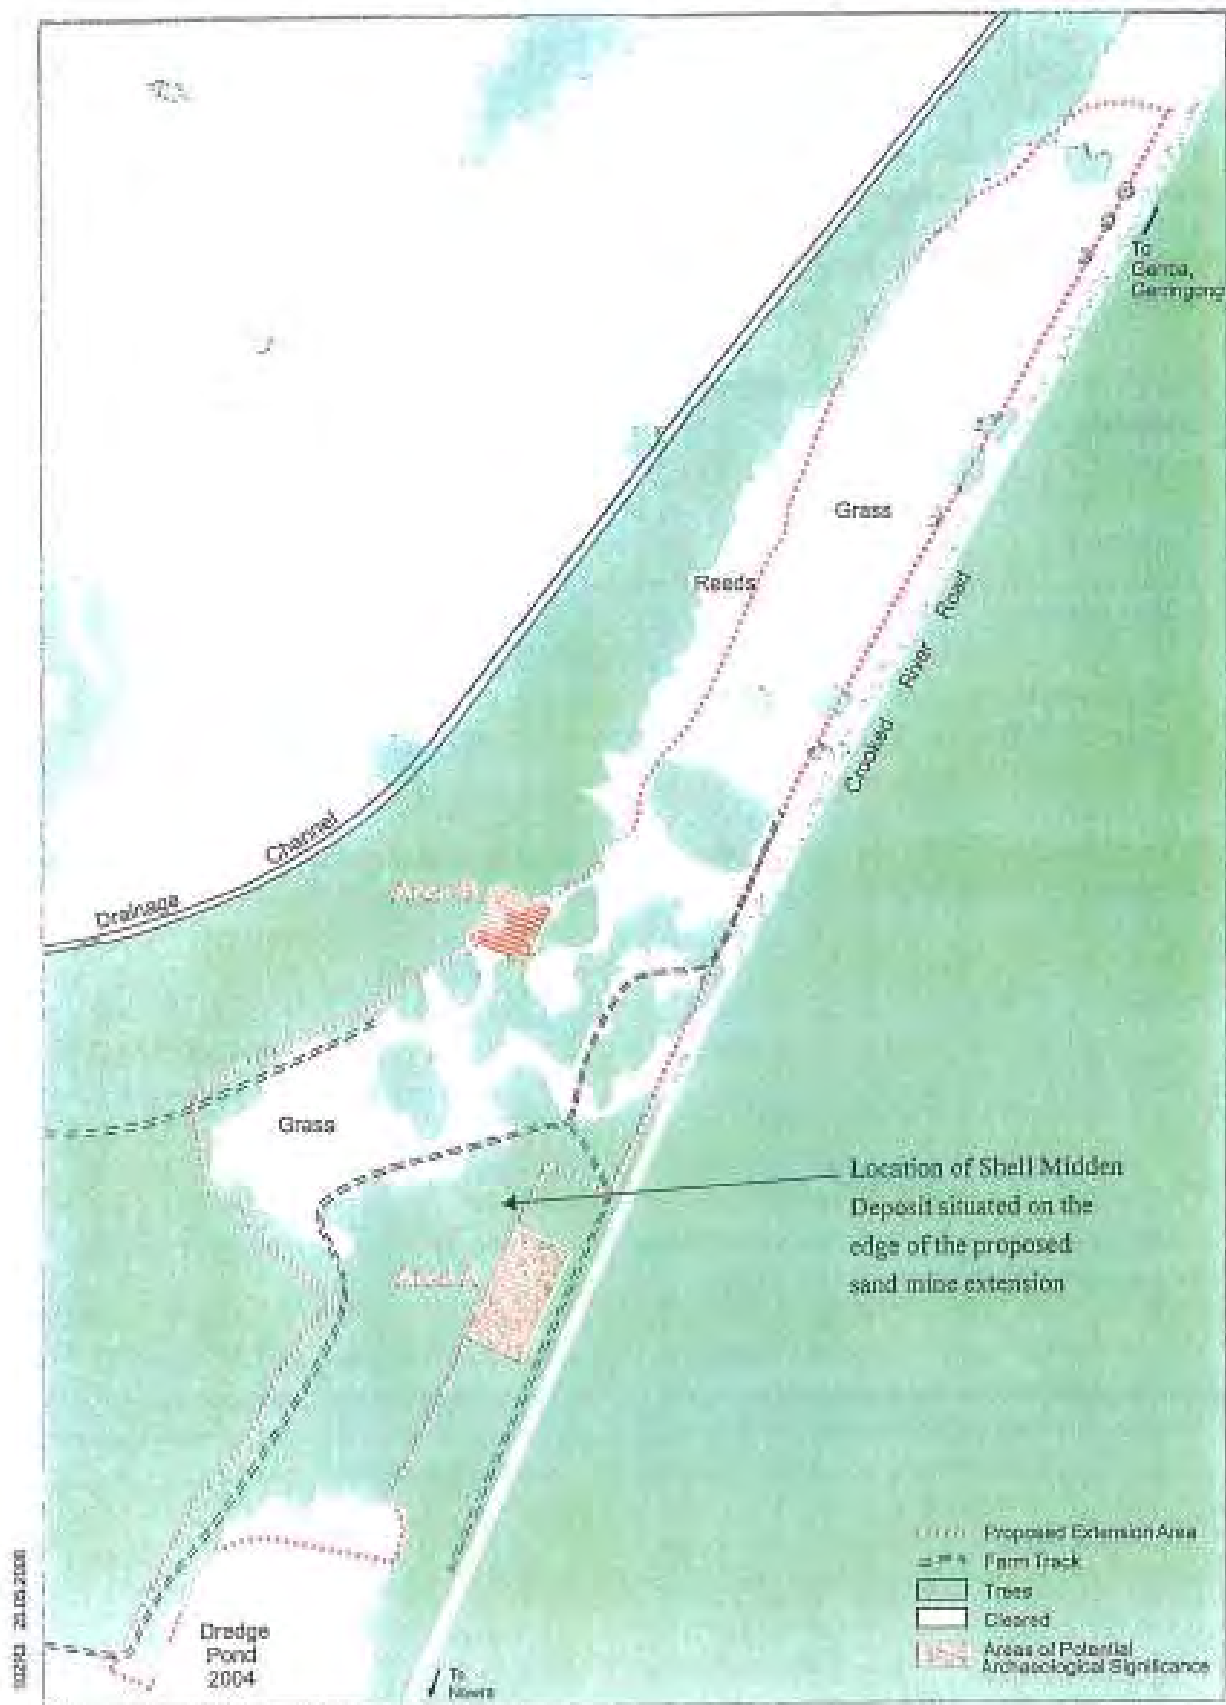
Figure 5.4 Archaeological Areas

Previous reports have identified Area A and Area B as areas of archaeological significance (Paton 1992), as shown in Figure 5.4 of the EA. These areas have been reassessed as part of this current proposal. In the original report by Paton the locations of Area A and Area B were sketched, however, precise grid references were not given. Cleary Bros had surveyors plot their locations based on Paton's descriptions (Navin Officer para. comm.) and as such their locations may not be exact. Reassessment of these areas (Navin Officer 2006) have concluded that there was no material of archaeological significance in Area B, and as such it is likely that mining the proposed area of Area B will have minimal impact on Aboriginal cultural heritage values. Cleary Bros proposed to remove the conservation status for Area B to allow mining to occur in that area. They also propose that Area A be extended to include more of the dune crest and that this area be conserved through a long term agreement.

The section identified as 'Area A' in Figure 5.4 of the EA has been identified to conserve some of the cultural heritage and threatened species values on site. It is understood that weed eradication and other rehabilitation works will occur in this area. Due to the aboriginal cultural heritage values of Area A the DEC consider it important that any disruption to the area is minimised. In this regard we recommend the following additional SOCs be added:

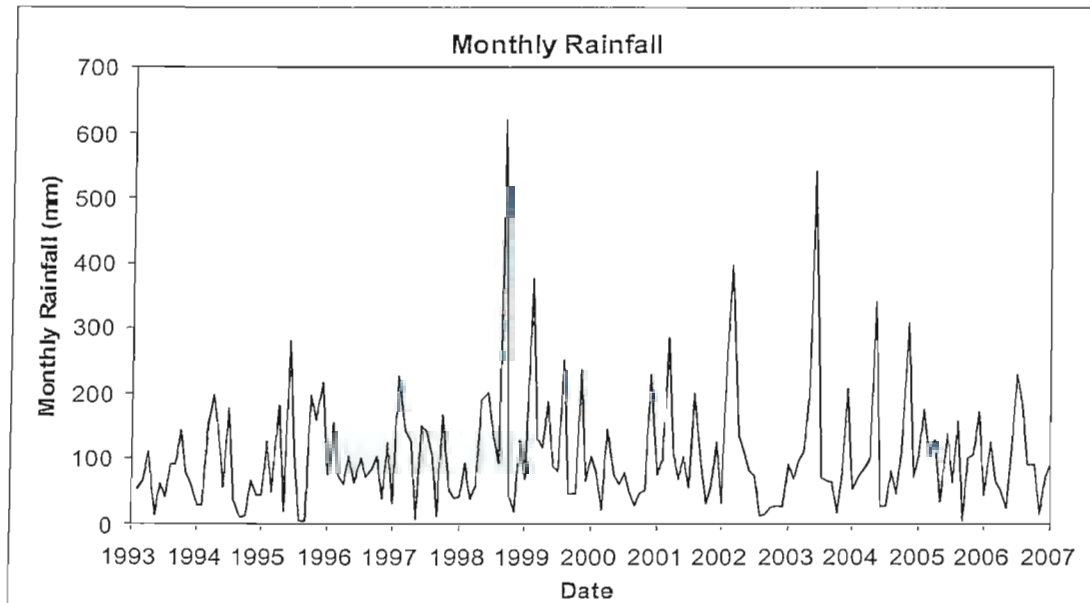
Figure B-1: Monthly Rainfall 1993 - 2006

8. Figure B-1 graphically shows the same monthly rainfall that is presented in Table B-1 and illustrates the significant variation in rainfall that has occurred over the period 1993 – 2006.

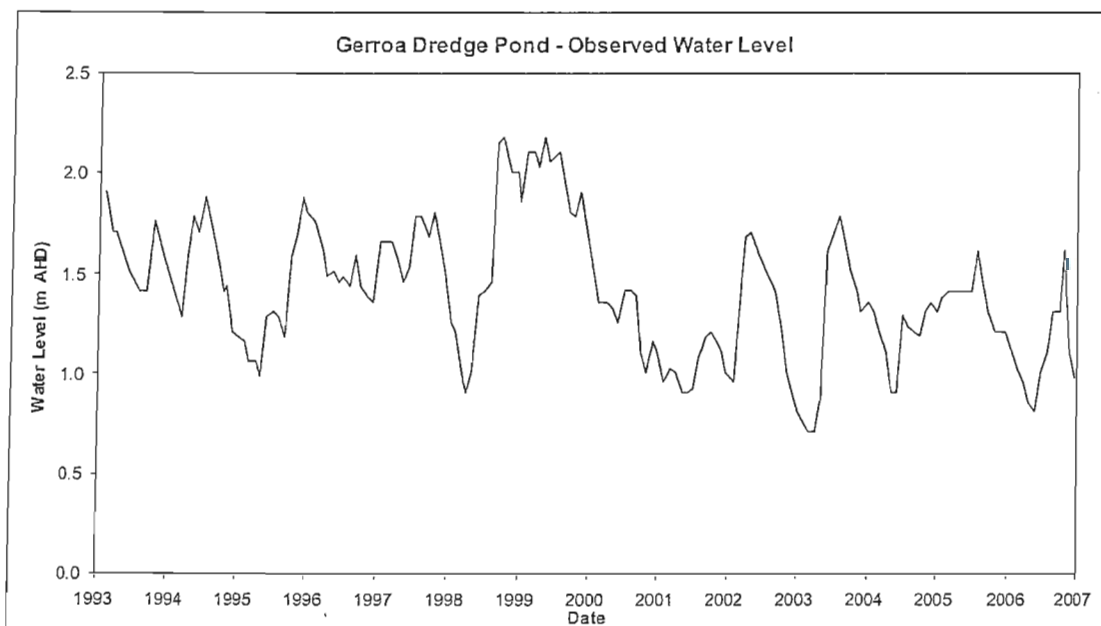
Figure B-2: Recorded Dredge Pond Levels

9. Water levels in the dredge pond at Gerroa have been monitored at approximately 10 day intervals since 1993. Figure B-2 shows the variation of pond water level over this period.

10. As would be expected, Figure B-2 shows a distinct correlation between pond water level and the preceding rainfall as set out in Table B-2 and Figure B-1. In particular the peaks in the pond water level are directly related to rainfall as shown in Table B-3.

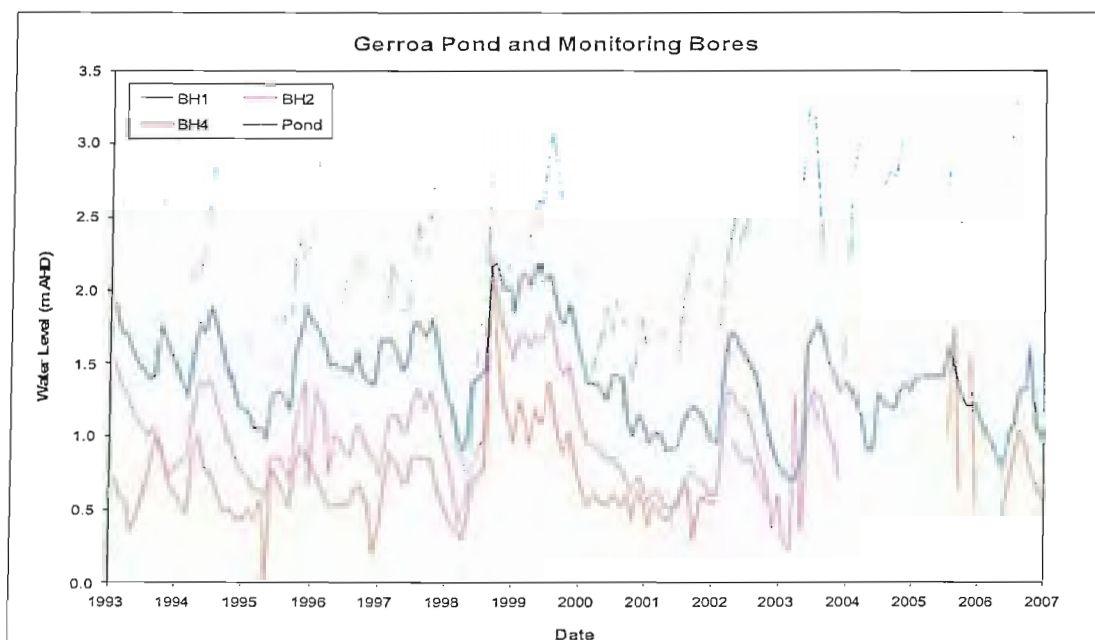
Figure B-3: Recorded Water Levels in Dredge Pond and Monitoring Bores

- BH1 Located near the quarry entrance to the west of the southern end of the existing dredge pond;
- BH2 Located near the corner of Beach Road and Crooked River Road to the east of the southern end of the existing dredge pond;
- BH4 Located approximately 500 m north east of the existing dredge pond adjacent to Crooked River Road (near the centre of the proposed sand mine extension).

12. The water levels in Figure B-3 indicate the following characteristics:
- Groundwater levels respond to rainfall in a similar manner to the pond itself;

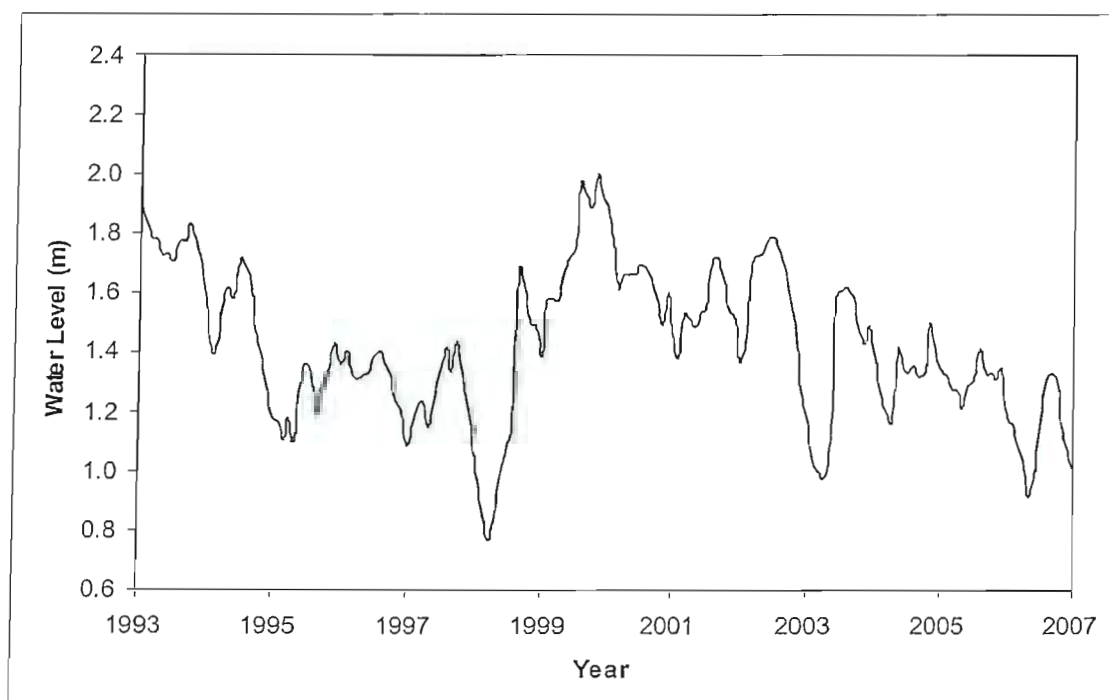
Figure B-4: Dredge Pond Water Levels under the Influence of Rainfall and Evaporation Only

16. Based on the average climatic data set out in Table B-1, the loss of water from the surface of the existing dredge pond under average climatic conditions would have varied from about 16 ML/year in 1993 (10 ha area) to 24 ML/year in 2006. At the completion of sand extraction the average annual water loss is estimated to be 36 ML/year (22 ha water surface area).
17. Figure B-4 shows the results of an analysis of the expected water level in the pond under the influence of rainfall and evaporation only. This figure has been derived by subtracting the monthly evaporation from the monthly rainfall using the historic records for the period 1993 – 2006. To make the levels comparable with the levels shown in Figure B-1, the analysis shown in Figure B-4 starts and ends with the same water levels as observed in the pond.

18. Figure B-4 shows that that rainfall and evaporation on the surface of the pond are significant factors in determining the fluctuation of pond water level. However the figure also indicates that groundwater outflow and inflow are significant factors. This is illustrated by the levels observed in the pond as a result of two periods of heavy rainfall from mid 1998 to the end of 1999.
