Albion Park Quarry Annual Review

Period 01 July 2020 – 30 June 2021

Cleary Bros (Bombo) Pty Ltd

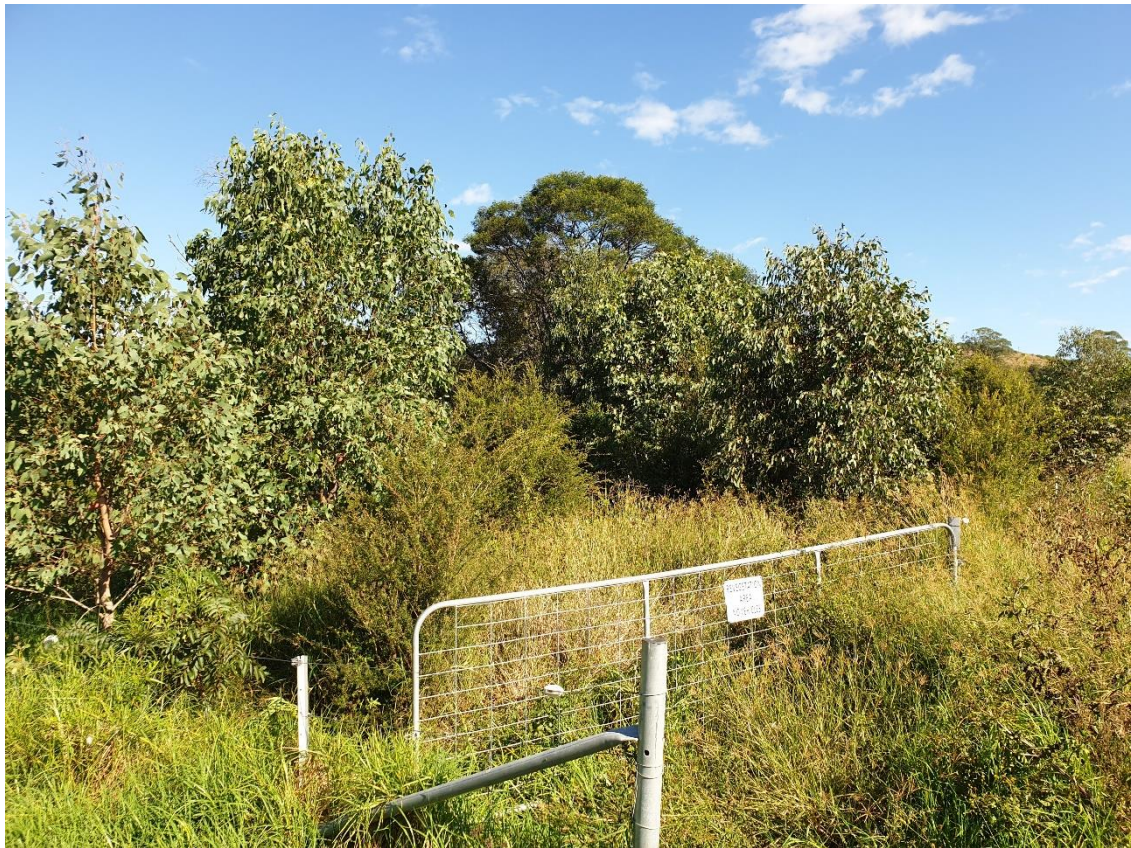
Zone 3, which was replanted in 2017 following significant dieback, has responded particularly well to the improved rainfall in the past year as shown by the following photo taken from the eastern end of this zone in April 2021. The growing canopy is now starting to restrict the growth of annual weeds in this zone.

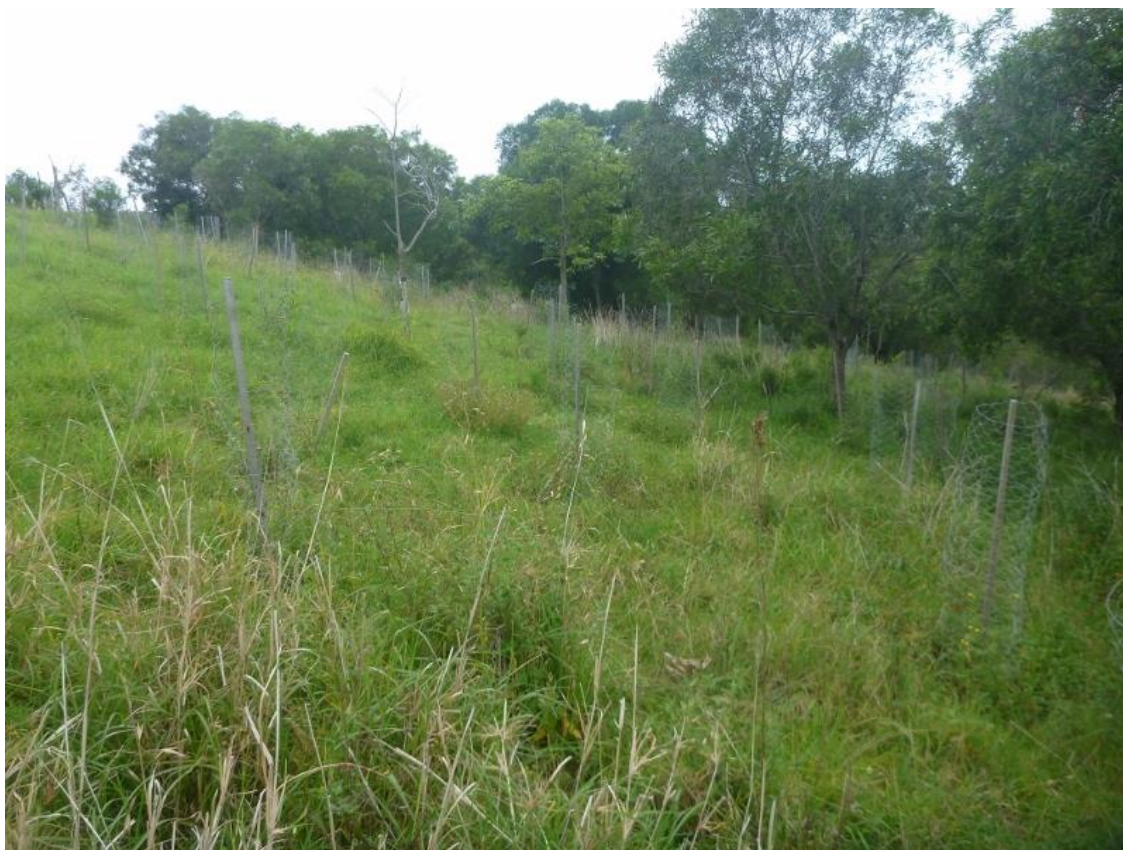
Zone 1 planting area after cage maintenance

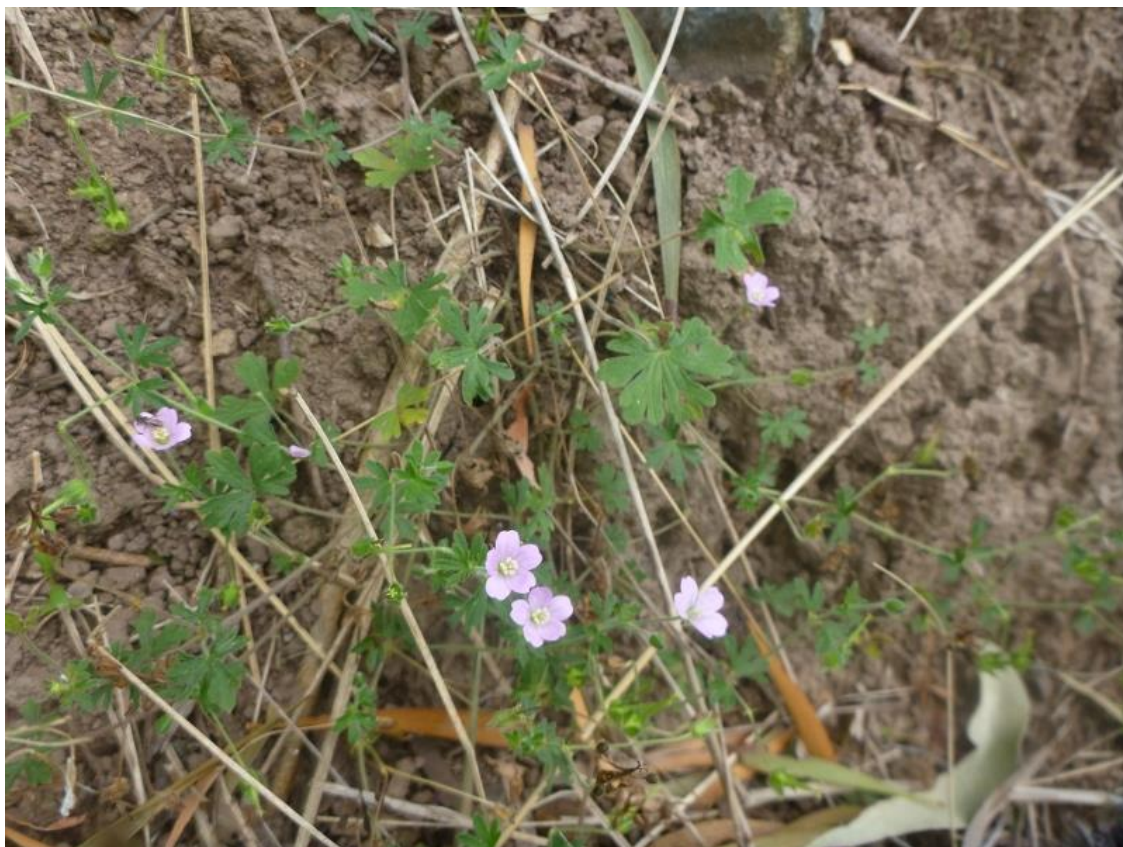
Regeneration of Cutleaf Cranesbill (*Geranium solanderi*) within Zone 2

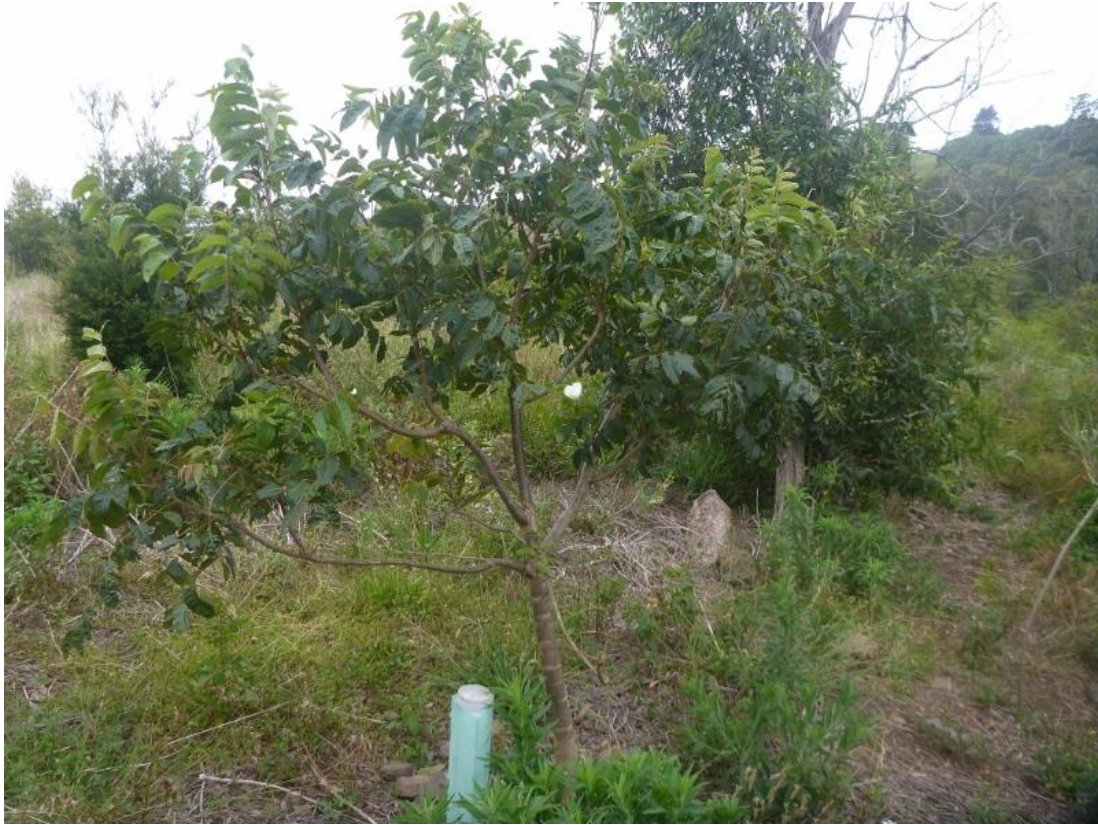
Zone 2 revegetation area showing plant establishment

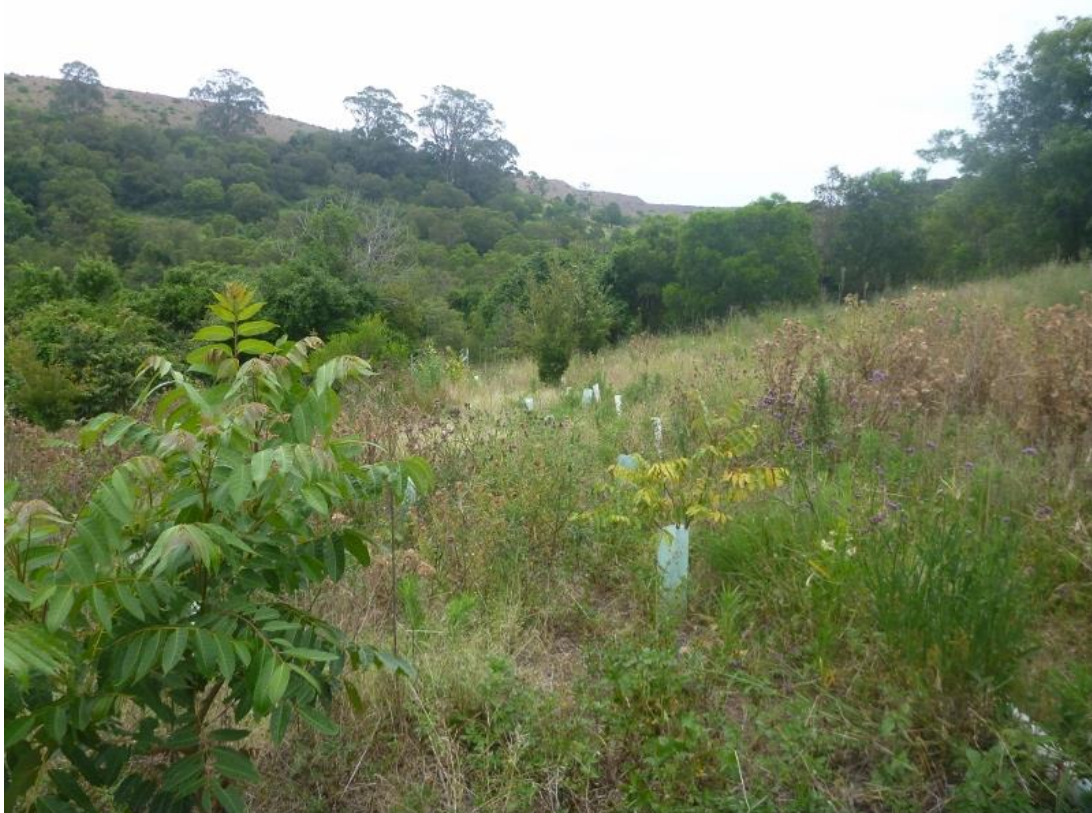
Zone 2 revegetation area showing plant establishment

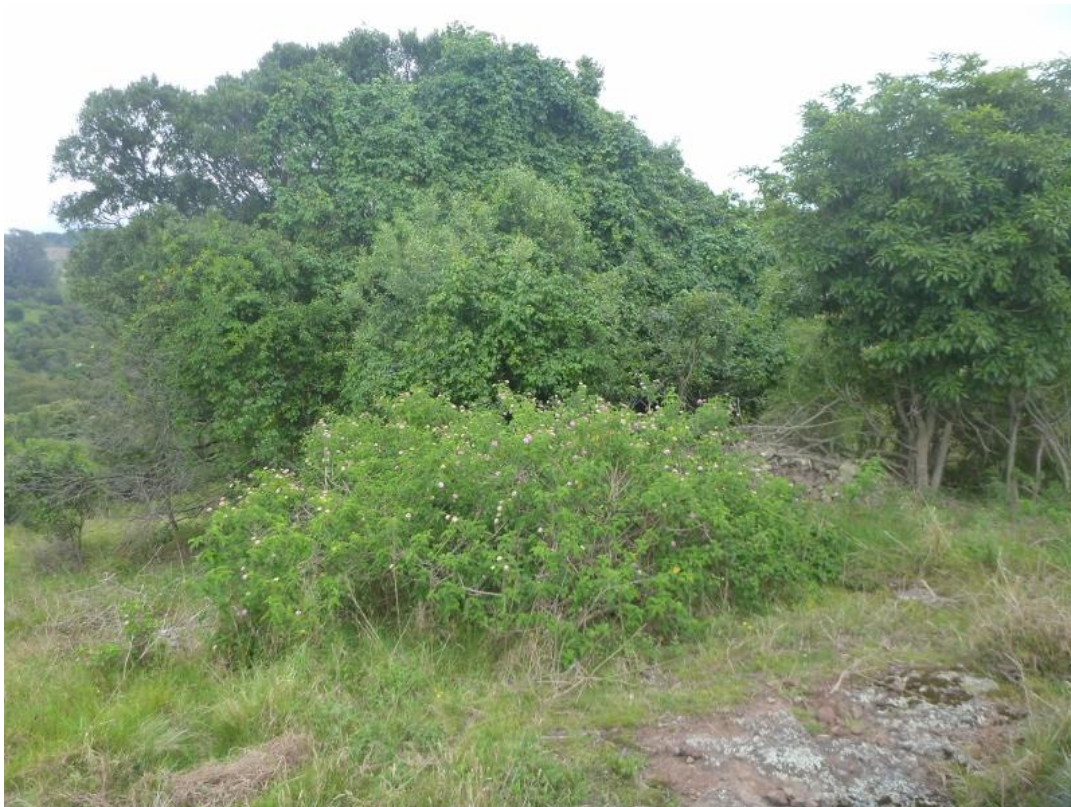
Zone 5 rainforest remnant prior to primary weed control

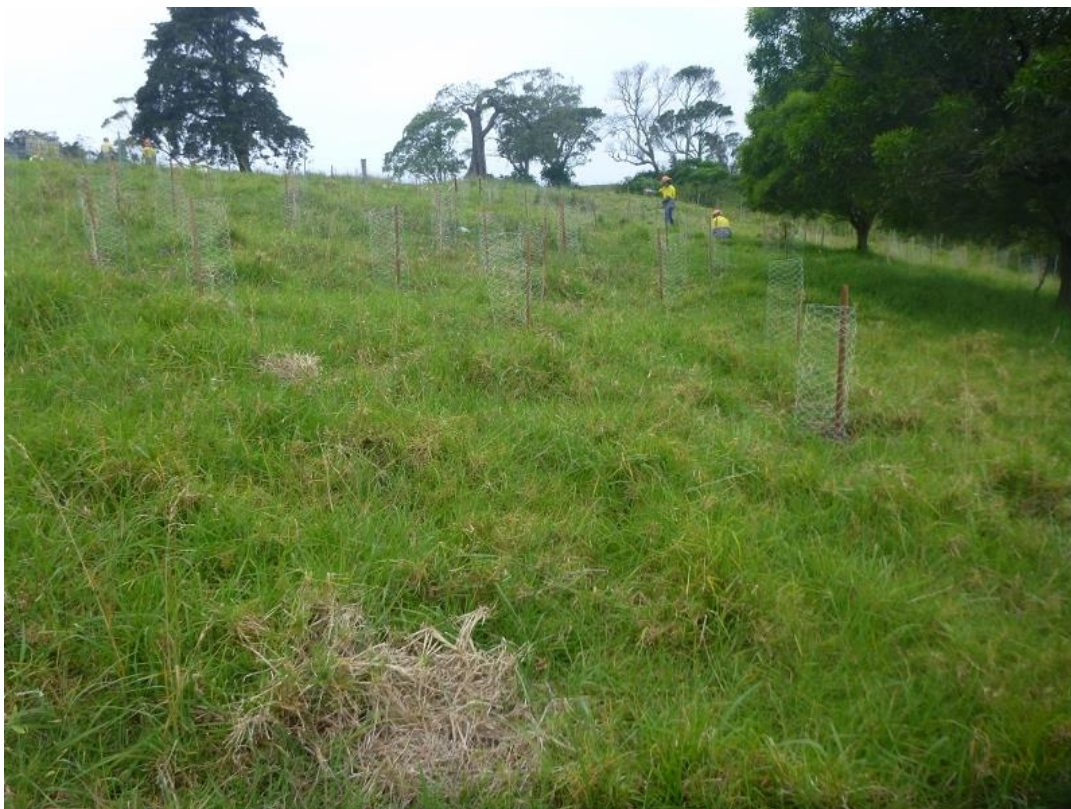
Installation of plant protection cages within Zone 5

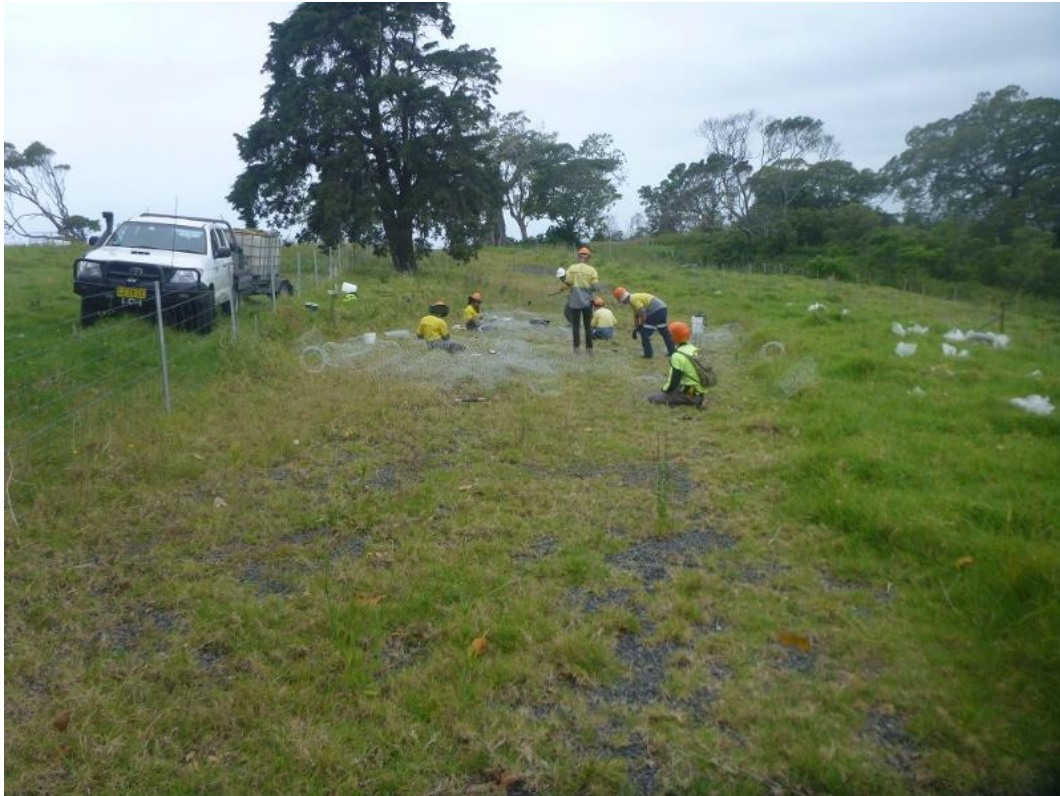
Zone 5 planting compound during construction of plant protection cages

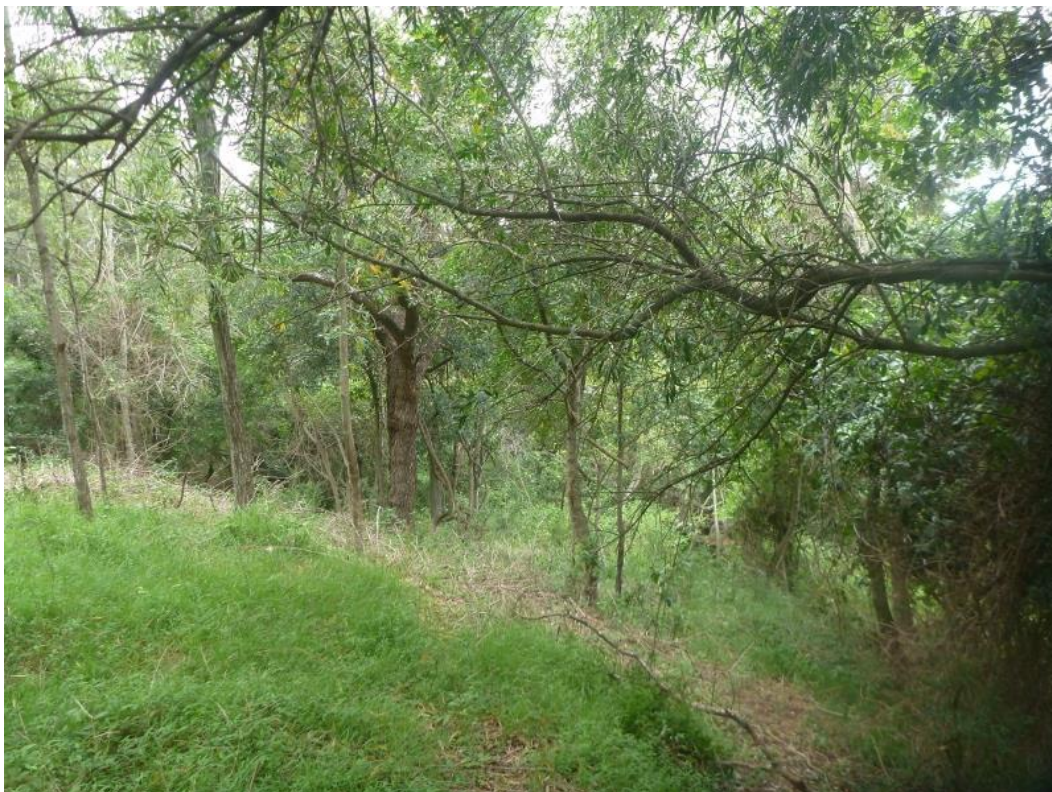
Zone 8 primary weed control area on the ecotone between woodland and rainforest

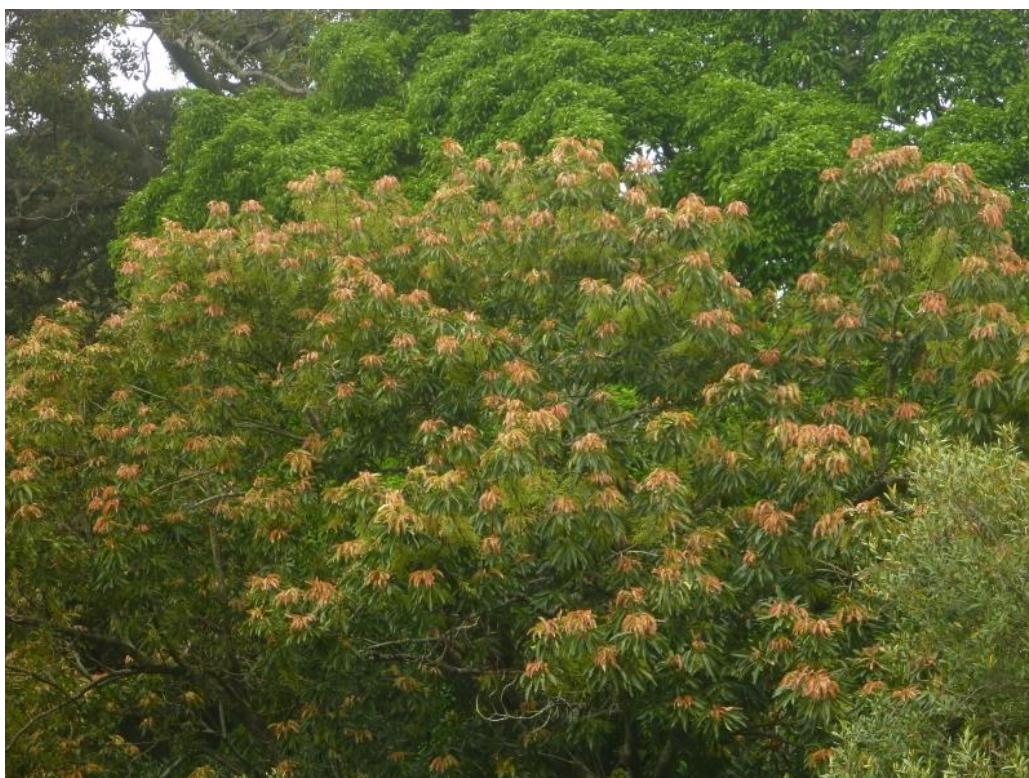
Pigeonberry Ash (*Elaeocarpus kirtonii*) with new growth in Zone 8

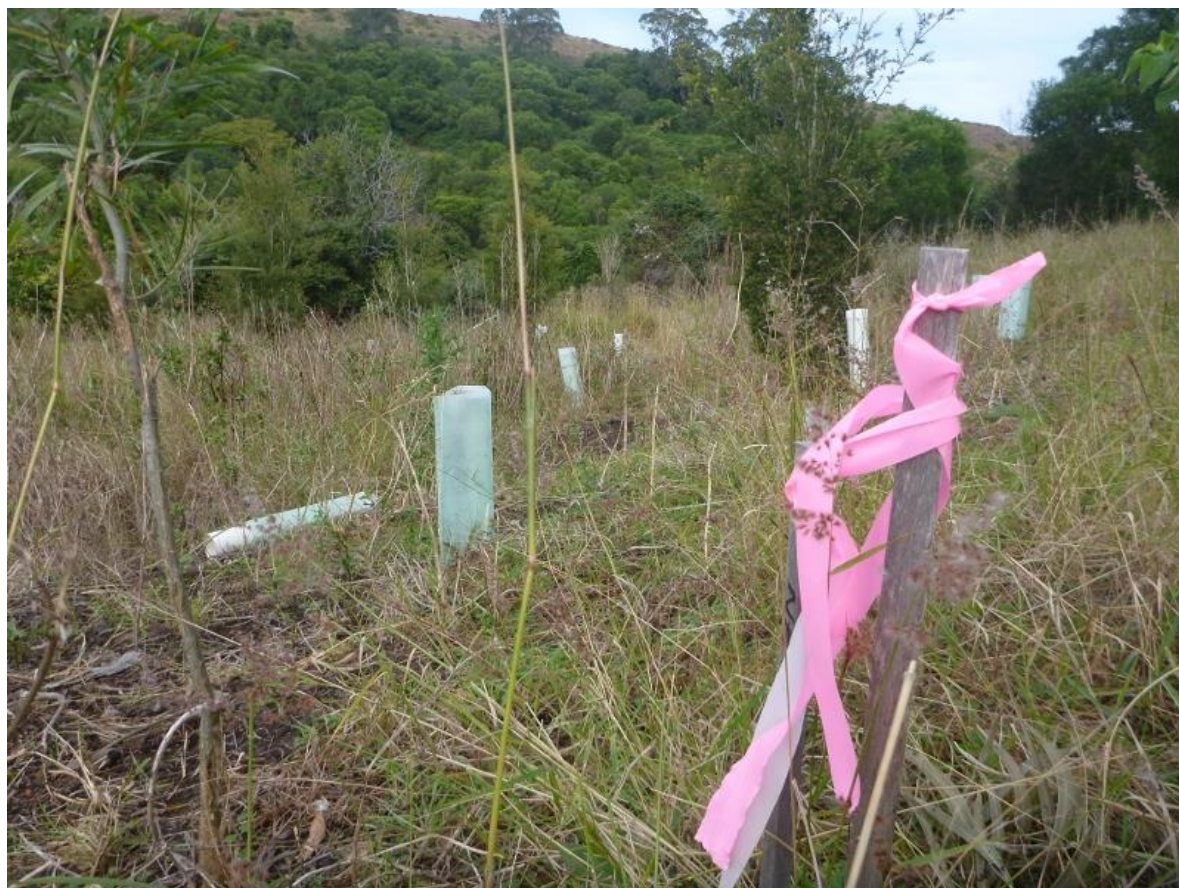
Plot 2 NE corner photo

Vegetation Condition:	Poor, disturbed weedy revegetation area
Fauna Evidence:	Wallaby
Significant Species:	n/a

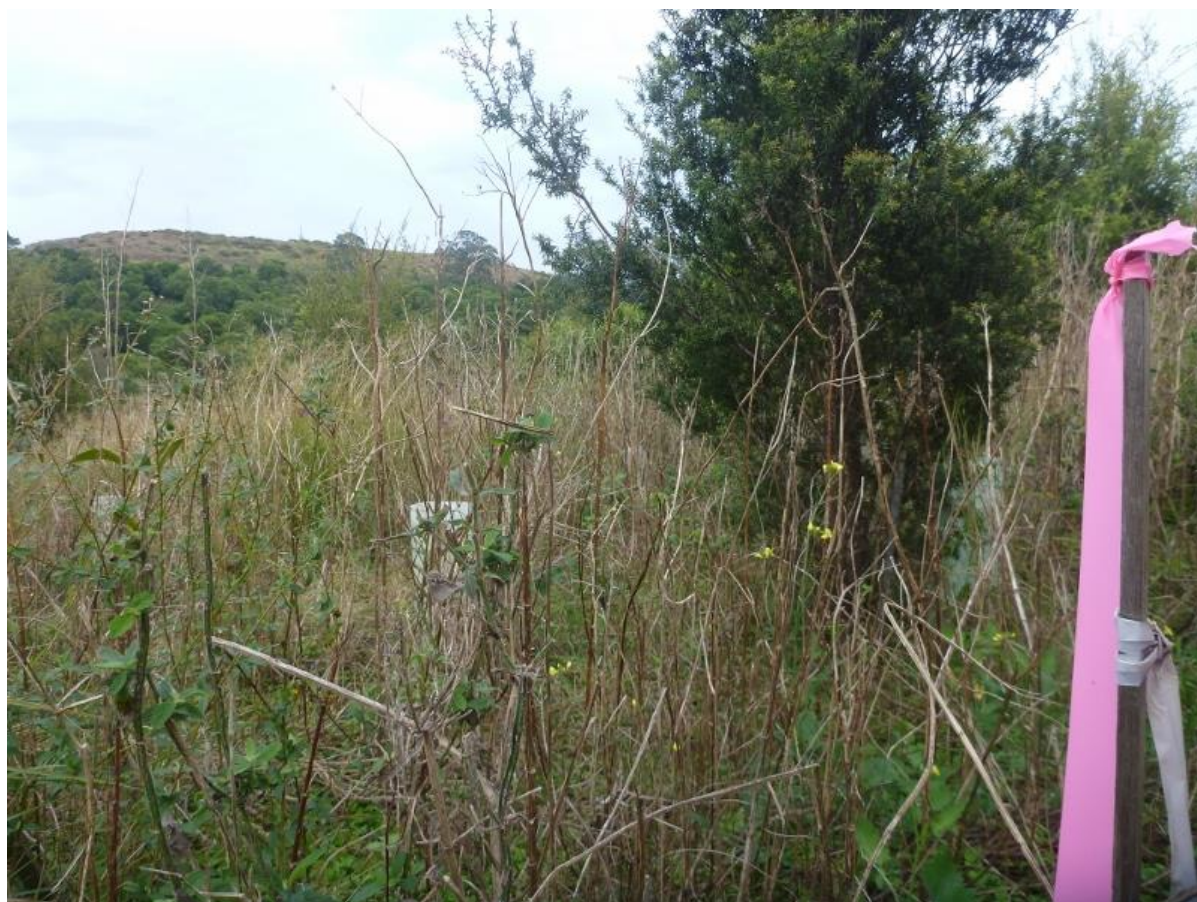
Plot 3 NE corner photo

Vegetation Condition:	Poor, disturbed weedy revegetation area
Fauna Evidence:	Wallaby
Significant Species:	<i>n/a</i>

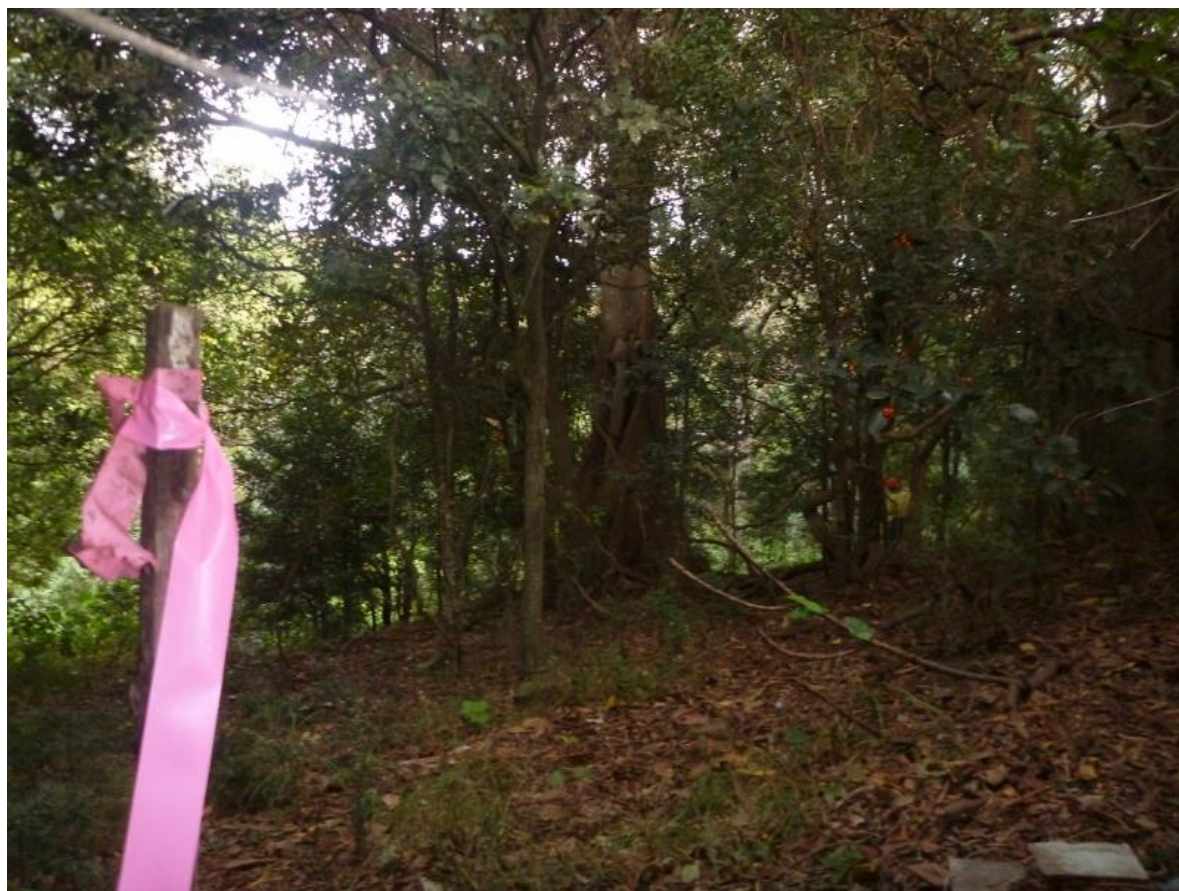
Plot 6.1 NE corner photo

Vegetation Condition:	Remnant Dry Rainforest intact canopy with a weedy sub-layer
Fauna Evidence:	n/a
Significant Species:	n/a

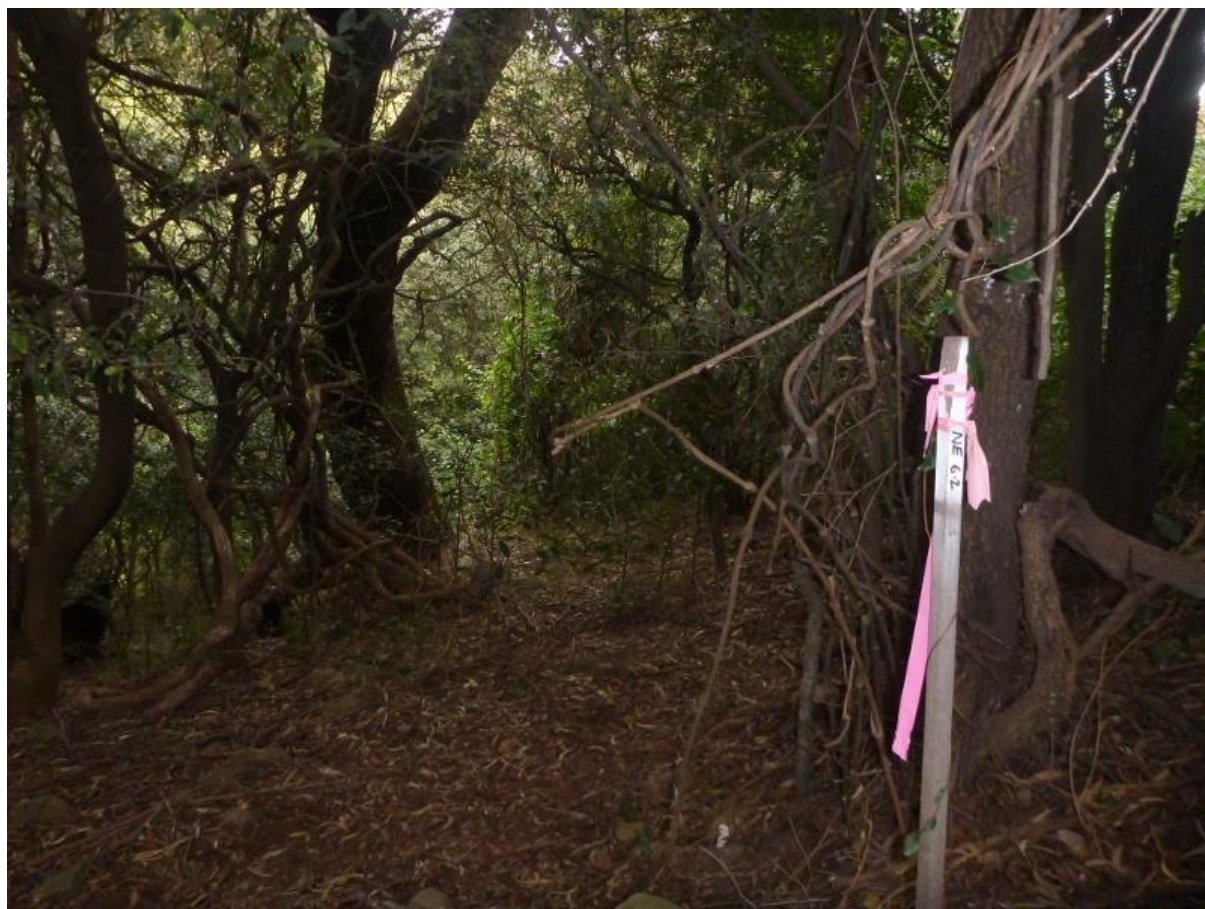
Plot 6.2 NE corner photo

Vegetation Condition:	Intact canopy, weedy shrub layer
Fauna Evidence:	n/a
Significant Species:	n/a

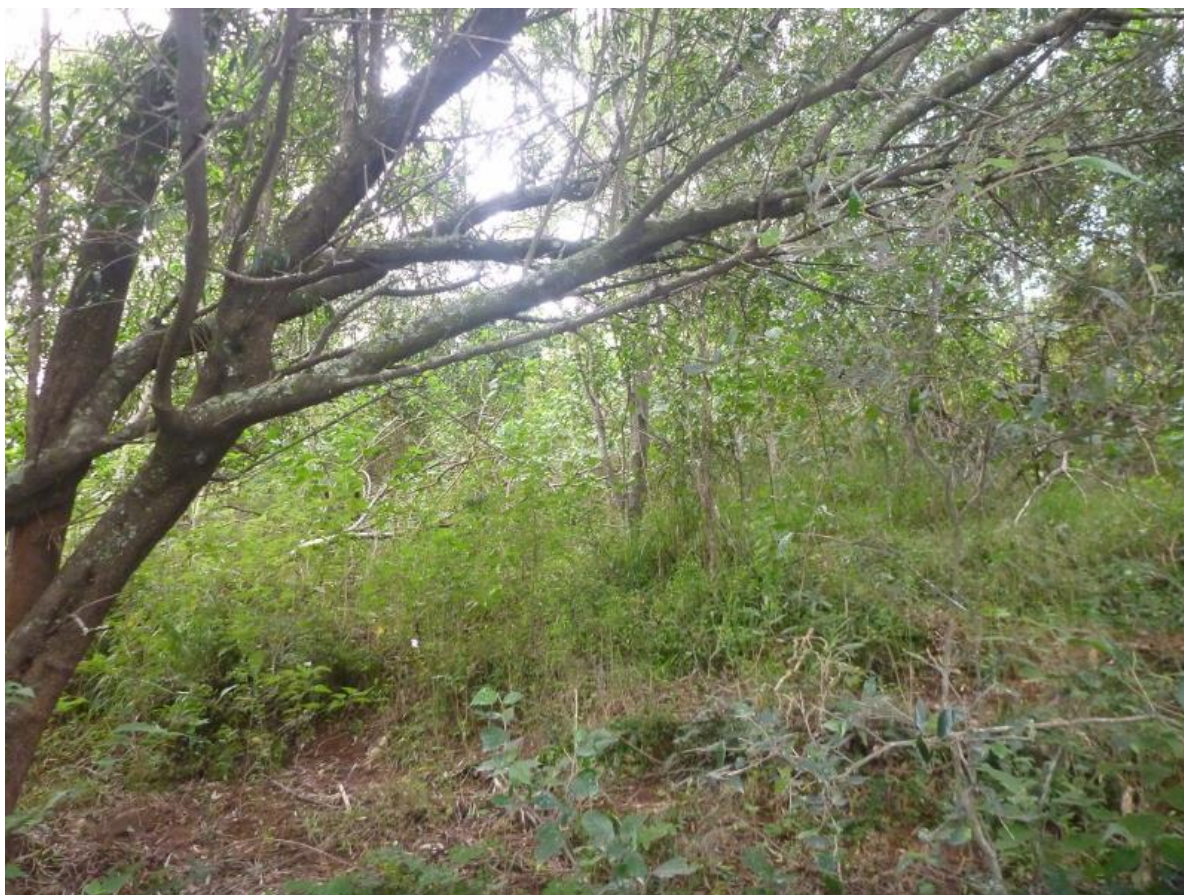
Plot 8.1 NE corner photo

Vegetation Condition:	Intact canopy with a disturbed understorey
Fauna Evidence:	Wallaby and cattle
Significant Species:	n/a

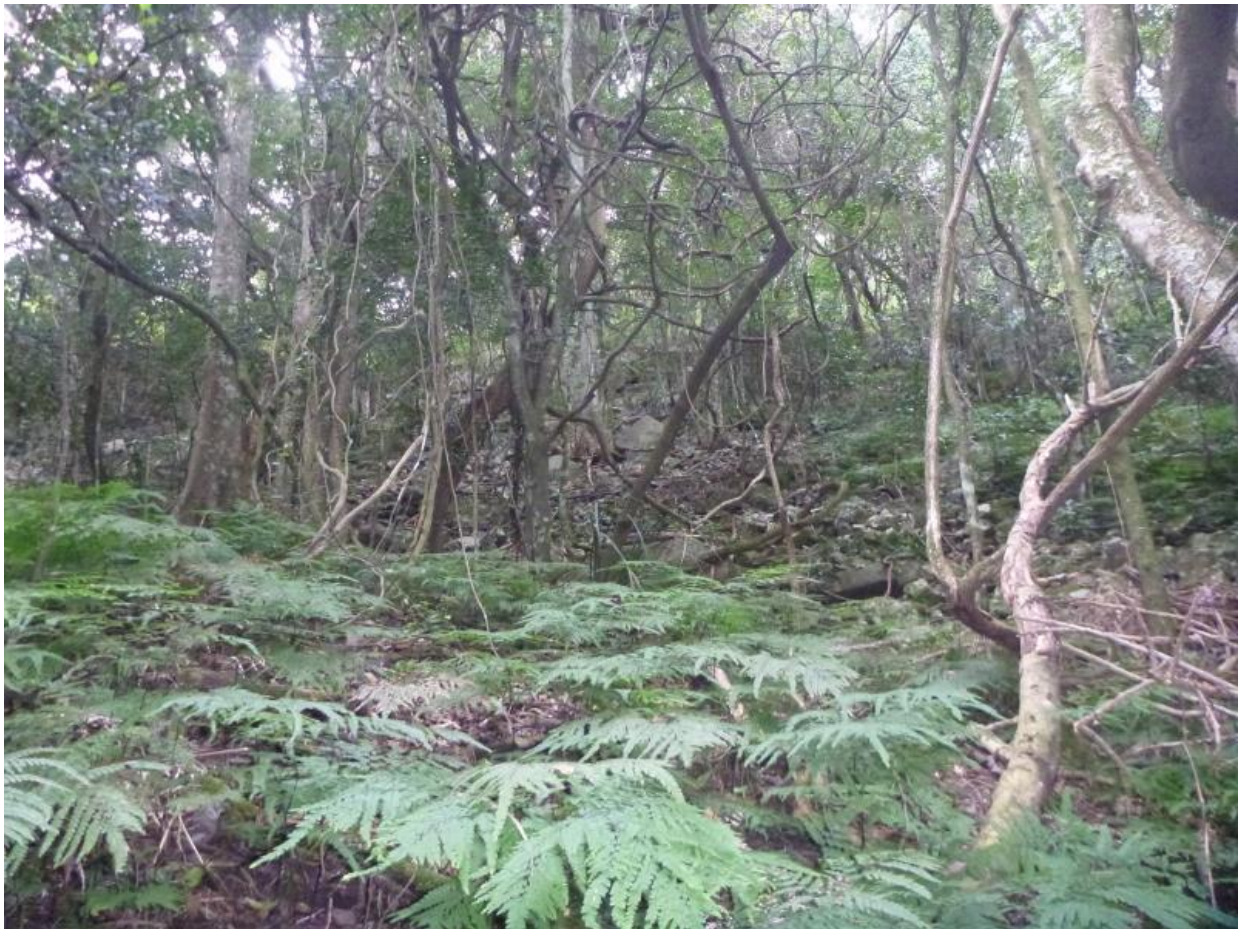
Plot 8.2 NW corner Photo

Vegetation Condition:	Remnant Subtropical Rainforest with intact canopy
Fauna Evidence:	Animal tracks
Significant Species:	<i>Daphnandra johnsonii</i> Illawarra endemic threatened species

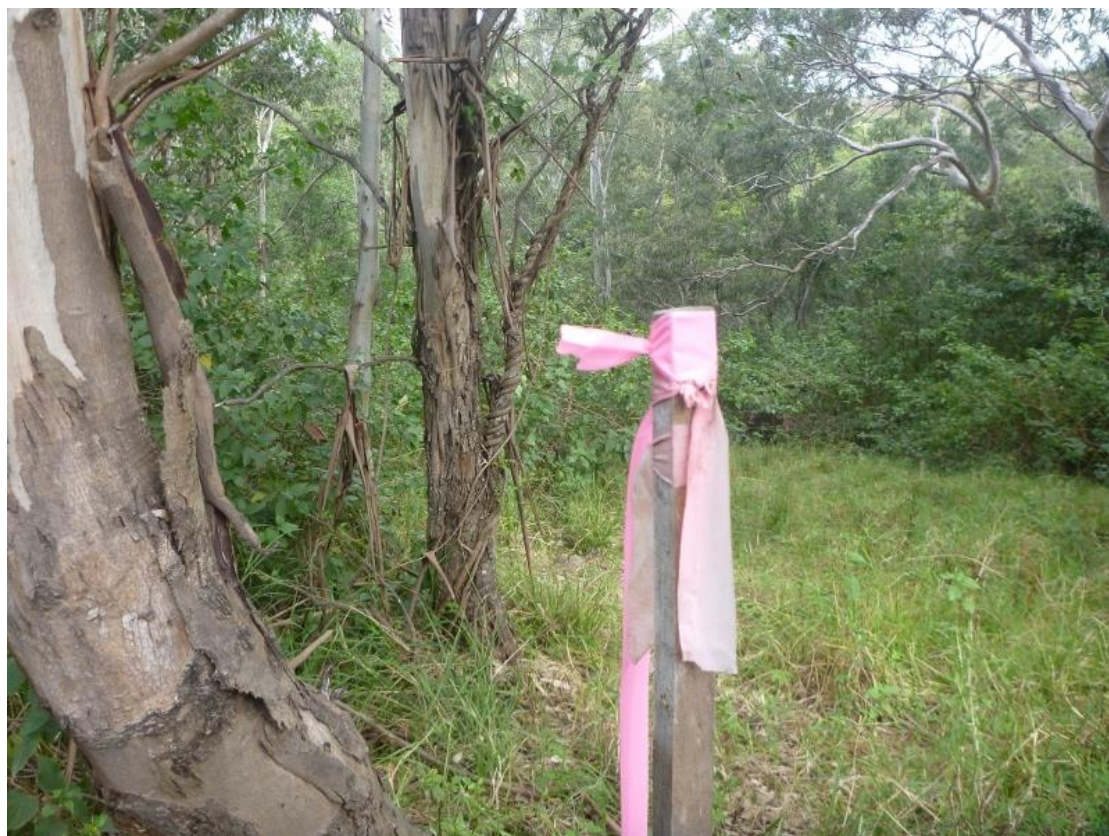
Plot 8.3 NE corner photo

Vegetation Condition:	Intact canopy, poor weed infested understorey
Fauna Evidence:	Grazing animals – cattle
Significant Species:	<i>n/a</i>

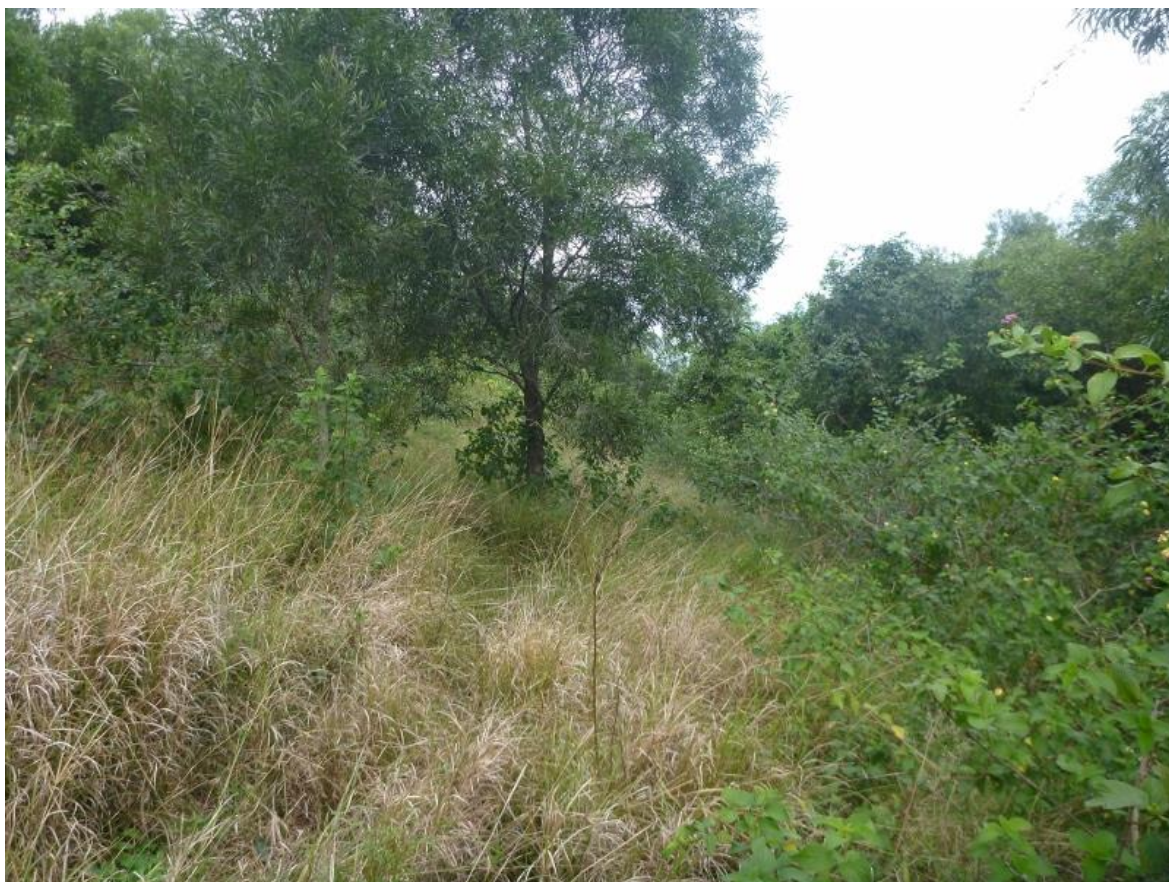
Plot 9 NW corner photo

Vegetation Condition:	Disturbed open grassland. Heavily weed infested, no canopy
Fauna Evidence:	Wallaby
Significant Species:	<i>n/a</i>

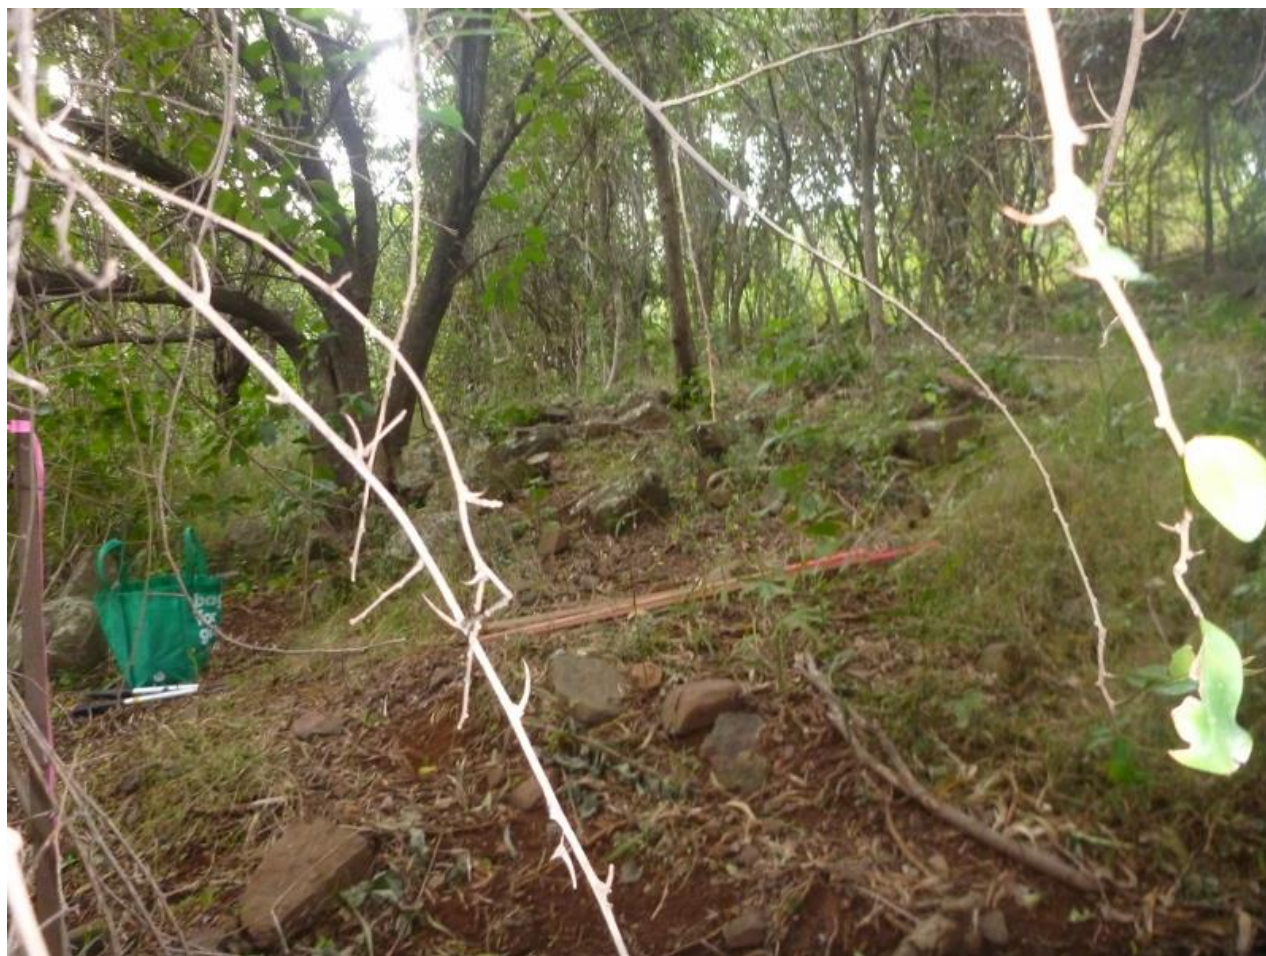
Plot 10.1 SW corner photo

Vegetation Condition:	Intact canopy, poor understory
Fauna Evidence:	Wallaby scats
Significant Species:	n/a

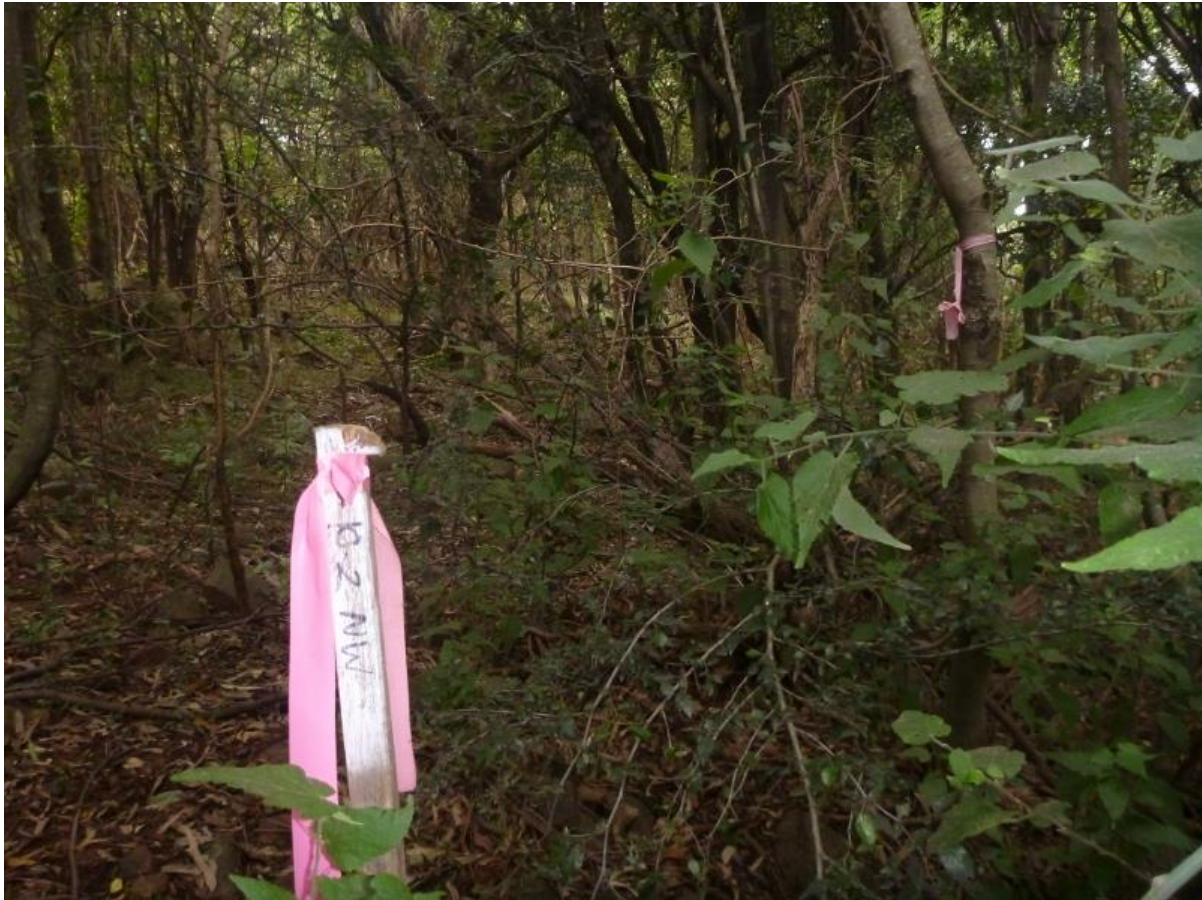
Plot 10.2 NW corner photo

Vegetation Condition:	Intact canopy with a poor understory
Fauna Evidence:	Wallaby
Significant Species:	n/a

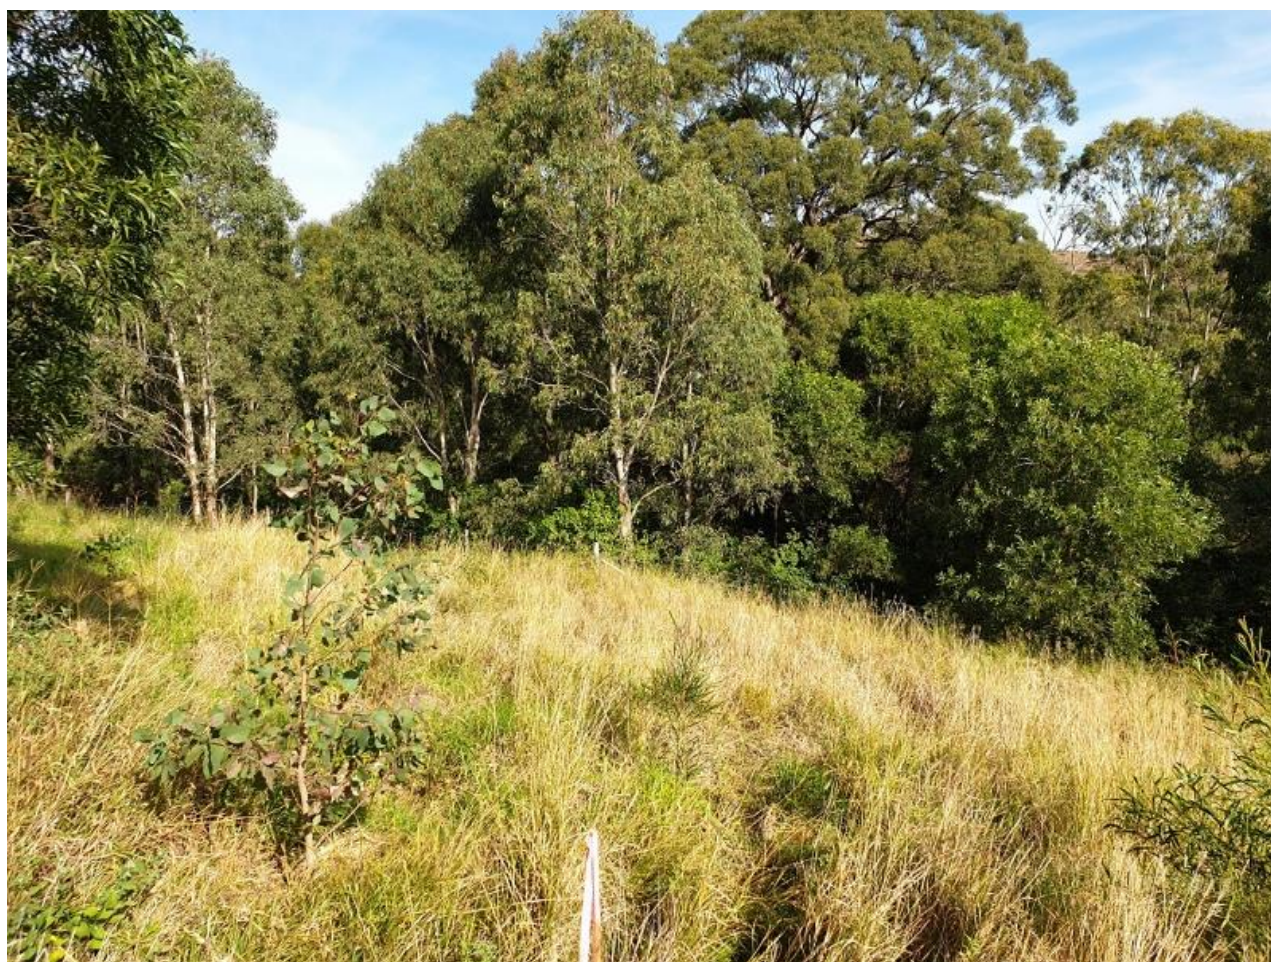
Plot4 NE corner photo

Vegetation Condition:	Recent revegetation area
Fauna Evidence:	Eastern Grey Kangaroo, Fox scats
Significant Species:	<i>n/a</i>

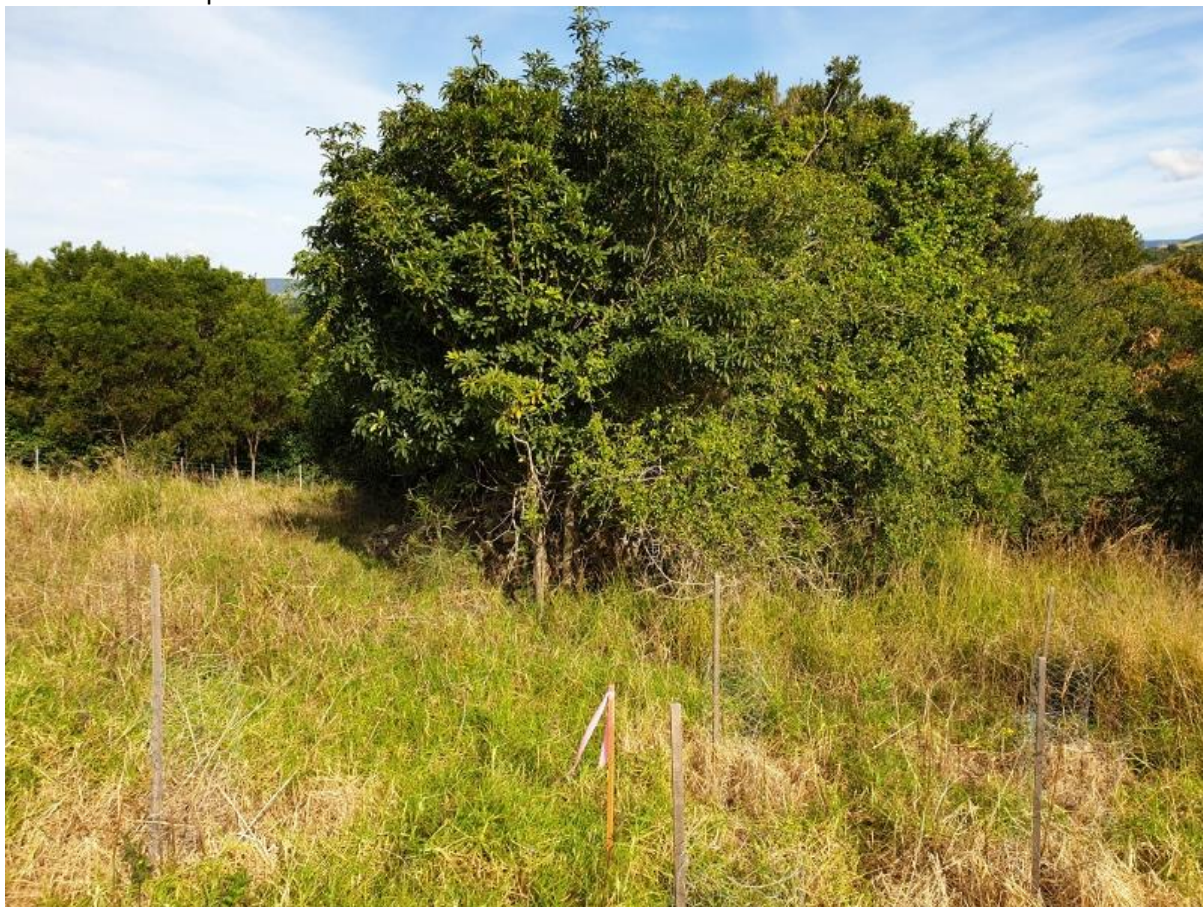
Plot 5 NE corner photo

Vegetation Condition:	Recent revegetation area/ dry rainforest in good condition
Fauna Evidence:	n/a
Significant Species:	<i>Cynanchum elegans</i>
