# **ALBION PARK QUARRY**

## **ANNUAL REVIEW**

**Period 01 July 2021 – 30 June 2022**

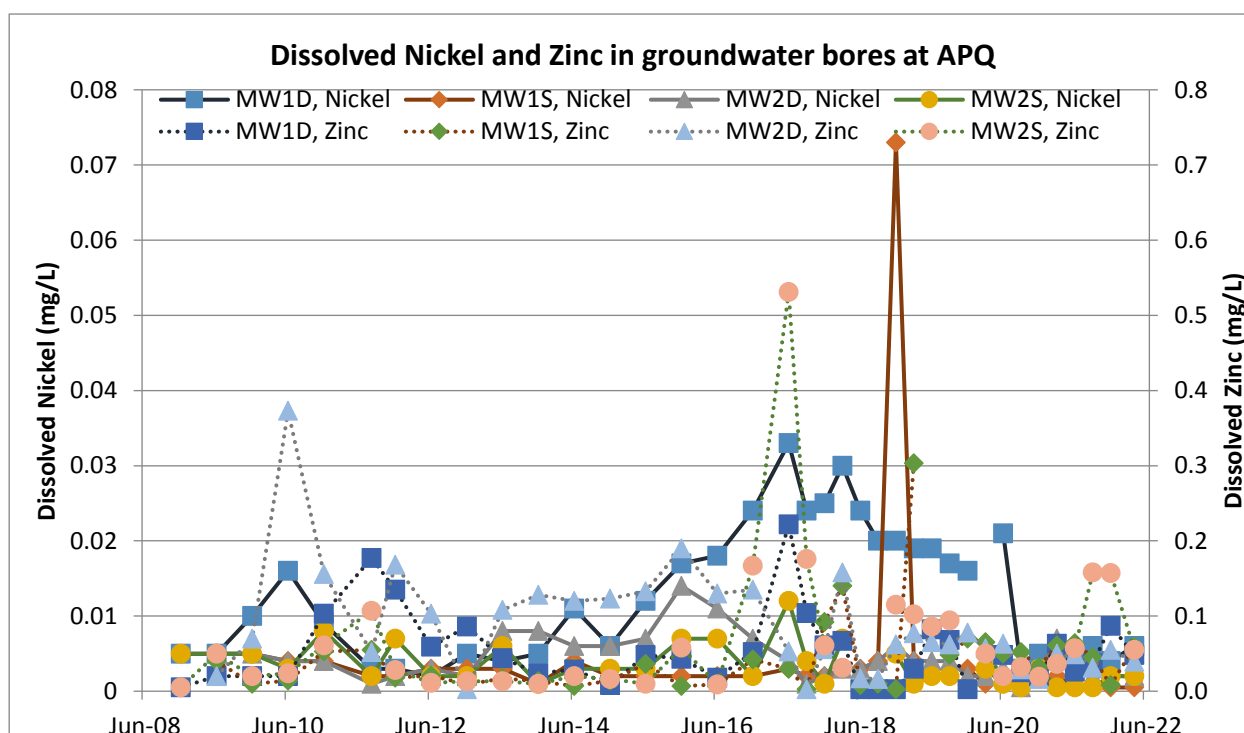
Concentrations of all dissolved metals remained low during the reporting period and within historical ranges of the respective analytes. Dissolved copper, iron, nickel and zinc concentrations showed similar patterns of natural variability to the historical results for these analytes, indicating no deterioration in groundwater quality related to concentrations of dissolved metals.

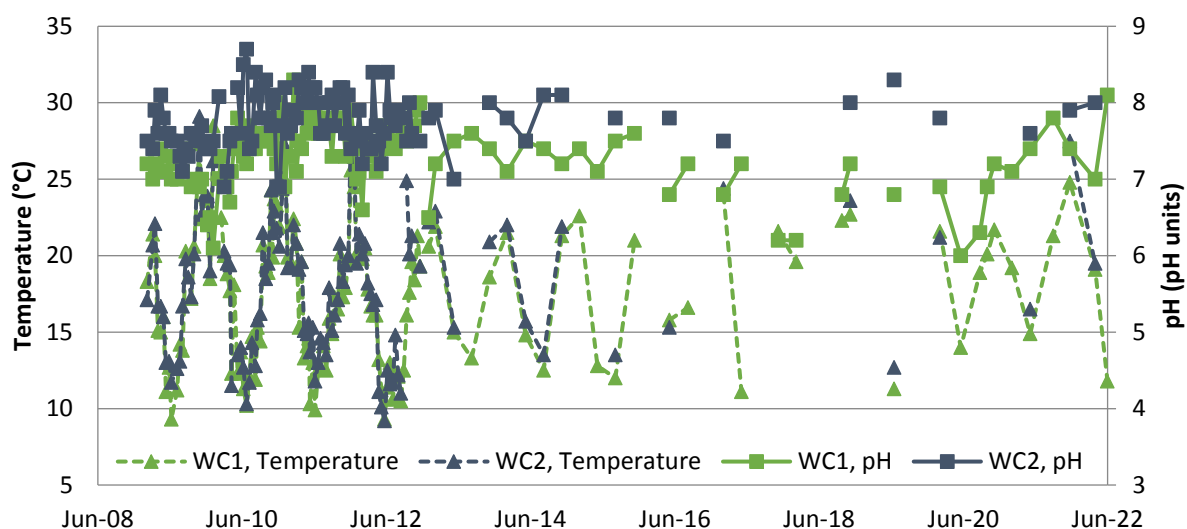
pH and Temperature of Watercourses 1 &amp; 2

pH has continued to show some variability in the current reporting period, which is consistent with the longer term trend. Temperature continues to show fluctuations in line with the seasons. Electrical conductivity has decreased during the current reporting period, likely a result of higher baseflows and a reduction in the electrical conductivity of the shallow groundwater. The monitoring point on WC1 was moved slightly downstream in 2020 to a small old on-stream farm dam, providing more reliable sampling opportunities, but the dam is subject to evaporative concentration outside of rainfall events. Turbidity measurements have remained low and relatively stable. All field measurements were generally consistent with the historical measurements for the respective watercourses.

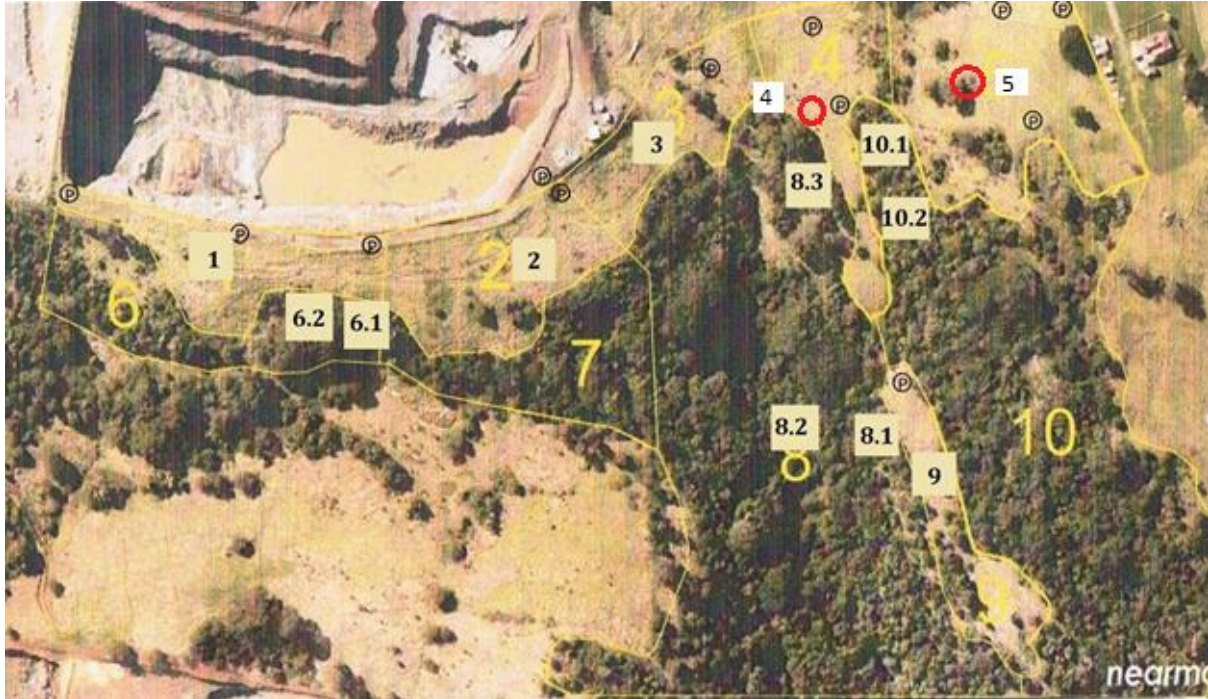
The rehabilitation areas were divided into 10 zones and the plan required 13 plots to be permanently established. The zones and location of the monitoring plots are shown on the map below (KMA 2018):

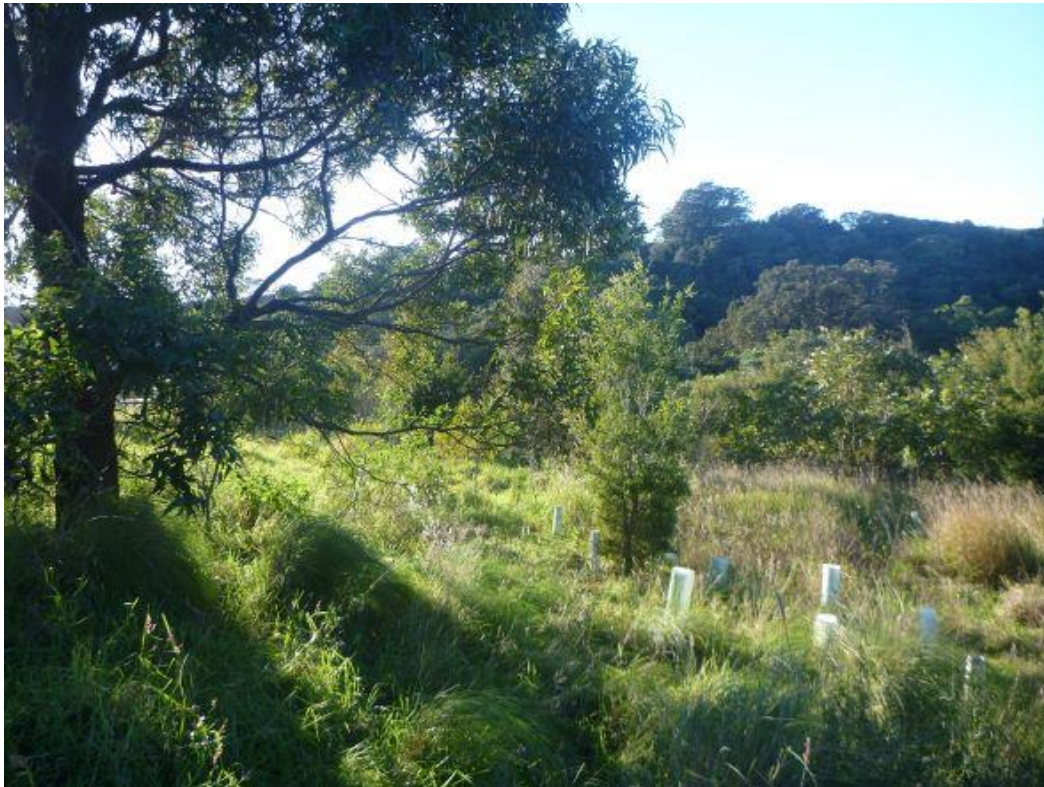
Zone 2 monitoring point showing establishment of revegetation

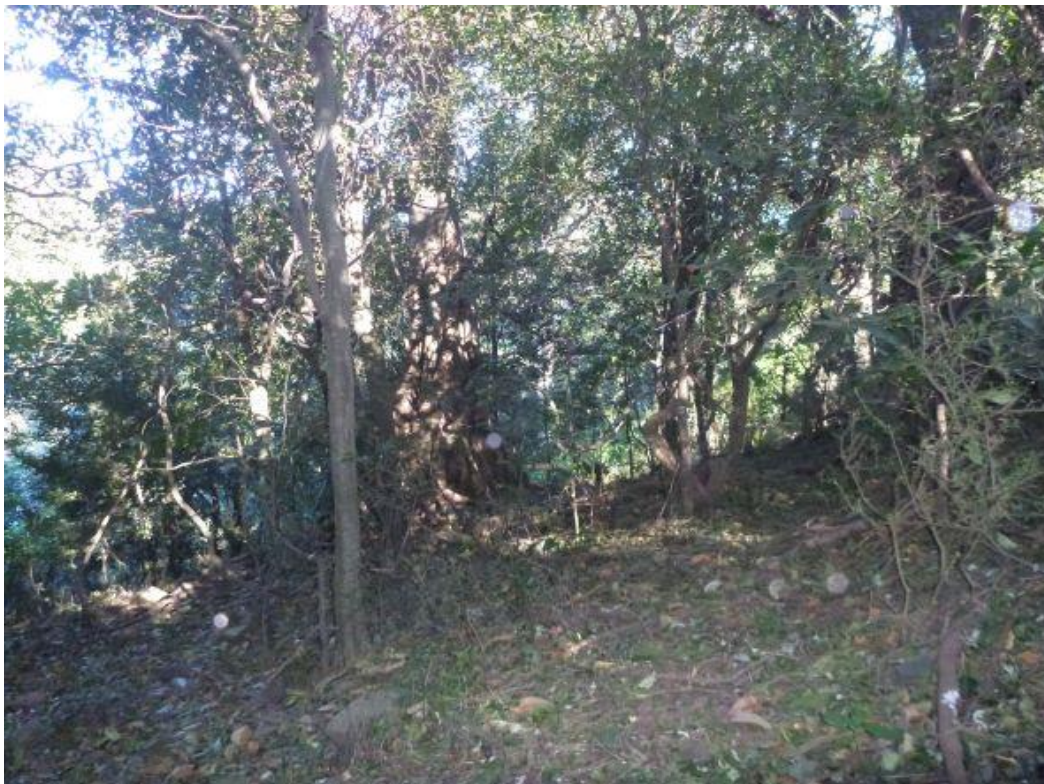
Plot 6.1 showing little change from last years survey

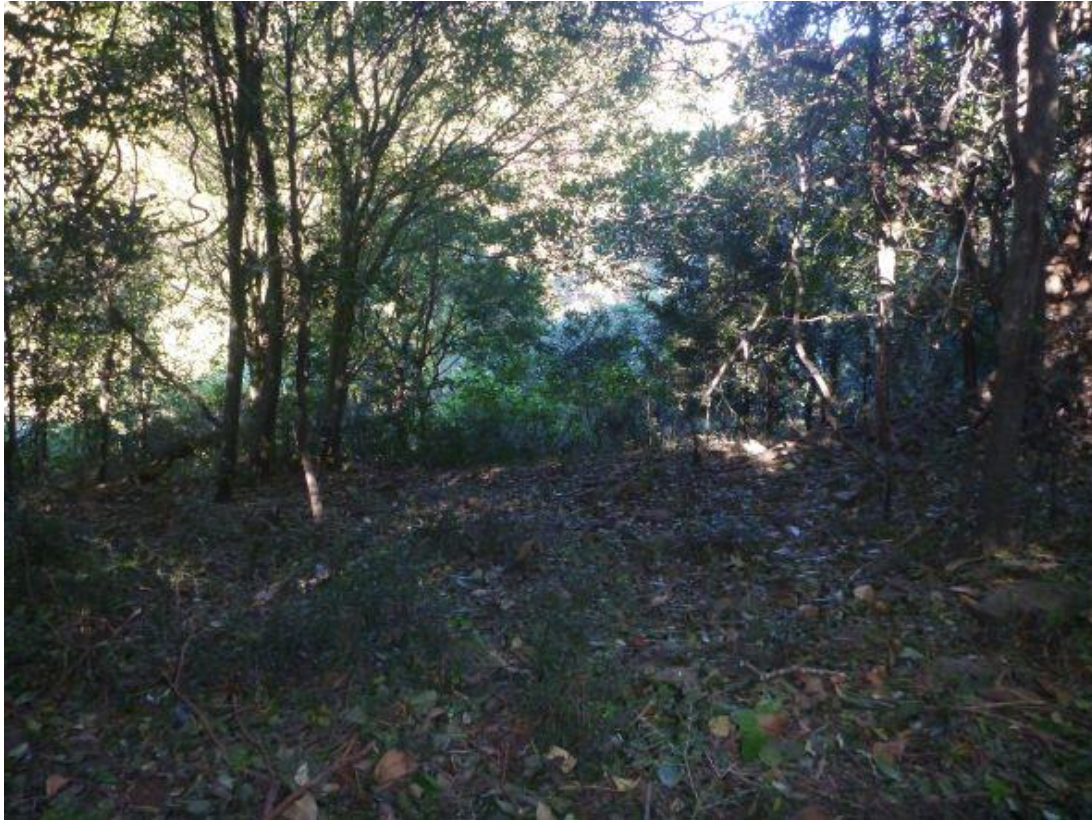
Plot 6.2 showing established intact canopy with little weed recruitment occurring

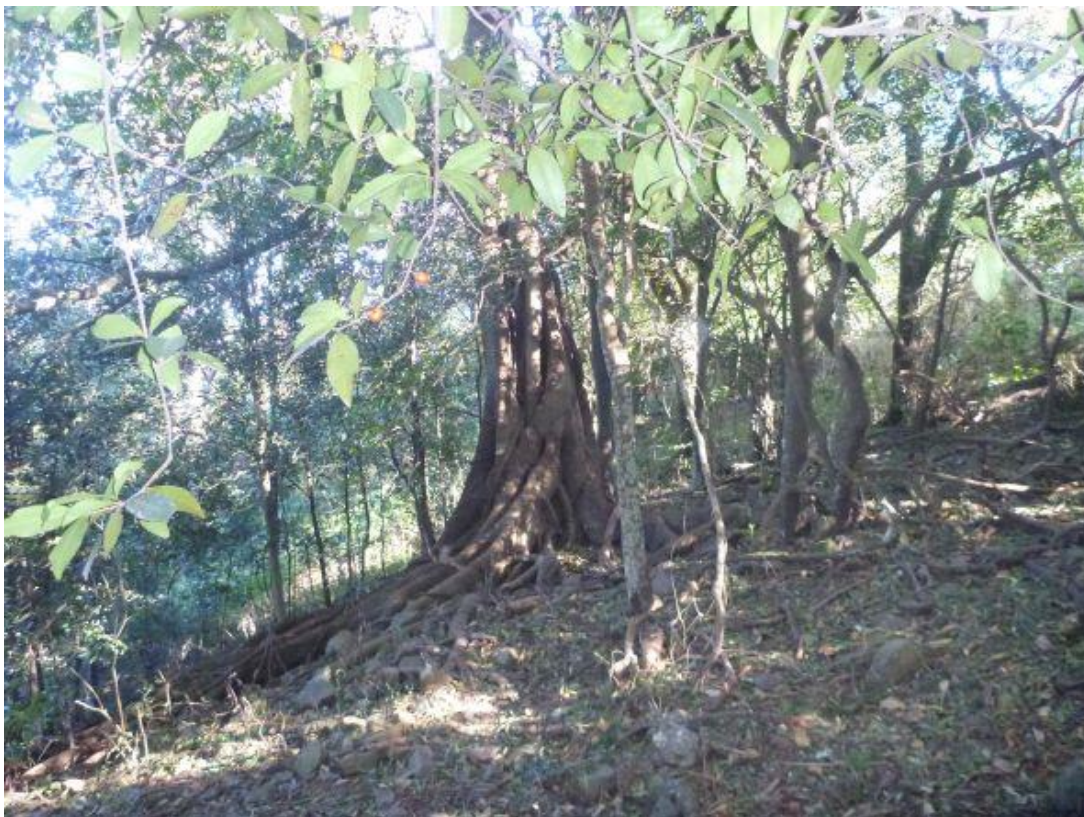
Plot 6.2 Moreton Bay Fig dominating the canopy and assisting to exclude weeds

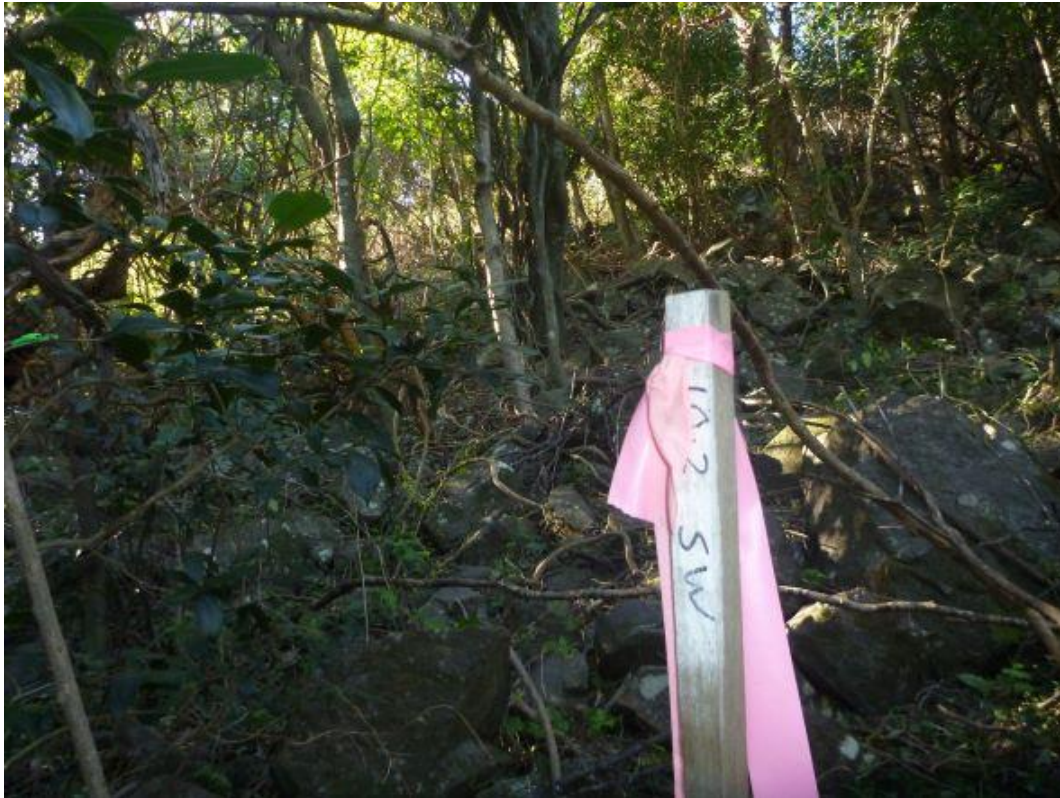
Plot 10.2 showing little change from previous surveys

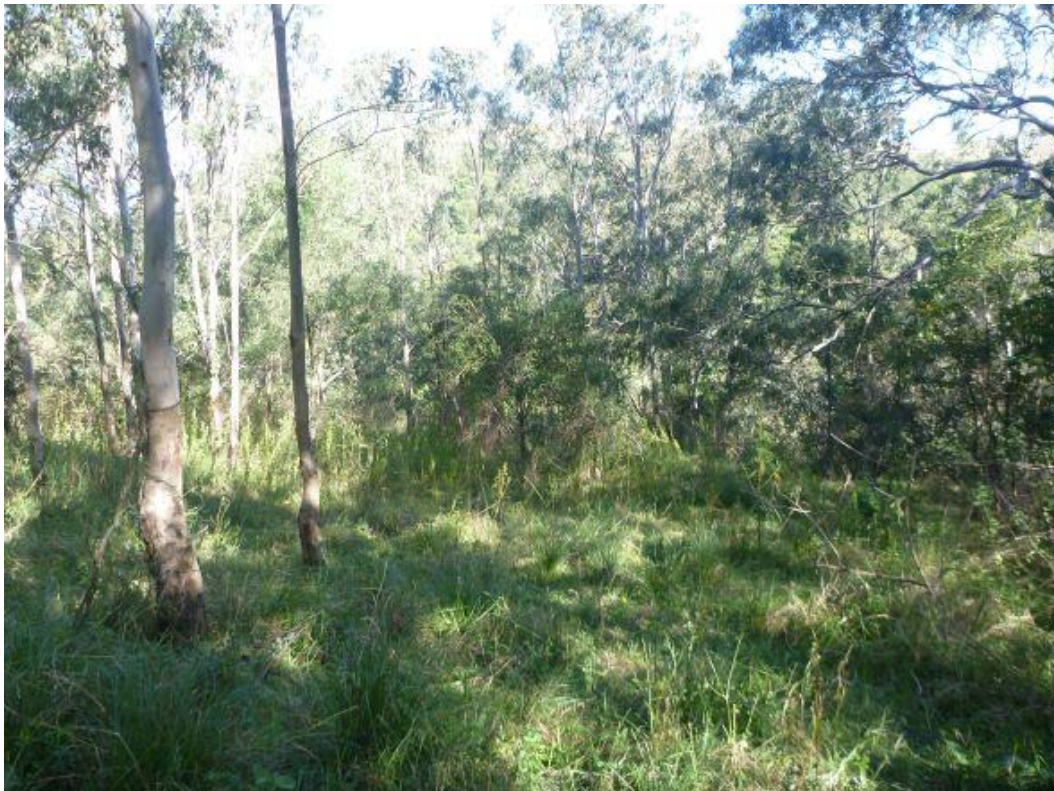
The newly established plot 4 Woodland treatment area showing areas where Lantana has been removed and regeneration of native grasses and groundcovers occurring

Woody weeds such as Lantana and Wild Tobacco were observed within some zones of the rehabilitation areas and Moth Vine is evident due to its high seed production and wind dispersed method. Treatment of woody weeds within this site should follow the Bradley method of working from areas of intact canopy and minimal weed encroachment toward the areas where weed frequency is higher.
