# Albion Park Quarry

## Historic Heritage Management Plan

Version 5 | Revision 2

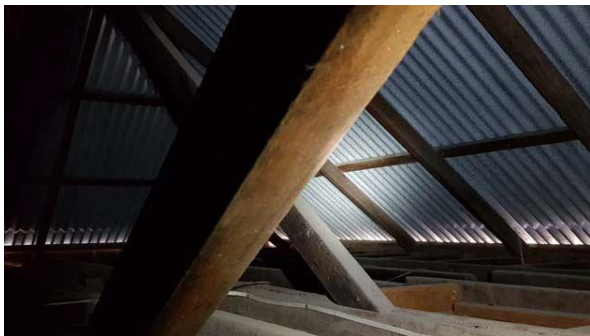
**Figure 6: Large Timber Beams in the roof (Source: Design 5, Dilapidation Survey 2018)**

‘Belmont’ homestead, upper roof structure	Good	Little	<ul style="list-style-type: none"> <li>Asbestos</li> <li>Lead paint</li> </ul>	<ul style="list-style-type: none"> <li>Larger structural beams and any smaller beams in good condition will be available to local interested parties for recovery or display</li> <li>Materials in poor condition beyond safe repair will be safely discarded</li> <li>Materials contaminated with asbestos or lead paint will be safely decontaminated if feasible, and if not safely feasible, discarded in accordance with EPA waste guidelines</li> <li>The items to be recovered will be stored safely on site until the materials can be claimed for recovery by the interested parties</li> </ul>
4-panelled internal doors

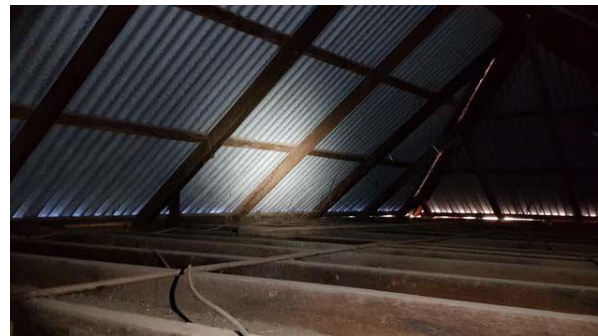
**Figure 7: Large Timber Beams in the roof (Source: Design 5, Dilapidation Survey 2018)**

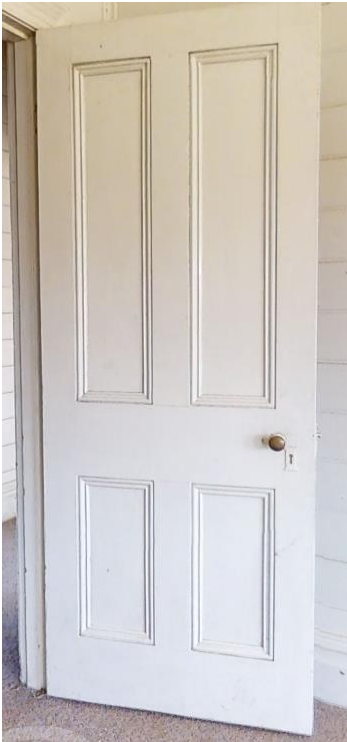
**Figure 8: Timber 4-panelled internal doors (Source: Cleary Bros. 3D Model – The ‘Belmont’)**

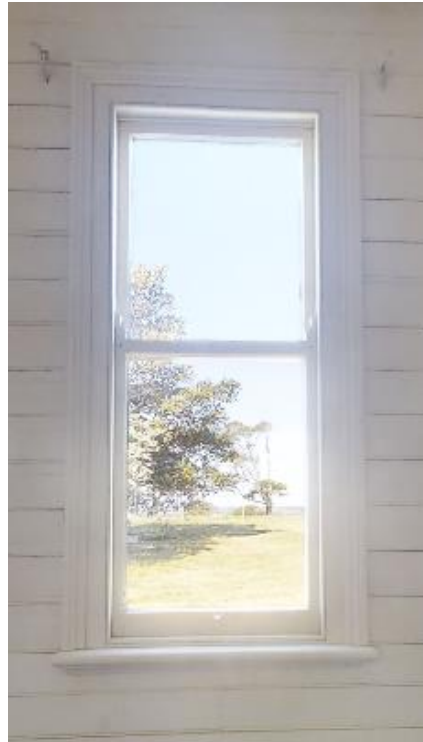
**Figure 9: Timber window frame Source: Cleary Bros. 3D Model – The ‘Belmont’)**

Inside 'Belmont' homestead at all window locations	Good	Little	<ul style="list-style-type: none"> <li>Asbestos</li> <li>Lead paint</li> <li>Broken glass/glass sharding</li> </ul>	<ul style="list-style-type: none"> <li>All timber window and door frames, and accompanying glass panelling will be available to local interested parties for recovery or display</li> <li>Any window or door framing with extensive flaking or powdering paint will be safely decontaminated if possible, or safely discarded in accordance with EPA waste guidelines</li> <li>The items to be recovered will be stored safely on site until the materials can be claimed for recovery by the interested parties</li> </ul>
<b>Timber skirting boards</b>

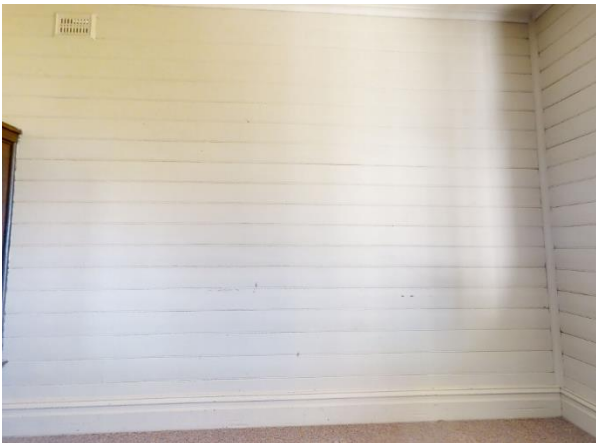
**Figure 10: Timber skirting boards (Source: Cleary Bros. 3D Model – The ‘Belmont’)**

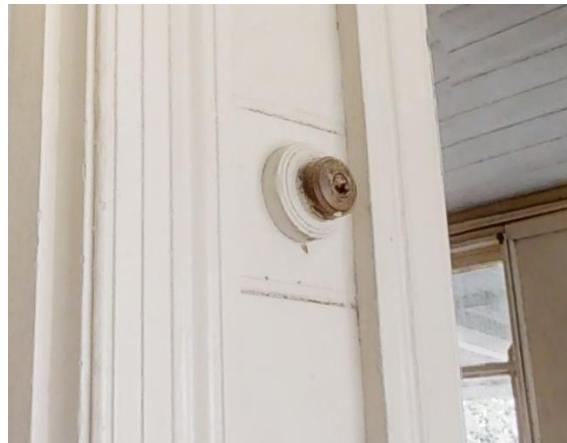
**Figure 11: Early light switch (Source: Cleary Bros. 3D Model – The ‘Belmont’)**

At varied locations throughout the 'Belmont' homestead	Fair	Moderate	<ul style="list-style-type: none"> <li>Asbestos</li> <li>Lead paint</li> <li>Loose electrical wires</li> </ul>	<ul style="list-style-type: none"> <li>All early light switches would be safely removed from the homestead and be available to local interested parties for recovery or display</li> <li>Any extensively damaged light switches will be safely discarded</li> <li>The items will be stored safely on site until the materials can be claimed for recovery by the interested parties</li> </ul>

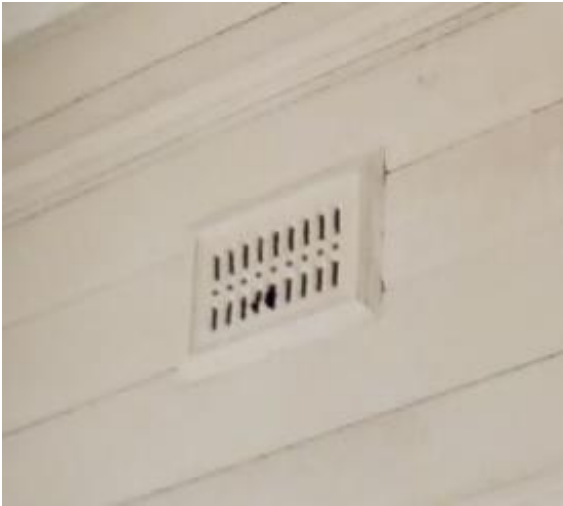
**Figure 12: Wall vent (Source: Cleary Bros. 3D Model – The ‘Belmont’)**

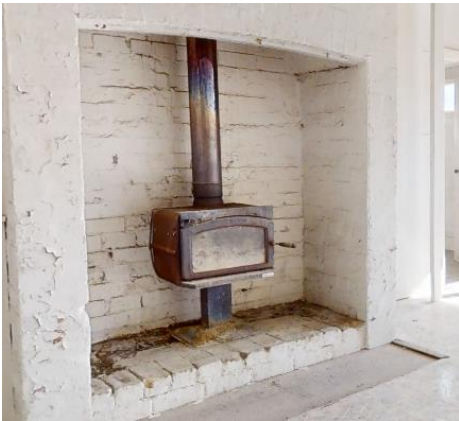
**Figure 14: Metal fireplace (Source: Cleary Bros. 3D Model – The ‘Belmont’)**

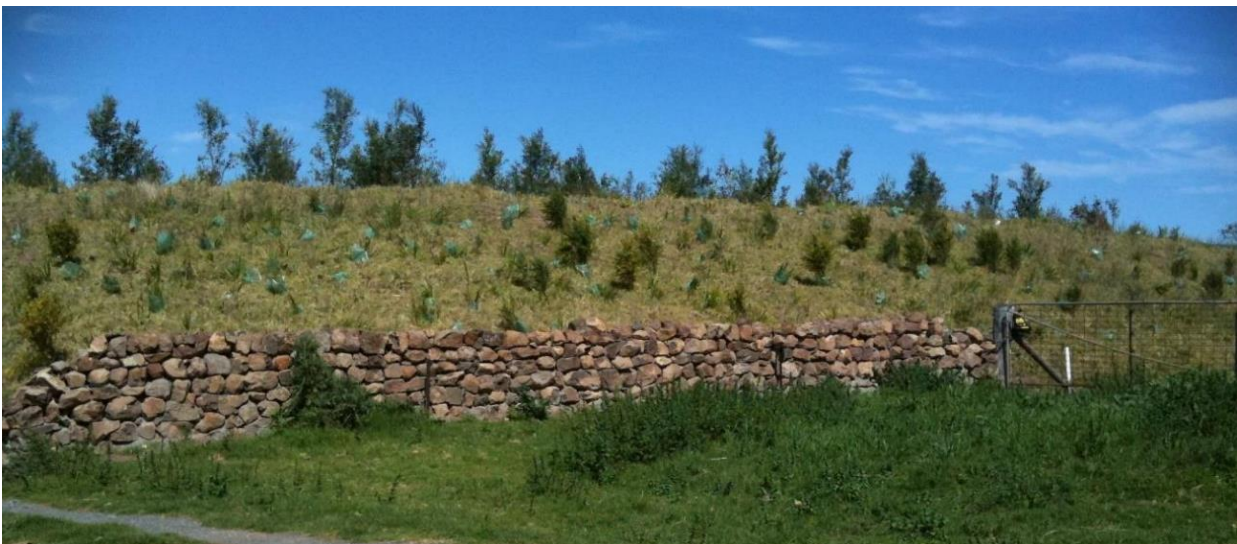
**Figure 16: Dry Stone walls, relocated to ‘Belmont’ property entrance, outside of development area in 2010 (Source: HMP 2017)**

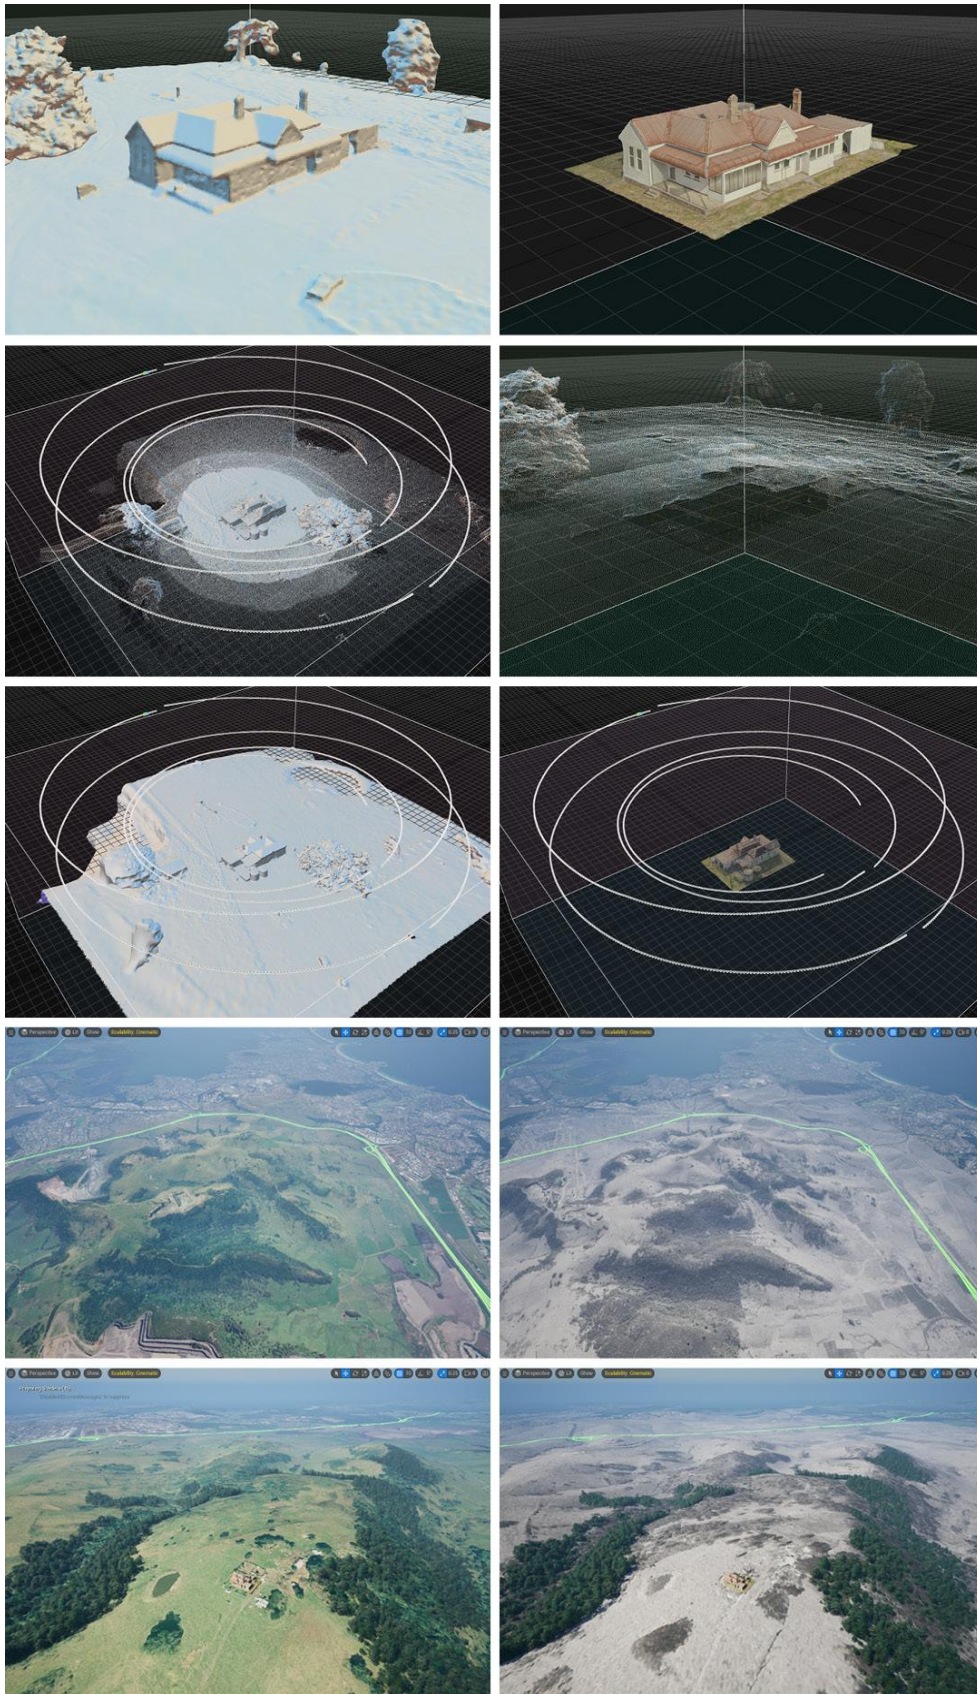
**Figure 18: Development of digital twin exterior as part of the Heritage Interpretation Plan**

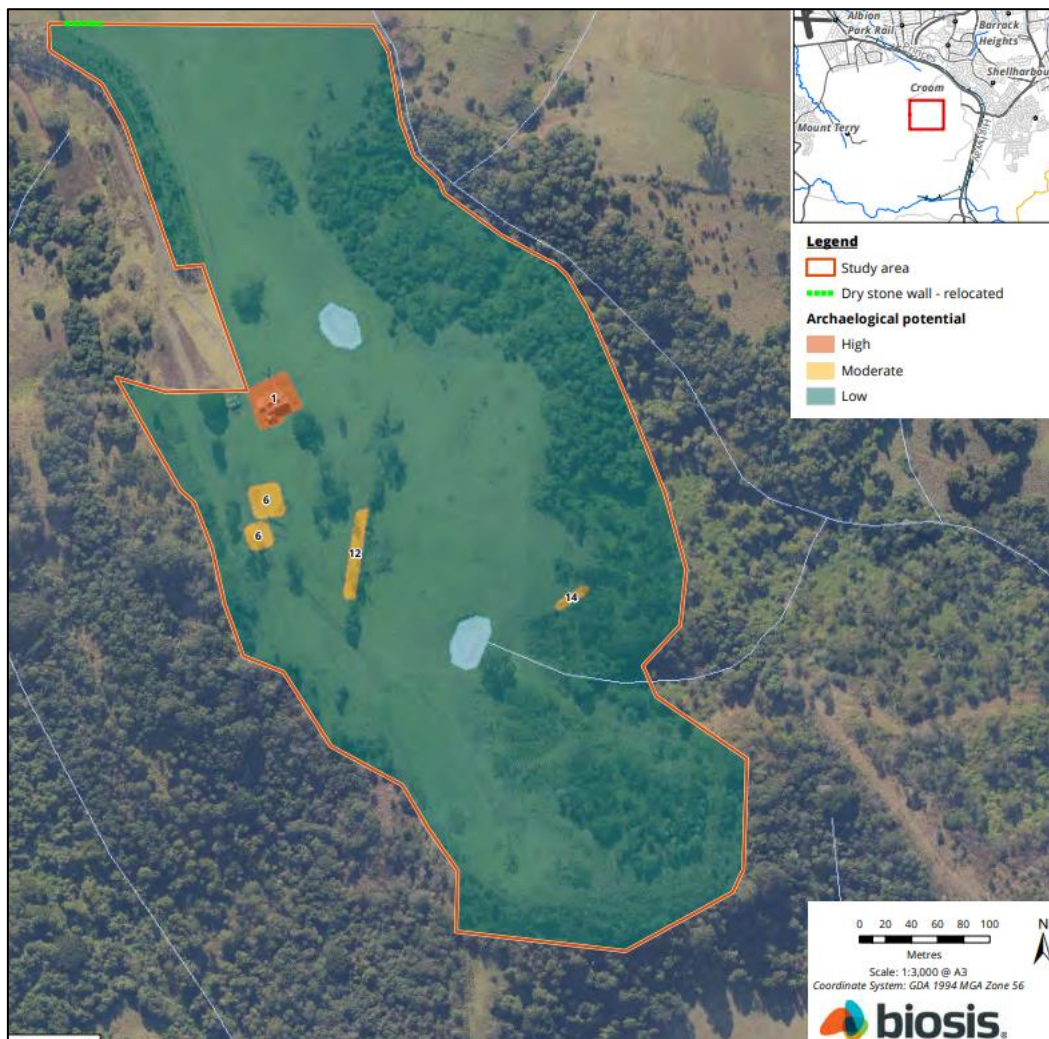
**Figure 19: Assessment of Archaeological Potential (Source: adaption from Biosisis Historic Heritage Assessment 2021)**

The proposed archaeological investigation consists of archaeological monitoring of two areas during demolition works, noted as Items 1 and 6 in Figure 19. The following has been quoted from the ARD:

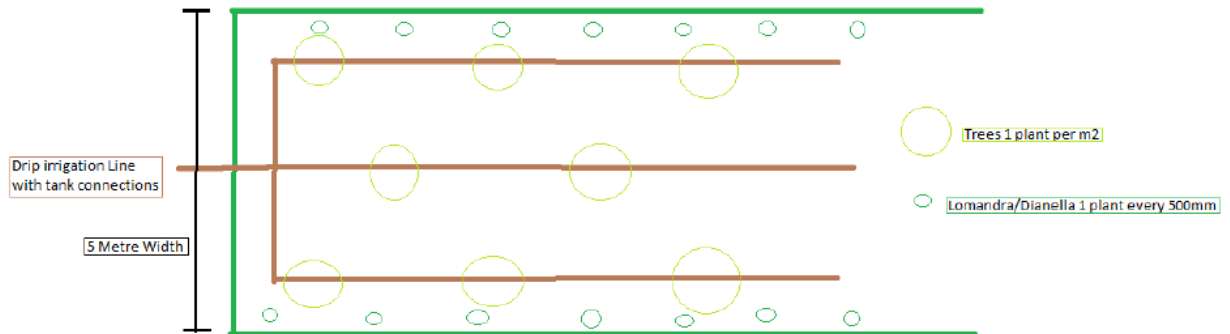
Figure 21: Planting Plan for the vegetation screens

The following planting plan shows the layout and density of plantings and the installation of irrigation lines:

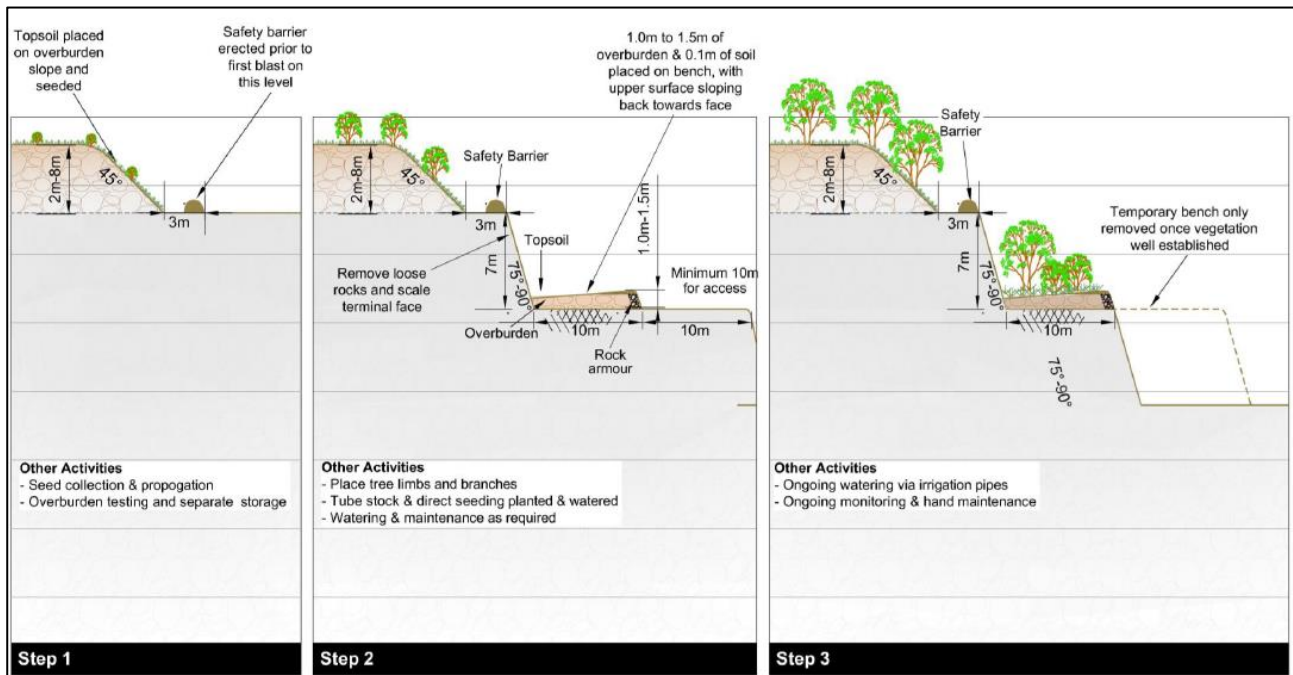
Figure 22: Upper bench rehabilitation schematic
