Albion Park Quarry

Historic Heritage Management Plan

Version 5 | Revision 3

Issued – April 2025

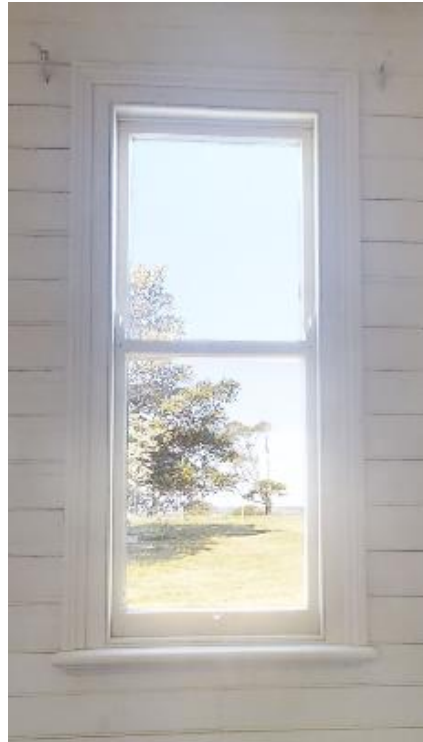
Figure 9: Timber window frame Source: Cleary Bros. 3D Model – The ‘Belmont’)

Inside 'Belmont' homestead at all window locations	Good	Little	<ul style="list-style-type: none"> Asbestos Lead paint Broken glass/glass sharding 	<ul style="list-style-type: none"> All timber window and door frames, and accompanying glass panelling will be available to local interested parties for recovery or display Any window or door framing with extensive flaking or powdering paint will be safely decontaminated if possible, or safely discarded in accordance with EPA waste guidelines The items to be recovered will be stored safely on site until the materials can be claimed for recovery by the interested parties
Timber skirting boards

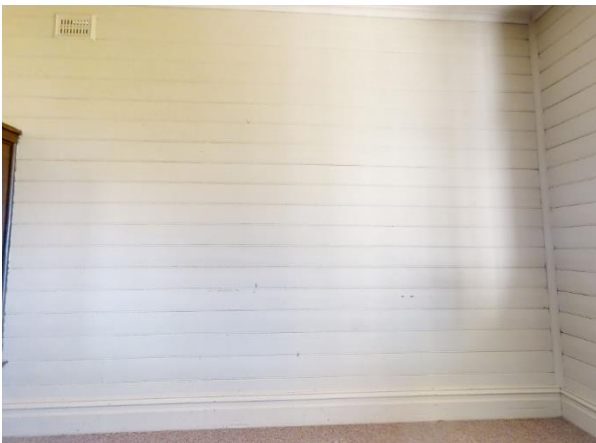
Figure 10: Timber skirting boards (Source: Cleary Bros. 3D Model – The ‘Belmont’)

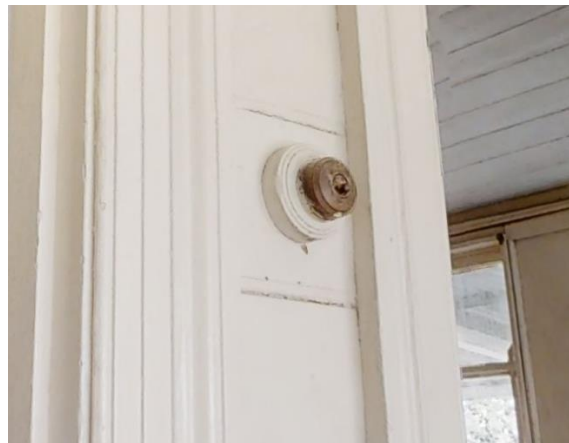
Figure 11: Early light switch (Source: Cleary Bros. 3D Model – The ‘Belmont’)

At varied locations throughout the 'Belmont' homestead	Fair	Moderate	<ul style="list-style-type: none"> Asbestos Lead paint Loose electrical wires 	<ul style="list-style-type: none"> All early light switches would be safely removed from the homestead and be available to local interested parties for recovery or display Any extensively damaged light switches will be safely discarded The items will be stored safely on site until the materials can be claimed for recovery by the interested parties

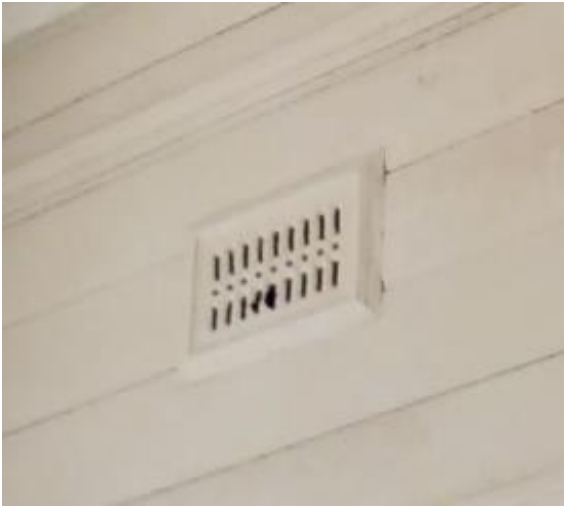
Figure 12: Wall vent (Source: Cleary Bros. 3D Model – The ‘Belmont’)

Item	Item	Location & Description	Condition	Significance once removed	Potential hazards	Recommendations for salvage methodology
Wall Vents

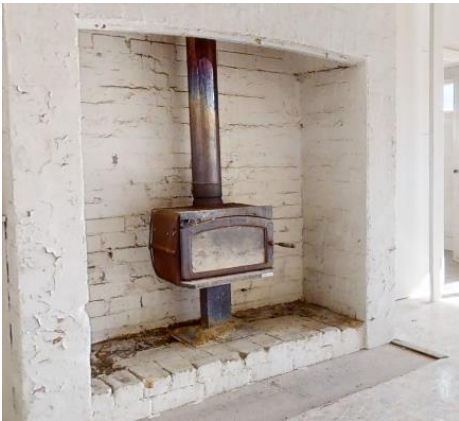
Figure 14: Metal fireplace (Source: Cleary Bros. 3D Model – The ‘Belmont’)

Item	Item	Location & Description	Condition	Significance once removed	Potential hazards	Recommendations for salvage methodology
Metal fireplace

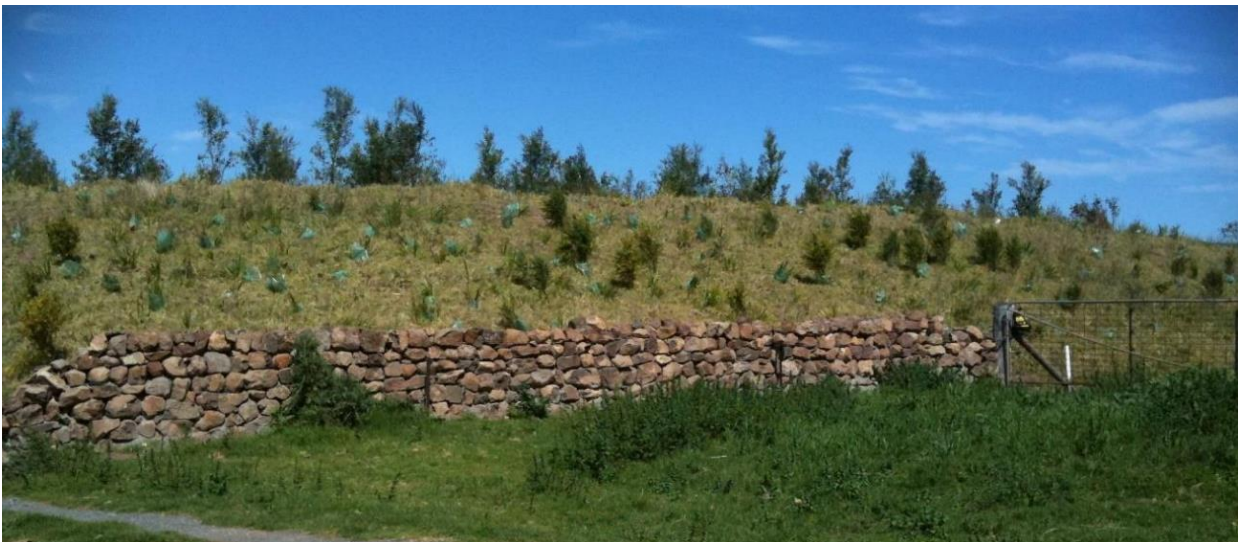
Figure 16: Dry Stone walls, relocated to ‘Belmont’ property entrance, outside of development area in 2010 (Source: HMP 2017)
