Gerroa Sand Resource

Quarry Environmental Management Plan

19 January 2017

Cleary Bros (Bombo) Pty Ltd

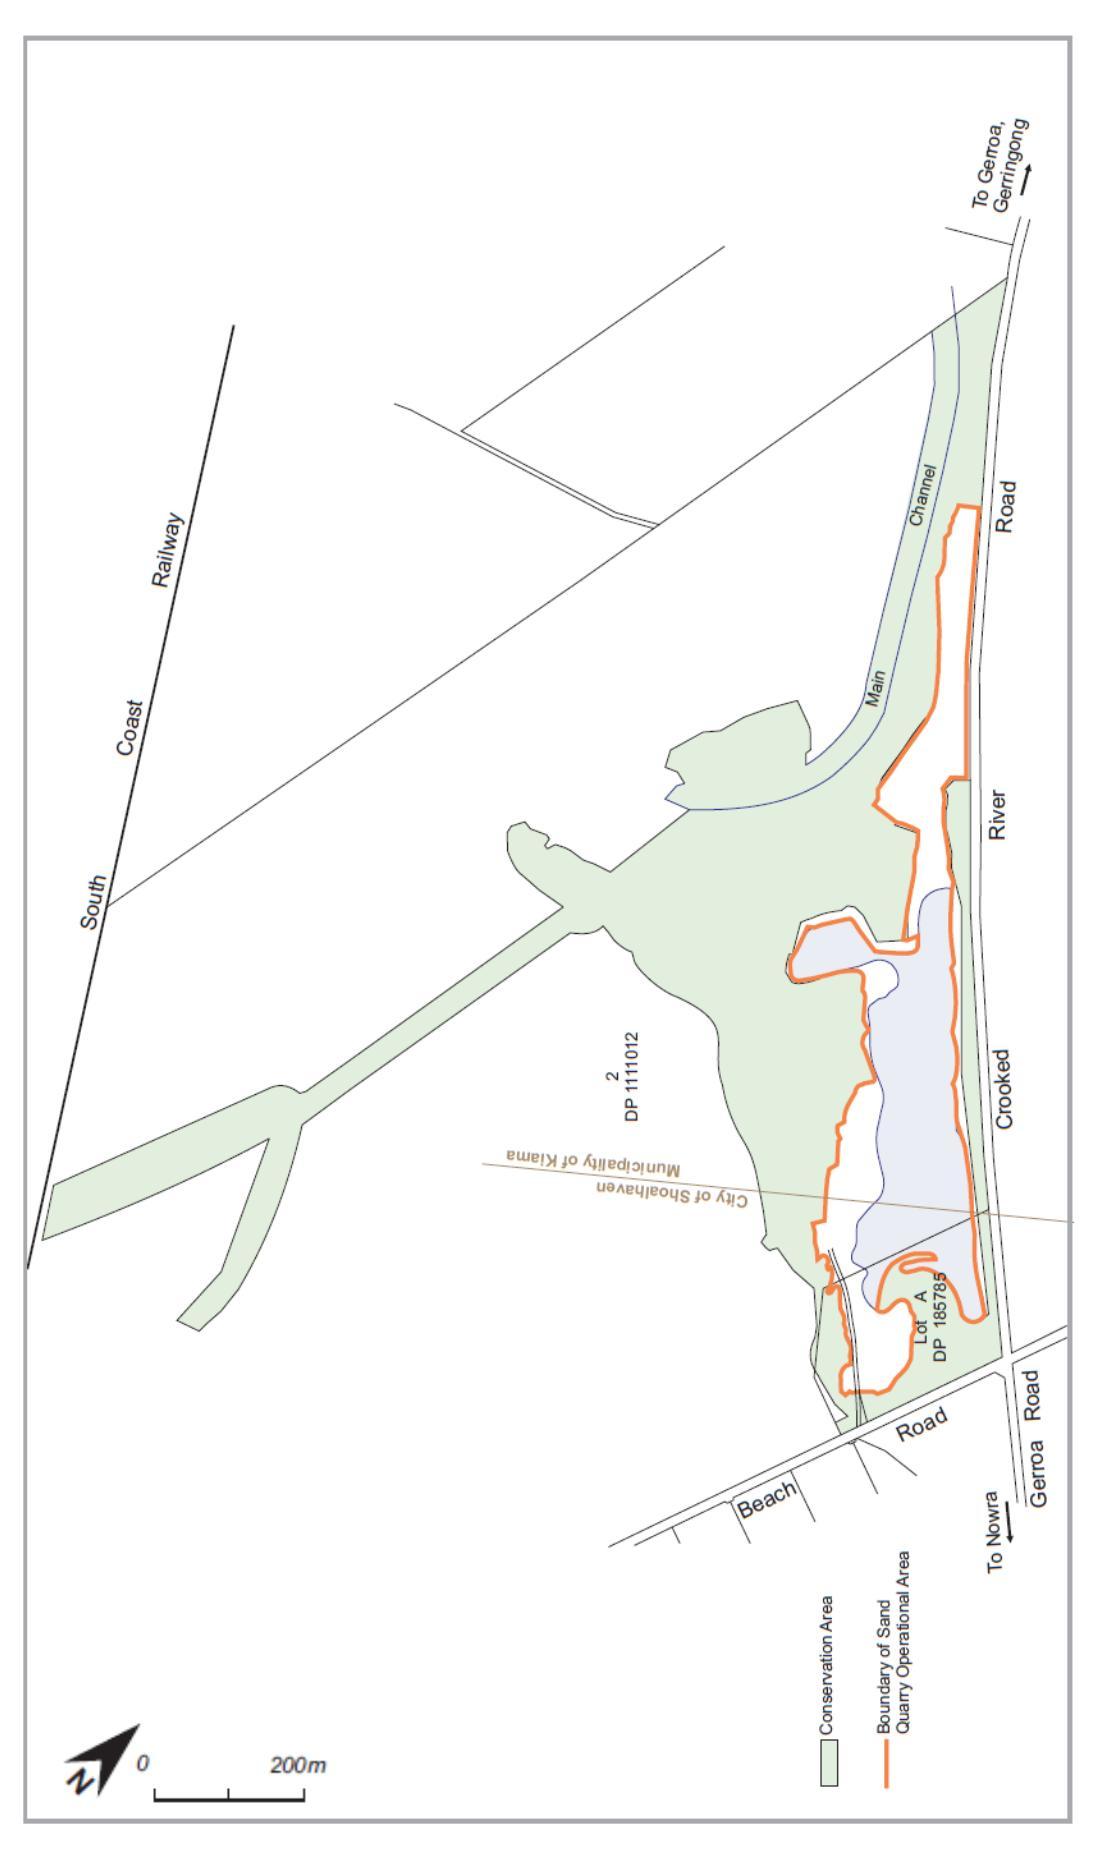
Figure 2-3 Conservation Area

The Conservation Area is defined in the project approval as the land shown on the surveyor's plan in Appendix 4 of the project approval. *Figure 2-3* has been derived from the surveyor's plan and shows the Conservation Area. The Conservation Area is located outside the quarry operational area and includes existing bushland, areas of the property to be planted in accordance with the project approval (Compensatory Planting) and land that has been rehabilitated following earlier quarrying activities.

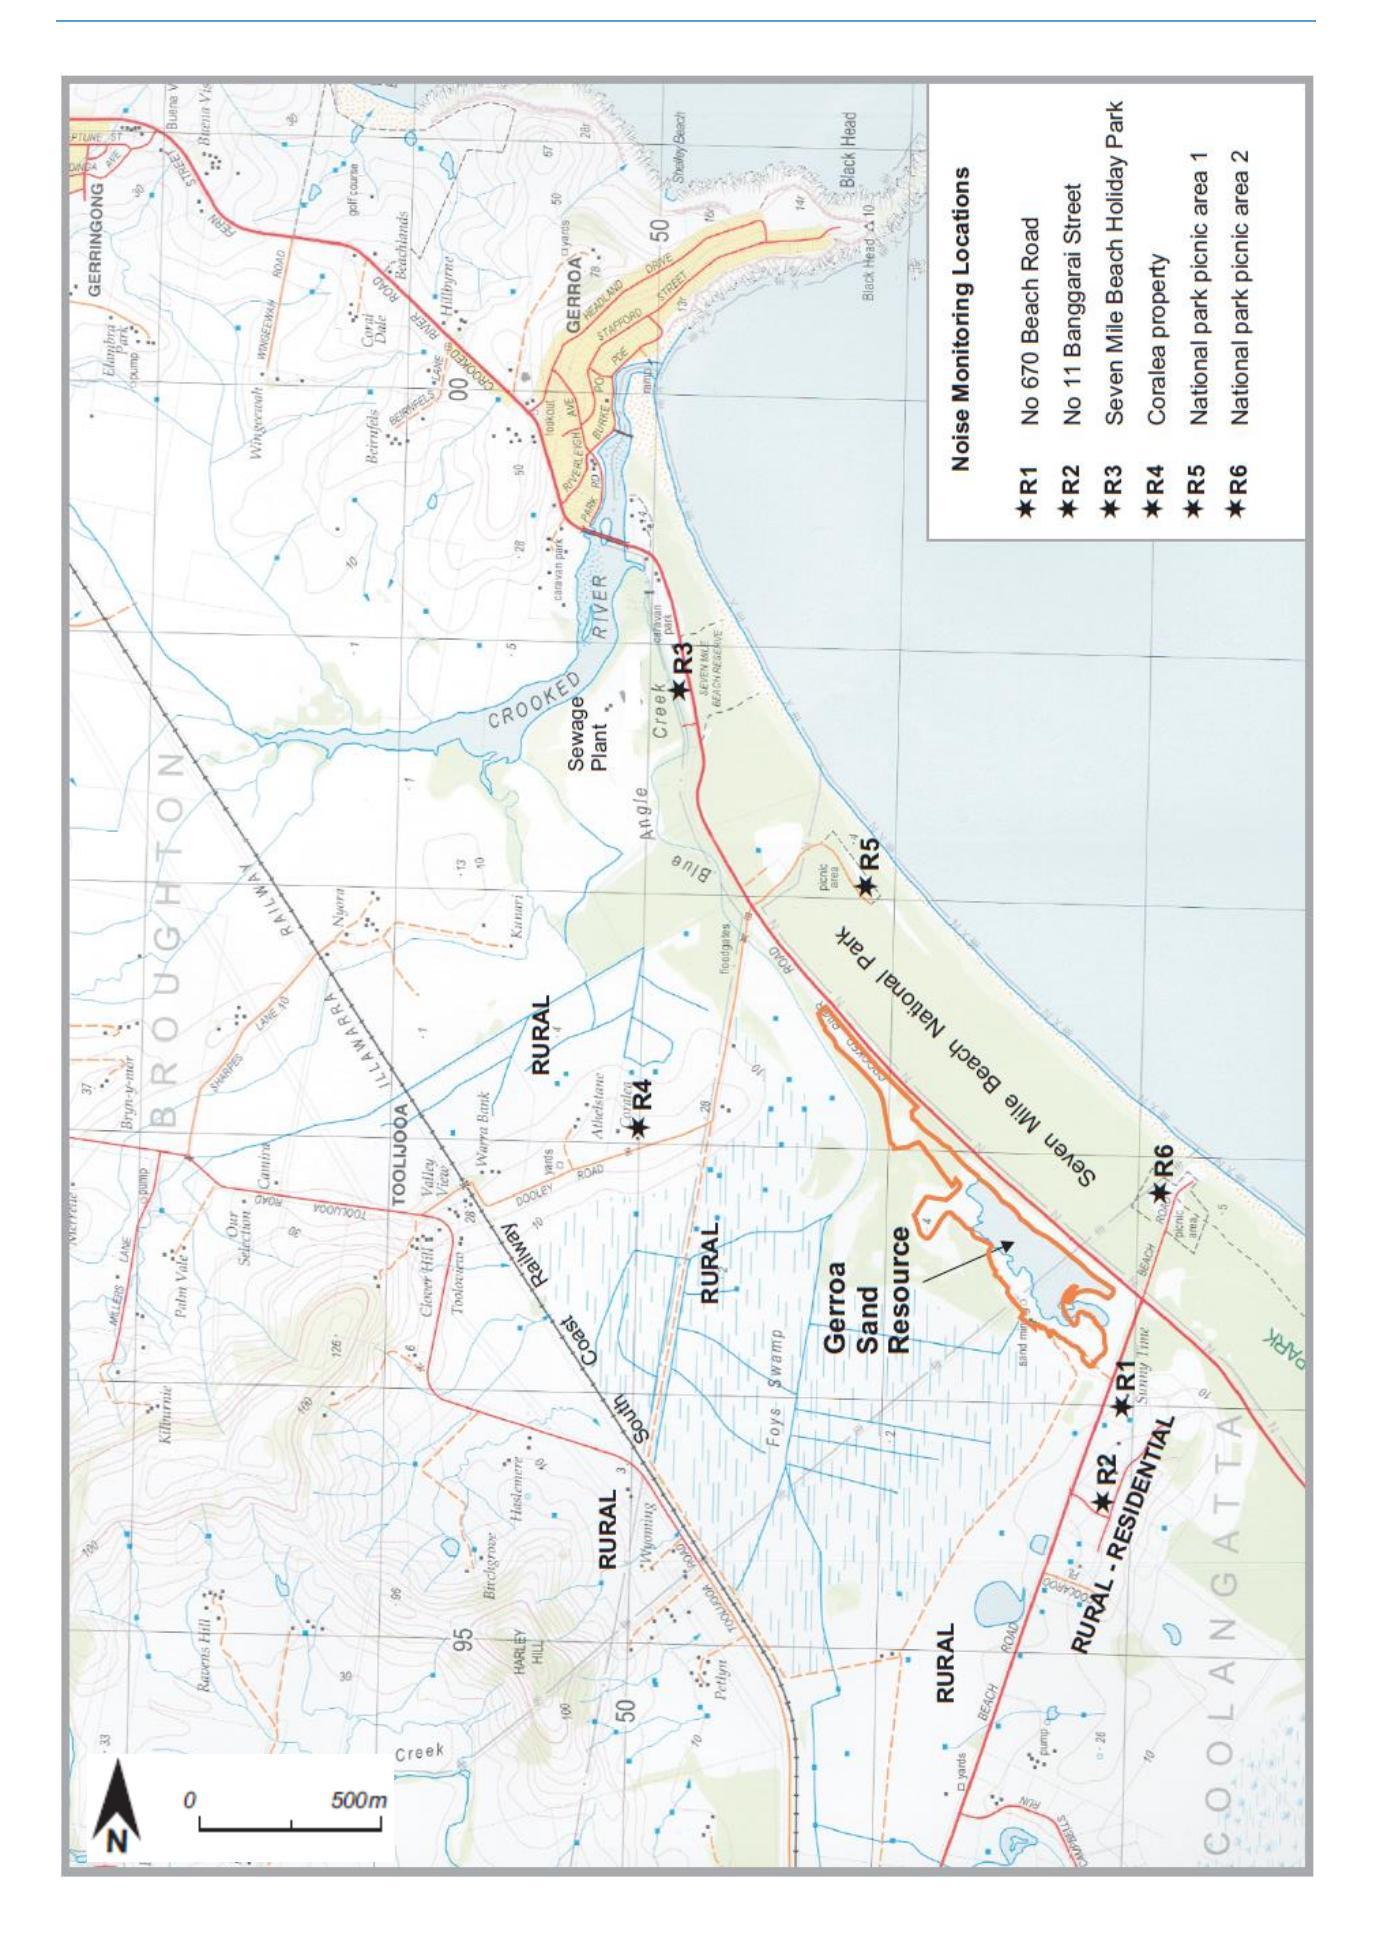
Figure 2-4 Surrounding Land Use

In August 2005 Renzo Tonin & Associates measured existing ambient noise levels at residences and other localities in the vicinity of the site, shown on *Figure 2-4*. The measured daytime L_{A90} background level and L_{Aeq} noise levels are summarised in *Table 2.2*.

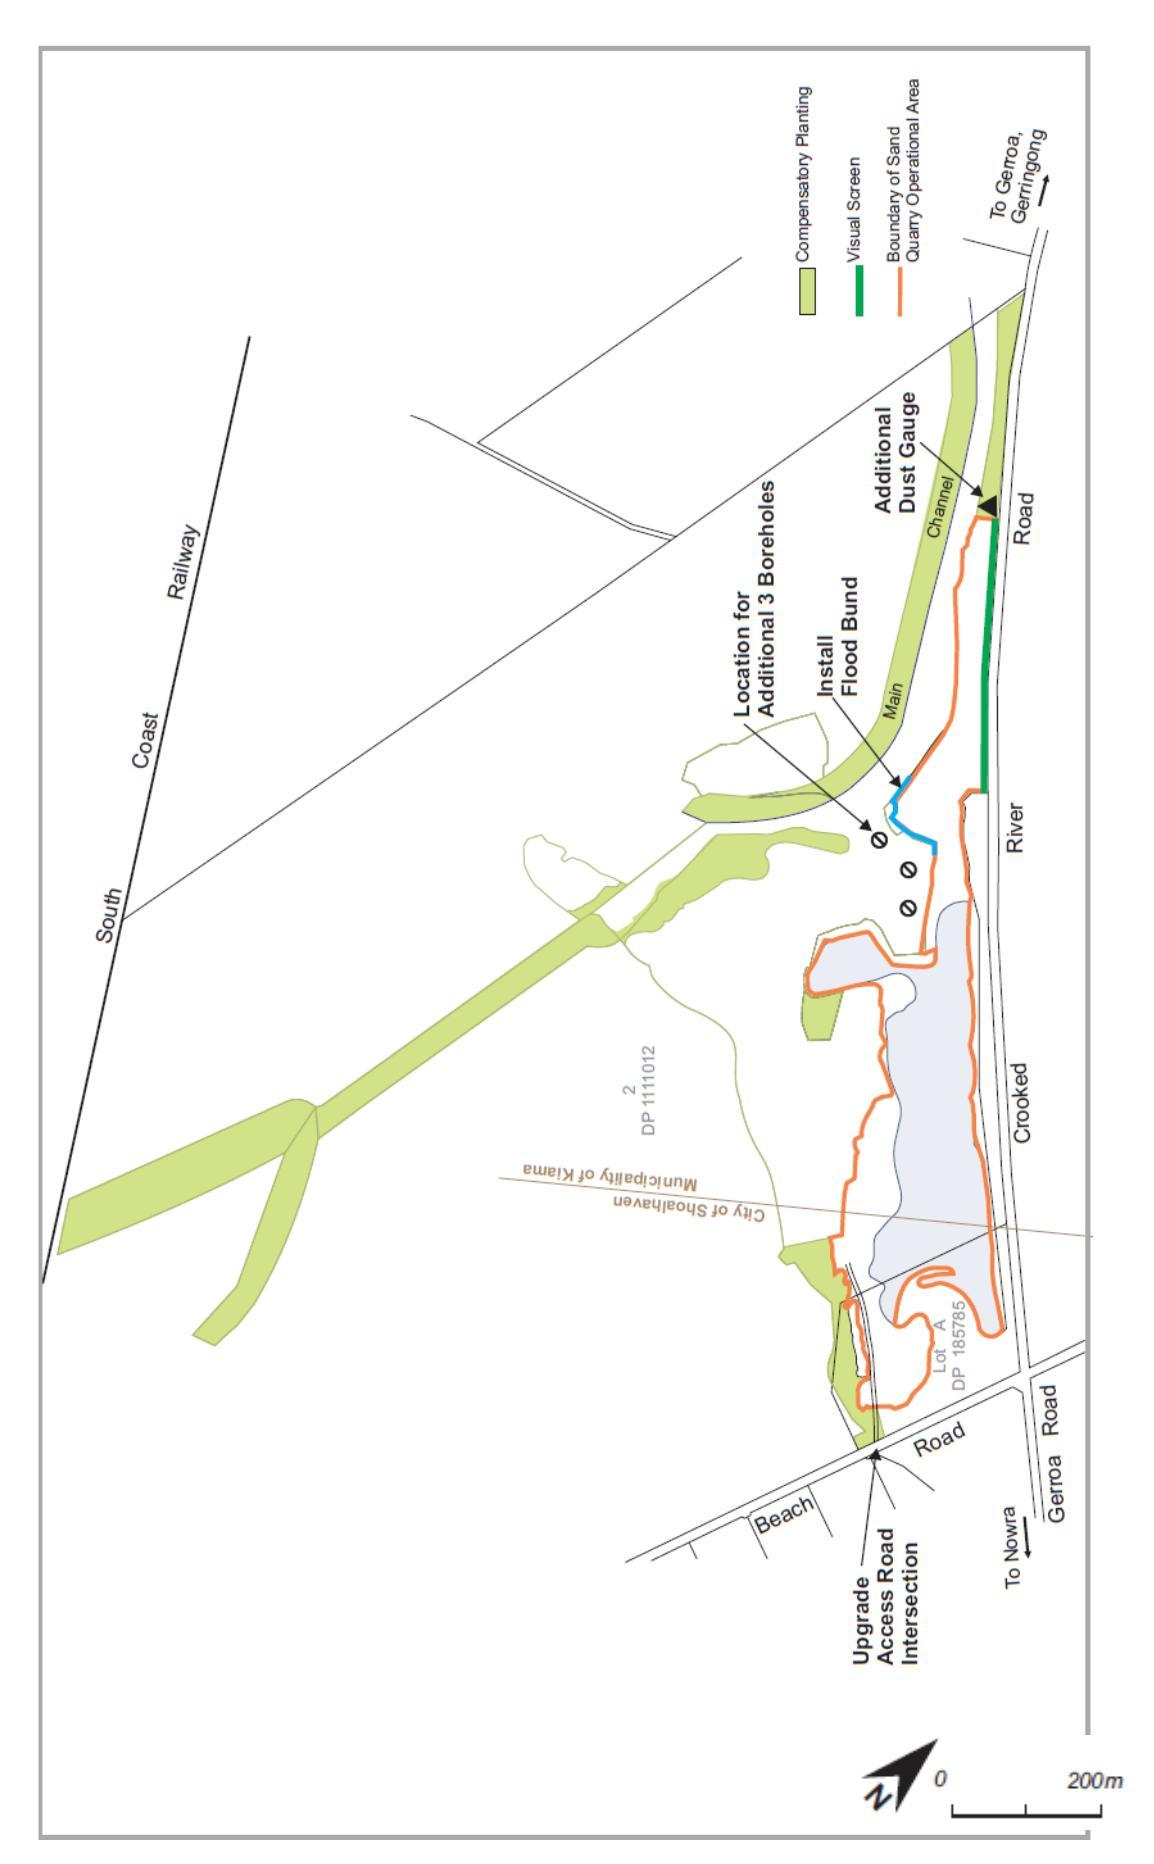
Figure 4-1 Location of Preparatory Works – note refers to old monitoring station locations

Preparatory work includes site activities to be undertaken either prior to sand mining operations moving into particular parts of the extension area or at an early stage of sand extraction. Where actions are specifically required by conditions of consent, the condition is referenced. The location of preparatory works is shown on *Figure 4-1*.

An existing unsealed access road leads from the site office to the northern end of the dredge pond. This road has been progressively extended to the north. Where a flood bund is required and if suitable, the road has been located on the bund. In other locations the existing sandy surface may be suitable for the road or may require improvement with hard fill.

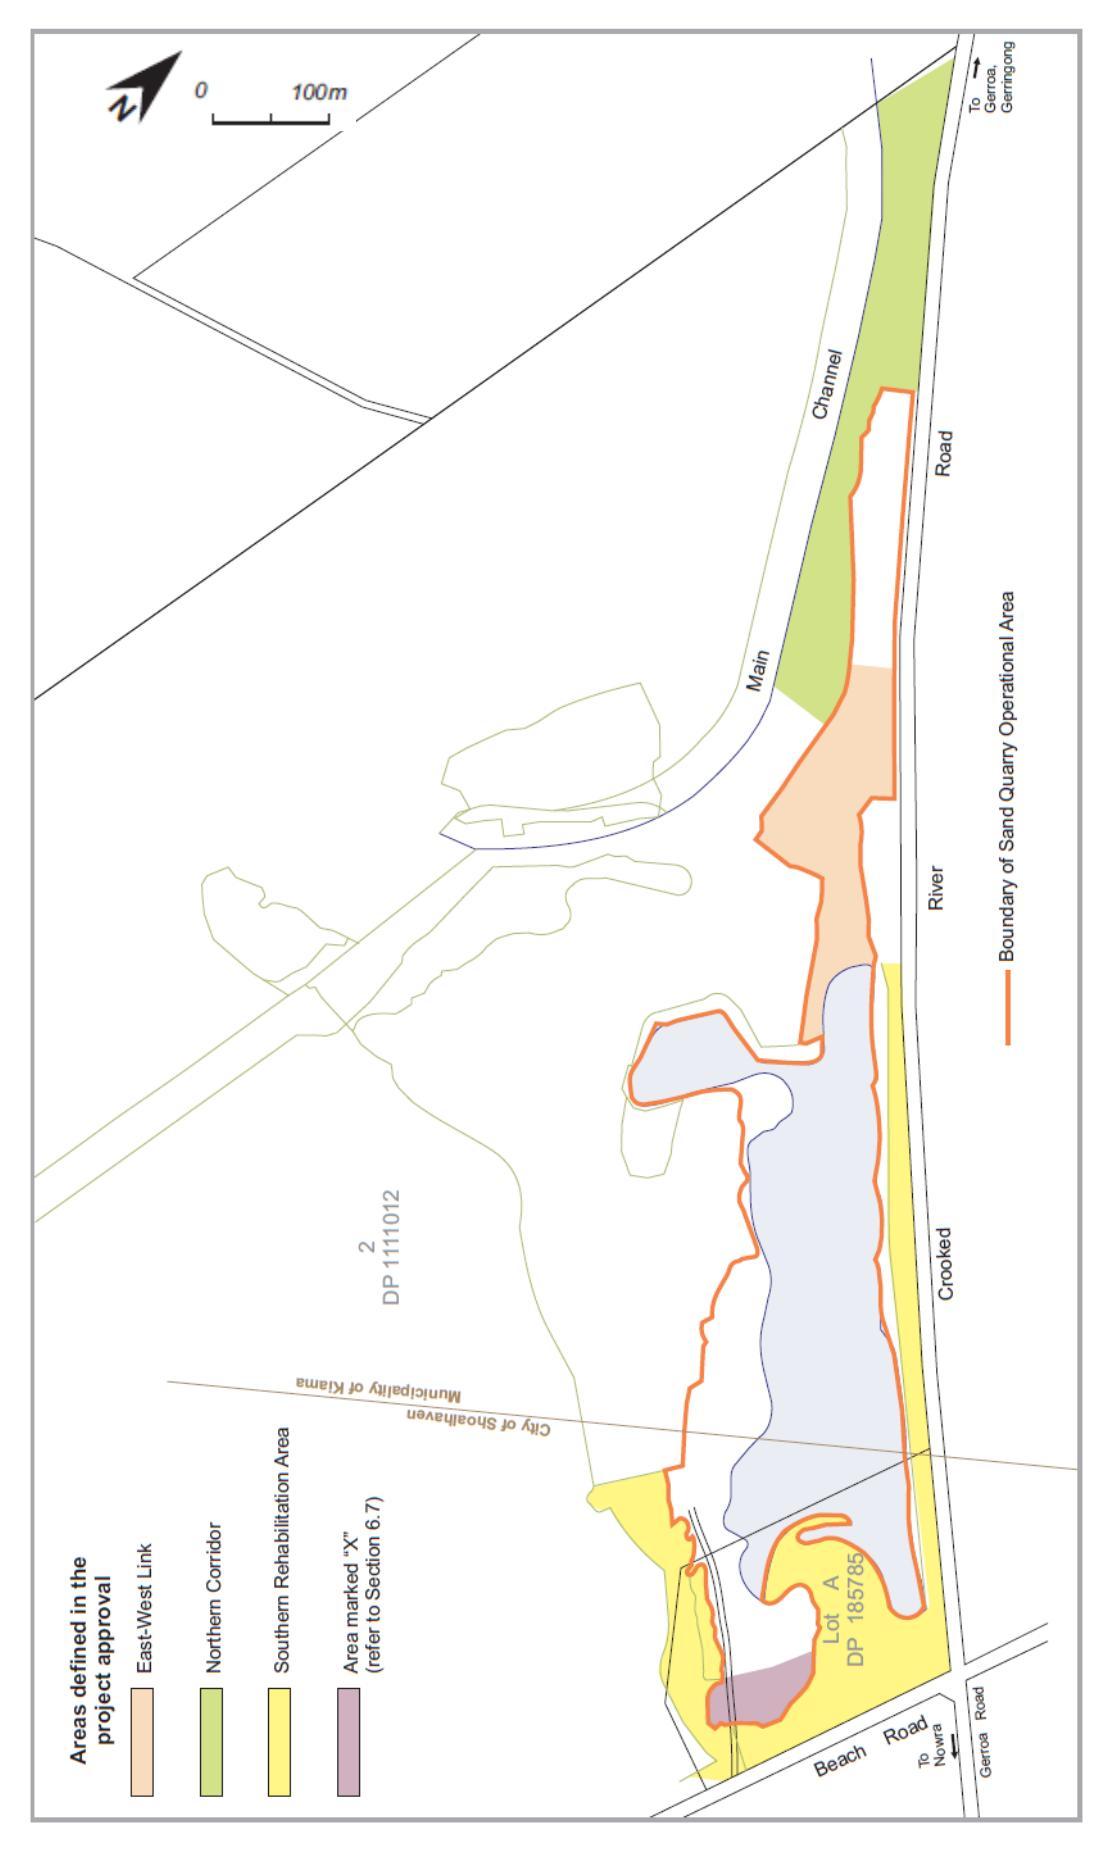
Figure 4-2 Defined Areas

¹ The "Northern Corridor" is defined in the Court conditions as the area shown stippled in Appendix 3 of those conditions (see Appendix 1 of this QEMP, also see Figure 4-2)

² The "East-West Link" is defined in the Court conditions as the area shown cross hatched in Appendix 3 of those conditions (see *Appendix 1* of this QEMP, also see *Figure 4-2*)

³ The location of the "**Compensatory Planting**" is defined in the Court conditions as areas marked 2A.1, 2A.2, 2A.3, 2B.1, 2B.2, 2C.1, 2C.2, 2D, 2E, 5C.1 shown in Appendix 3 of those conditions (see *Appendix 1* of this QEMP, also see *Figure 4-2*)

⁴ The "Southern Rehabilitation Area" is defined in the Court conditions as areas marked 1.2, 1.3 and 2A.2 shown in Appendix 3 of those conditions (see Appendix 1 of this QEMP, also see Figure 4-2)

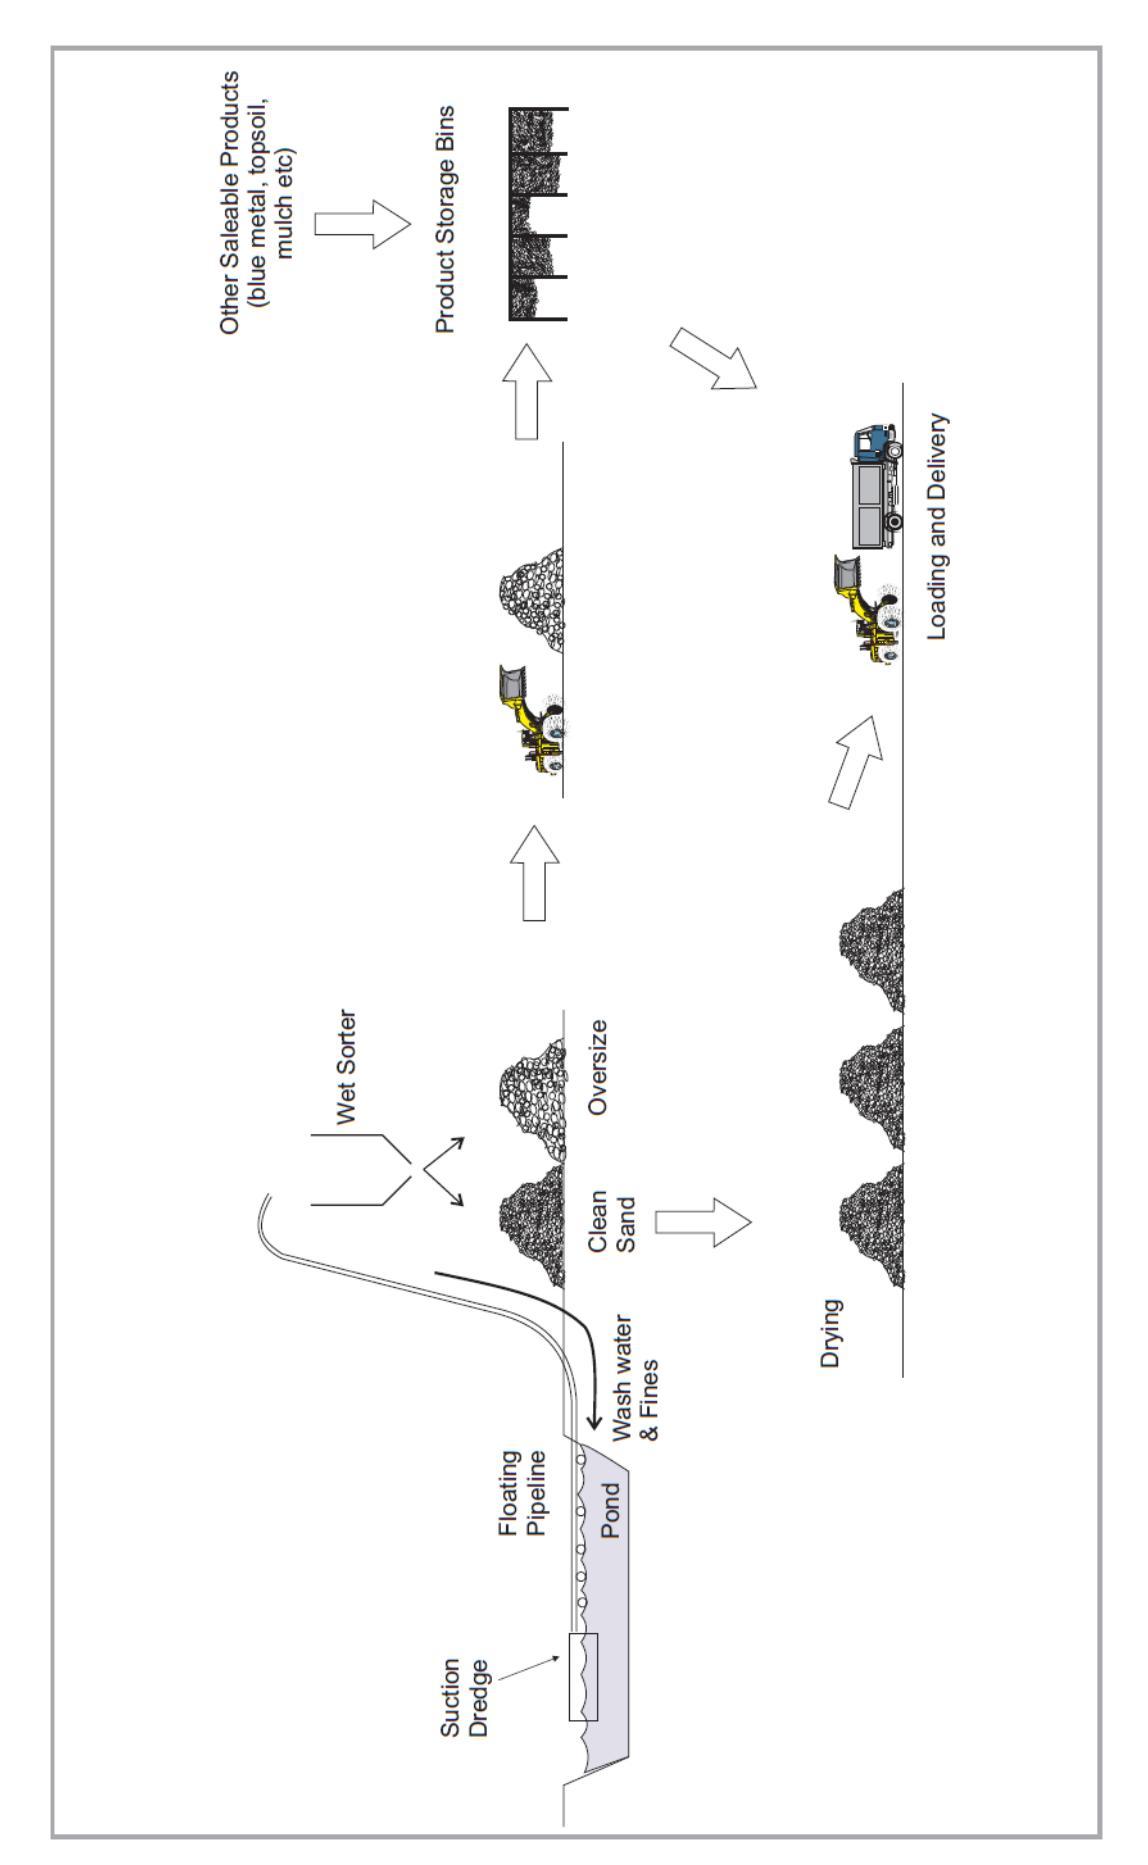
Figure 5-1 Process Flow Diagram

Material is extracted from the base and leading edge of the dredge pond using a floating suction dredge. The resulting slurry is piped to the shore and passed through various screens in the wet sorter and cyclone, as required. The wet sorter separates sand from stone and finer particles. Screened sand is pushed away from the sorter and allowed to drain back to the dredge pond, subject to acid sulphate soil procedures (see section 6.6). Heavier materials may be further screened to grade into saleable size ranges to meet market requirements. Fine particles return directly to the dredge pond with the wash water.

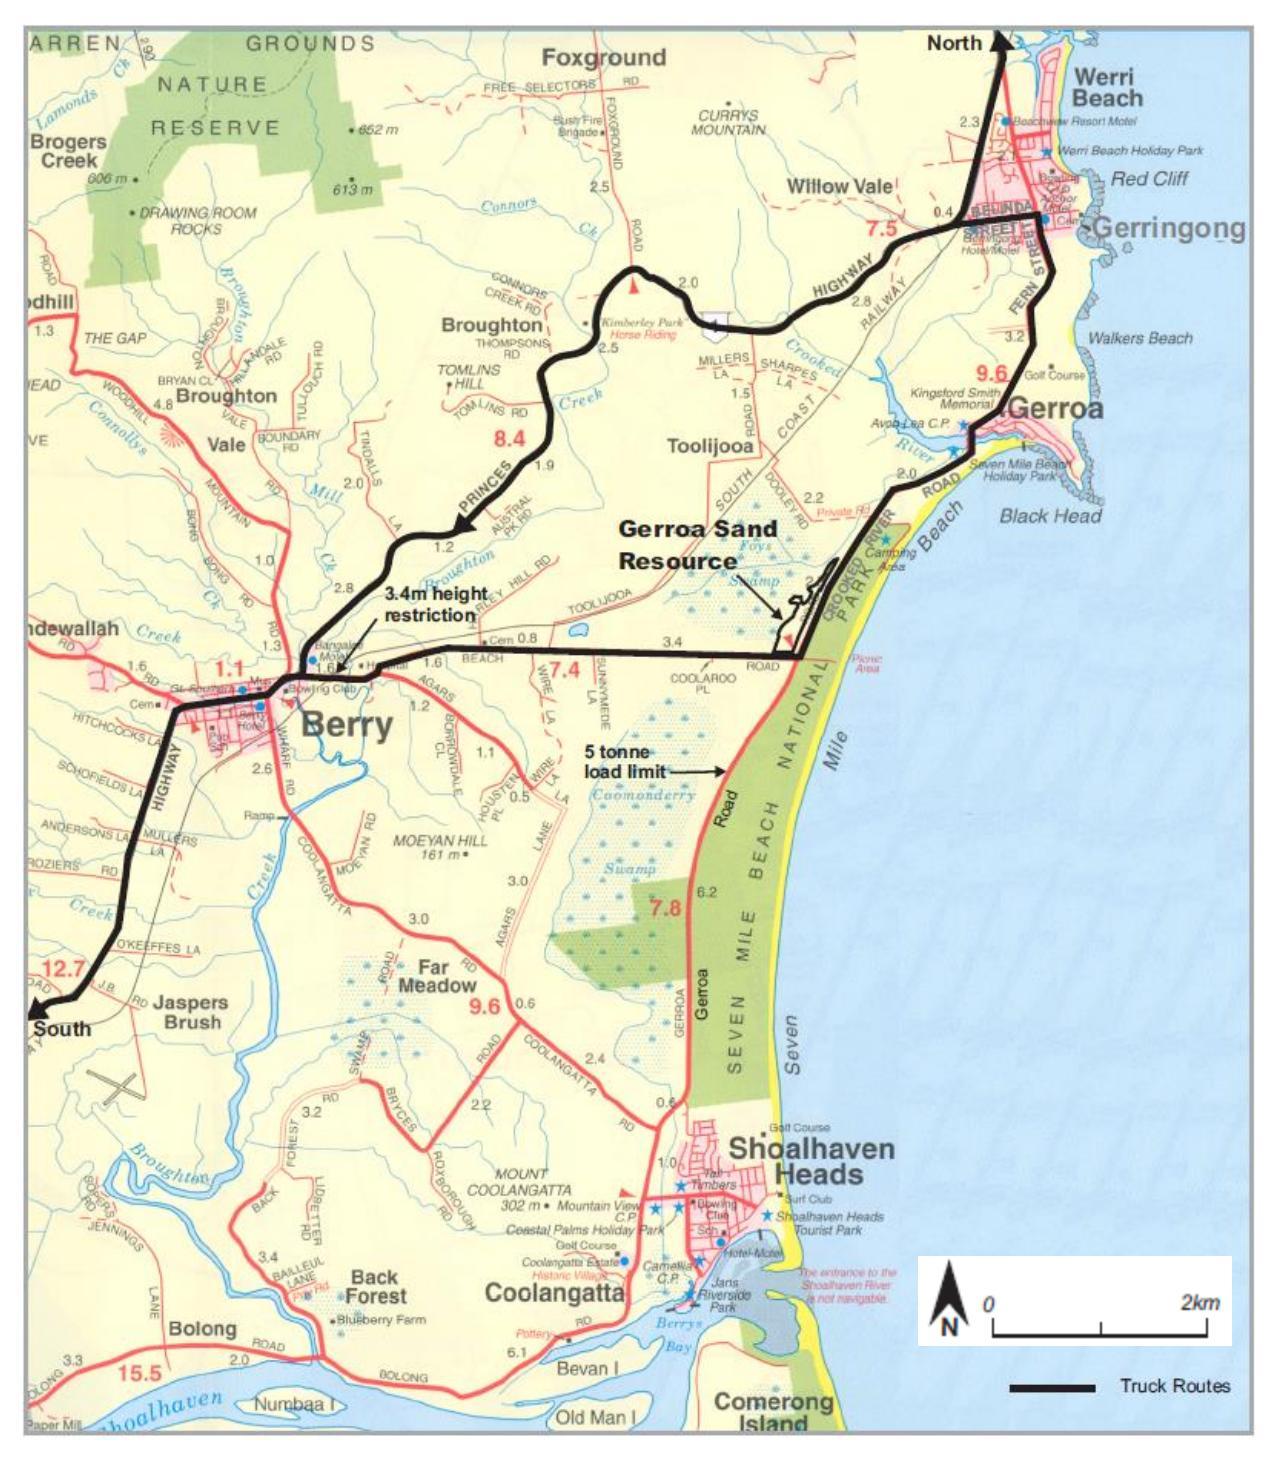
Figure 6-2Approved Truck Routes

- iv. Quarry trucks may travel on Gerroa Road only when the destination is accessed from that road and there is no other practical route.
- v. The following restrictions are in place on roads in the area and will be observed:
 - Beach Road 3.4 metre height limit at the railway underpass;
 - Gerroa Road 5-tonne load limit.
- vi. The approved truck routes are shown on *Figure 6-2*.
- vii. All loaded vehicles entering or leaving the site are to have covered loads.
- viii. Prior to departure, all loaded vehicles leaving the site are to be cleaned of materials that might fall to the road.

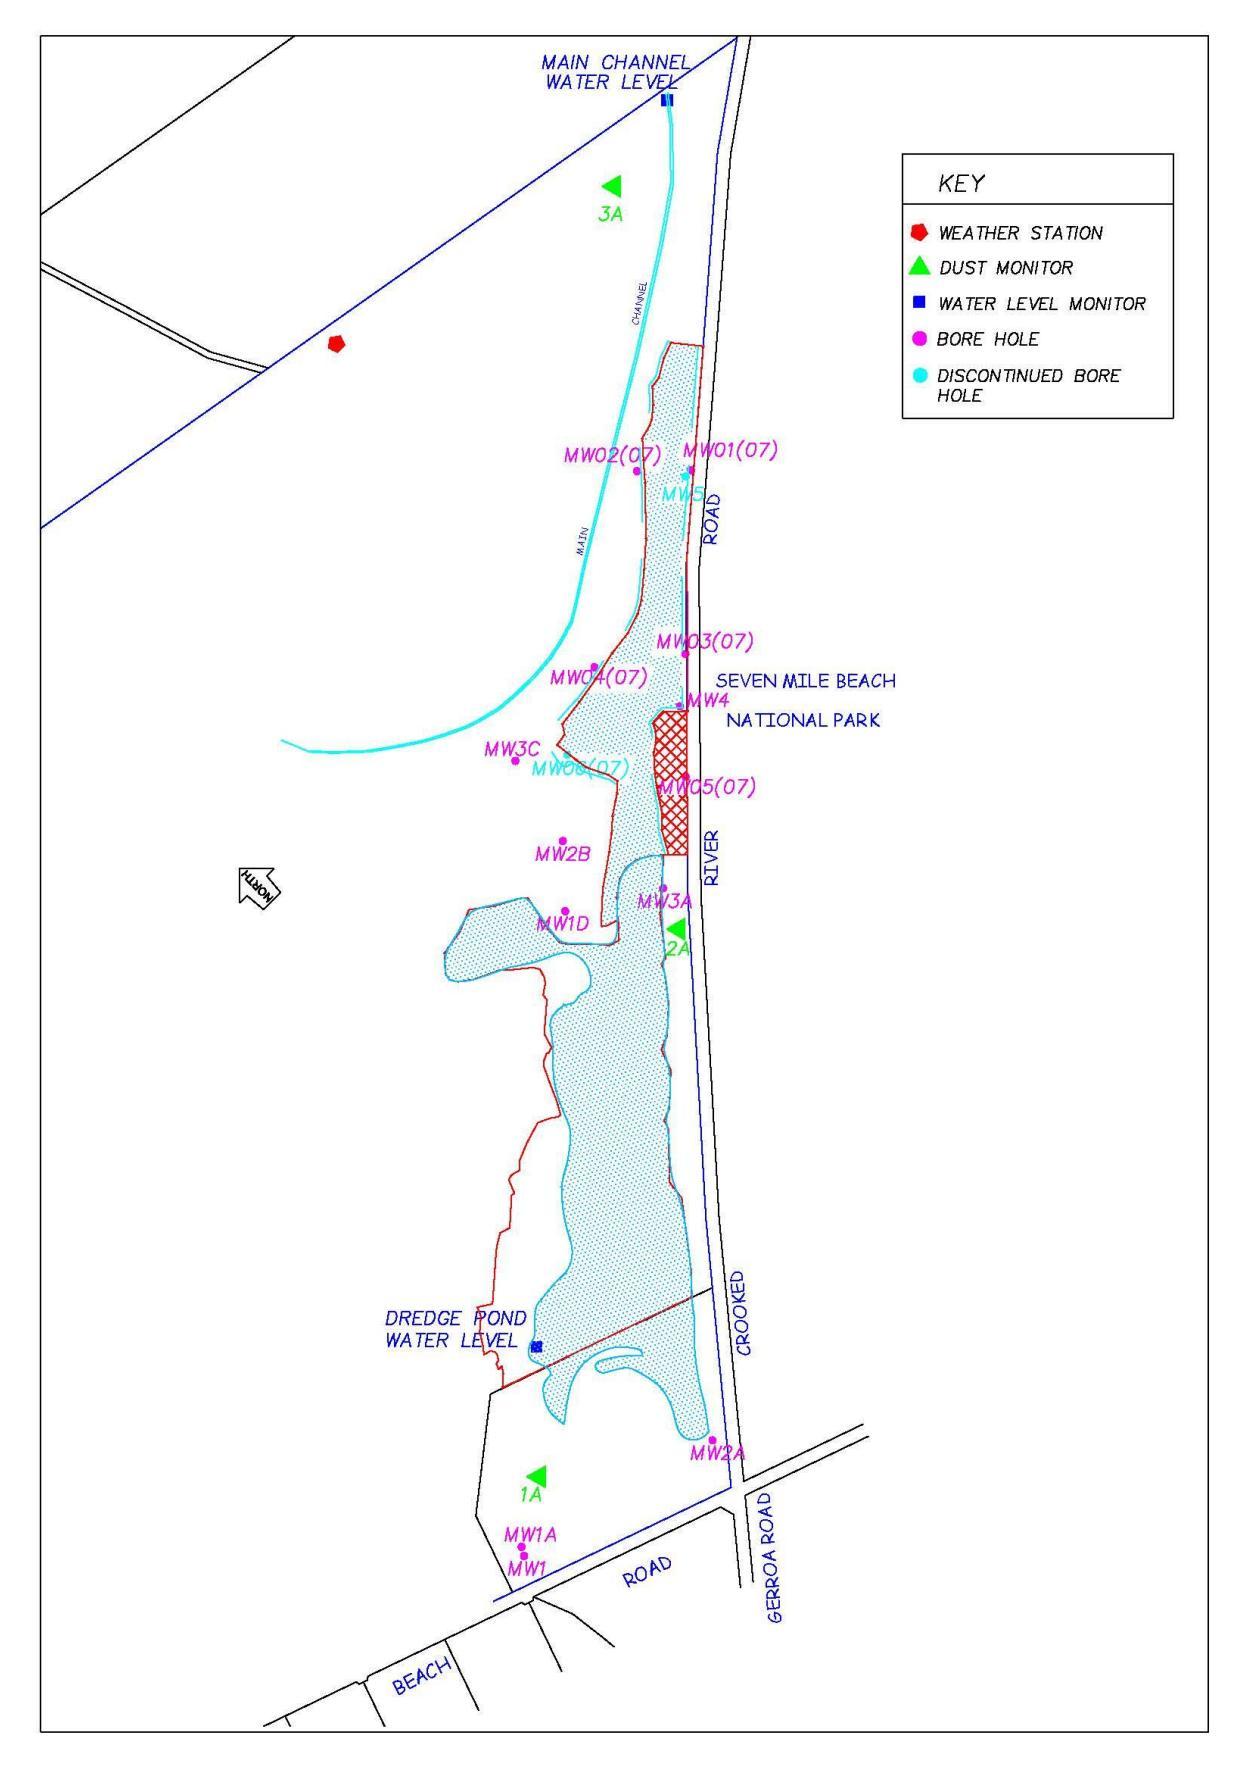
Figure 8-1 Location of Monitoring Devices

An additional six monitoring bores were installed as recommended by Douglas Partners in the environmental assessment (Perram & Partners 2006). These bores were installed in August 2007 following receipt of the (now superseded) approval from the Minister for Planning and are designated 1/Aug07 to 6/Aug07. The bores were licensed by the Department of Water and Energy (bore registration 10BL602133) and are located as shown on *Figure 8-1*. Borehole MW06(07) has now been decommissioned, as approved by the DP&E.

As recommended by Douglas Partners a further three boreholes were installed in the Swamp Sclerophyll Forest to the west of the quarry extension. These boreholes are necessary to comply with requirements of the project approval to assess the hydraulic conductivity of sections of the foreshore as they are completed and to monitor the groundwater level within the Swamp Sclerophyll Forest. The location of these further bores is indicated on *Figure 8-1*, and are labelled MW1D, MW2B, and MW3C.

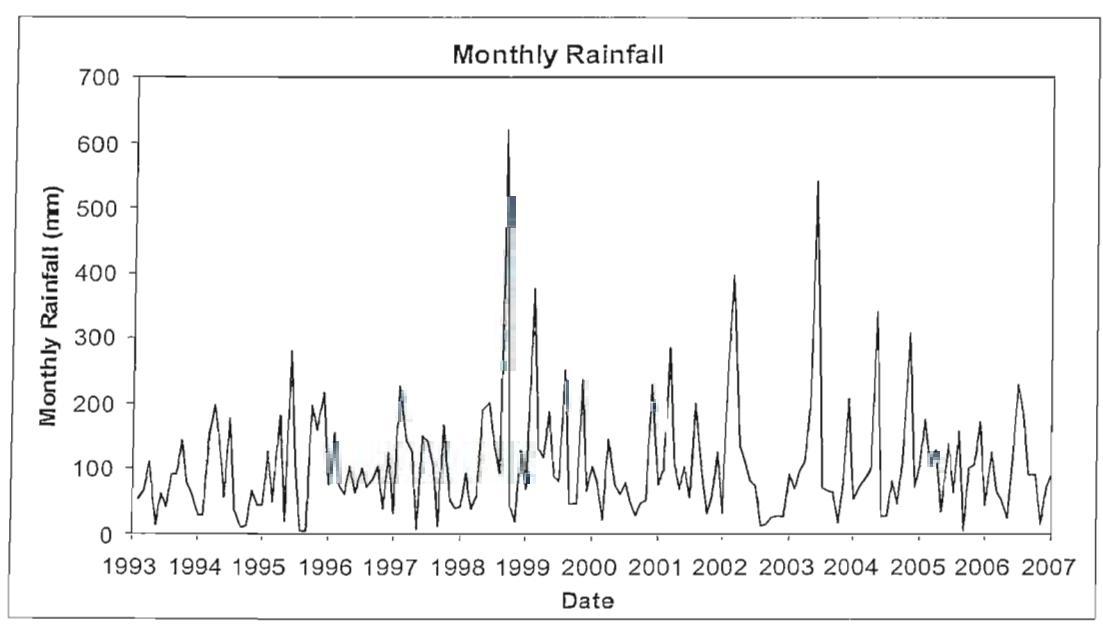
Figure B-1: Monthly Rainfall 1993 - 2006

Figure B-1 graphically shows the same monthly rainfall that is presented in Table B-1 and illustrates the significant variation in rainfall that has occurred over the period 1993 ~ 2006.

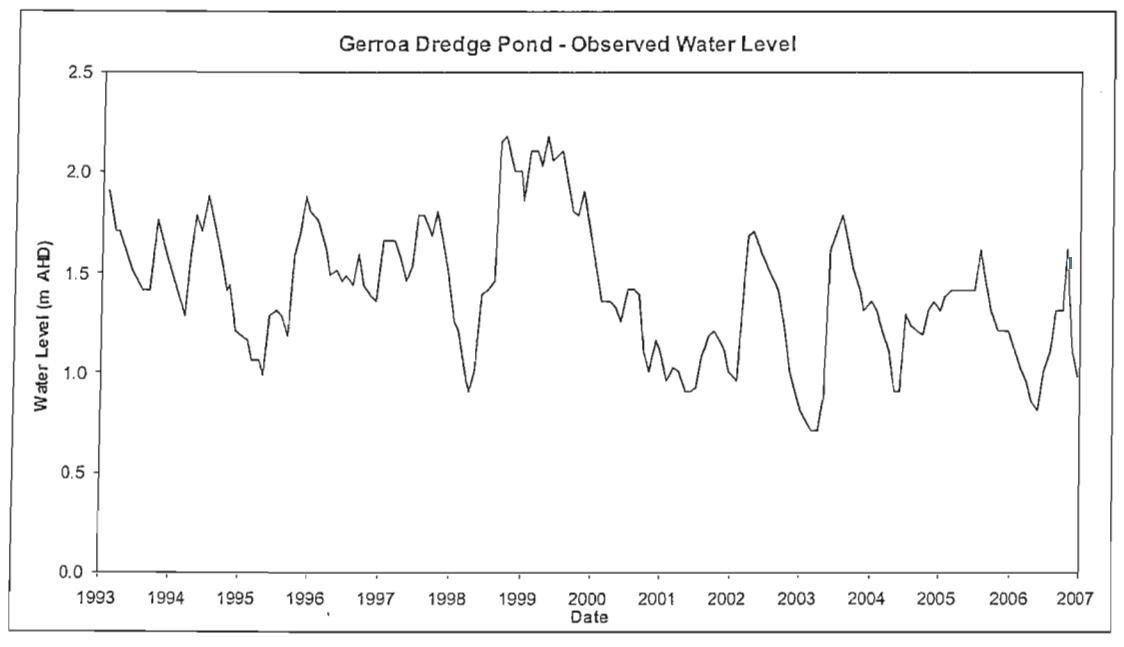
Figure B-2: Recorded Dredge Pond Levels

9. Water levels in the dredge pond at Gerroa have been monitored at approximately 10 day intervals since 1993. Figure B-2 shows the variation of pond water level over this period.
