ALBION PARK QUARRY

ANNUAL REVIEW

Period 01 July 2023 - 30 June 2024

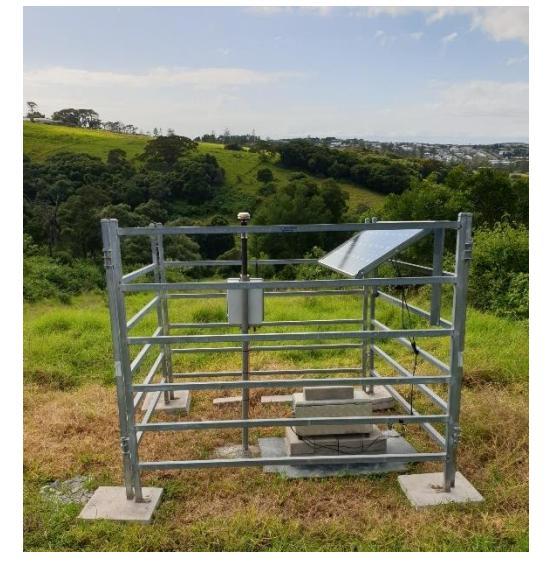
APD4 – Continuous real time particulate monitor in operation

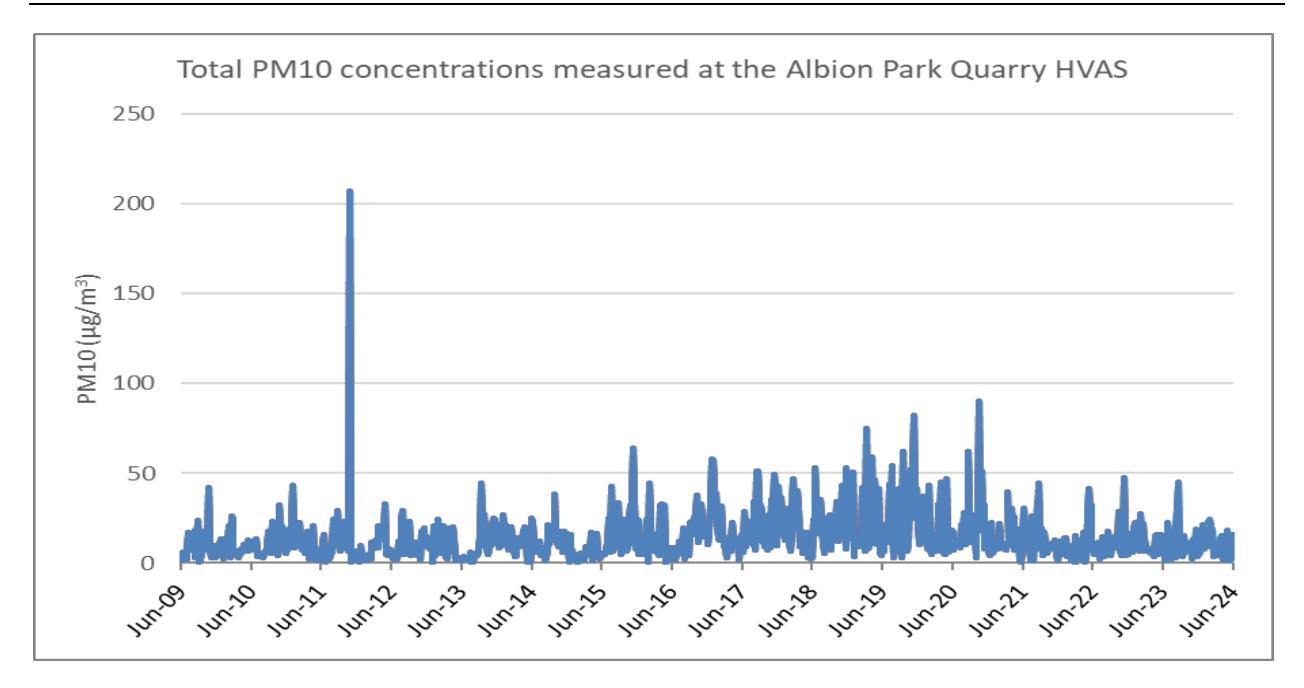
The following table provides a summary of PM_{10} concentrations (μ g/m³) for the High Volume Air Sampler at the Albion Park Quarry, with the following graph showing the historical trend in PM_{10} concentrations. Incremental impacts were determined by subtracting the average PM_{10} levels measured by the NSW Government Albion Park South air quality monitor (TEOM unit) from the data recorded by the site HVAS unit.

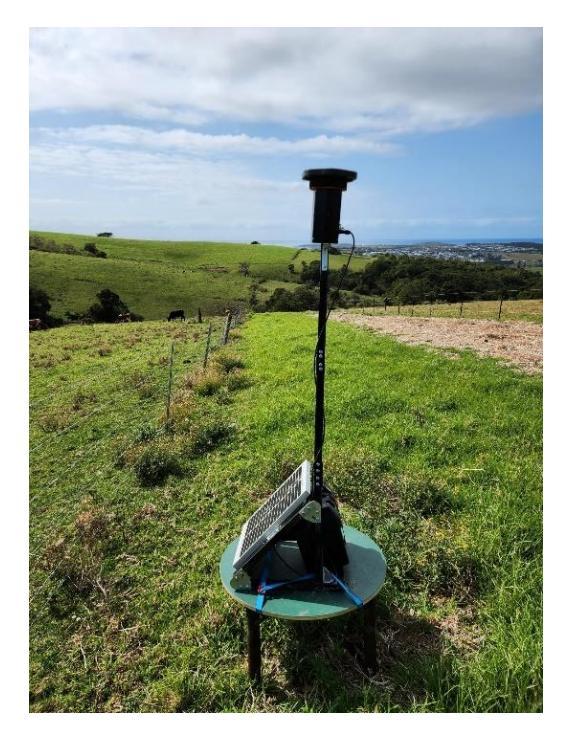
The continuous noise monitor was validated as part of the compliance monitoring undertaken in June 2024, with measured noise levels within 2 dB(A), in line with the requirements of the Noise Monitoring Program.

N2 – SiteHive Continuous real time noise monitor in operation

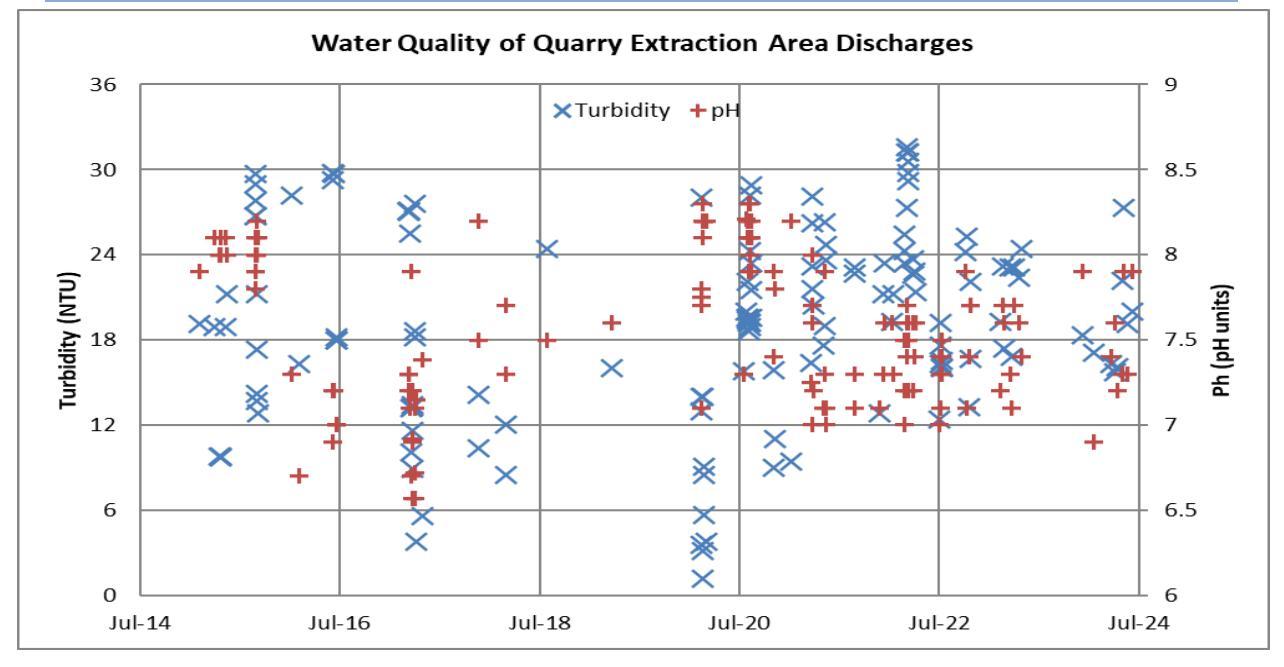
All discharges from the Quarry Extension complied with the limits of the EPL and DC for turbidity and pH during the current reporting period.

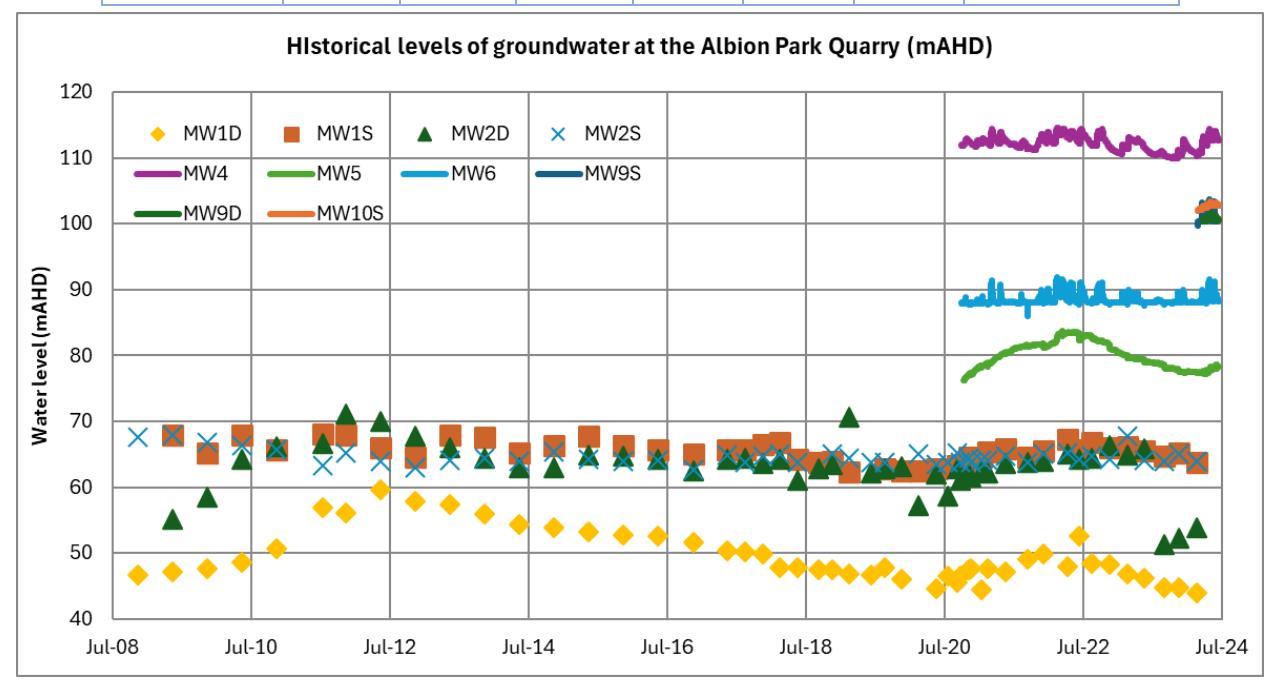
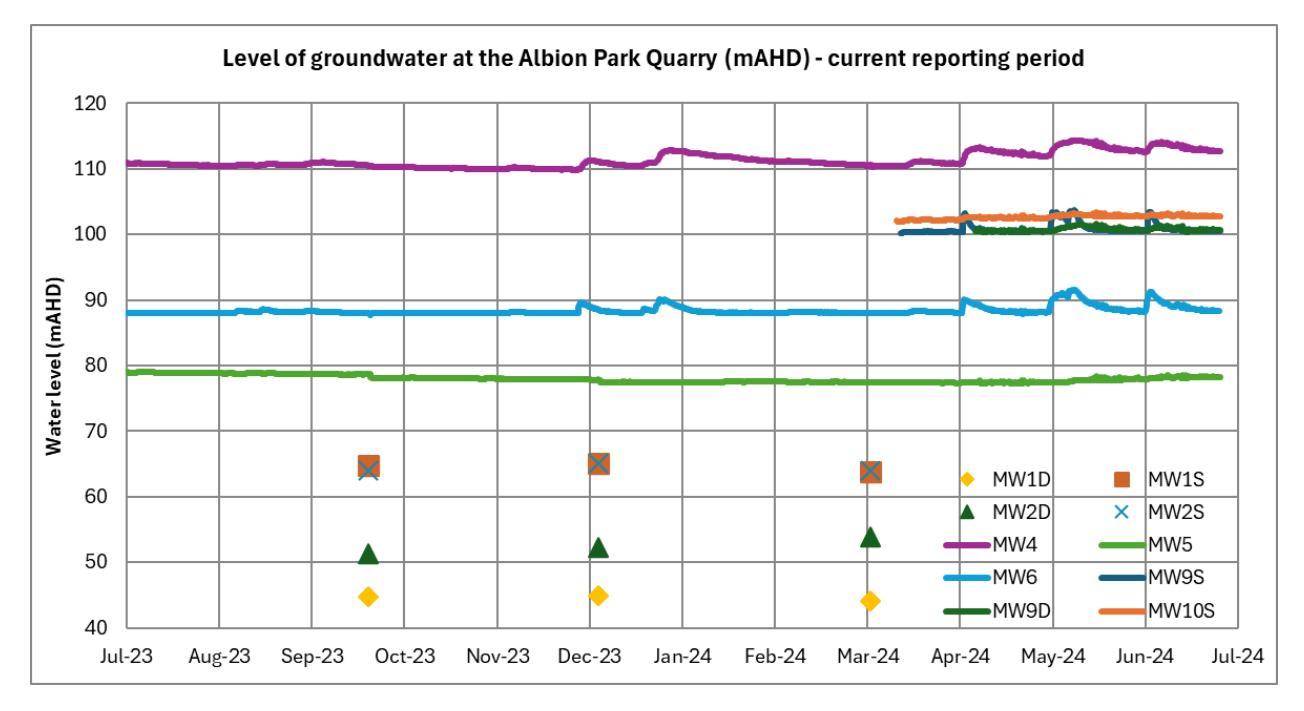
Bores MW2D and MW9D recorded groundwater levels below the Stage 7a trigger levels in the current reporting period. Due to very low TDS results in the previous reporting period, MW2D was purged dry at the start of the current reporting period to ensure water samples reflected the quality of the groundwater at this location. The water level of MW2D has been on a steady increase since this time, reflective of the inherently very low permeability of the latite. The water level in the monitoring bore continues to increase, and it is expected that over coming months it will continue to rise until an equilibrium is reached with the surrounding groundwater. The ground level at bore MW9D is 104.57 mAHD, which is lower than the trigger level for this bore. As such, this trigger level is not appropriate for this bore and will need to be revised once at least 12 months of data is captured for this bore.

- Bores MW4, MW5, and MW9S respond quickly to significant rainfall events. It is likely that similar trends would be observed in bores MW1S and MW2S however the temporal resolution of these bores is limited. It is interesting that bore MW10S does not show this relationship, perhaps as the water level is stabilised by the springs on the northern side of the farm dams.

- Bores MW9S and MW9D follow very closely with the exception of the short term spikes observed in MW9S following significant rainfall events.
- Bore MW5 appears to follow a similar long-term pattern as the deep groundwater monitoring bores (MW1D, MW2D), albeit at a much stronger amplitude, reflective of its elevated position in the landscape. It also shows a slow recovery after sampling, as would be expected from a low permeability rock unit.

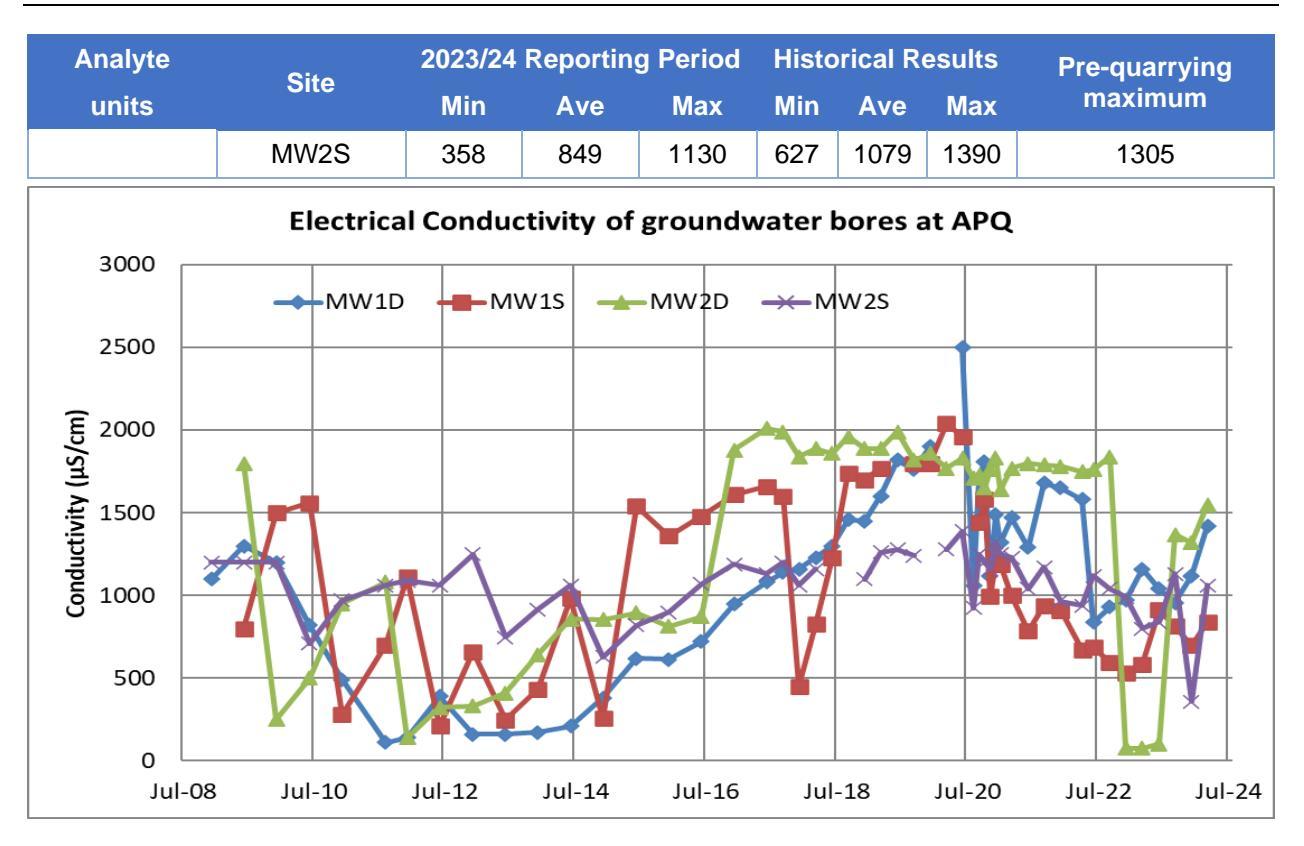
Electrical Conductivity (µS/cm)

The electrical conductivity (EC) of groundwater bores have been highly varied throughout the historical period of monitoring, as has been the case in the current reporting period. MW2D has returned close to its historical EC following purging of the bore at the start of the reporting period. Meanwhile the shallow bores have shown some variability consistent with rainfall patterns, with lower EC recorded in the December 2023 sample following significant rainfall. With the exception of this result for bore MW2S, which was below the historical range, all results have been consistent with the historical ranges for the respective bores in the current reporting period.

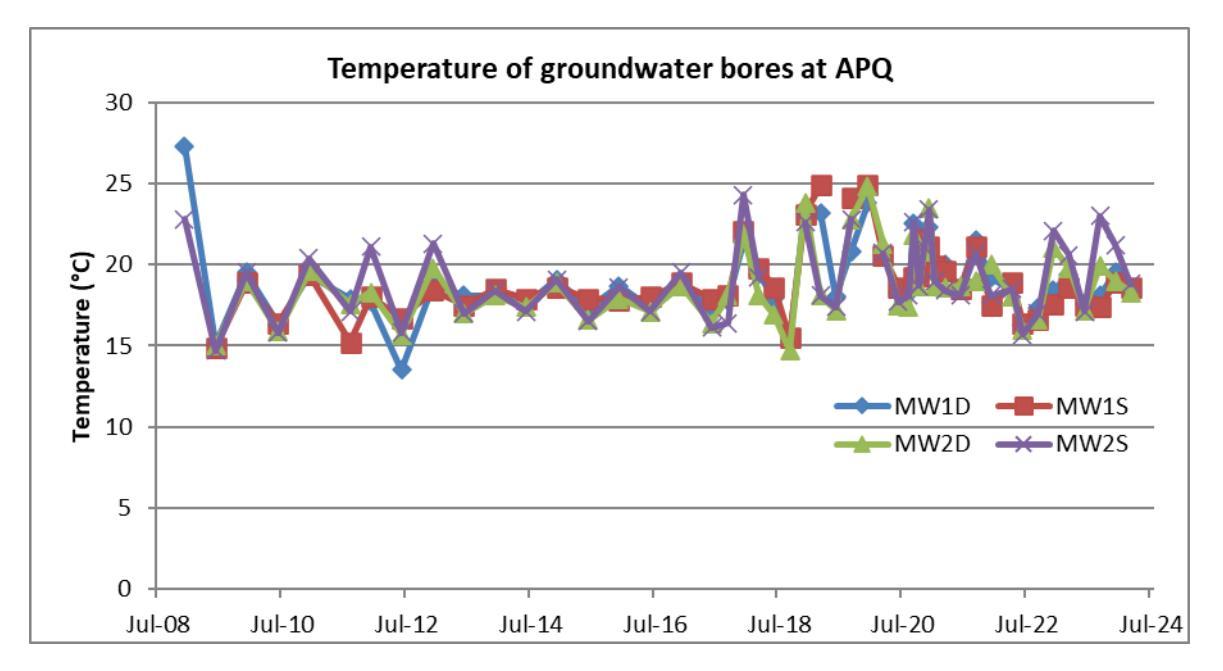
Temperature

Water temperature has fluctuated according to the season and remains consistent with the historical ranges for each bore.

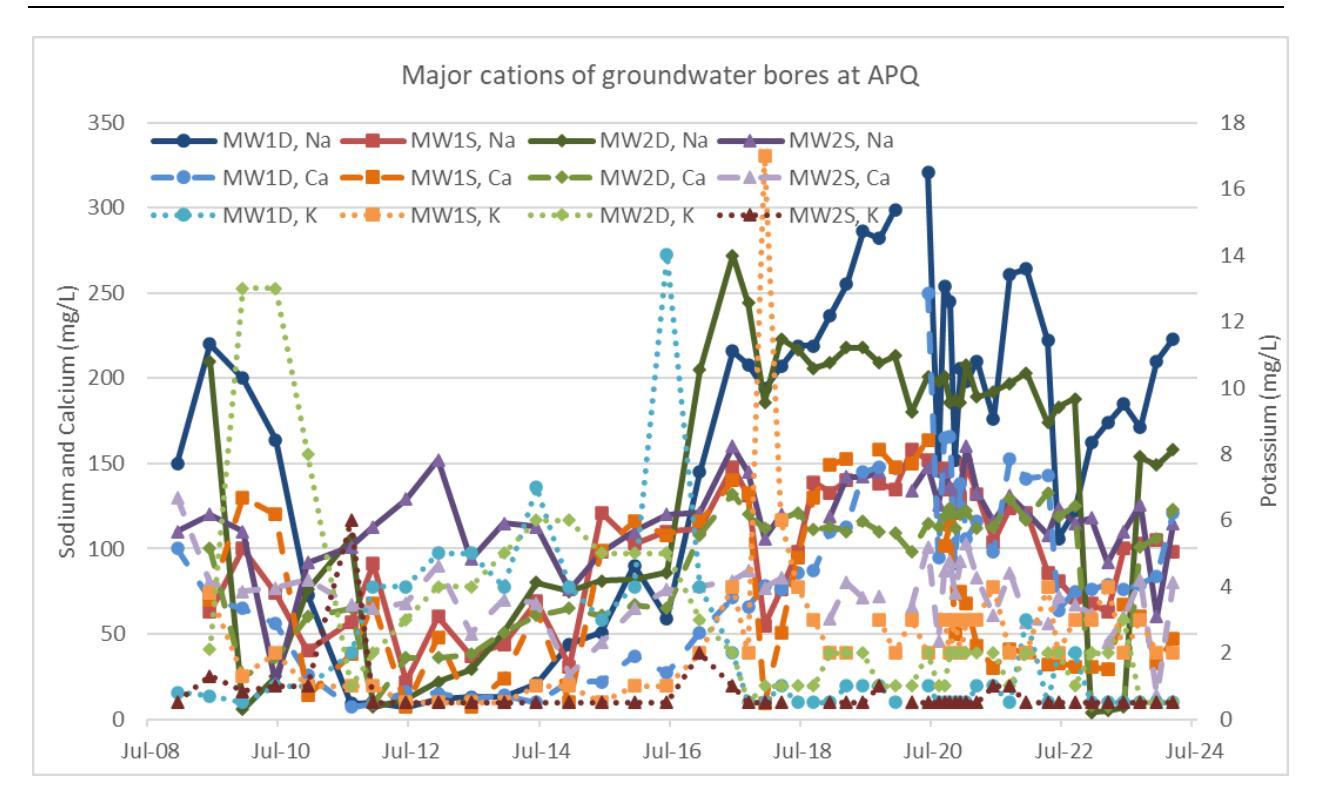
Major Cations

Concentrations of all major cations have been generally consistent with the historical ranges of the respective bores, with some inherent variability in results typical of past trends. The concentrations of cations in MW2D have returned to historical levels in the current reporting period following purging of this bore.

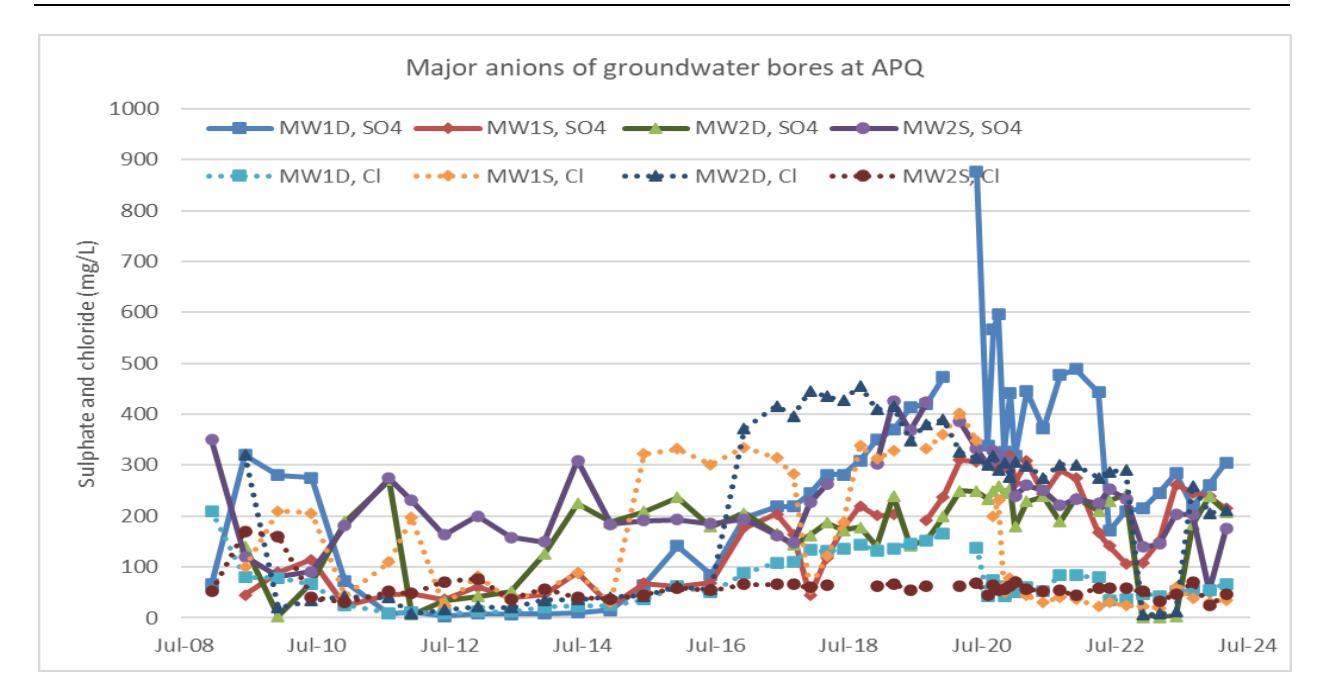
Major Anions

Concentrations of major anions have been generally consistent with the historical ranges of the respective bores, with some inherent variability in results typical of past trends. The concentrations of anions in MW2D have returned to historical levels in the current reporting period following purging of this bore.

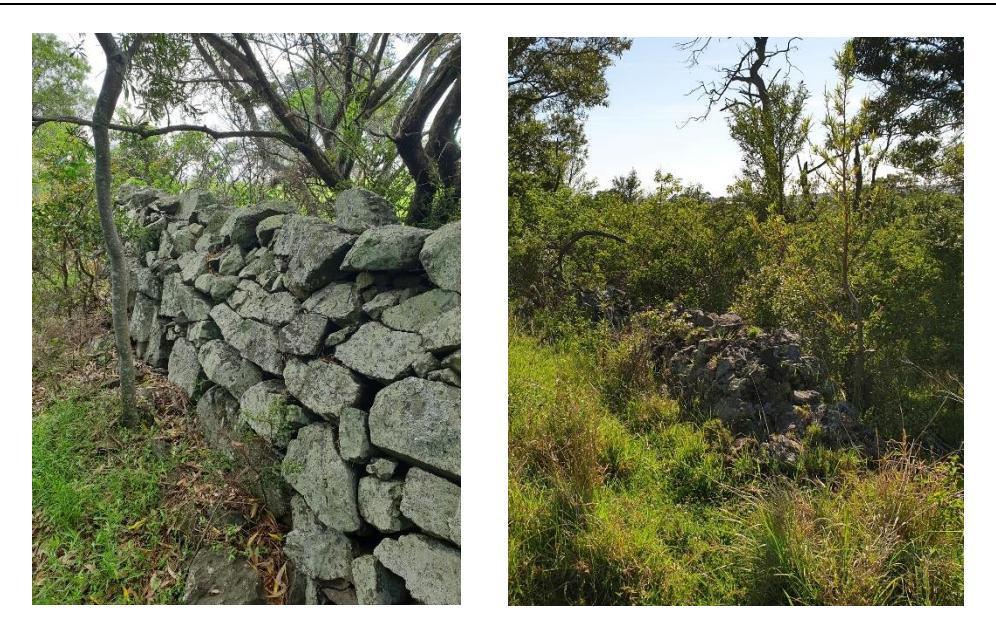
The existing dry stone walls within the Project footprint (walls 3 and 4) were not disturbed during the current reporting period, and remain in their original location as shown in the below photographs. Wall 3 may be relocated to extend wall 5 in the next reporting period, depending on the availability of a suitably experienced dry stone waller. Wall 4 is within Stage 7c, and will not be impacted by the project for a number of years. The reconstructed wall 5 remains in its present location at the northern boundary of the Stage 7 area, where it can be viewed by members of the public from Dunsters Lane.

Dry stone walls within the project footprint (Left: Wall 3; Right: Wall 4)

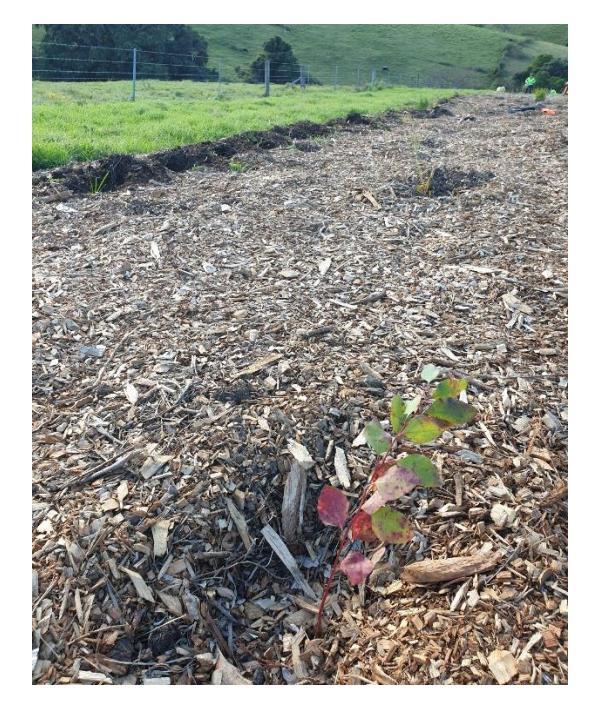
New plantings within the northern vegetation screen

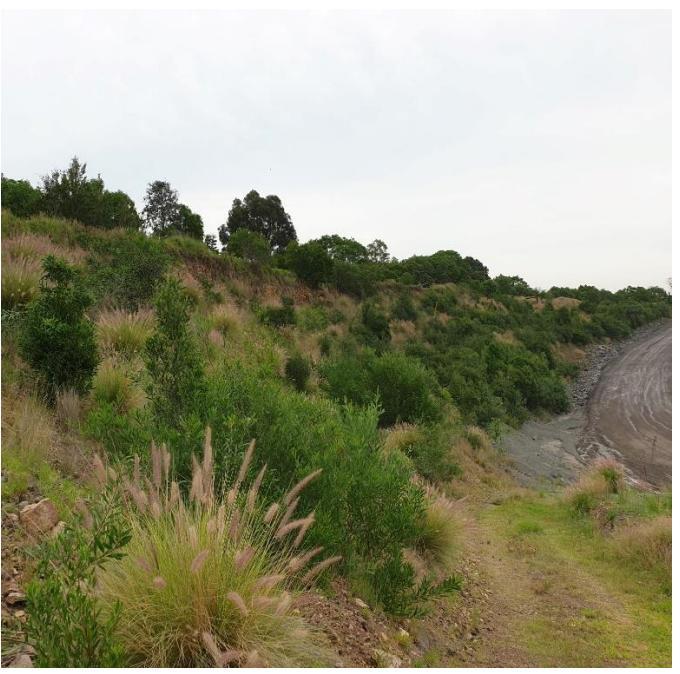
Within the existing extraction area (Stages 1 to 6), vegetation growth along the southern batter (hydroseeded in 2020-2021) has shown excellent growth, with some acacias within the seed mix now reaching maturity (refer photo below right). Similarly, areas of rehabilitated overburden within Stages 1-4 are now well established as a future agricultural domain.

Acacias and Eucalypts establishing along the southern batter seeded in 2020

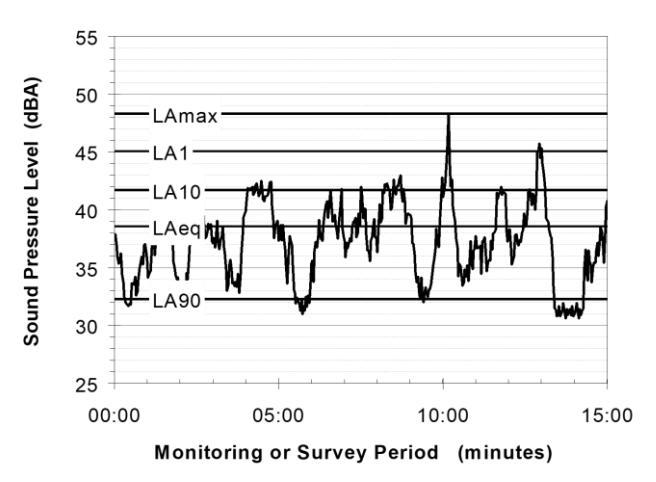
The following figure presents a hypothetical 15 minute noise survey, illustrating various common statistical indices of interest.

- LA1 The noise level exceeded for 1% of the 15 minute interval.
- LA10 The noise level exceeded for 10% of the 15 minute interval. This is commonly referred to as the average maximum noise level.
- LA90 The noise level exceeded for 90% of the sample period. This noise level is described as the average minimum background sound level (in the absence of the source under consideration), or simply the background level.
- LAeq The A-weighted equivalent noise level (basically, the average noise level). It is defined as the steady sound level that contains the same amount of acoustical energy as the corresponding time-varying sound.

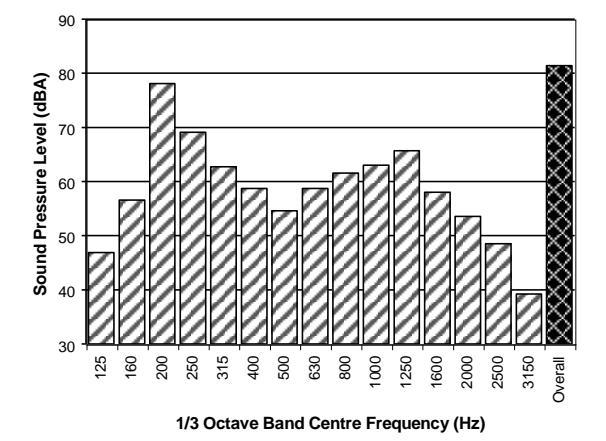
The following figure shows a 1/3 octave band frequency analysis where the noise is dominated by the 200 Hz band. Note that the indicated level of each individual band is less than the overall level, which is the logarithmic sum of the bands.

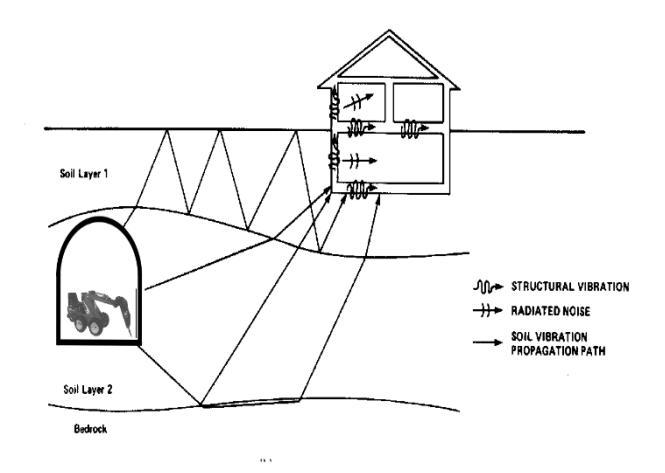
The following figure presents an example of the various paths by which vibration and ground-borne noise may be transmitted between a source and receiver for construction activities occurring within a tunnel.

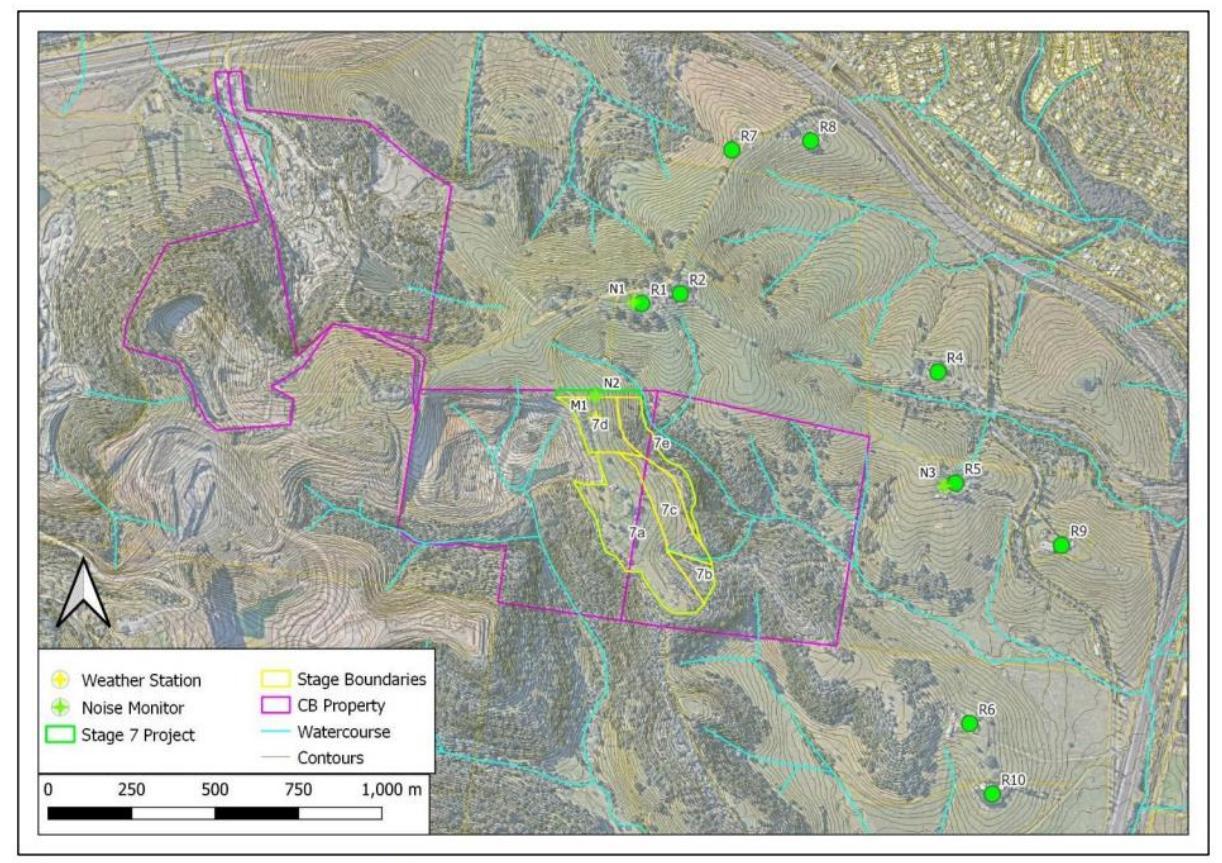
Figure 1 Extraction area and monitoring locations

The noise measurement locations in **Figure 1** are reproduced from the Noise Monitoring Program.
