Albion Park Quarry Community Consultative Committee

Minutes of the Meeting of the Albion Park Quarry CCC

Held on: 28/8/2025 – 1:00pm to 2:00pm

Item 6 – Albion Park Quarry CCC Meeting 28th August 2025

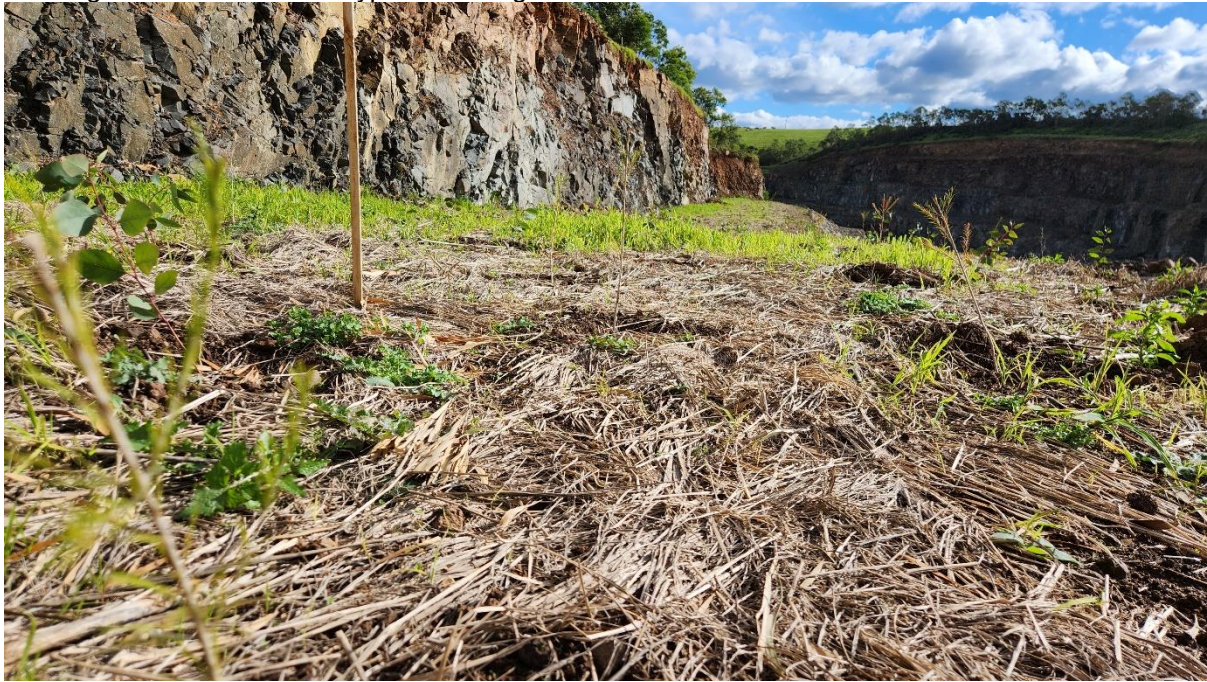
Since the last meeting, Cleary Bros have revegetated the first upper bench of the Stage 7a area. A 100m section was divided into five zones, with 3 of the zones planted out with a total of 300 *Eucalyptus tereticornis* (Forest Red Gum) and *Melaleuca armillaris* (Bracelet Honey-Myrtle) tubestock, as well as a Moreton Bay fig in each zone. The other two zones were direct seeded with a seed mix comprising 7 local species as a trial into this rehabilitation method. The revegetation has benefited from excellent rainfall since the June planting, with fresh growth observed and negligible losses so far (refer Figure 1).

Figure 1 – Rehabilitation of initial 100m section of upper bench, 1 month after planting (7/7/2025) showing *Melaleuca* and *Eucalyptus* seedlings

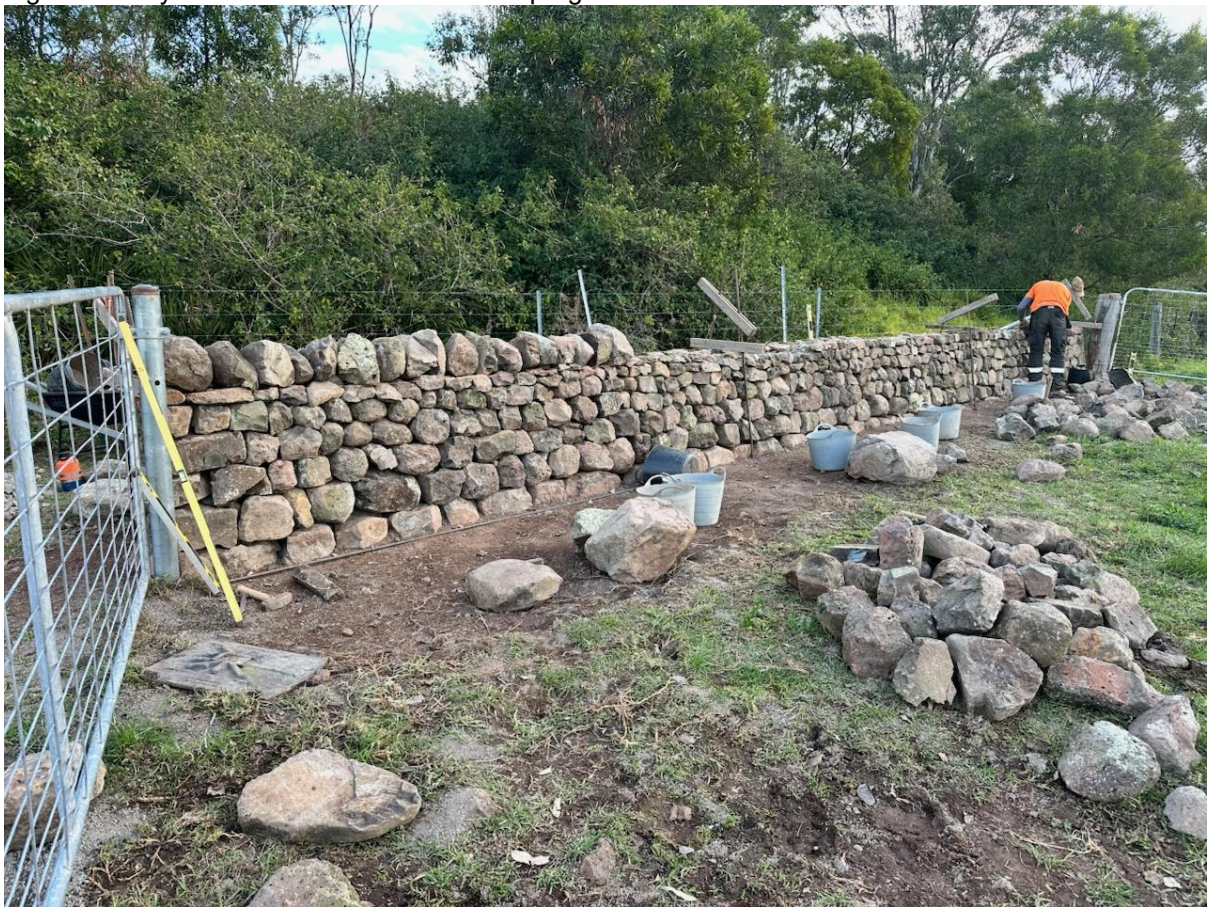
Cleary Bros have commenced the relocation of the dry stone wall from the Stage 7a area to the entrance of the property. Cleary Bros have engaged accredited dry stone wallers from Stone of Arc to undertake this work. Stone of Arc have also been commissioned to restore the existing dry stone walls at the entrance to the property to ensure their longevity. At the time of preparation of this report, all existing rocks from the Stage 7a wall have been excavated and relocated to the property entrance, ready for reconstruction. Figure 2 shows the reconstruction of the dry stone walls in progress. The reconstruction work will continue through August and September 2025.

Figure 2 – Dry Stone Wall Reconstruction in progress
