Albion Park Quarry

Rehabilitation Management Plan

Version 1 | Revision 5

Issued – October 2024

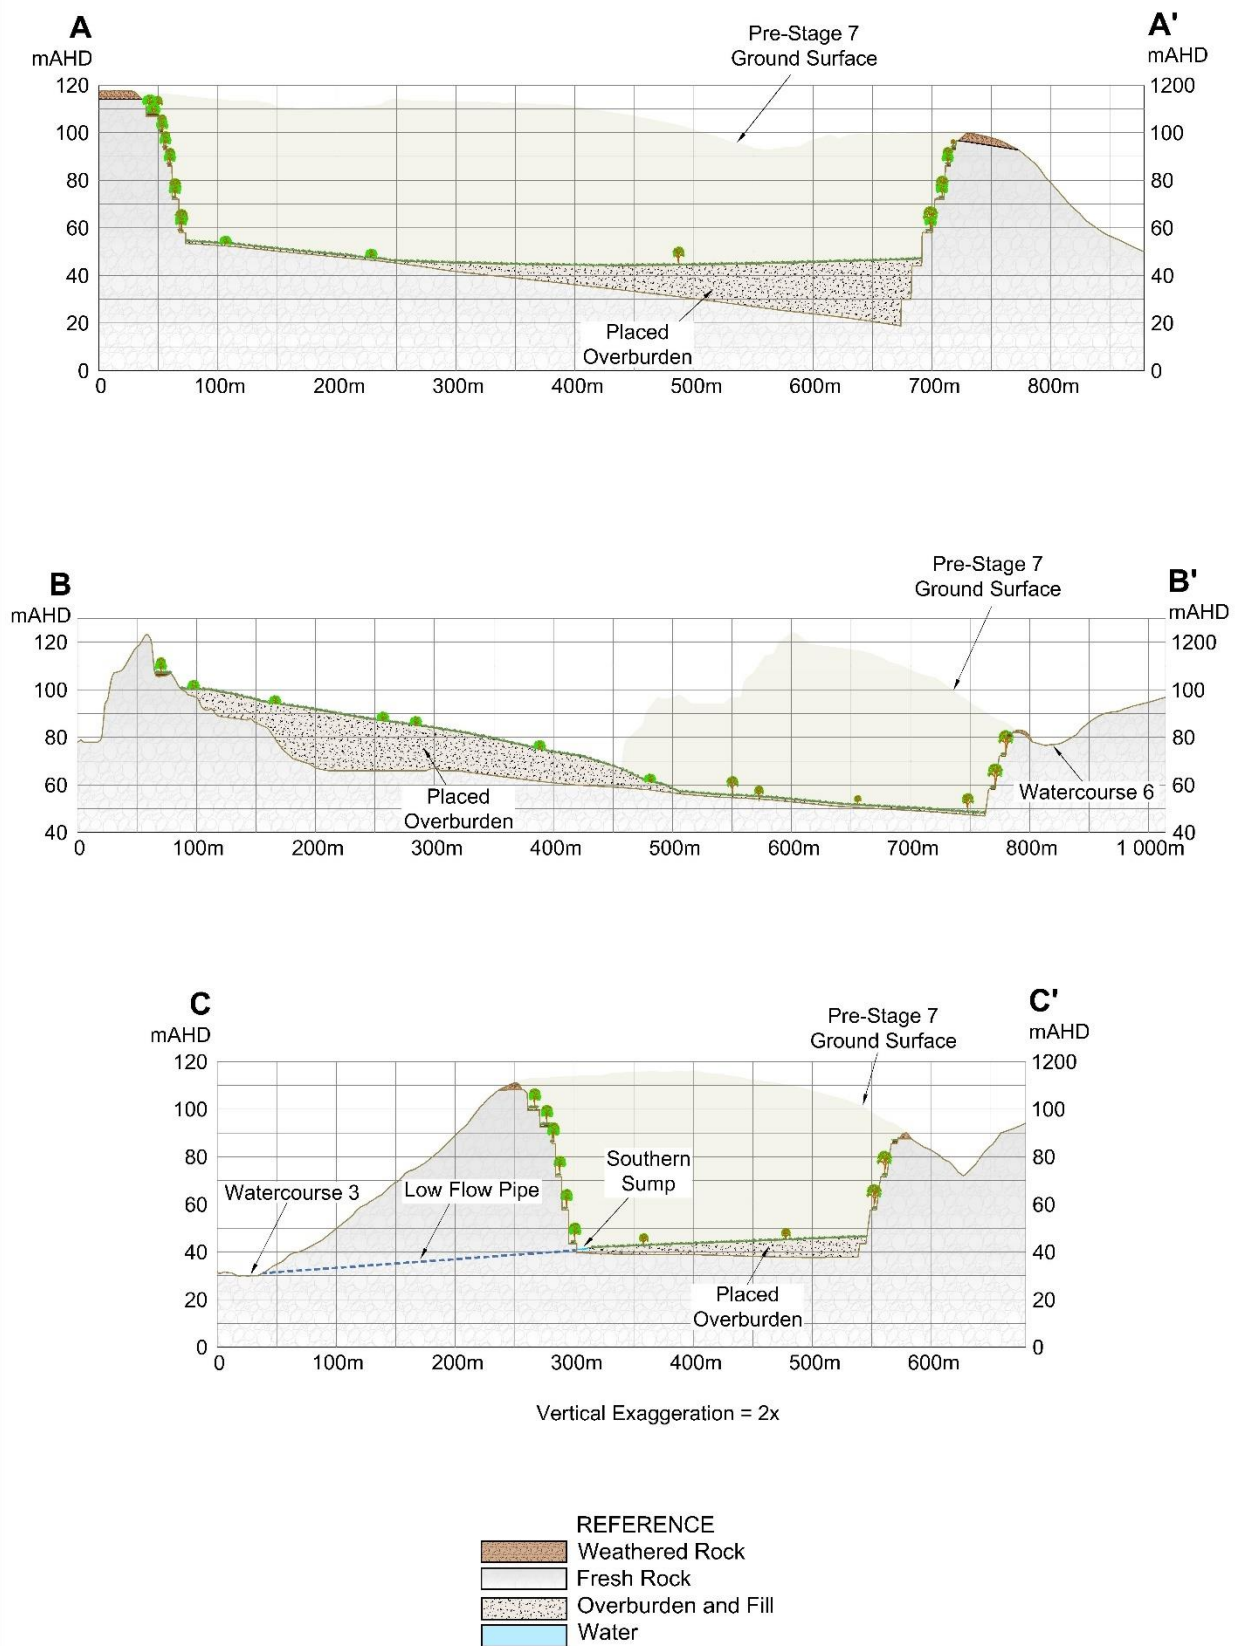
Figure 5
FINAL LANDFORM CROSS-SECTIONS

Source: RPM Global

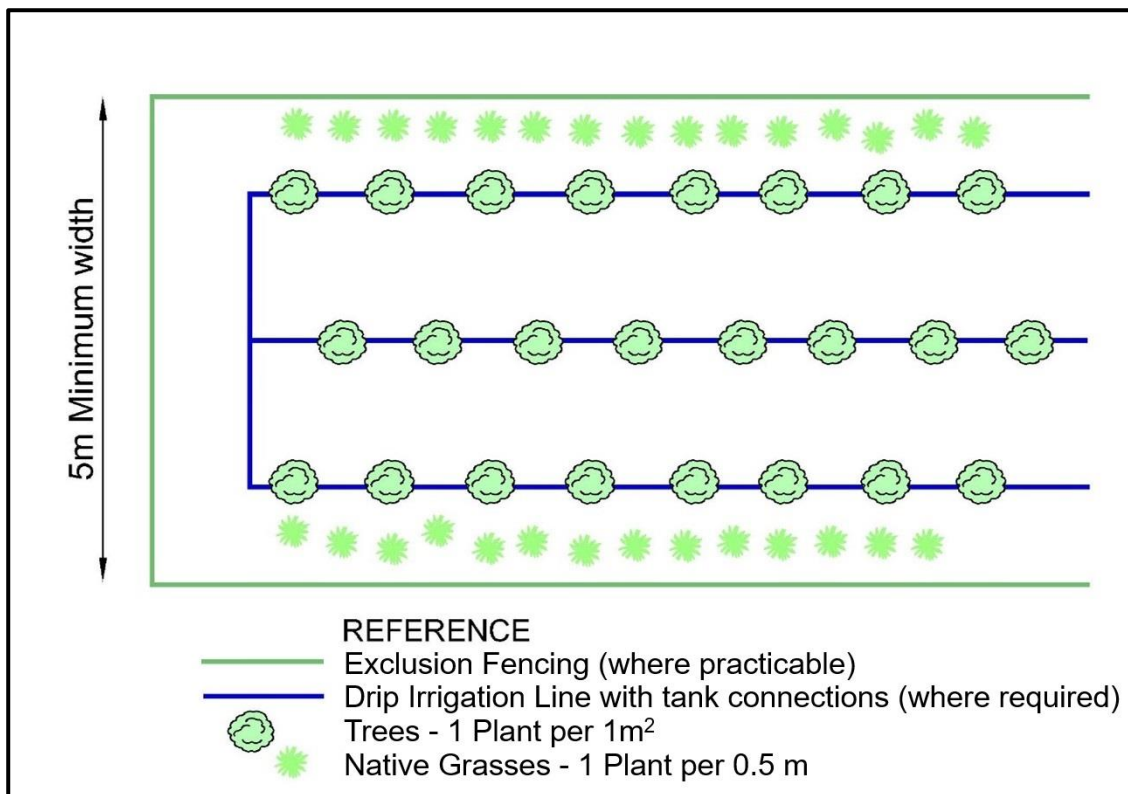
Tree screens would be configured generally as shown in the below diagram.

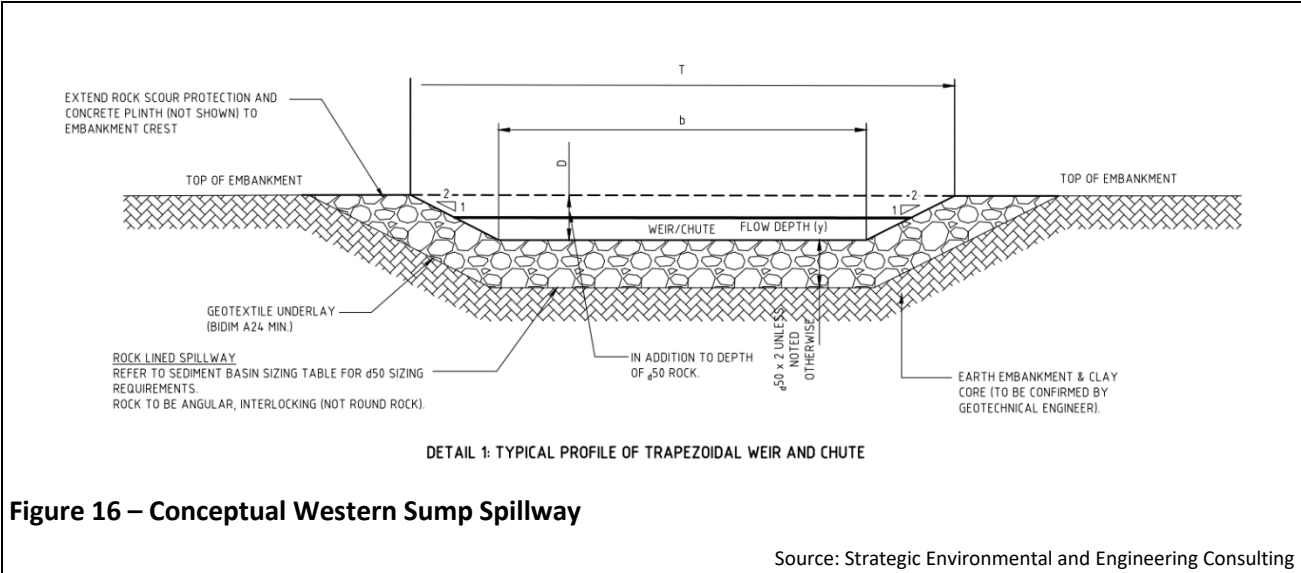
Following confirmation that water quality is suitable for passive discharge to Watercourse 1, an engineered, stabilised spillway will be constructed in accordance with the relevant design criteria applicable at the time. **Figure 16** presents a conceptual layout for the Western Sump spillway to Watercourse 1.
